**HIGH STREET, SPOFFORTH
NORTH YORKSHIRE**

ARCHAEOLOGICAL WATCHING BRIEF

JB Archaeological Services

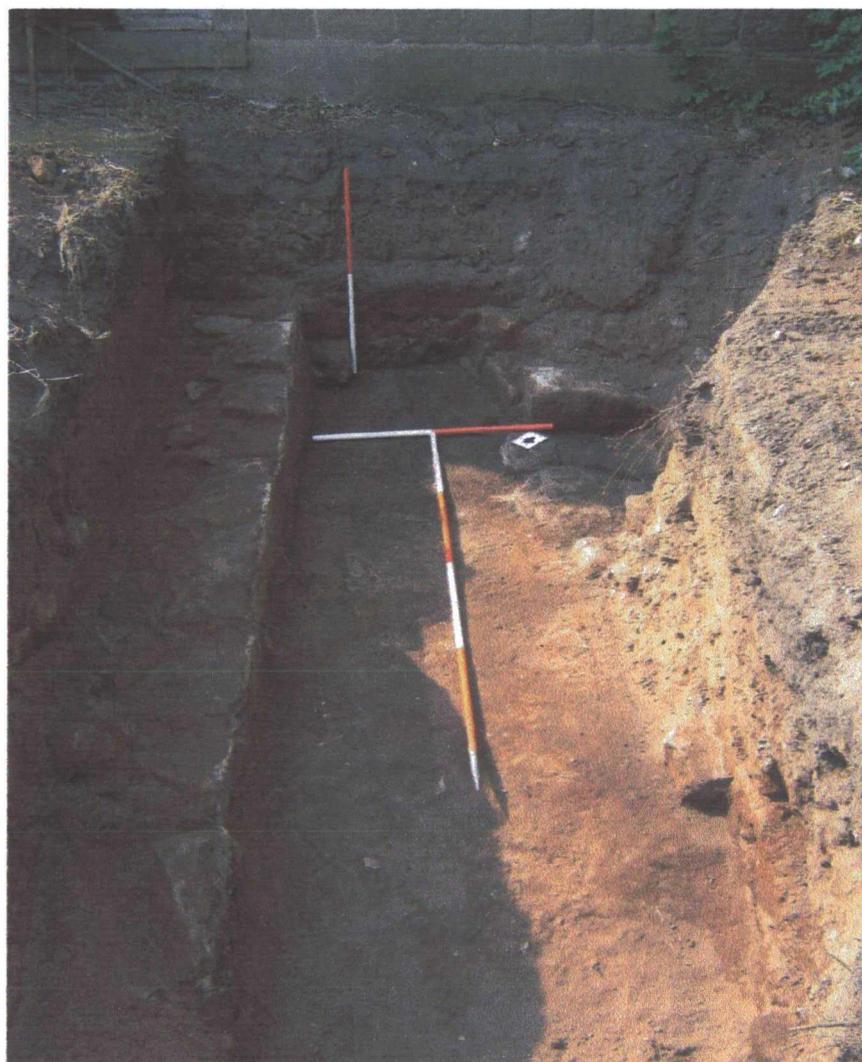
Front Cover. Inside of the Northern End of the Building.

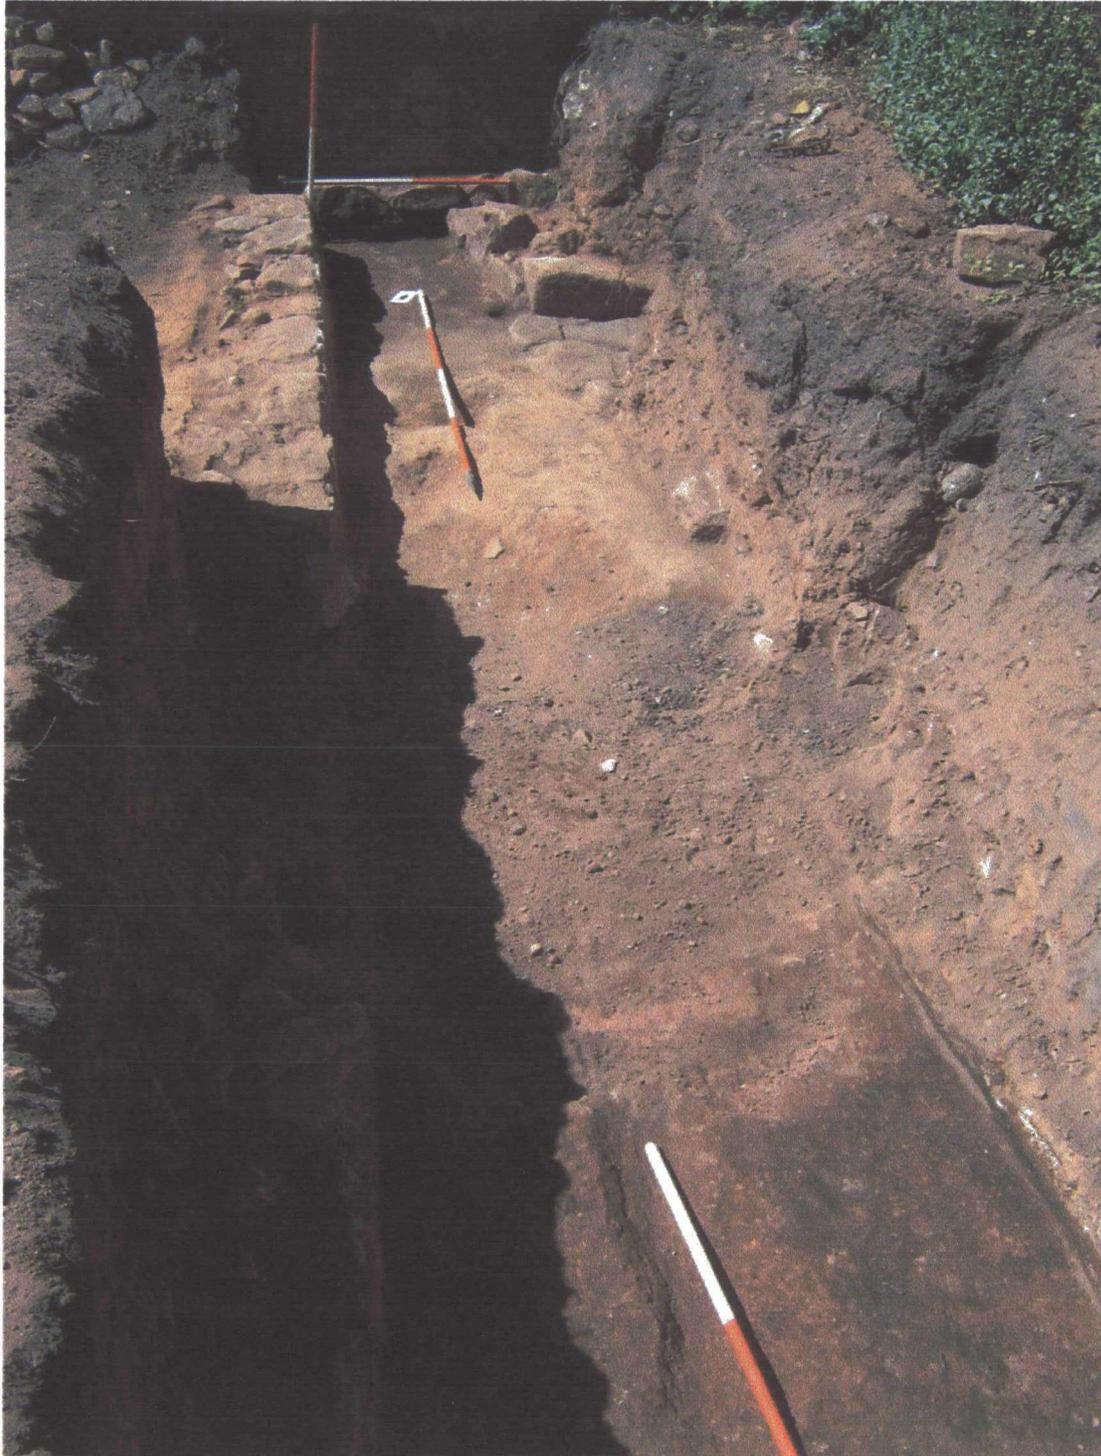
5.2 The archaeological investigation showed that there were the remains of a narrow building running along the eastern frontage of the plot adjacent to the modern public highway (Figure 1). The building was at least 7.05m long and 2.2m wide and survived to a height of 0.4m (49.75mOD), and had been constructed from a single thickness of roughly squared sandstone blocks [03] which had been built directly into a recess [05] cut into the slope of the hillside [02] (Plate 2). The sandstone blocks ranged in size from 0.52m by 0.18m to 0.2m by 0.18m and did not bear any traces of tool marks or dressing. Where the wall had been cut into the hillside the void behind it had been backfilled with stone fragments and the previously excavated backfill.

Plate 1. Interior of the Remains of the Building. Looking north. Scales 1 & 2m.
