ALL SAINTS' CHURCH
HUNMANBY
NORTH YORKSHIRE

ARCHAEOLOGICAL
WATCHING BRIEF

REPORT
DECEMBER 2005

SITE CODE: HAS05

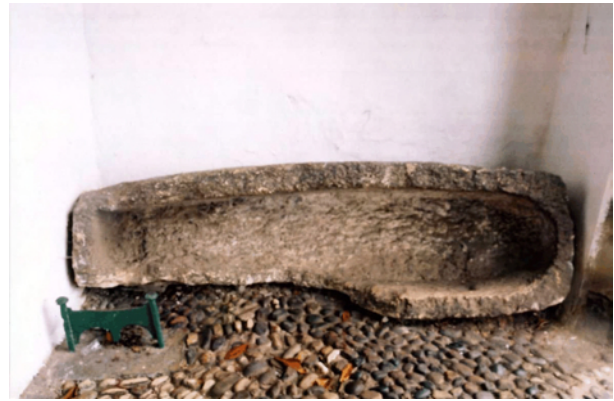
presumably of iron Age date (Sheppard 1907). A stone sarcophagus deposited within the church porch may date to the Roman period (Plate 2).

Plate 2 Roman sarcophagus at All Saints'

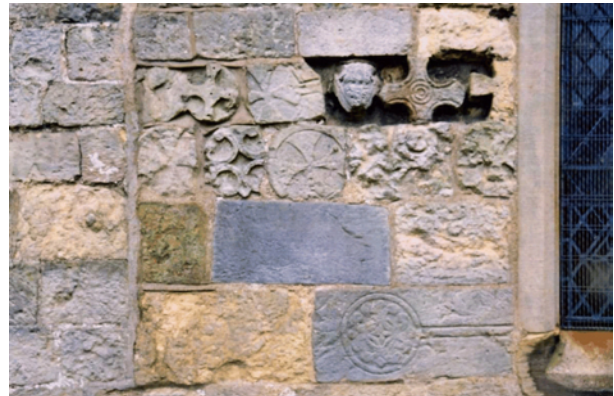
Much of the church itself dates to the Norman period, although it is frequently assumed that the foundation could have been Saxon (Bulmer 1892). A number of pieces of carved stone, including fragments of crosses and an Anglian cross-head, were rebuilt into the north wall of the north aisle during 19th-century alterations (Plate 3), providing an indication of early medieval ecclesiastical activity (Pevsner and Neave 1972, 569; Allison 1974, 243). The place-name *Hunmanby* may also reflect early medieval activity, as it contains the Scandinavian element *-by*, generally translated as homestead: the name is variously translated as homestead of the huntsmen, houndsmen, or hundredsmen.

Plate 3 Reused carved stone in north aisle
