*Plate 1 St. Andrew's, Weaverthorpe, viewed from the south-east.*

# Humber Field Archaeology

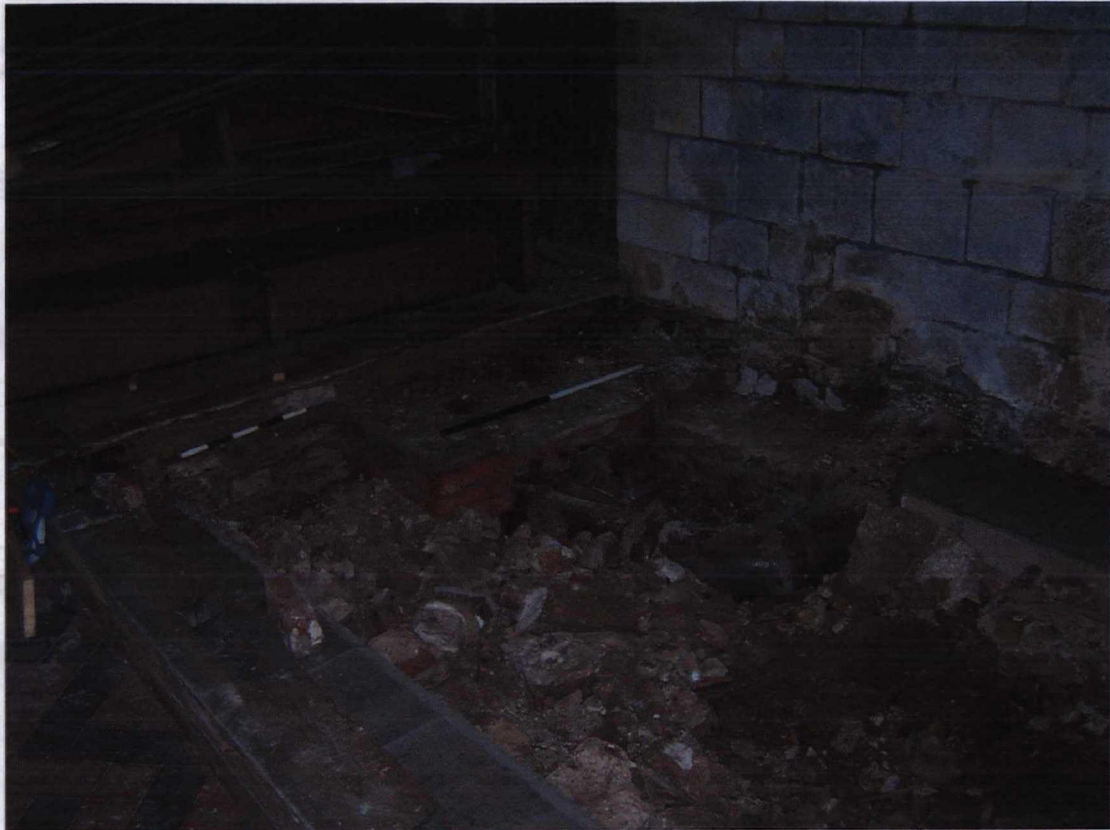
*Plate 3 The western end of the northern pews: limestone and chalk foundations, 19<sup>th</sup> century services, church foundations and underpinning, modern concrete beams and rubble, looking north-west.*

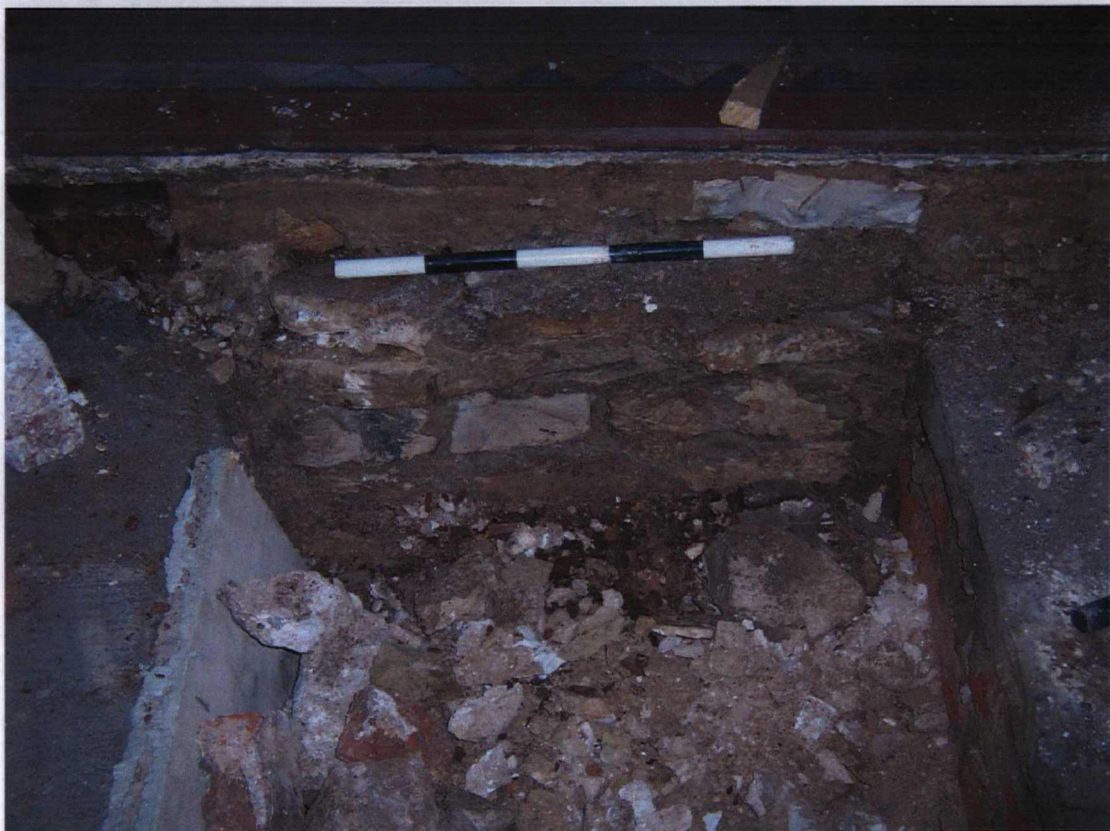
*Plate 4 The isolated limestone foundations (1012), with concrete(1005) to the left and 19<sup>th</sup> century brick services to the right, looking west.*

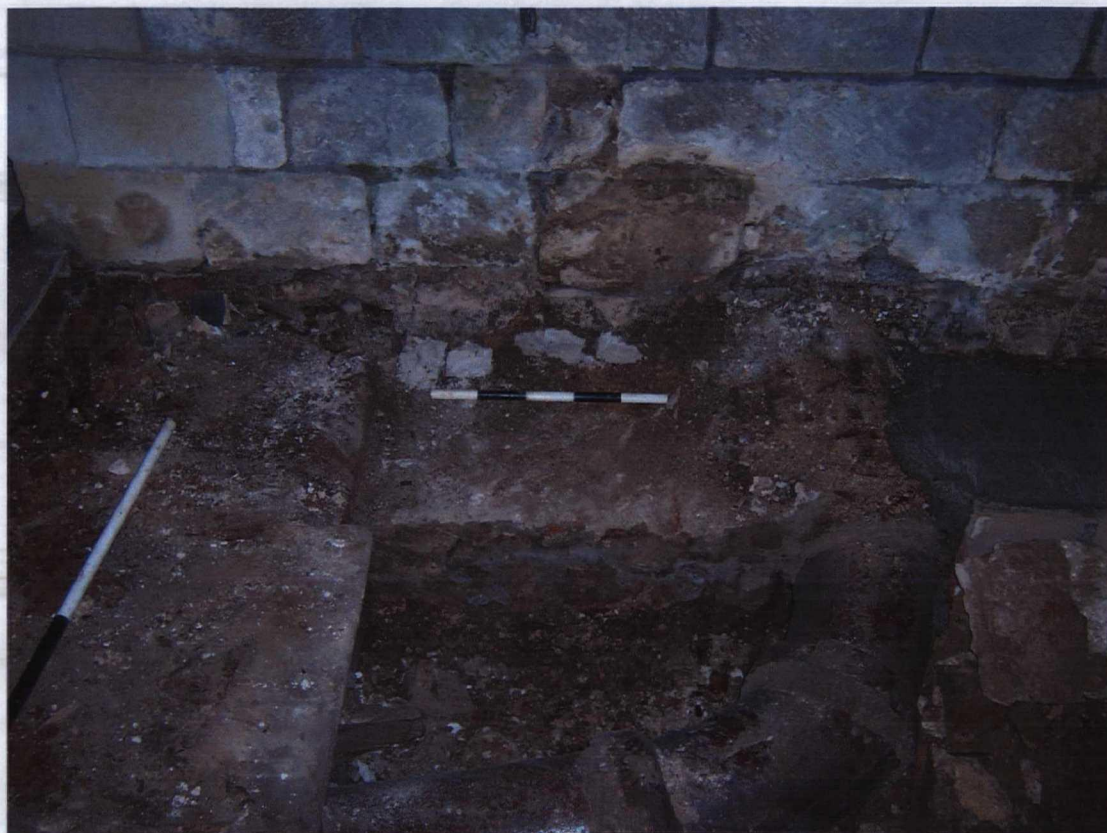
*Plate 5 Brick underpinning (1020) for church wall (1021) overlying compact chalky clays (1018), showing 19<sup>th</sup> century air duct (1015) to right and mid left. Viewed from the south.*

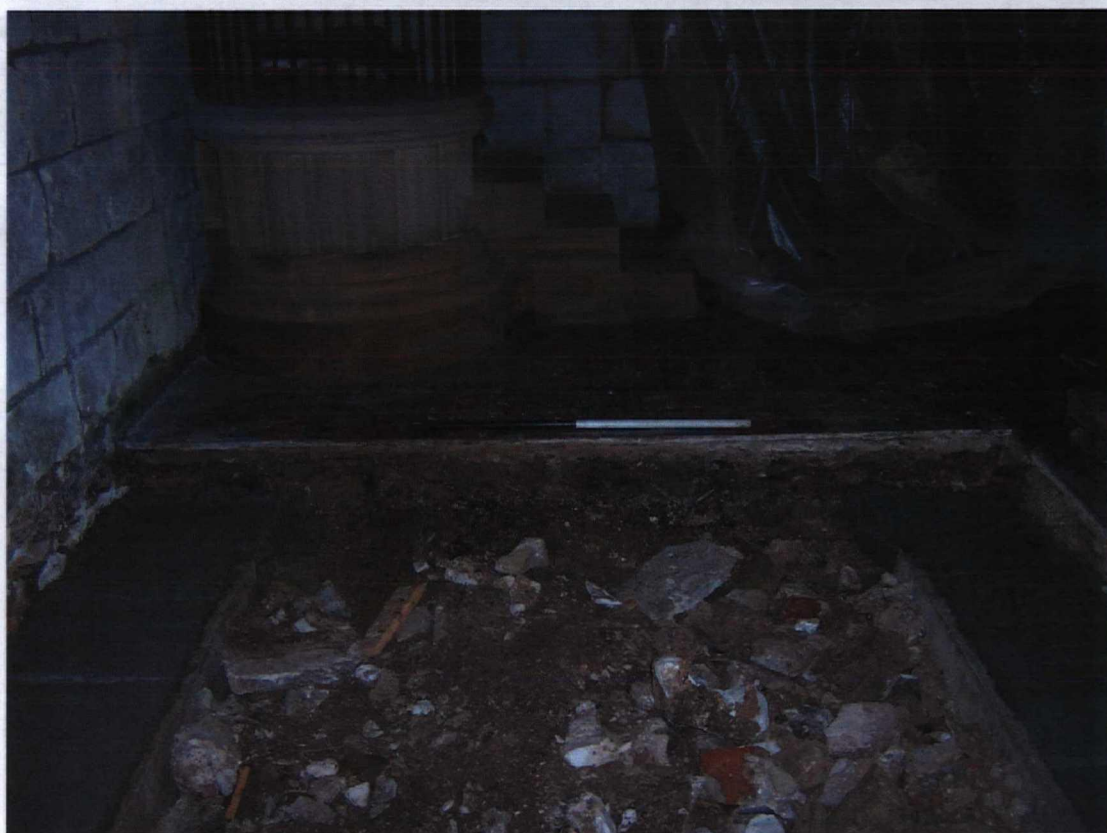
*Plate 6 The eastern end of the northern pews showing layers (1003), (1004) and (1002) underlying the black and blood-red floor tiles (1001), looking east. Note modern rubble (1013).*

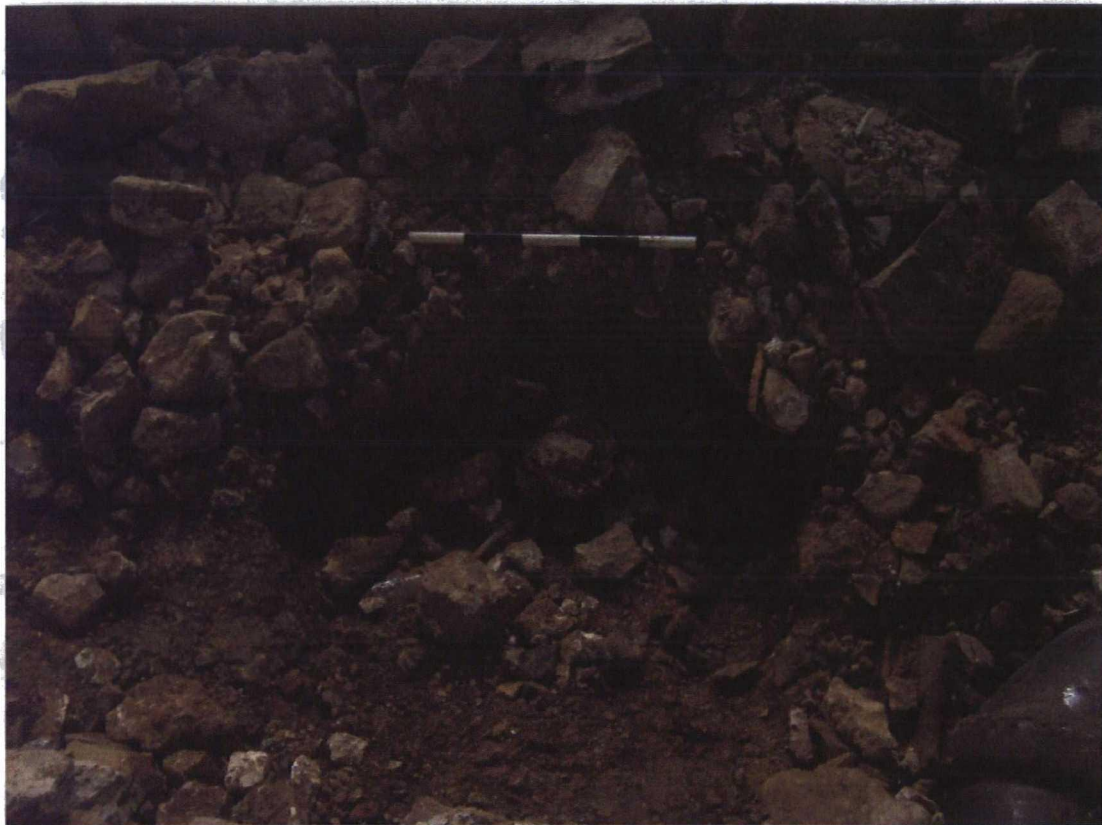
*Plate 7 Collapse/depression (1025) within (1013), looking south-west.*

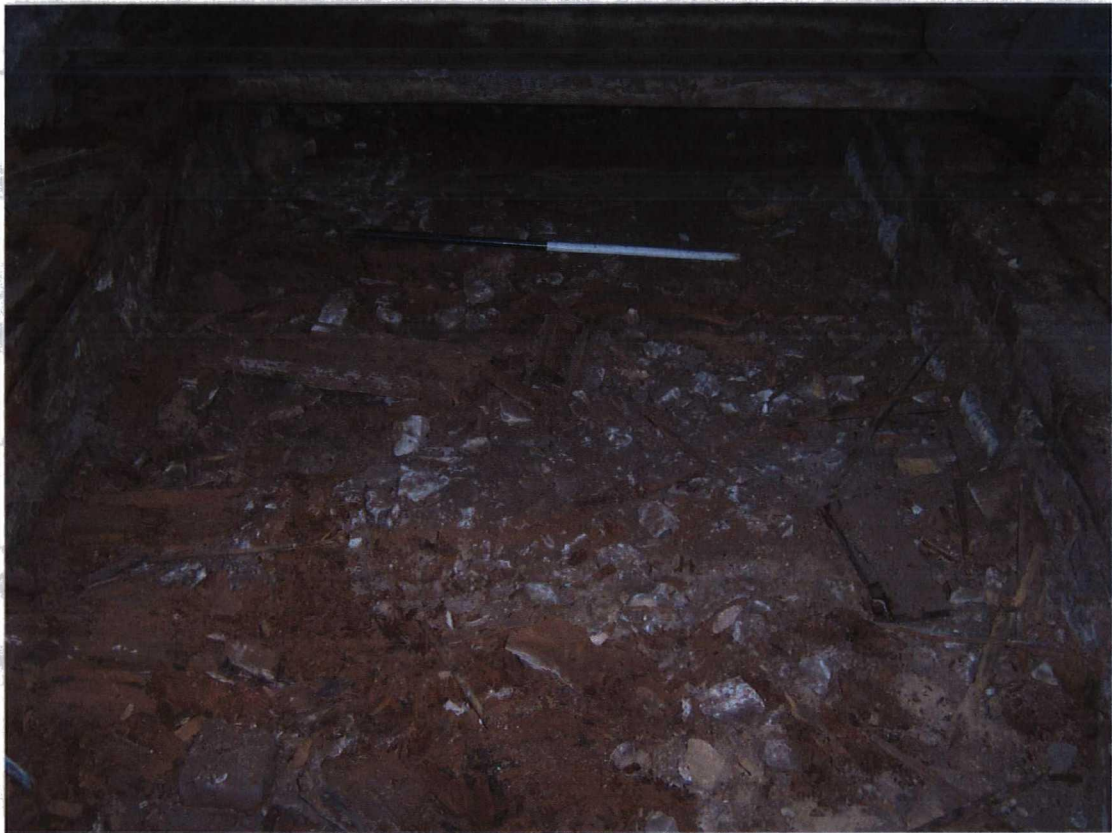
*Plate 9 ?Floor deposit (2013) in the central area of the southern pews, looking west.*

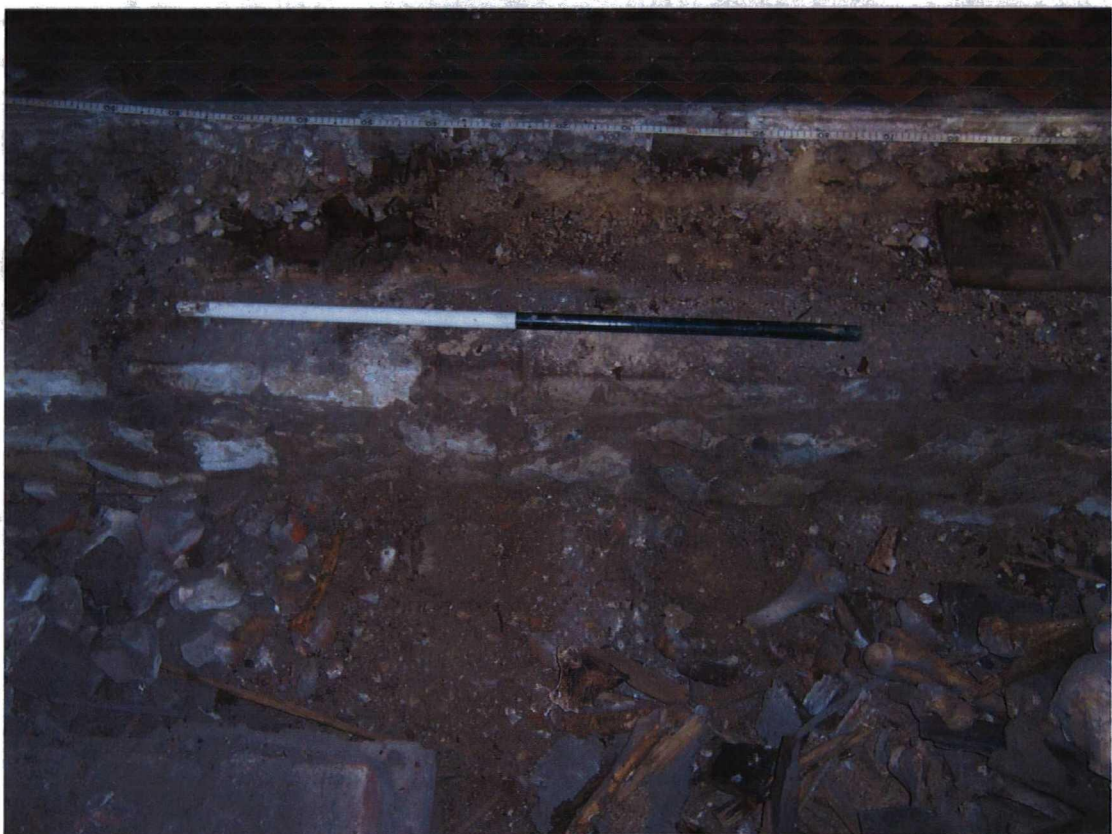
*Plate 10 Northern limestone foundations (2005), with later brick repairs (2004), underlying the nave flooring (2001) within the southern pews. Viewed from the south.*

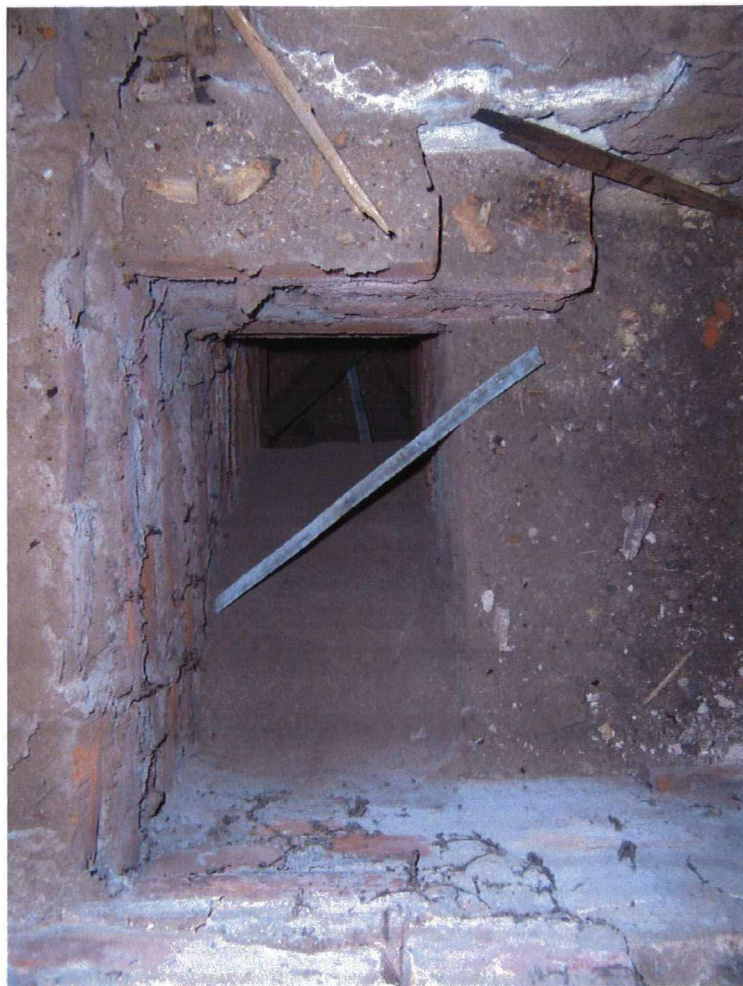
*Plate 11 'Void' and deposit (2010) at the western end of the southern pews.*

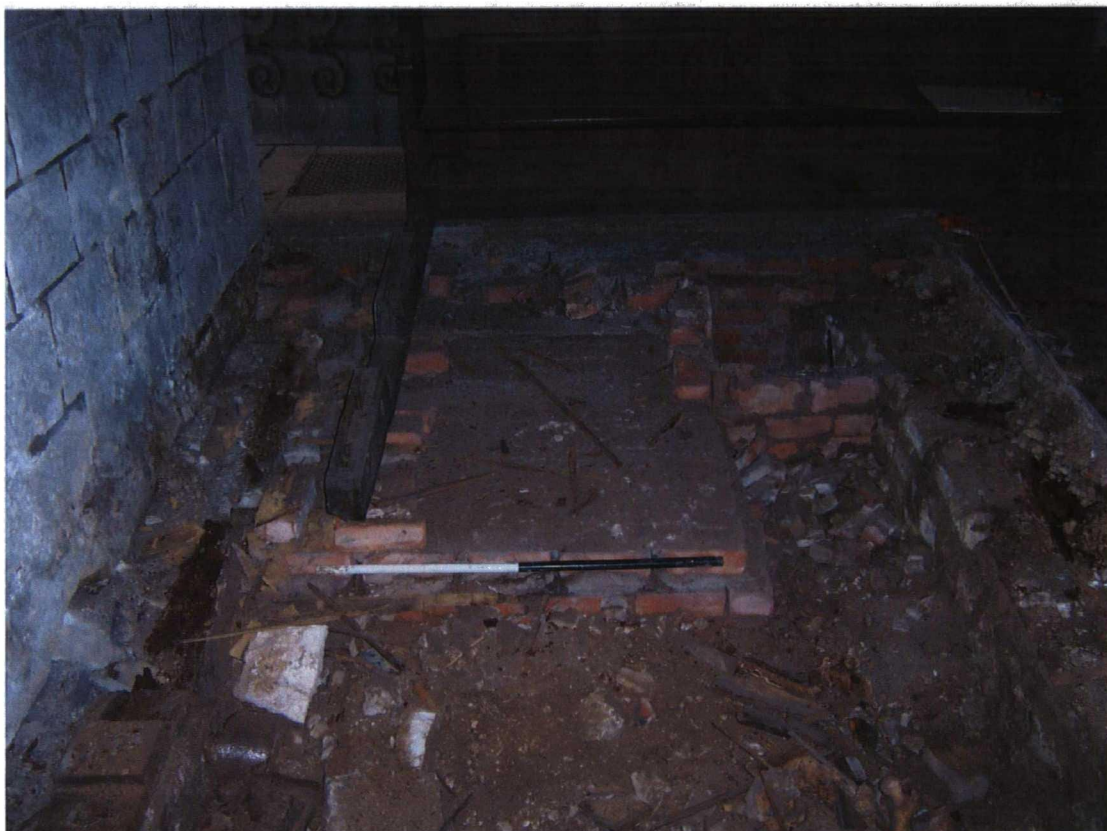
*Plate 12 The likely 19<sup>th</sup> century brick structure (2007), with (2008) to the right, viewed from the east.*

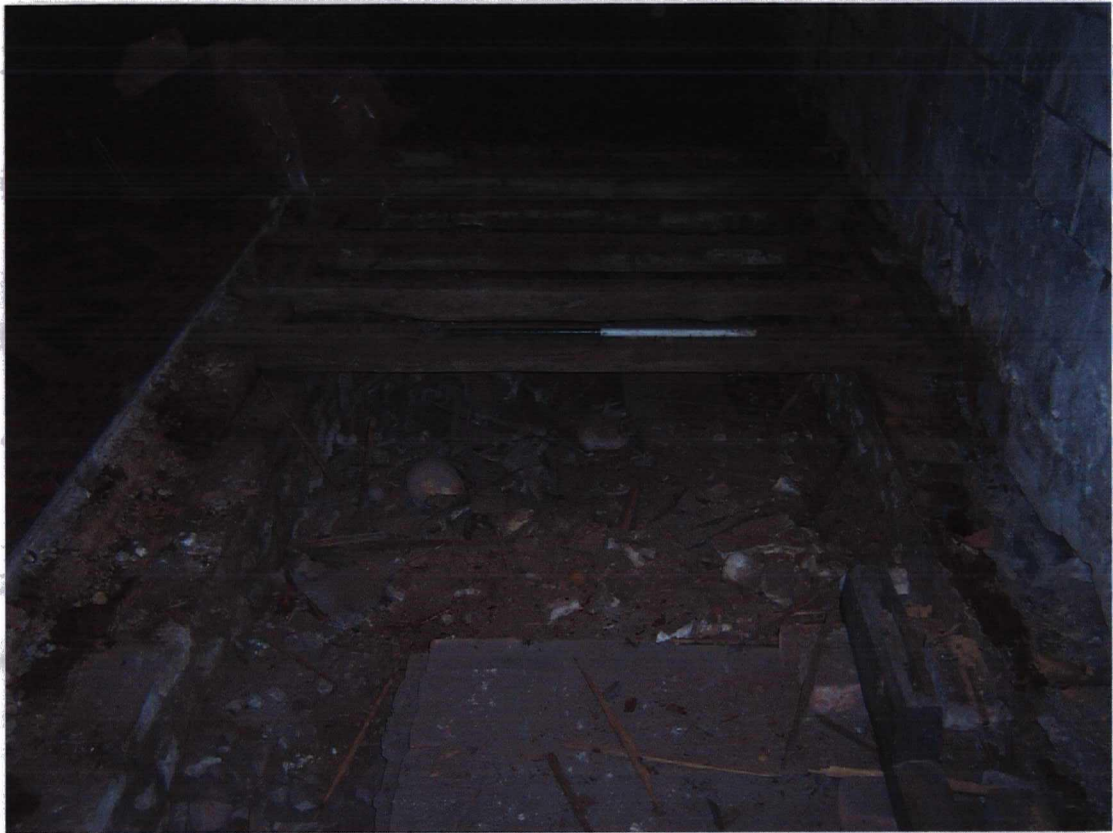
*Plate 13 Remains of spoil (2011) leading to the disarticulated human remains (2014) in the western and central area of the south pews, looking east.*

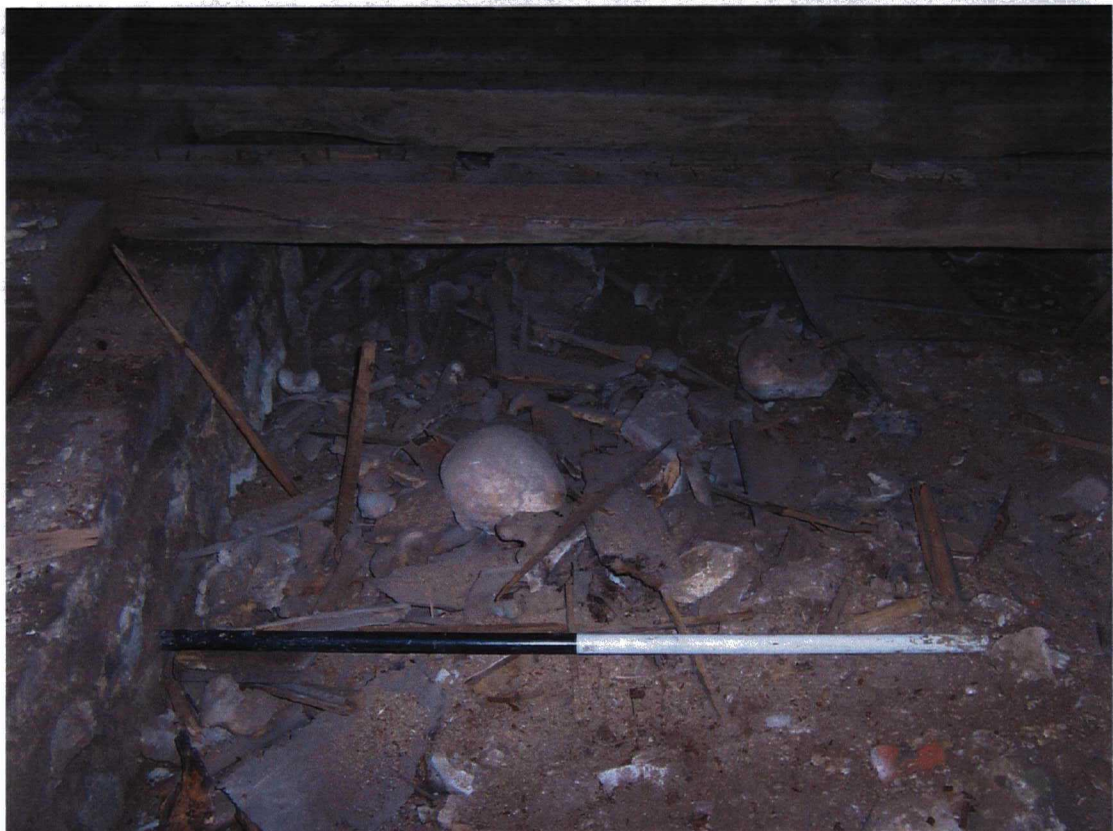
*Plate 14 Detail of the arrangement of the disarticulated human remains (2014), viewed from the west.*

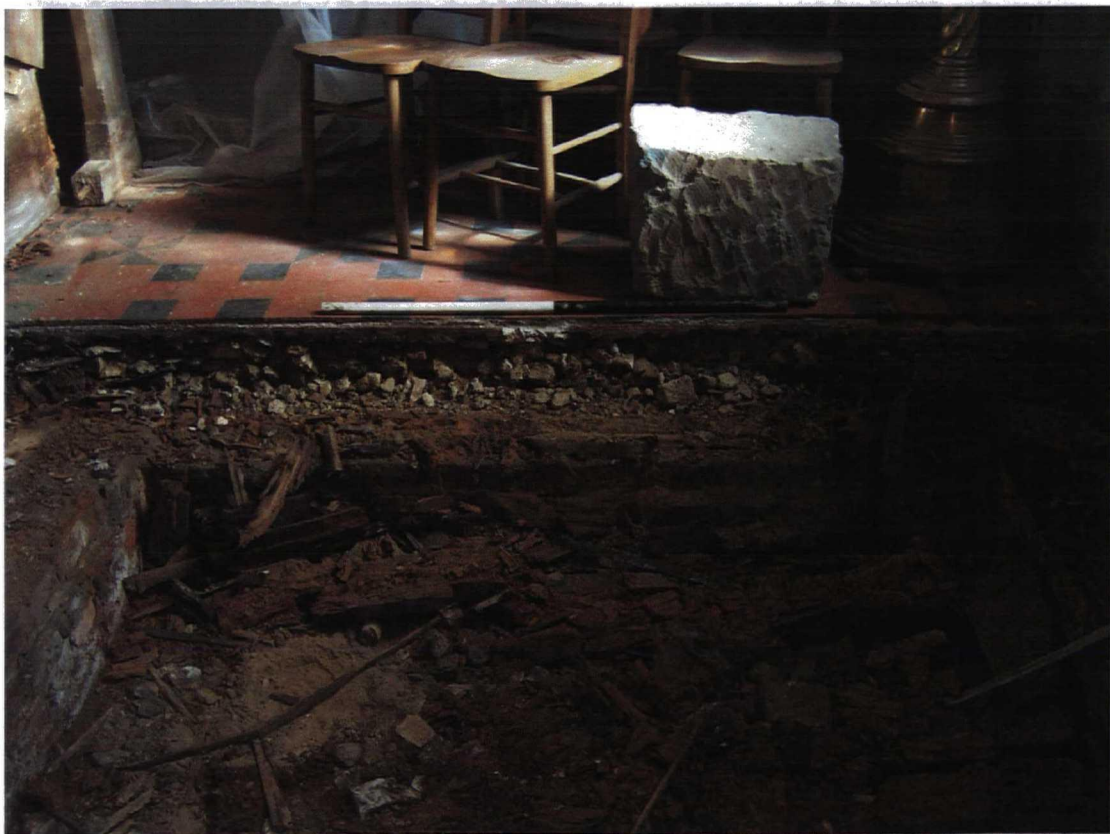
*Plate 16 19<sup>th</sup> century floor (2001) and associated hardcore overlying 19<sup>th</sup> century brick foundations (2004), at the eastern end of the southern pews, viewed from the west.*
