A1(T) Dishforth to Barton Improvement, North Yorkshire

Phase 2 geophysical surveys

Report 1368

May 2006

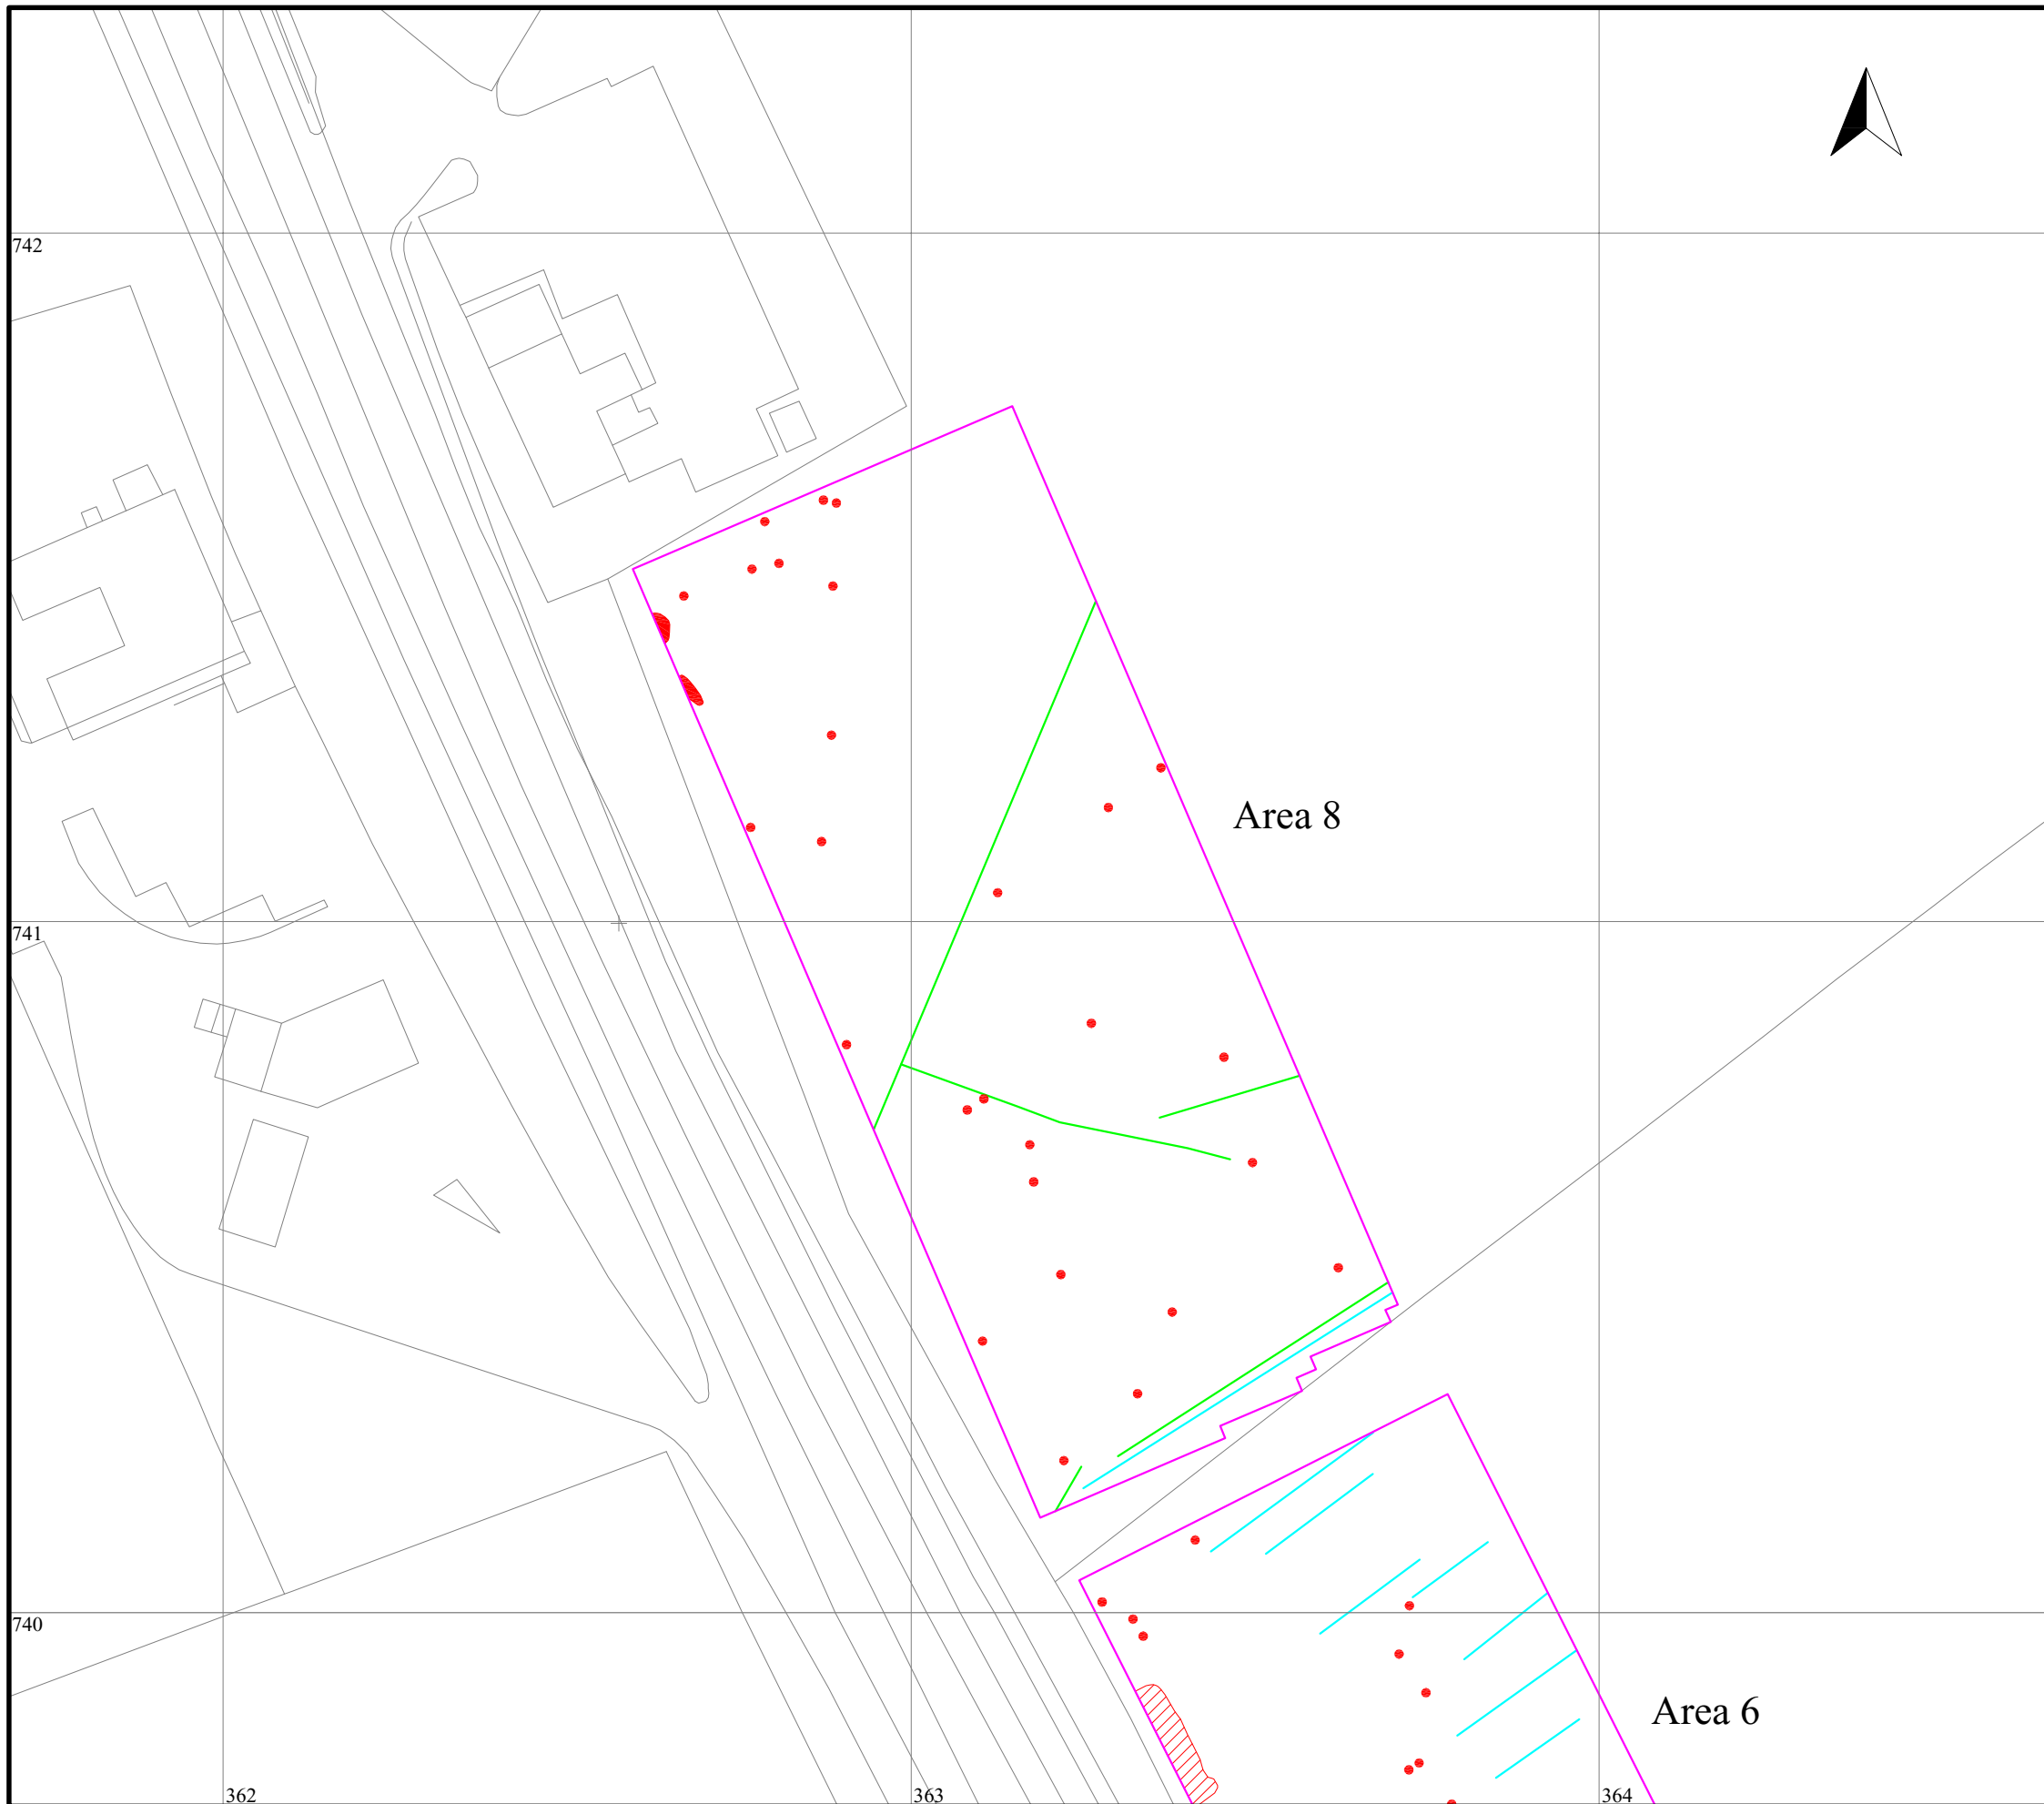
Figure 7

Geophysical interpretation of Area 8

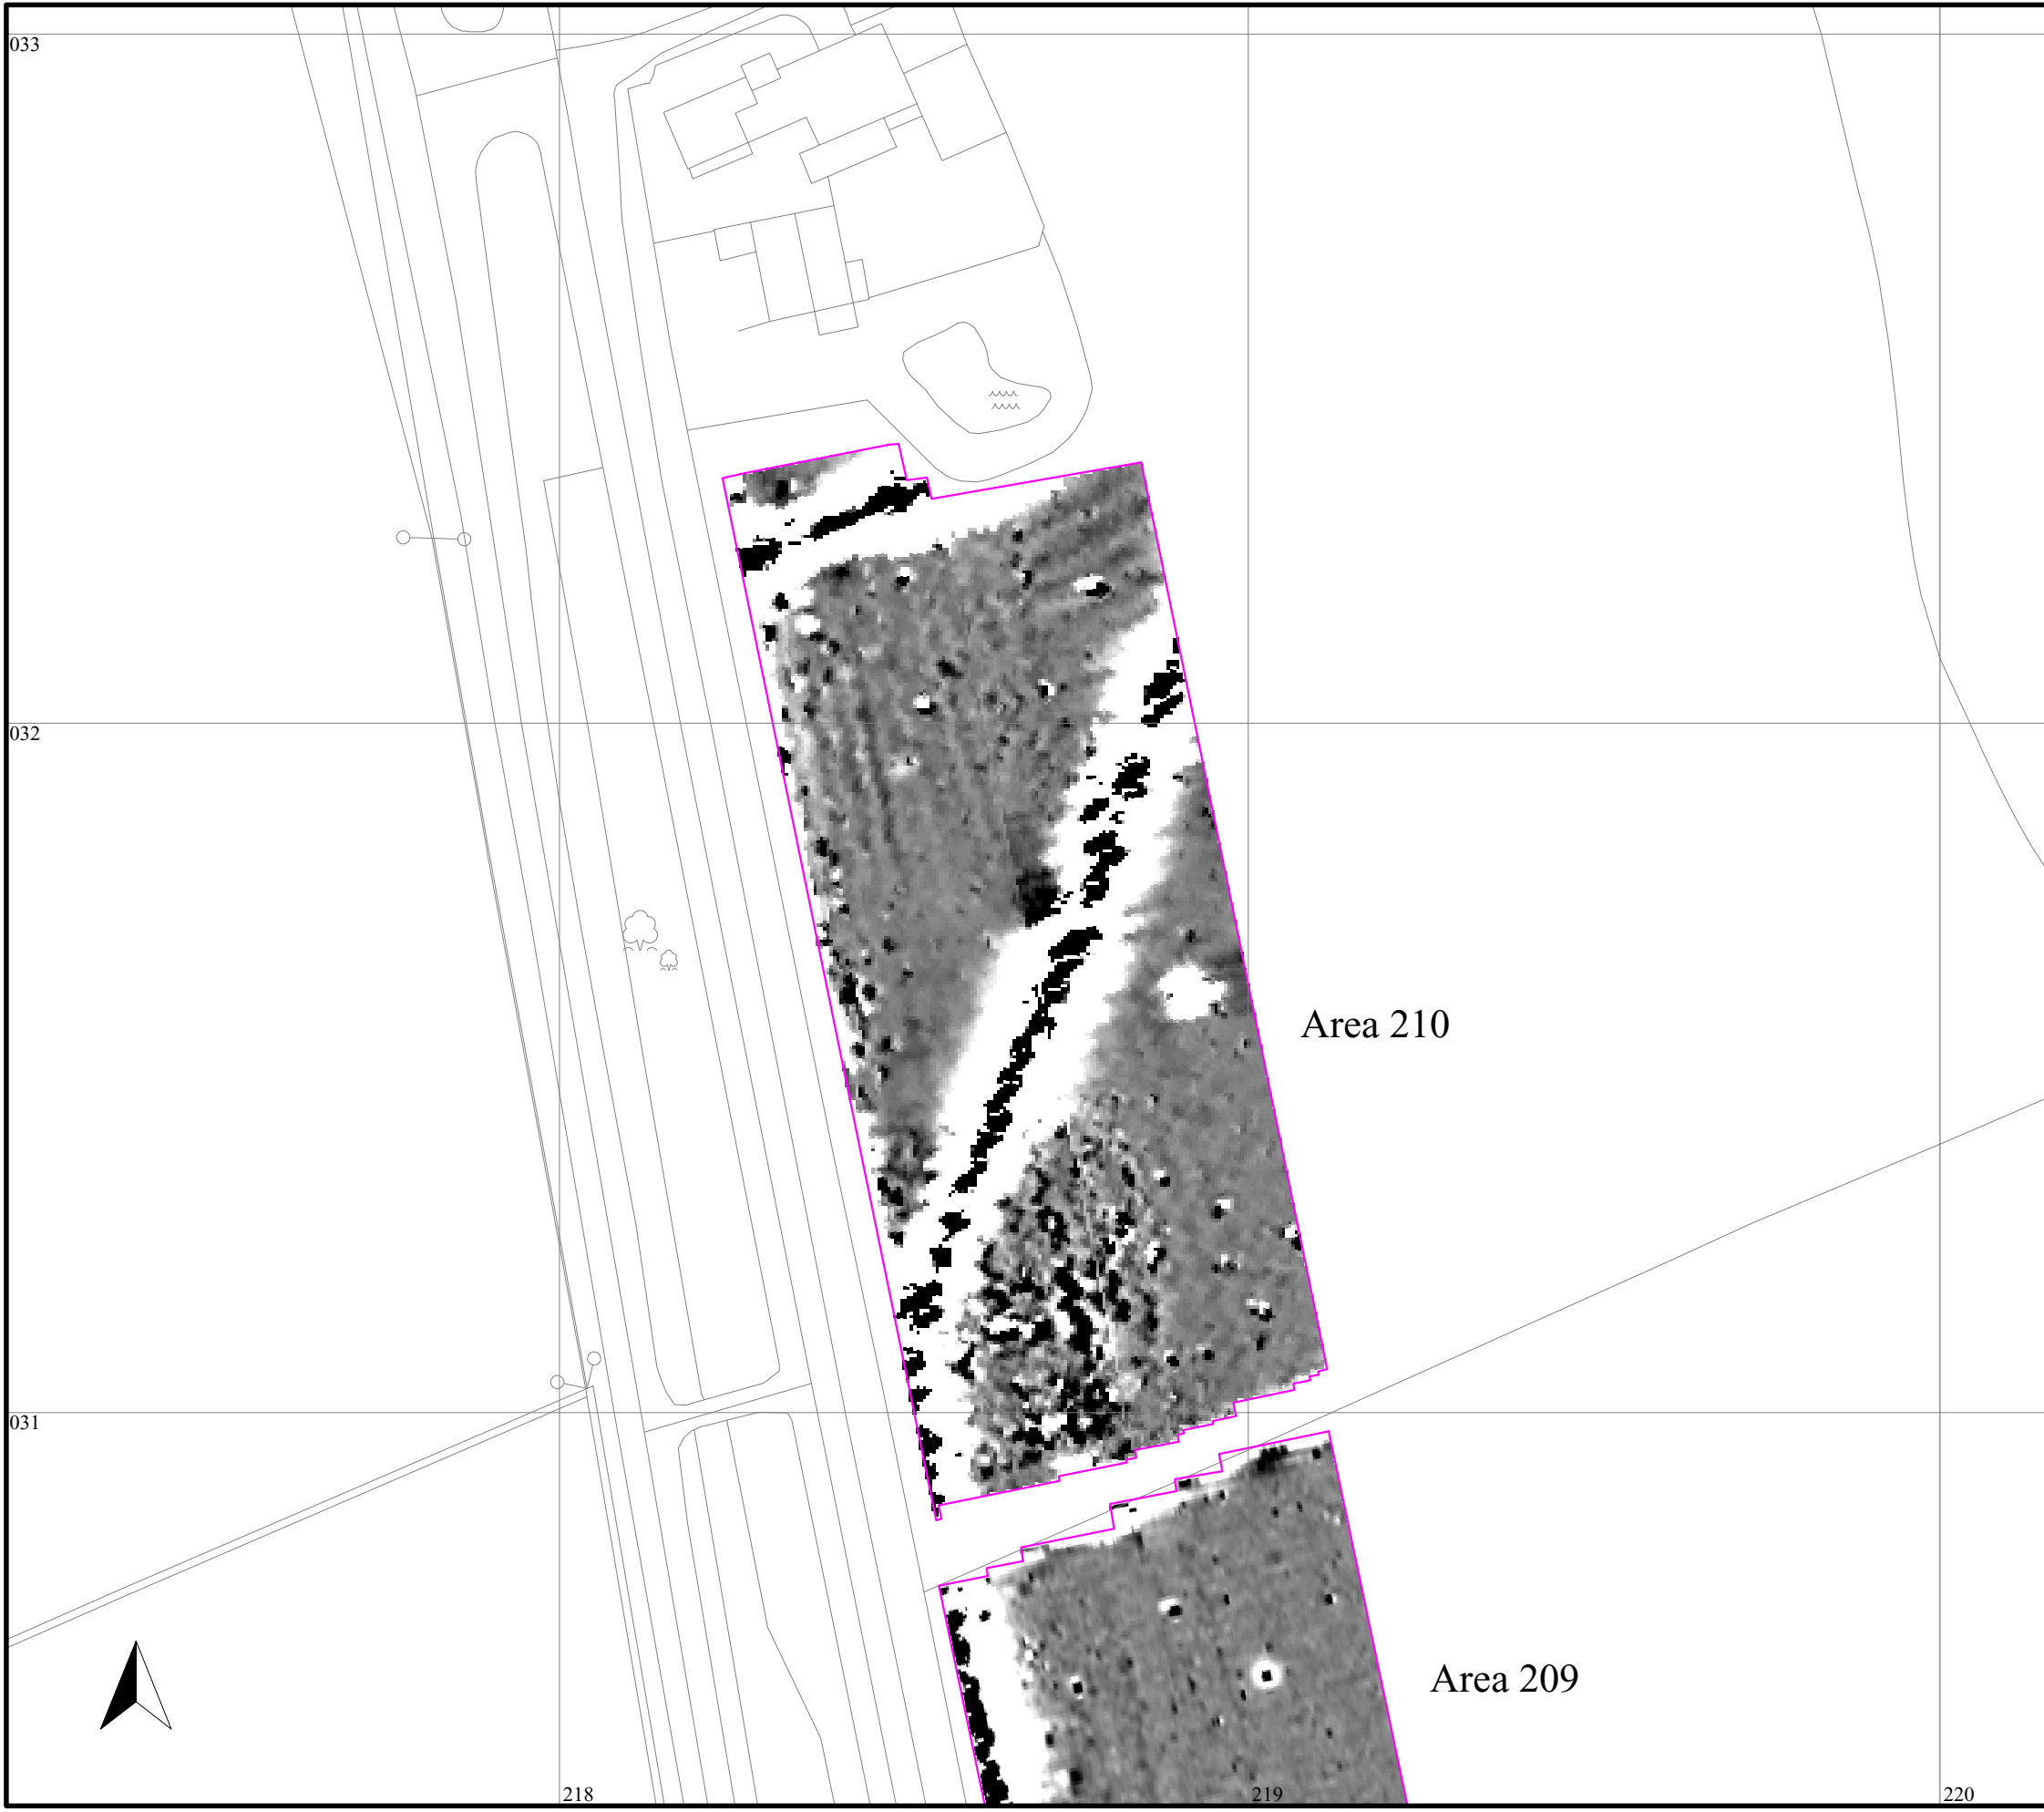
Figure 90

Geophysical survey of Area 210

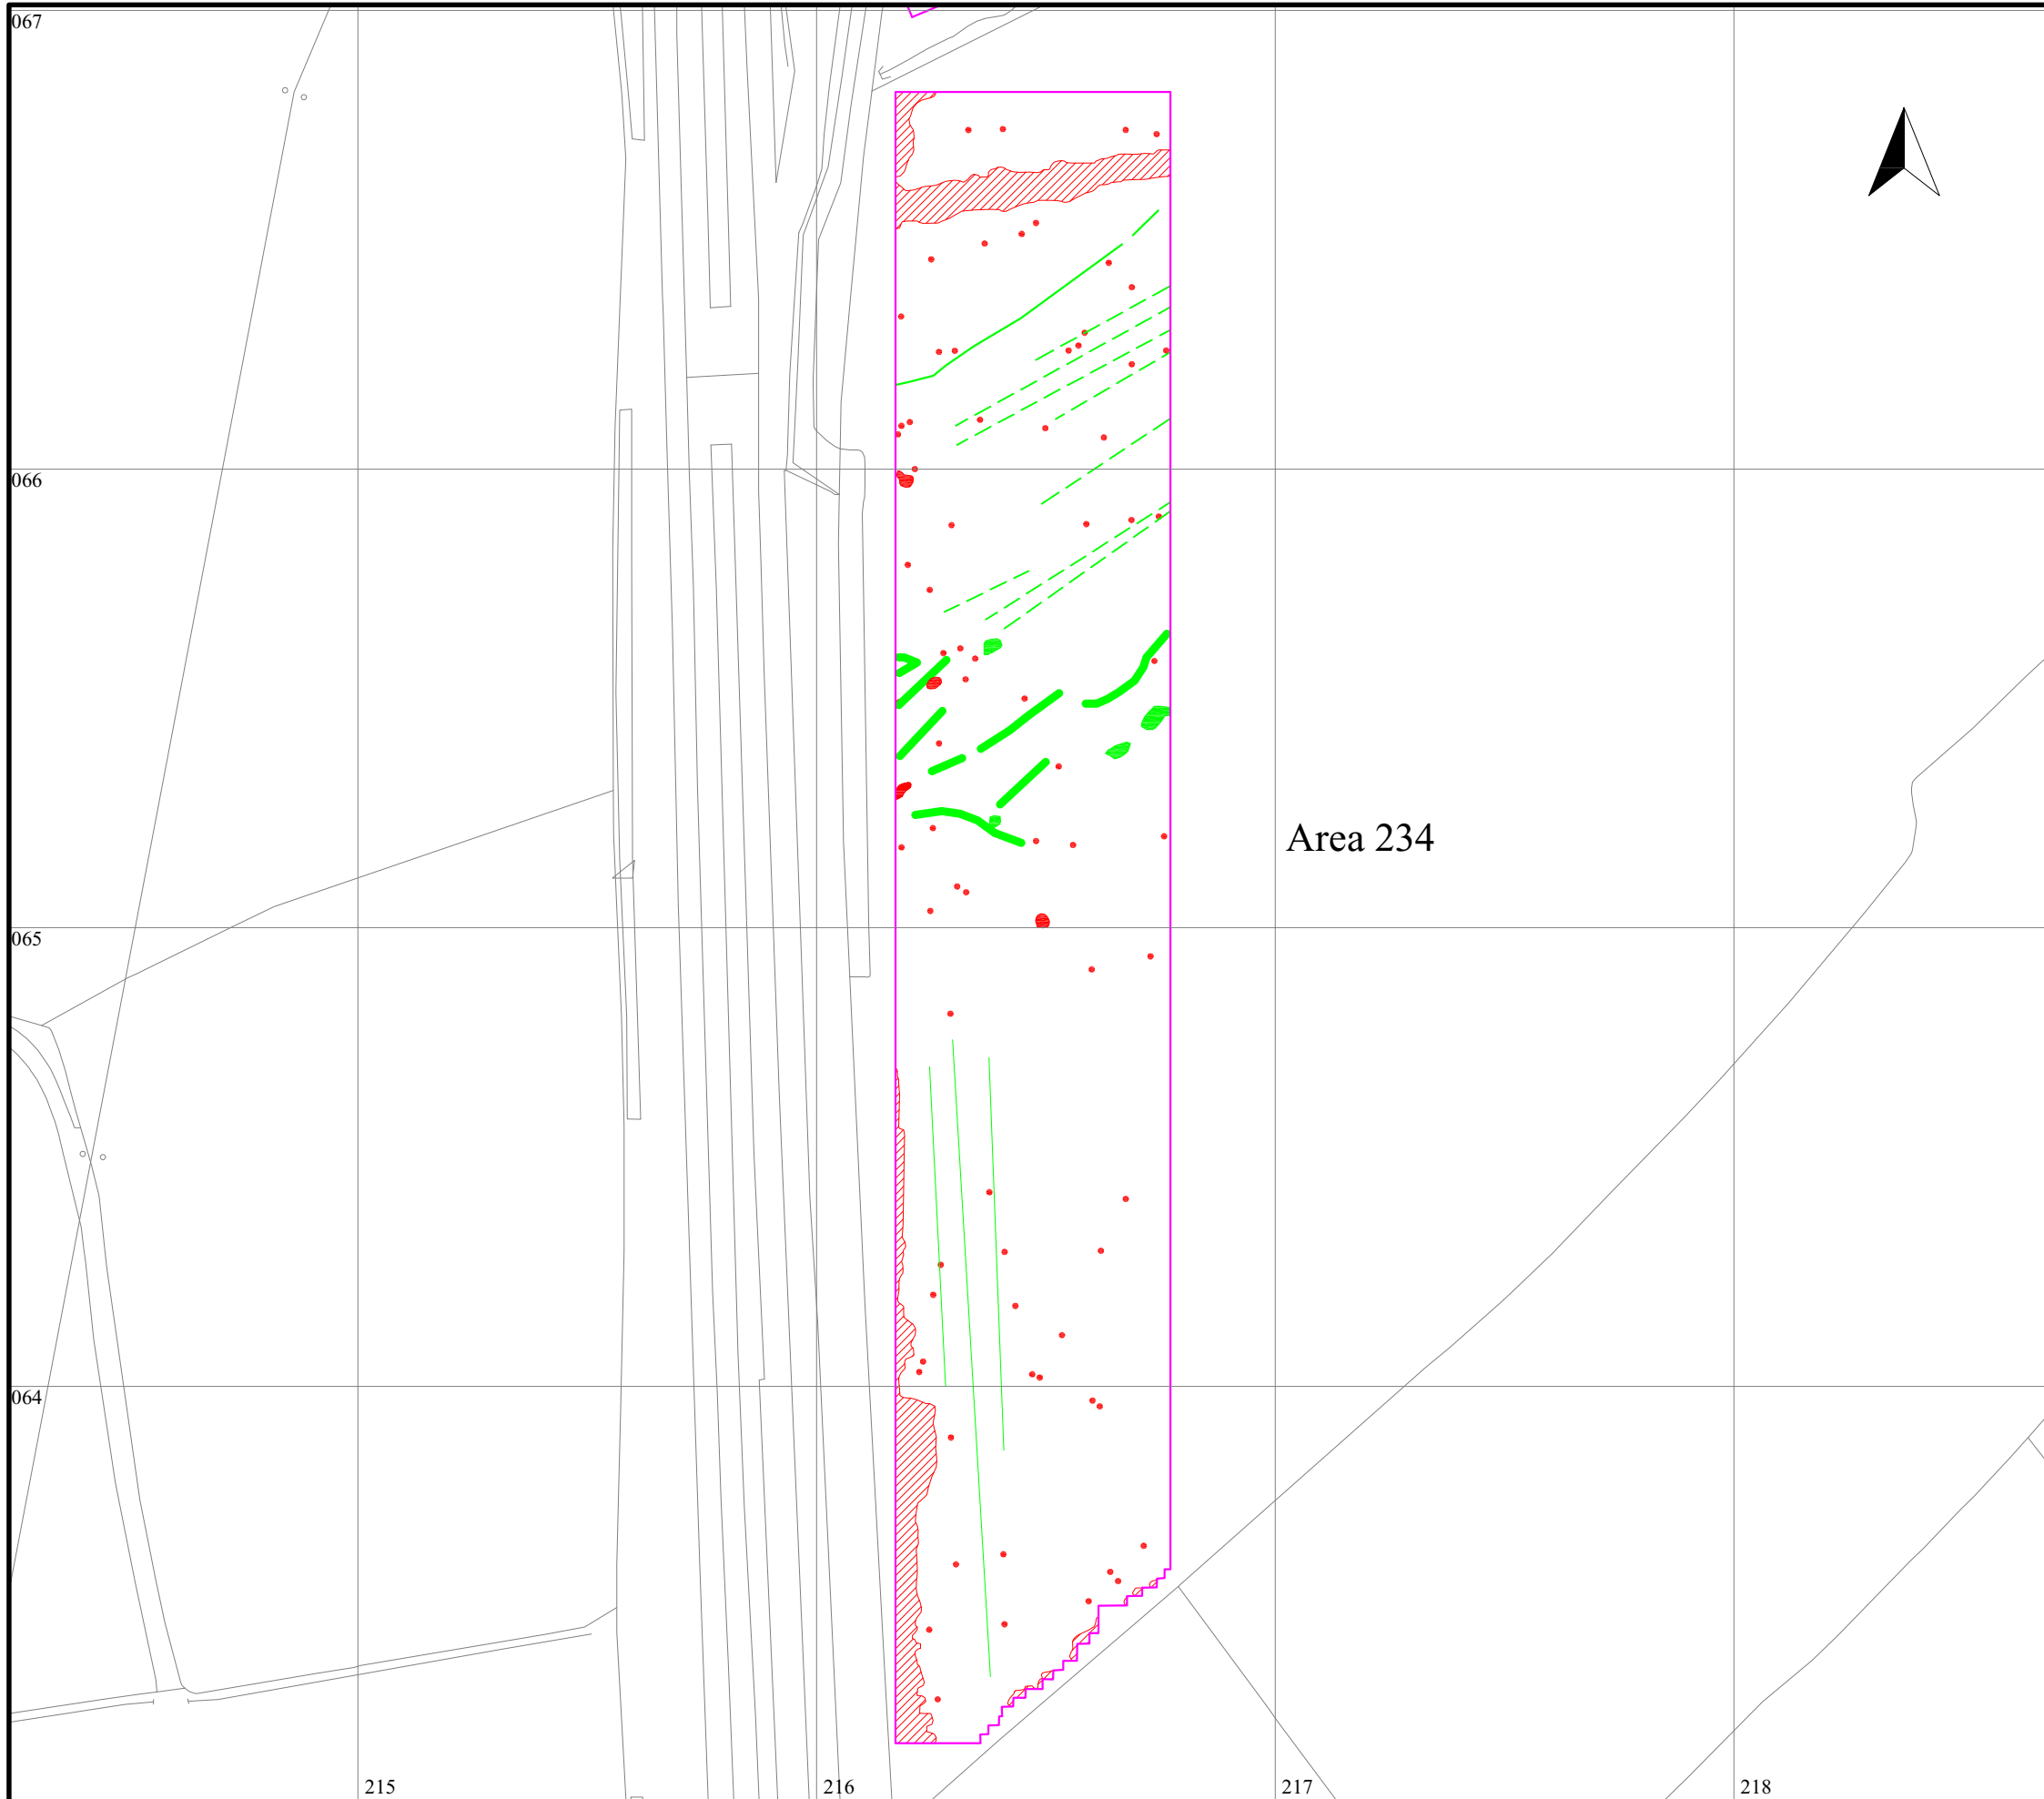
Figure 94
Geophysical interpretation of Area 234

outline of Phase 2 survey area
-

positive magnetic anomalies
-

dipolar magnetic anomalies

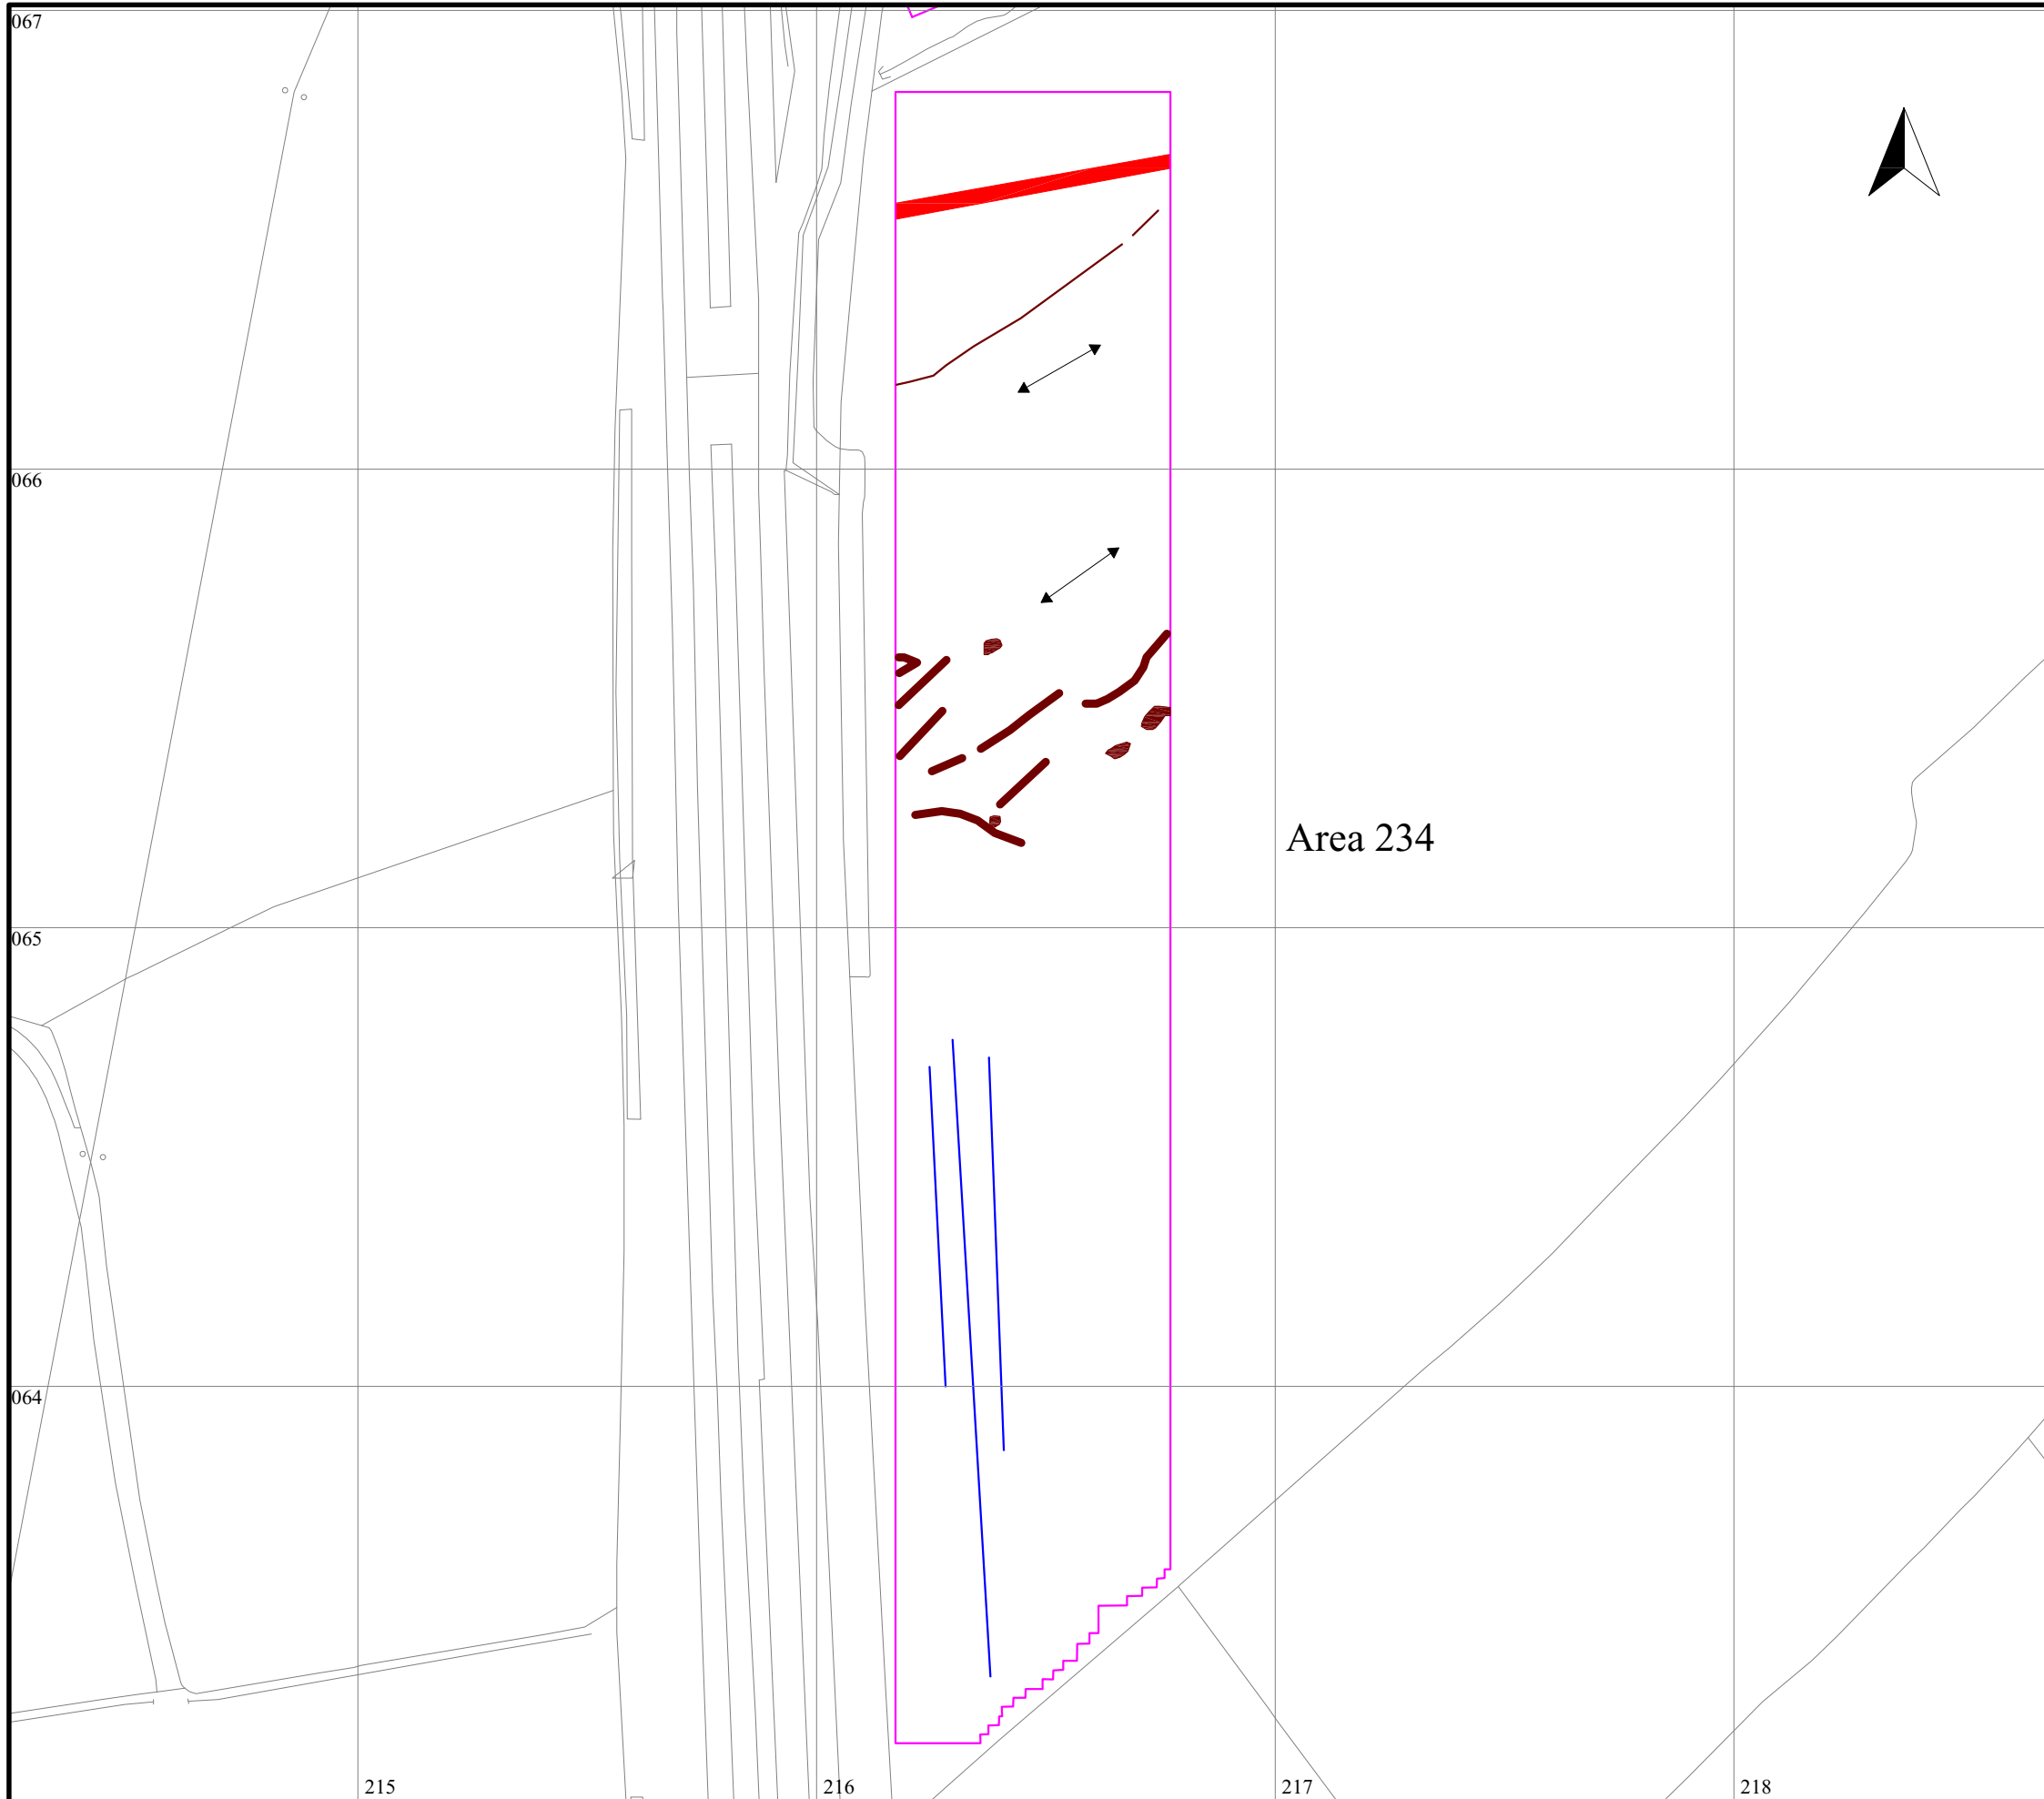
Figure 95

*Archaeological interpretation of Area 234
basemap courtesy of Faber Maunsell*

soil-filled features
-

service pipe
-

direction of ridge and furrow
-

land drains
