LAND NORTH OF HAVELOCK HOUSE LEPPINGTON NORTH YORKSHIRE

> A Report on an Archaeological Watching Brief

REPORT NUMBER 2006/65

November 2006

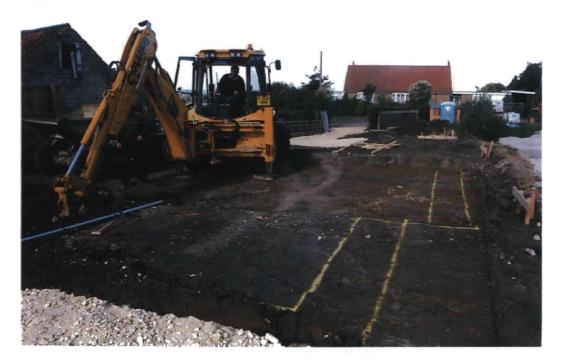
Plate 1 View of house plot looking west showing subsoil exposed in western half of the house footprint (centre right)

road had already taken place, although examination of the site, particularly the spoil from the road-strip, indicated that subsoil had not been reached along the access road. The ground works were mostly undertaken by a JCB. As the site sloped steadily down to the west, the area of the dwelling was reduced in two terraces about 0.3m high, to form level building surfaces. The underlying subsoil was found to slope down to the south-west; as the topsoil was about 0.3m thick, the subsoil was only encountered in the north-east corner of each terrace (Plate 1). Furthermore, the thickness of the topsoil increased towards the west end of the site. so that even the road strip did not reach the subsoil. Consequently, the extent to which any archaeological features on the site would be exposed, not to mention disturbed, during these ground works was limited. However, the excavation of the house foundation trenches did provide an opportunity to investigate beneath the topsoil (Fig. 2, B). The foundation trenches were 0.8m wide and 0.6m deep. The other ground works of any significant depth was the excavation of the trench for the gas tank, in the north-west corner of the site (Fig. 2, A). This excavation measured 4m long (east-west) by 2m wide and 1.6m deep. As no archaeological features were observed here and the service trench alongside the road was not sufficiently deep to reach the subsoil, it was decided not to monitor the excavation of the service trench or the septic tank trench.

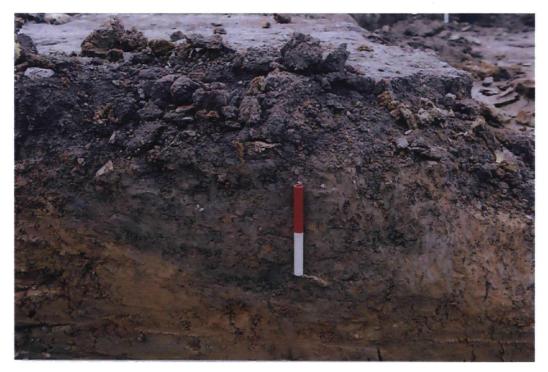
In the north-west corner of the house footprint was a curvilinear feature aligned roughly northsouth (1010), which is also thought to have been a ditch. It was observed in the sides of the foundation trenches and in the reduced ground surface, which had reached the subsoil in this part of the house footprint. This ditch was 0.9m wide at the north end but around 0.6m wide further south and around 0.3m deep (Plate 2). It contained compact, mixed mid grey silty clay loam and light brown clay loam (1001), from which 13th pottery was recovered. To the south, the probable continuation of this ditch was observed in the sides of a foundation trench in the middle of the house (1015, fill 1016), but here it was only 0.5m wide by 0.15m deep, and the ditch was not observed in adjacent foundation trenches; this suggests that the ditch was shallower towards the middle of the trench, and/or had been largely truncated there.

Plate 2 Ditch 1010, south facing section
