**Land adjacent to 3 King Street
Scarborough,
North Yorkshire
TA 0435 8859**

Archaeological Evaluation

An Archaeological Evaluation was carried out by MAP Archaeological Consultancy Ltd on land to the south of No. 3 King Street, Scarborough, North Yorkshire between April 10th and April 18th 2007. The work was undertaken in response to a consultation on a planning application for the redevelopment of the site (ref. no. 06/02273/FL). The Evaluation consisted of two trenches situated within the entrance and to the rear of the site.

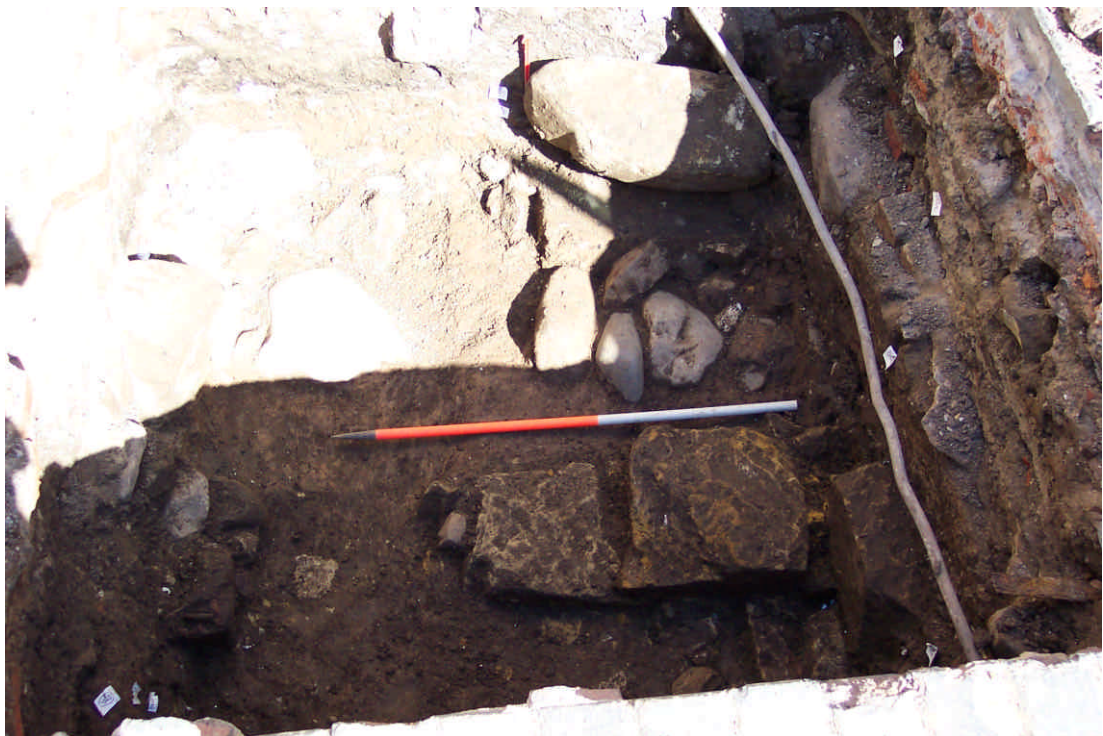
Plate 6. Walls 1031 & 1032. Facing North

returned to the south in the south-east corner of the trench whereas Wall 1032 was only partially seen in the western side of the trench (Fig. 17 : Pl. 6). The gap between Walls 1031 and 1032 may represent a socket for an upright timber. Associated with Walls 1031 and 1032 was a cobbled and stone surface (1034) which probably represented a street/yard surface.

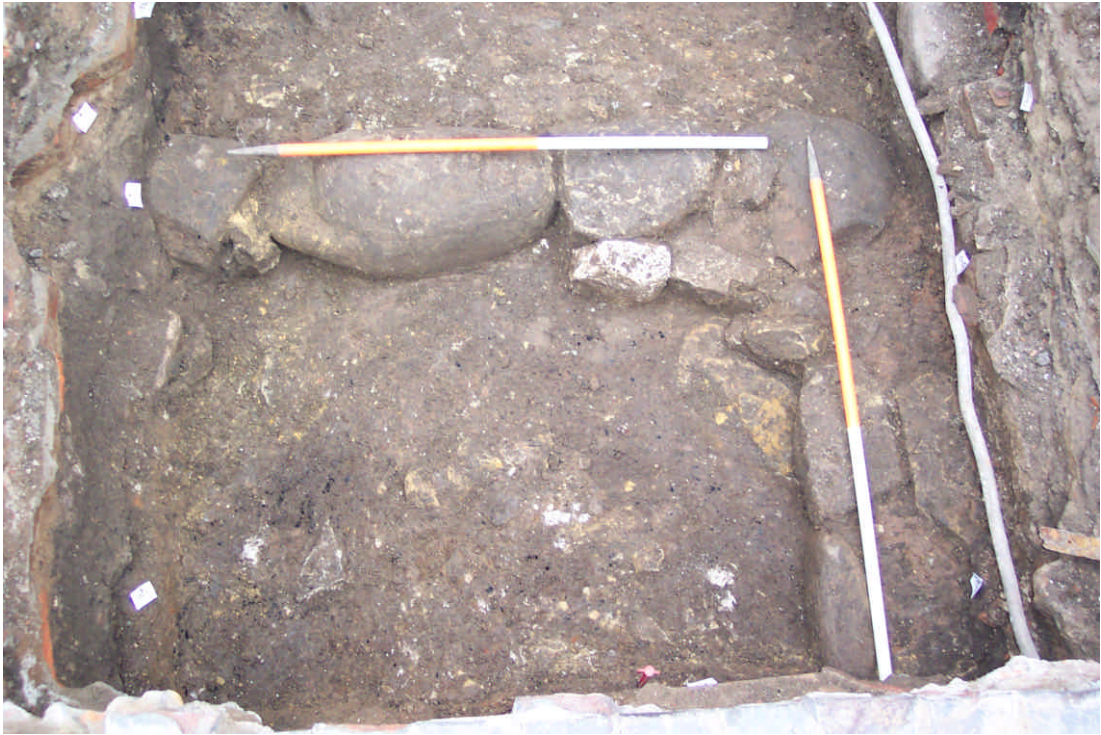
Plate 7. Wall 1026. Facing North

Phase 2c : Built onto Deposit 1030 was a further stone structure (1026), which survived only as a single foundation course (Fig. 18 : Pl. 7). Wall 1026 was associated with a street/yard surface (1027). Of interest is that Wall 1026 followed the same alignment but not the location as Walls 1031 and 1032 suggesting either a larger property or a change in property boundaries.

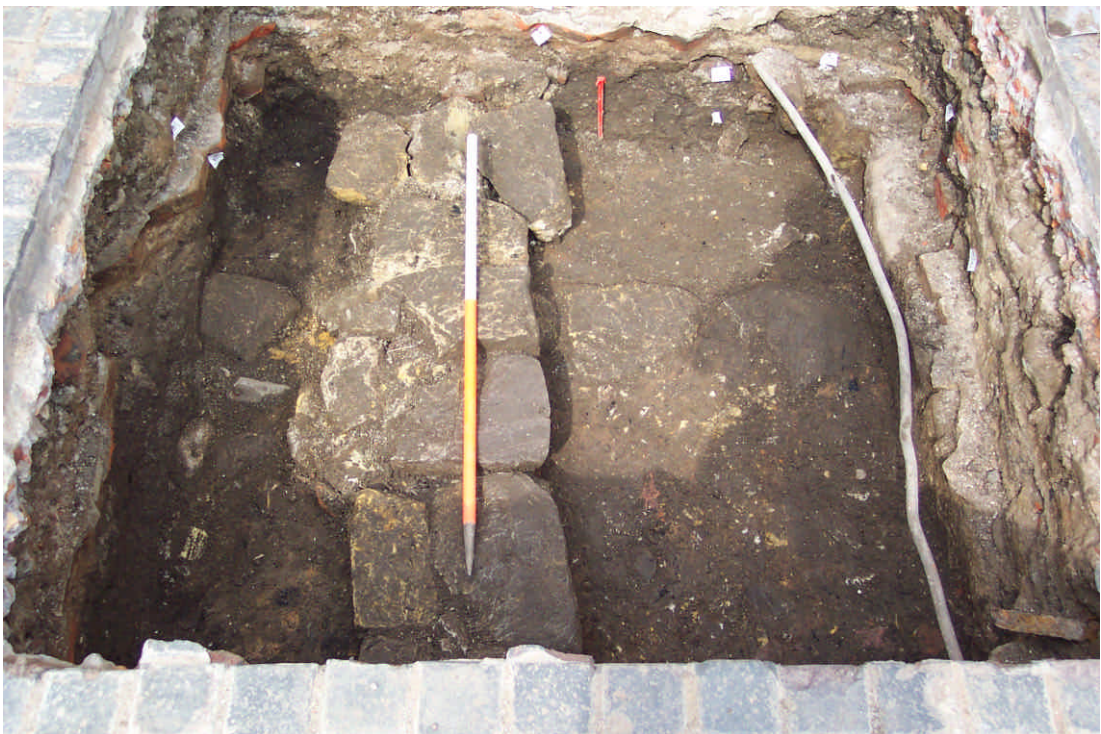
Plate 8. Wall 1018. Facing North

7.1.5 *Phase 4* : Further structural activity characterised Phase 4. During this phase two walls were constructed (1018 & 1024) on a north-south alignment. Wall 1024 (only partially seen in section) and Wall 1018 only survived as single foundation courses and continued beyond the limit of the trench (Figs. 19 & 21: Pl. 8).

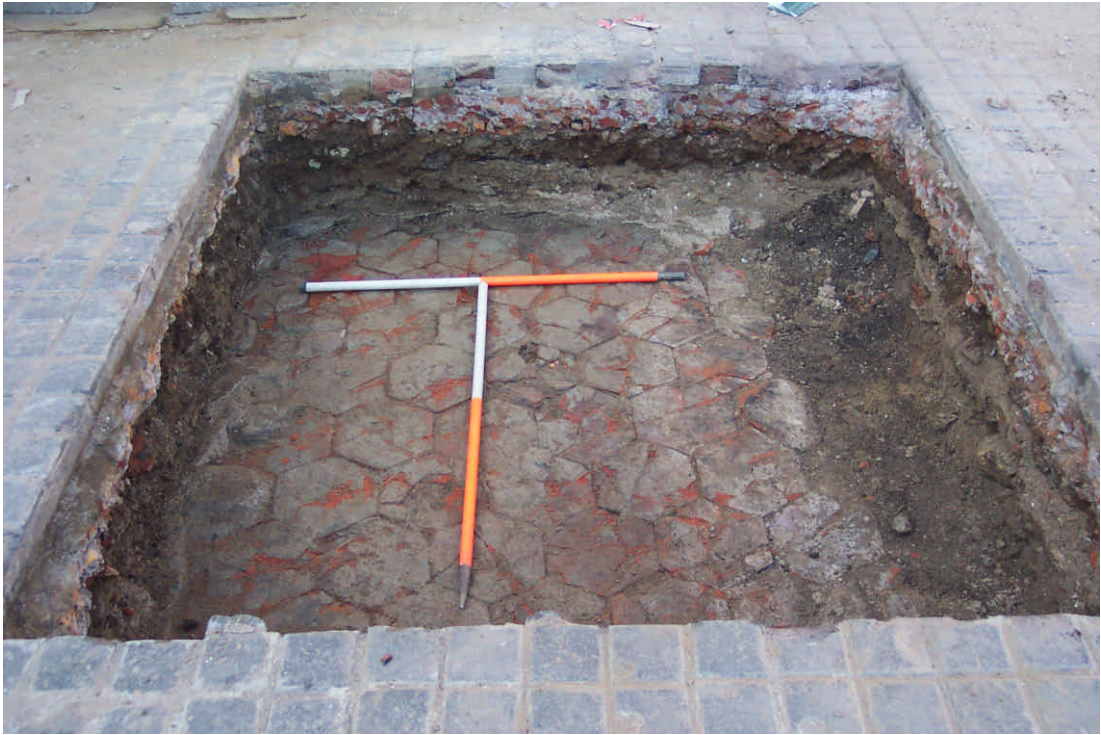
Plate 9. Yard Surface 1006. Facing North

7.1.7 *Phase 6* : The latest deposits in Trench 1 were represented by a series of bedding deposits and yard surfaces (1017, 1006 (Pl. 9), 1007 & 1003). Further

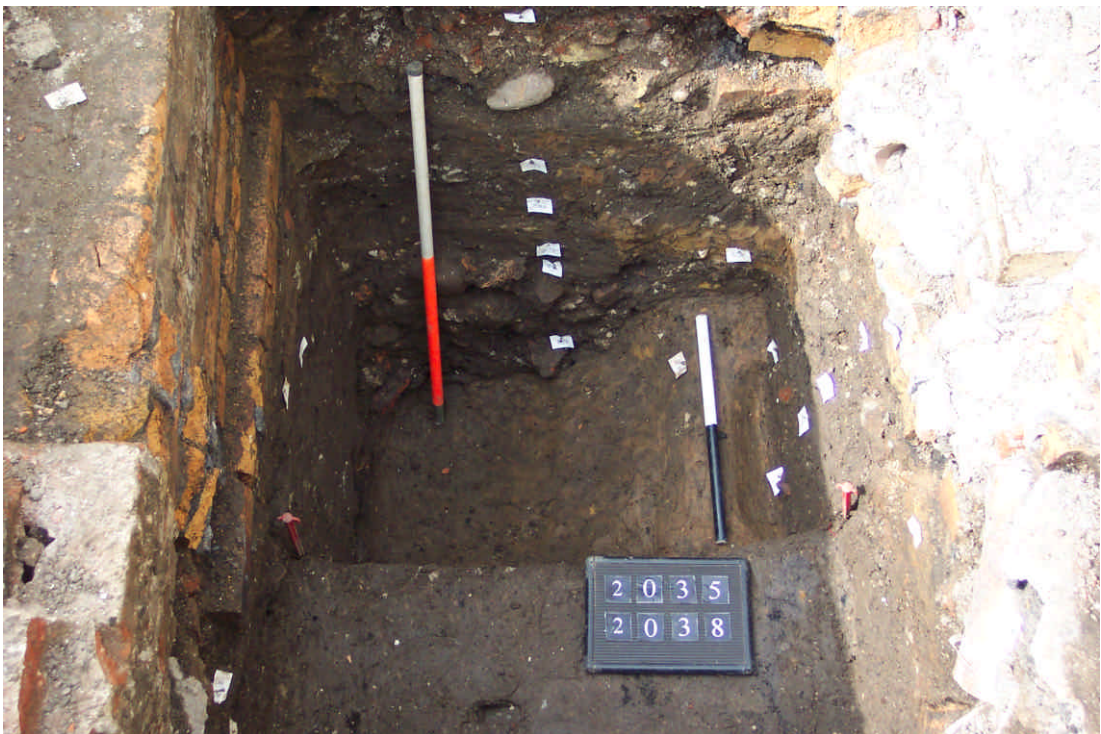
Plate 14. Trench 2. Features 2035 & 2038. Facing West

7.2.2. *Phase 1:* The earliest activity in Trench 2 was represented by a semi-circular feature (Fig. 22 : 2038) cut into the natural clay to a depth of 0.08m (Pl. 14). The fill (2037) contained a single pottery sherd of 17th century date (Appendix 2).
