FIELD ARCHAEOLOGY SPECIALISTS

WATCHING BRIEF

PRECEPTORY FARM TEMPLE HIRST
NORTH YORKSHIRE

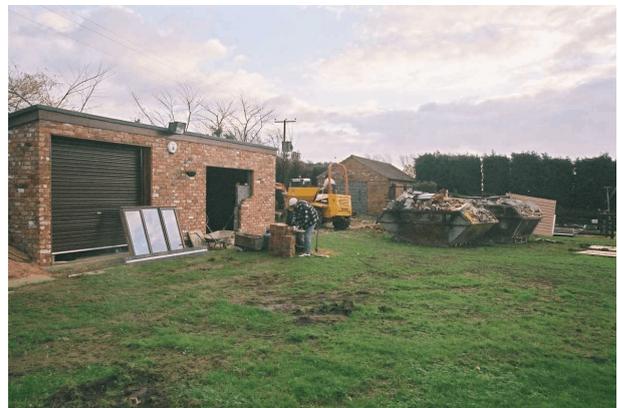
Plate 1 General site view

The development area lies in the village of Temple Hirst, Selby, North Yorkshire (Figure 1; NGR SE 5976 2512) within the grounds of Preceptory Farm. The site is located to the rear of the main farm house, in a large grassed area bounded on all sides by trees. The proposed site for the new dwelling was situated between two existing buildings; a workshop to the northwest and the existing day care centre to the southeast (Plate 1).

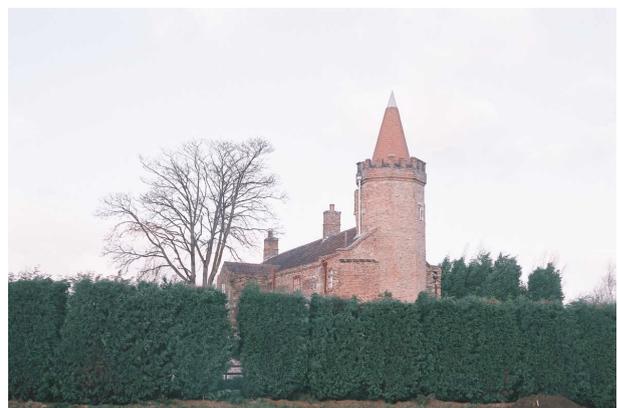
Plate 2 The remains of Temple Hirst

The proposed development lies within an area of archaeological interest, in the area of the Preceptory of the Knights Templar at Temple Hirst (Plate 2), a site which is reflected in the name of both the farm and the village. The preceptory was a monastery for military men, which included provision for worship and communal living.

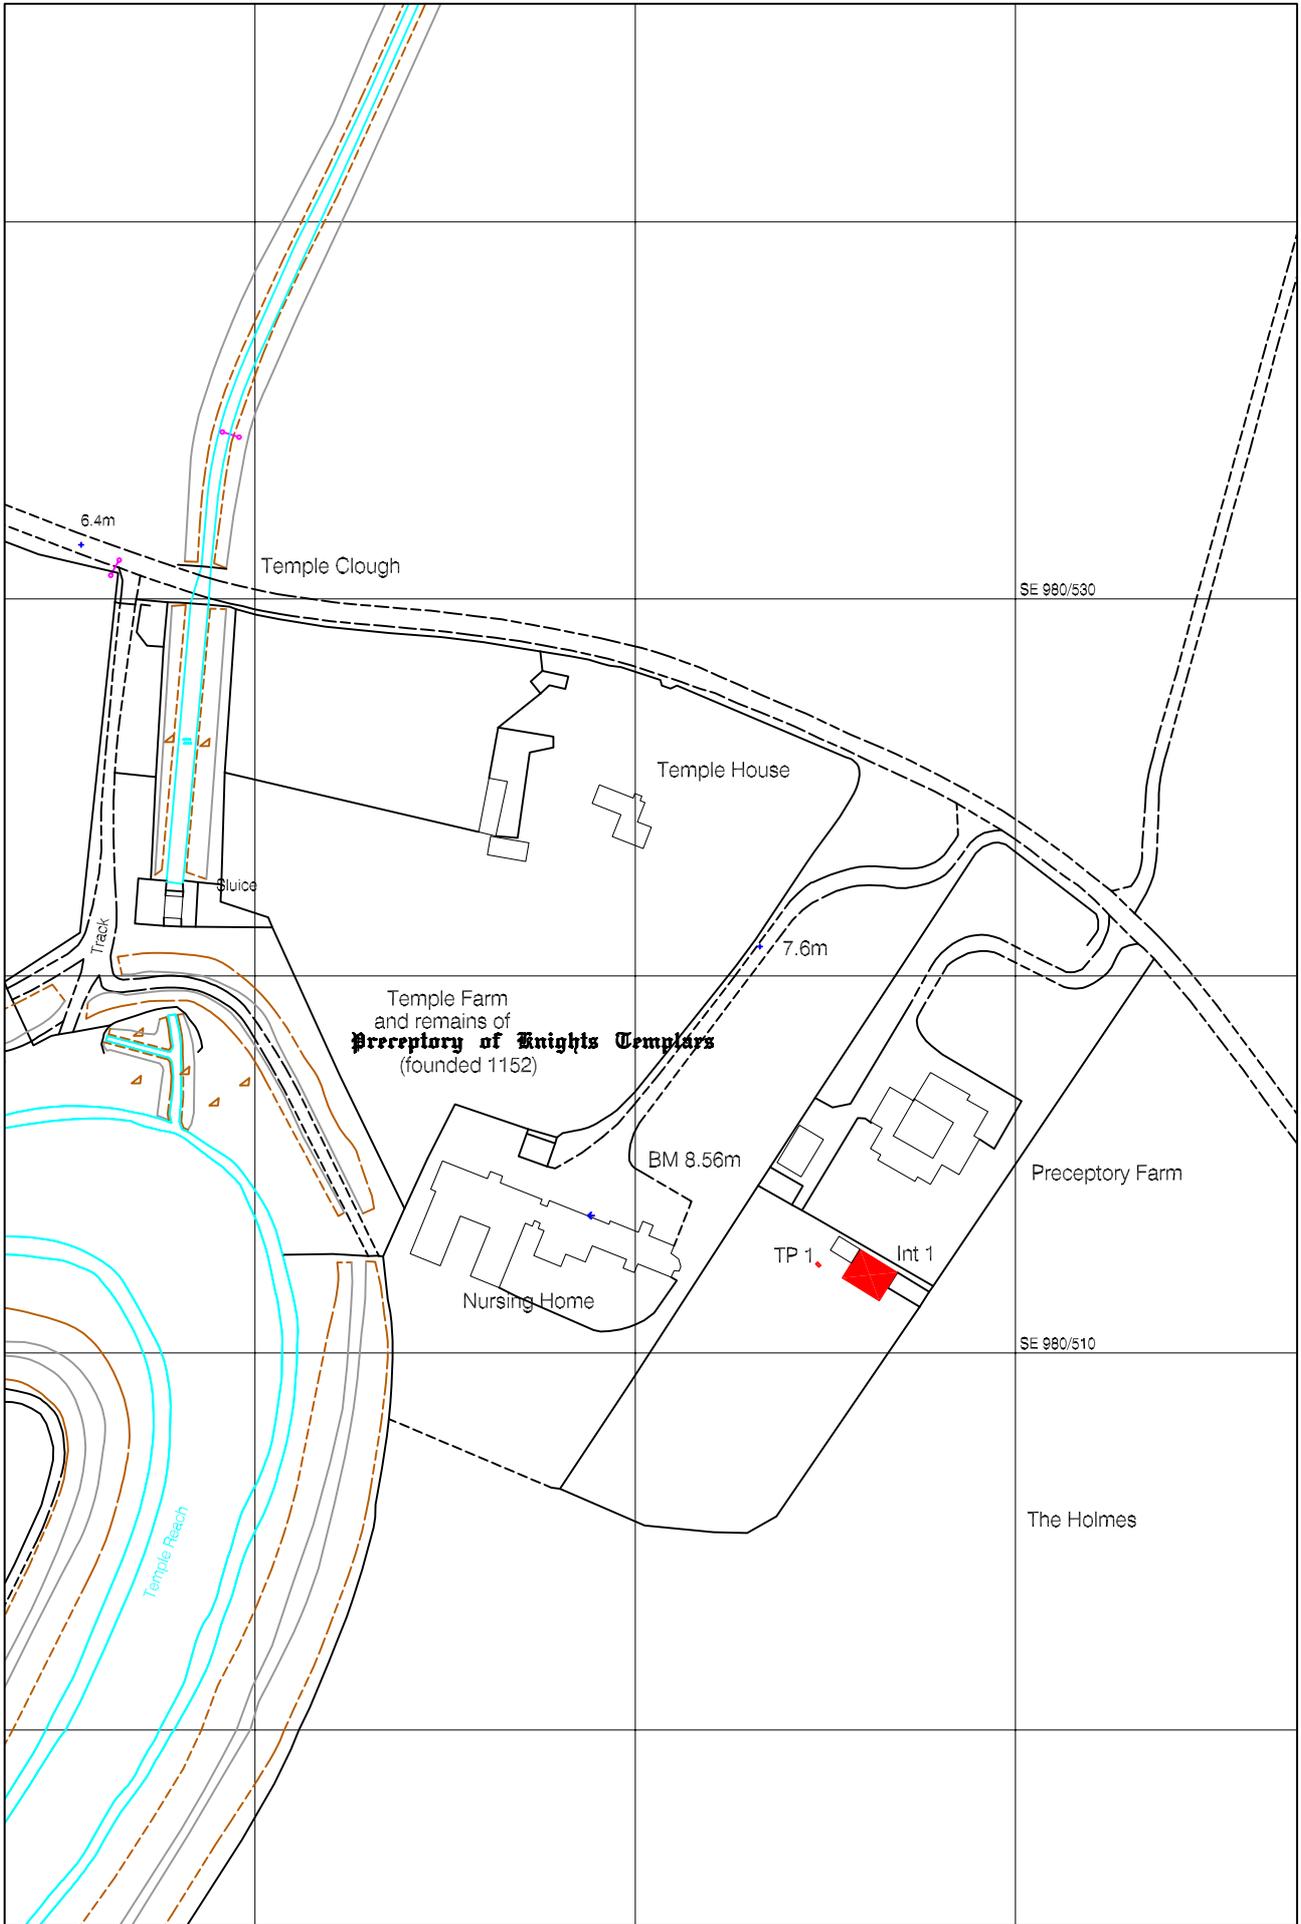
Figure 1

Location of watching brief

Scale 1:2000

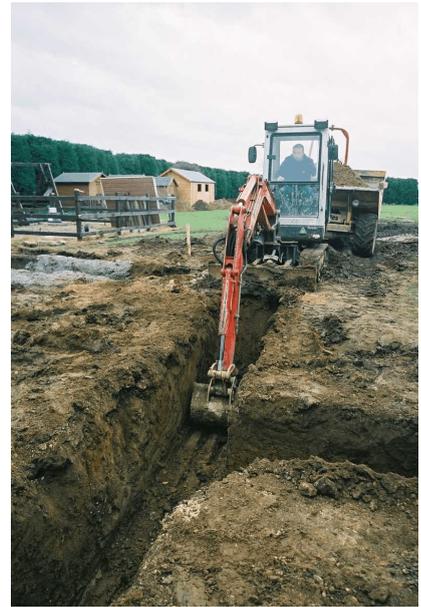
Plate 3 Machining trenches

The excavation of all foundation trenches was undertaken using a tracked excavator fitted with a toothless ditching bucket. The foundation trenches, allocated Intervention 1 (Int.1), measured 0.60m wide and were excavated in machined spits to a depth of between 1.30m to 2.40m below current ground level. The foundations measured 11.55m in length and 8.95m wide forming a roughly rectangular shaped plot orientated NW-SE (Figure 2). Due to the existence of trees along the northeastern boundary of Intervention 1 it was necessary to excavate the adjacent foundation trench, and all other trenches within 3.0m of the trees, to a depth of 2.40m. A small test pit (TP1) was excavated to the south of the existing workshop to establish subsoil depth. This measured 1.30m long, 0.8m wide and was 1.50m deep (Plate 3).
