SCARBOROUGH ARCHAEOLOGICAL AND
HISTORICAL SOCIETY

WATCHING BRIEF REPORT 01/07

SITE WAREHOUSE, MARLBOROUGH STREET, SCARBOROUGH

SITE CODE MS/07

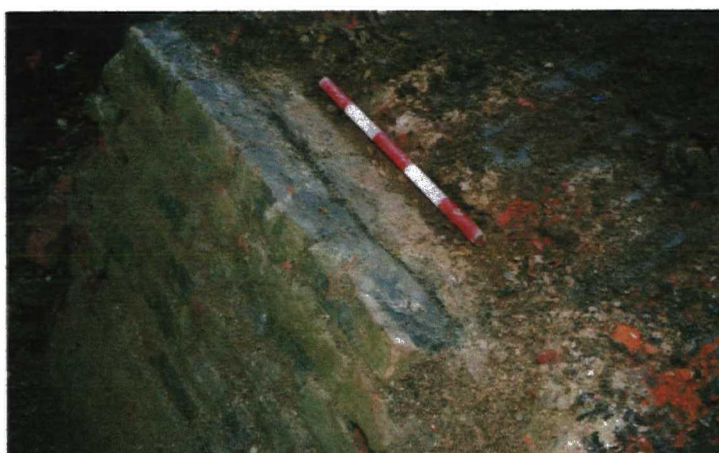
Figure 1 Film 1 frame 5 showing the wall thought to be a barrel drop for the basement to the former works building
Scale 500mm

- 2.1 The sloping wall of brick seems to be cut into the thick sticky, orangey brown clay, which is interpreted as natural. This sloping brick wall was probably built as an easy access from the street level, for rolling barrels and other items for storage, into a cellar area underneath the then existing building.
- 2.2 The finds of the whole excavation amounted to a few pieces of late 19thC pancheon or kitchen ware pottery, treacle glazed with cream interior, some late 19thC Willow pattern Staffordshire pottery, again used for food preparation and a small piece of clay pipe stem (19thC). These finds are compatible in date with the development of the building which formerly stood on the site (Castle Works) in the late 19thC.

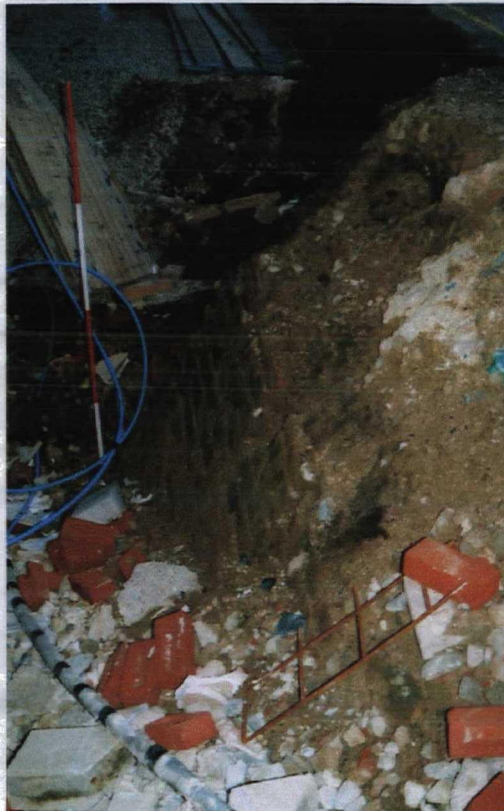
Figure 2 Film 2 frame 28a
Showing the top of the wall in relation
to the building
Scale 2 metres in 500mm divisions

- 1.1 The size of the area for the watching brief was approx. 3 metres by 2 metres and on its north-western side butted up against the hard tarmac road surface of Marlborough Street.
- 1.2 The surface layer consisted of the tarmac road surface and below that a layer of loose fill of rubble, stones mixed with mid brown loamy soil. This was consistent with garden composition for planting.
- 1.3 Below this was a light mid-brown layer of clay, bricks and heavier rubble,(see Film 1 frame 6.) interpreted as material deposited during the building phase. To the south of the excavation the top two rows of a brick wall were exposed – (Film 1 frame 5 –see below). This wall was built as a slope which fell down wards to the base of the building, see Film 2 frame 28a. leading to a depth of approx 1 6 metres.
