**Seamer Road Corner
Falsgrave
Scarborough
North Yorkshire**

Archaeological Watching Brief

A Watching Brief was carried out by MAP Archaeological Consultancy Ltd over six days in September 2006 at land on a development site that lay immediately southeast of the junction of Falsgrave Road and Seamer Road, Falsgrave, Scarborough, North Yorkshire, during the reduction of the site to prepare a piling platform. No archaeological features or finds were revealed during the Watching Brief.

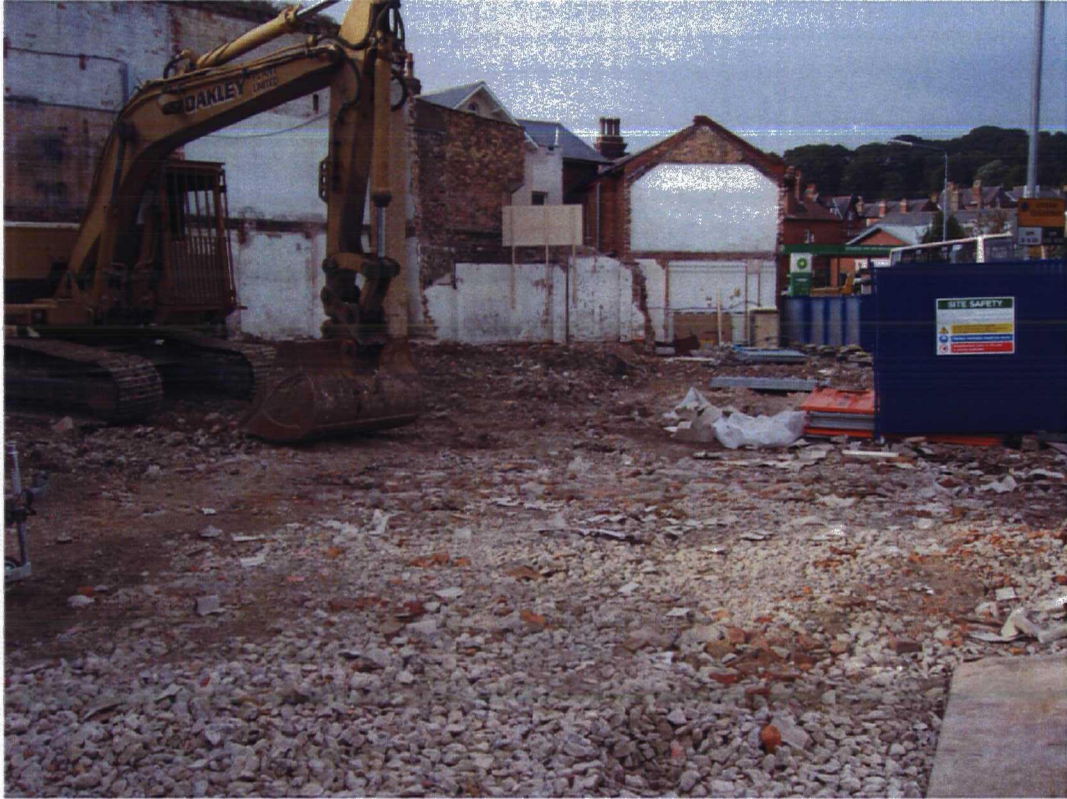
- 2.1 The site lies immediately to the southeast of the junction of Seamer Road and Falsgrave Road, which form part of the main A64 trunk road (Figs. 1 and 2). This location was formerly occupied by commercial premises, which have been recently demolished to allow the redevelopment to take place (Pl. 1). The Tap and Spile public house and its grounds lie to the east, with 19th century dwellings to the south, beyond which the land drops fairly steeply into the valley along into which St James Road descends.
- 2.2 The underlying geology of the site consists of glacially-deposited boulder clay (Mackney *et al* 1983).

Plate 1. General View of Site. Facing South West

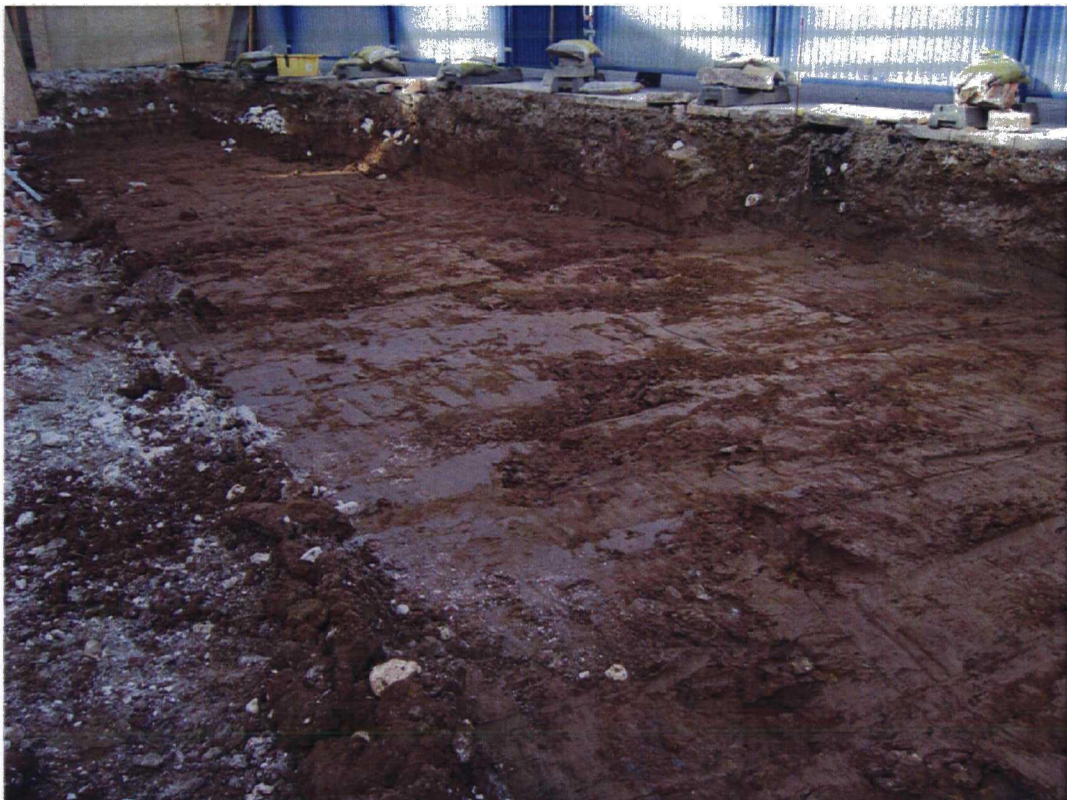
- 5.1 Natural deposits, consisting of compact reddish brown boulder clay, were identified at a depth of 0.65m from the present ground surface at the western side of the site, adjacent to the pavement, rising to c. 1.20m at the eastern side (Pl. 2).
- 5.2 In the northern and central areas of the site, the boulder clay was overlain by a c. 0.25m deep deposit of yellowish clay with varying concentrations of pebble inclusions. Although clearly different from the underlying boulder clay, this deposit would appear to be a variation in the natural rather than having been artificially brought into the site (e.g. as a raft for the 19th century buildings).
- 5.3 The natural boulder clay was covered by a deposit of greyish brown clay silt, which was around 0.40m thick. This layer contained 19th century sherds (not

Plate 2. Southern Area of Site after Stripping. Facing South West
