The Former Derwent Saw Mill
To the Rear of George Cartwright Close
Norton
North Yorkshire
~~SE 8062 7223~~ X
 SE 7977 7171
Archaeological Watching Brief Report

Archaeological Watching Brief Report

An Archaeological Watching Brief was conducted by MAP Archaeological Consultancy Ltd on the site of the former Derwent Saw Mill, to the rear of George Cartwright Close, Norton, Malton, North Yorkshire (SE 8062 7223) during September and October 2006. The work involved monitoring the groundworks associated with excavation of new services and foundations for a proposed residential development. (Ref 05/00922/FUL).

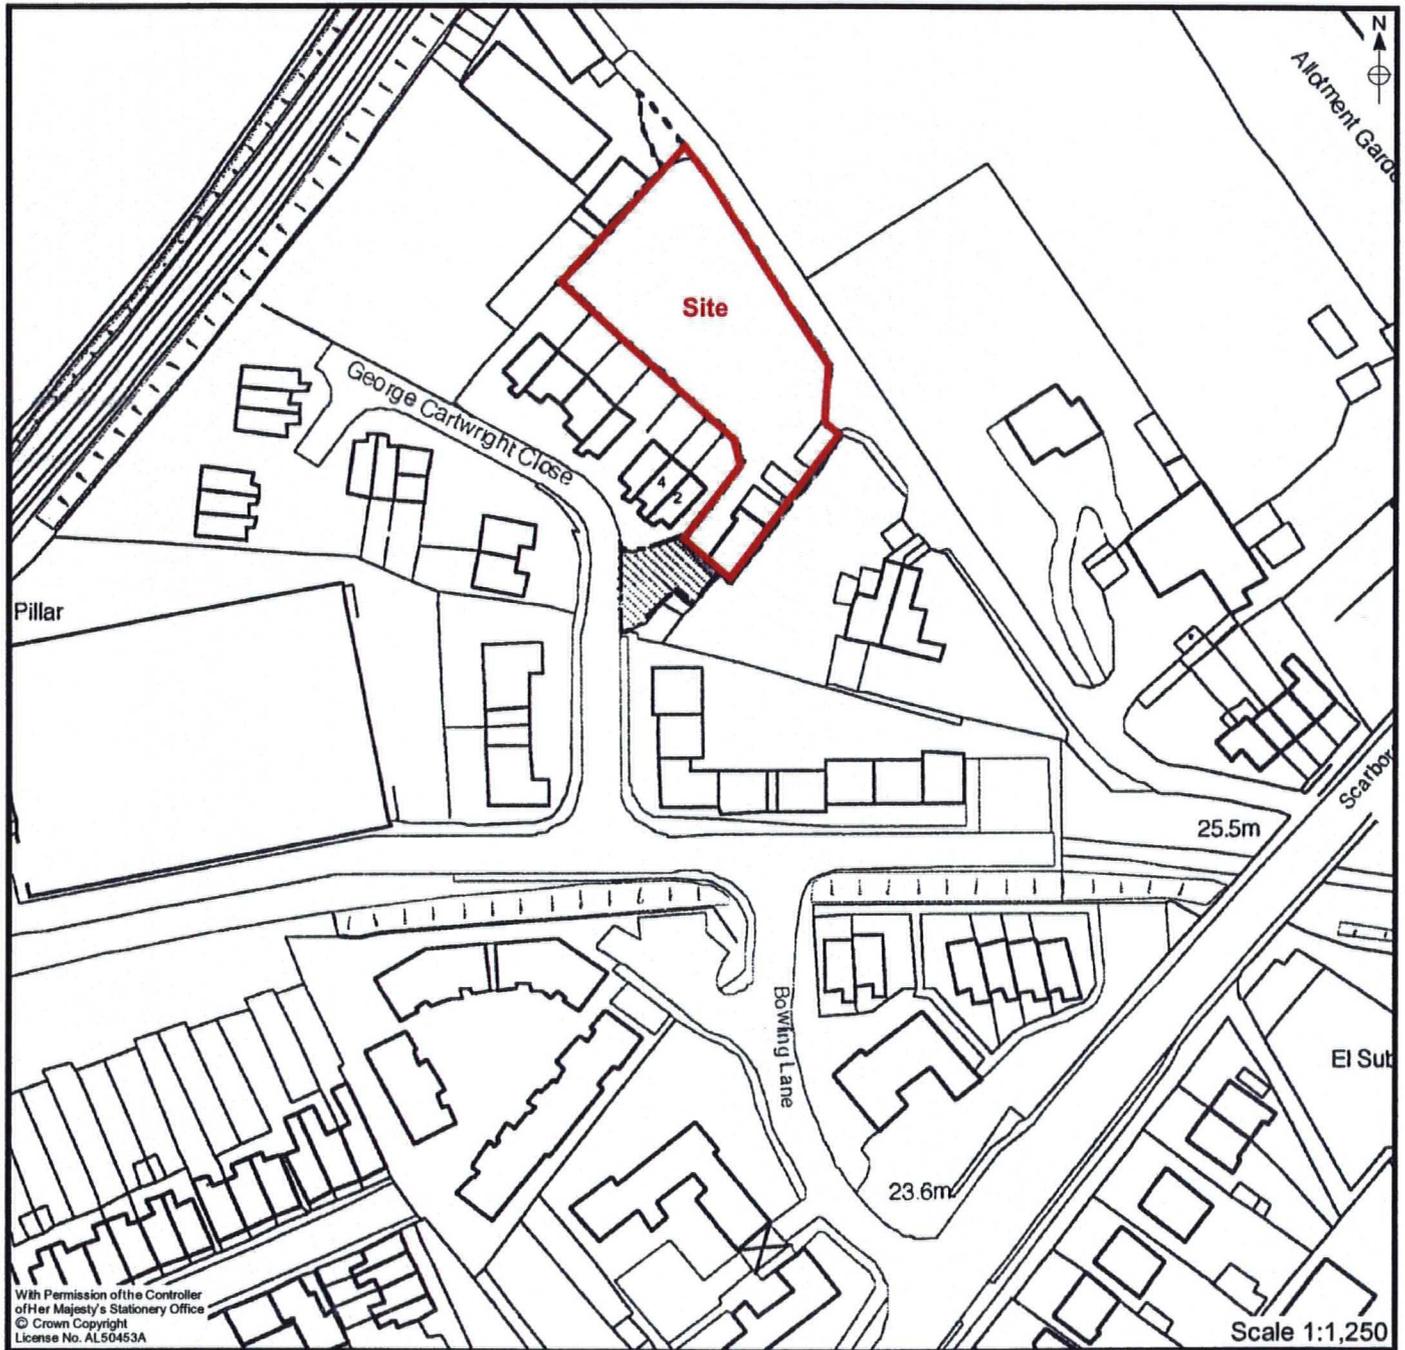
Figure 2. Area of Development

- 2.1 The site covers an area of approximately 50m x 44m and is situated within the District of Ryedale, to the east of the town of Norton, on the southern side of the River Derwent, approximately 32km from York and Scarborough. The site is bounded to the south by commercial properties, to the north by the York to Scarborough railway line, and by residential properties to the west.
- 2.2 The site lies on soils of the Landbeach Association, which consist of permeable calcareous and non-calcareous loamy soils, overlying a solid geology of chalky glaciofluvial and river terrace drift (Mackney, 1984, 194).
- 2.3 At the time of the Watching Brief the area to be watched consisted of open waste ground bounded by a timber fence (Pis.1 and 2)

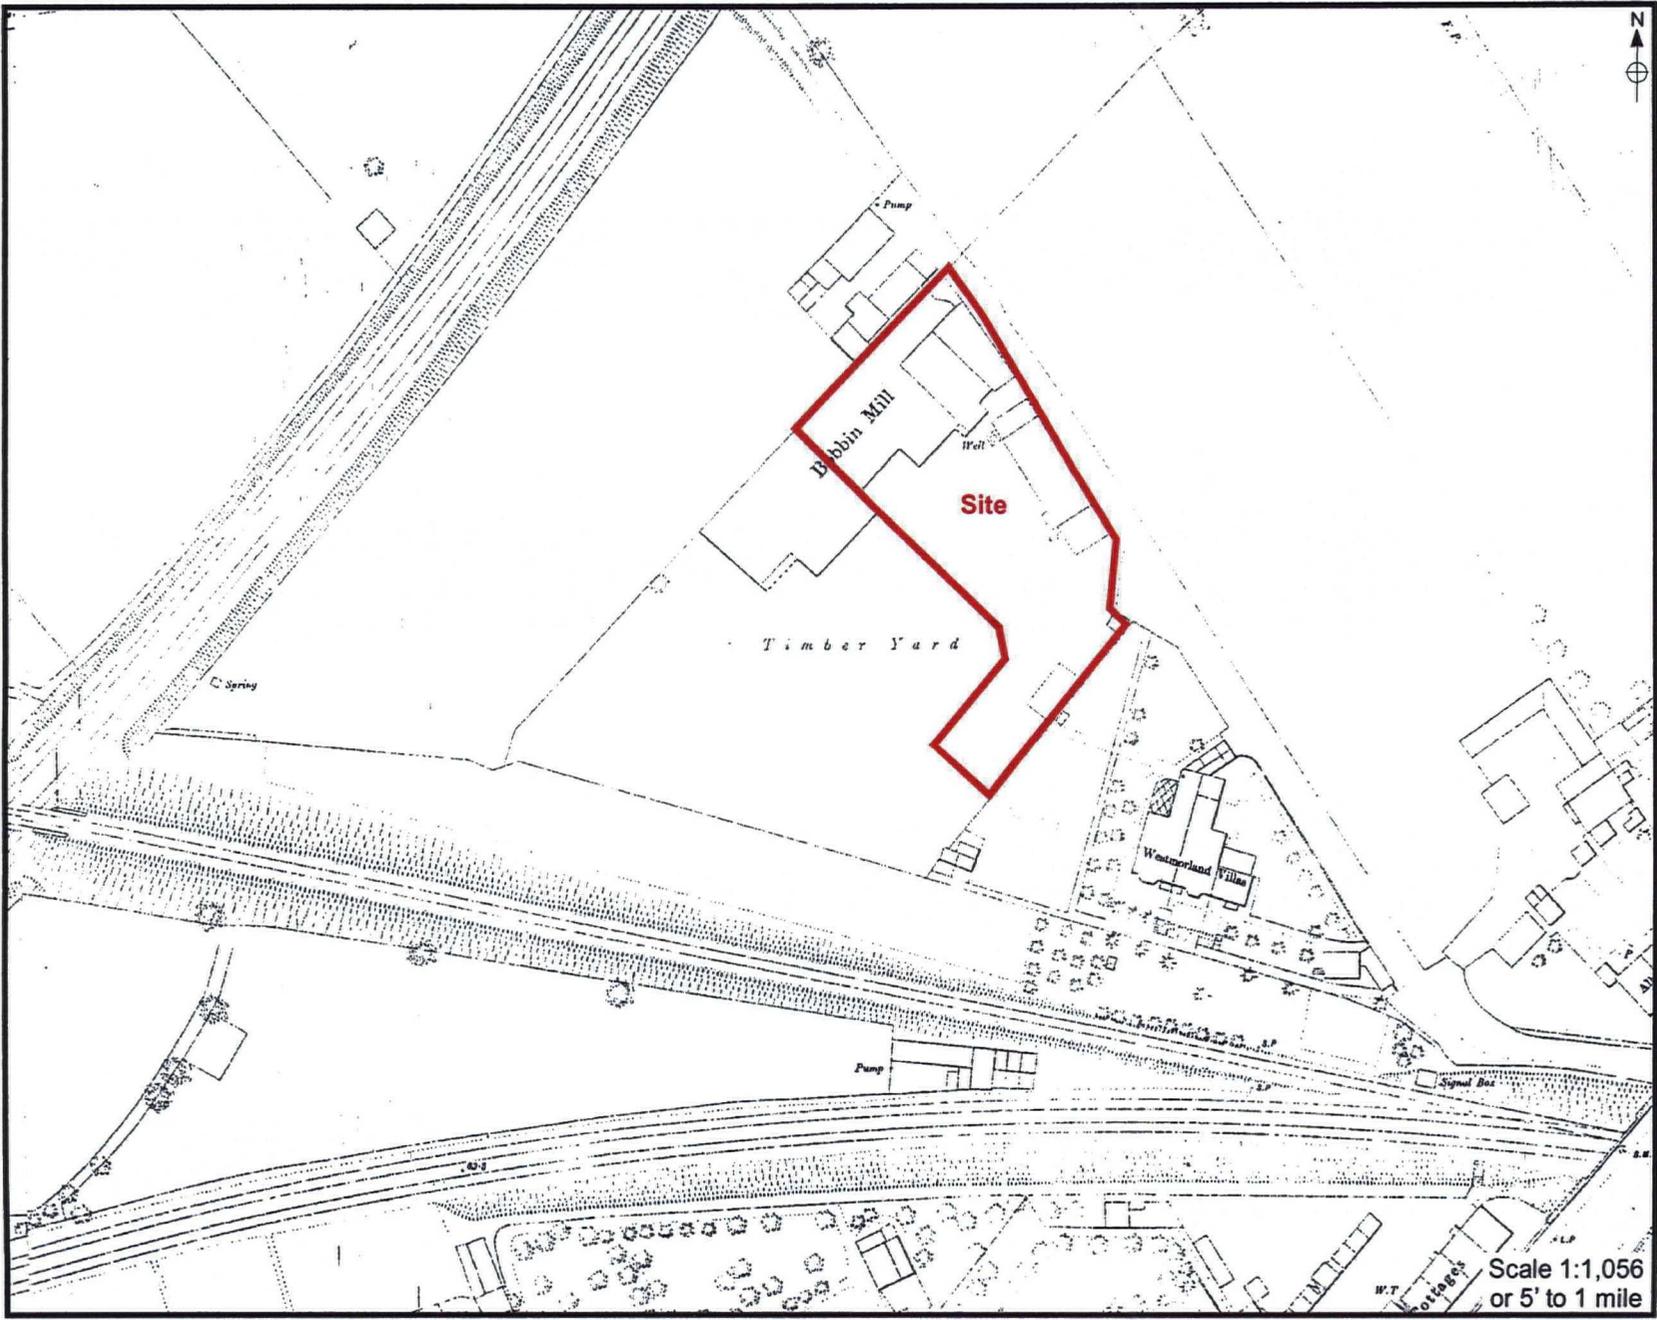
Figure 3. Extract from the 1890 Edition Ordnance Survey Map

- 3.6 The 1890 Ordnance Survey map records a series of buildings on the site, including a “*Bobbin Mill*”, surrounding a walled timber yard (Fig. 3). The map also shows the location of a well, close to the north-east entrance of the site. To the north-west lies the Malton to Scarborough railway, and immediately to the south of the site lies the Thirsk-Malton-Driffield branch of the York, Newcastle and Berwick Railway. To the north east, the site is bounded by enclosed fields that appear to be associated with Providence Row and Brunswick Row, properties situated on the northern side of the Malton to Scarborough road.

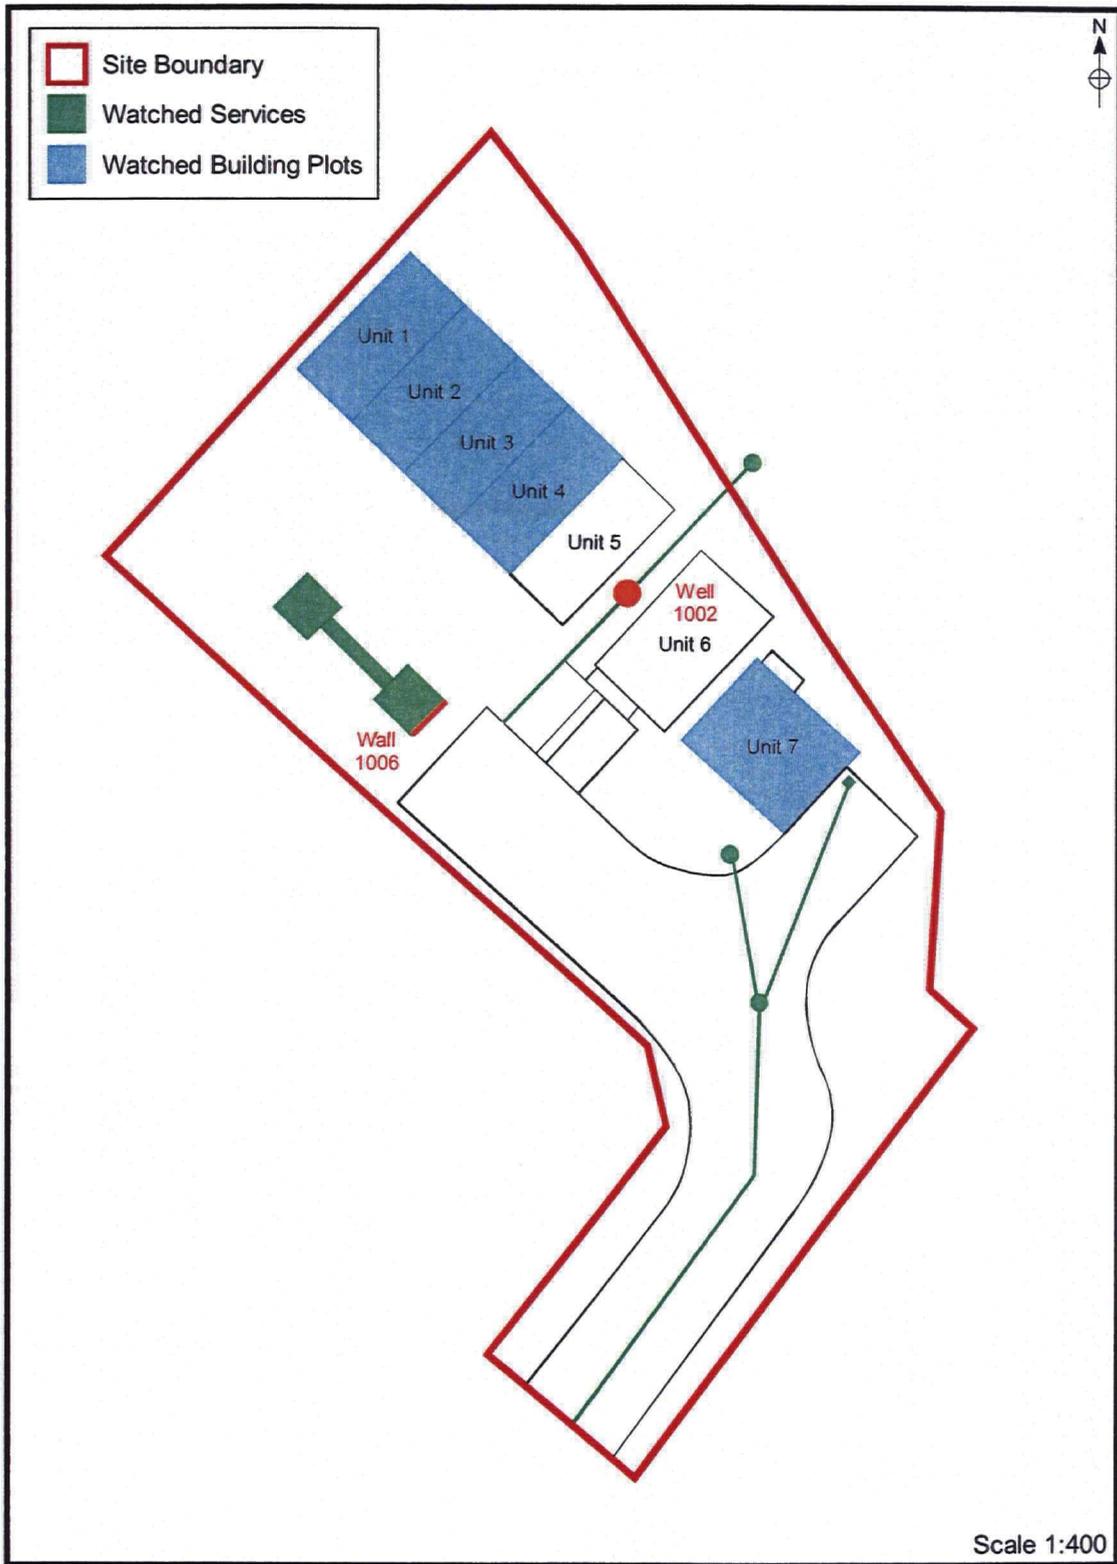
Figure 4. Development Plan and Watched Areas

6. Results (Fig. 4)

- 6.2.1 The foundation groundworks consisted of a series of strip trenches for each of seven house units (Plots 1 to 7). Plots 1 to 5 measured 9m x 4.5m, whilst Plots 6 and 7 measured 14m x 9m. All the foundation trenches were excavated to a mean depth of 1.10m (Pis. 4, to 9).

- 6.2.4 Undisturbed deposits of naturally-formed clay (context 1004) were seen in the base of both soakaways at a depth of 2.40m below existing ground level. Situated immediately above Deposit 1004 was a deposit of natural sand (context 1005) that was sealed by Subsoil Deposit 1003. Deposit 3003 was truncated by deep modern brickwork that was partially exposed in the eastern corner of soakaway no.1 and the southern corner of soakaway no.2 (context 1006). Structure 1006 probably represented the remains of modern cellarage and was sealed by a layer of modern concrete (context 1007).
