LAND TO THE REAR OF 23 FINKLE STREET, SELBY.

REPORT ON AN ARCHAEOLOGICAL WATCHING BRIEF
OSA REPORT No: OSA07WB02.

JULY 2007.

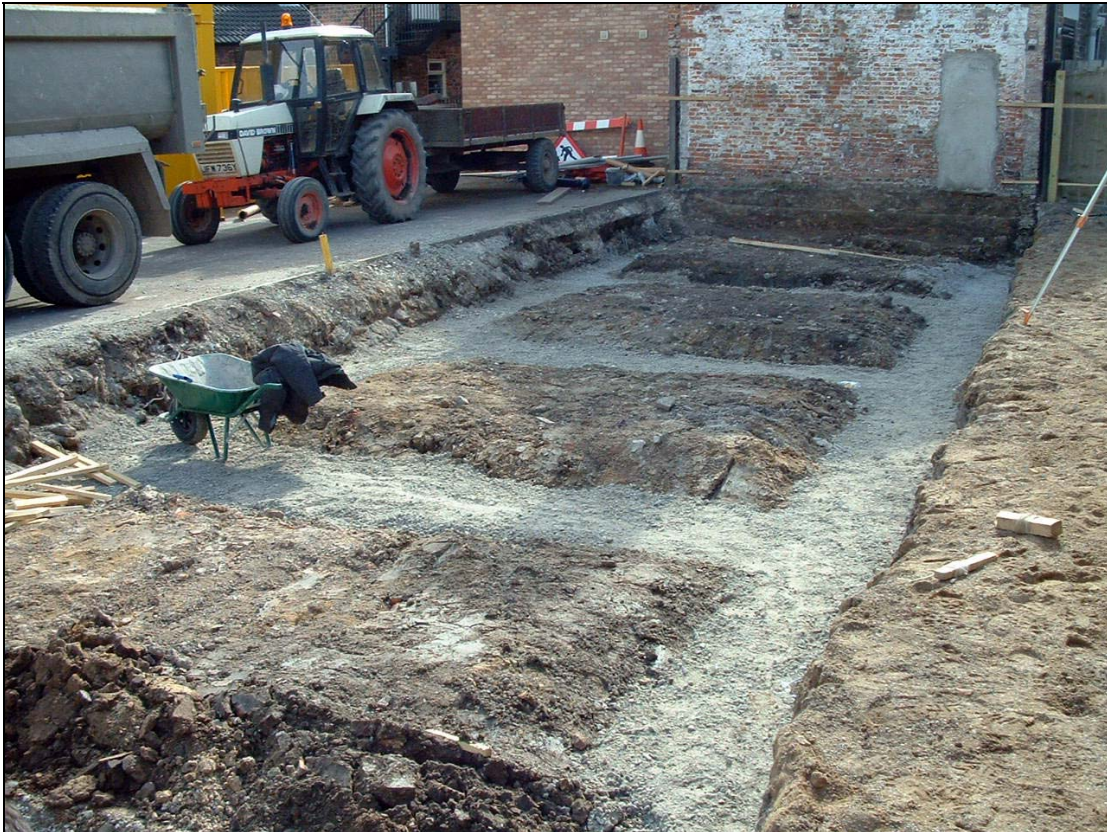
Plate 1. Photo showing the shallow nature of the raft foundation.

Excavation for the new build properties and associated bike store revealed a range of modern disturbances within their relatively shallow depth of c1m below existing ground level. The natural soils were not generally encountered within the excavation area. The bulk of the lower deposits encountered were a complex and disturbed series of rubble heavy demolition spreads from the in-situ destruction of brick built structures. This raked material was subsequently cut by a whole range of ceramic drains, gully's and modern foundation stretchers. As a consequence of the intensity of modern activity the archaeological strata was heavily truncated within the excavated depth of the trench.

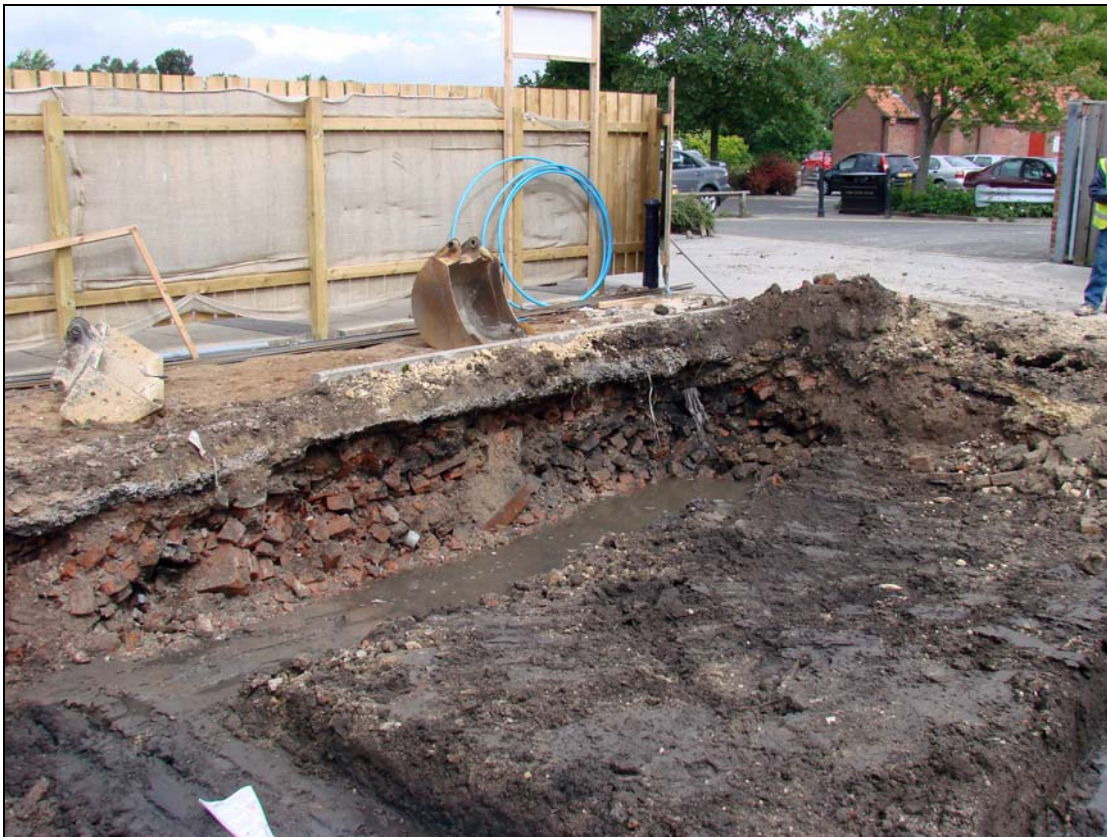
Plate 2. Photo showing the truncation at northernmost end.

The natural soils were not generally encountered but, when they were (mainly at the northern end) they consisted of a red brown clay (1007)
