**ALDENE, BACK LANE, ALDBOROUGH
BOROUGHBRIDGE, NORTH YORKSHIRE**

Planning Reference 6/64/11D/FULL

Scheduled Monument Number 436

ARCHAEOLOGICAL WATCHING BRIEF

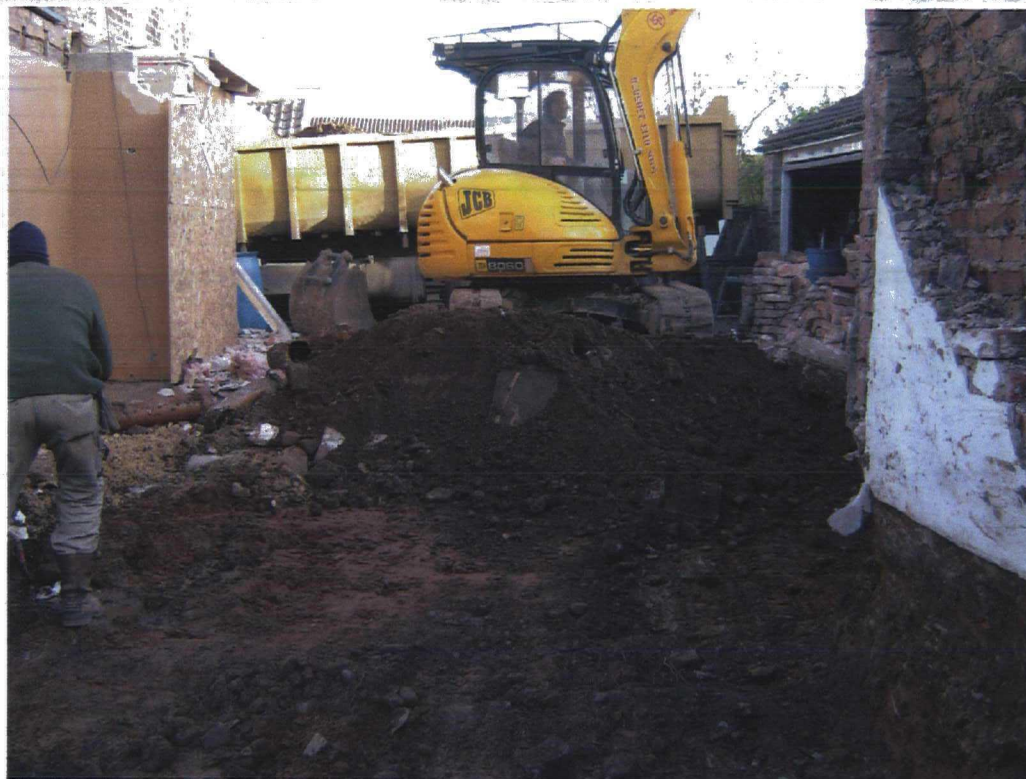
Plate 1 General view of site looking east during ground reduction.

4.1 After the demolition of the existing extension, the previous footings and floors were removed using a tracked mechanical digger with a toothed bucket. Once the building rubble had been removed, the ground reduction, footings and services work was undertaken by the contractors using a tracked mechanical digger with a toothless bucket under direct archaeological supervision (Plates 1 & 2).

5.1 The watching brief was generally negative due to the extensive ground disturbance for the erection of the earlier extension in 1997. Due in part to this ground disturbance and the subsequent restoration after the 1997 extension was built, it was impossible to determine if any earlier ground surfaces survived (Plates 1 & 2).

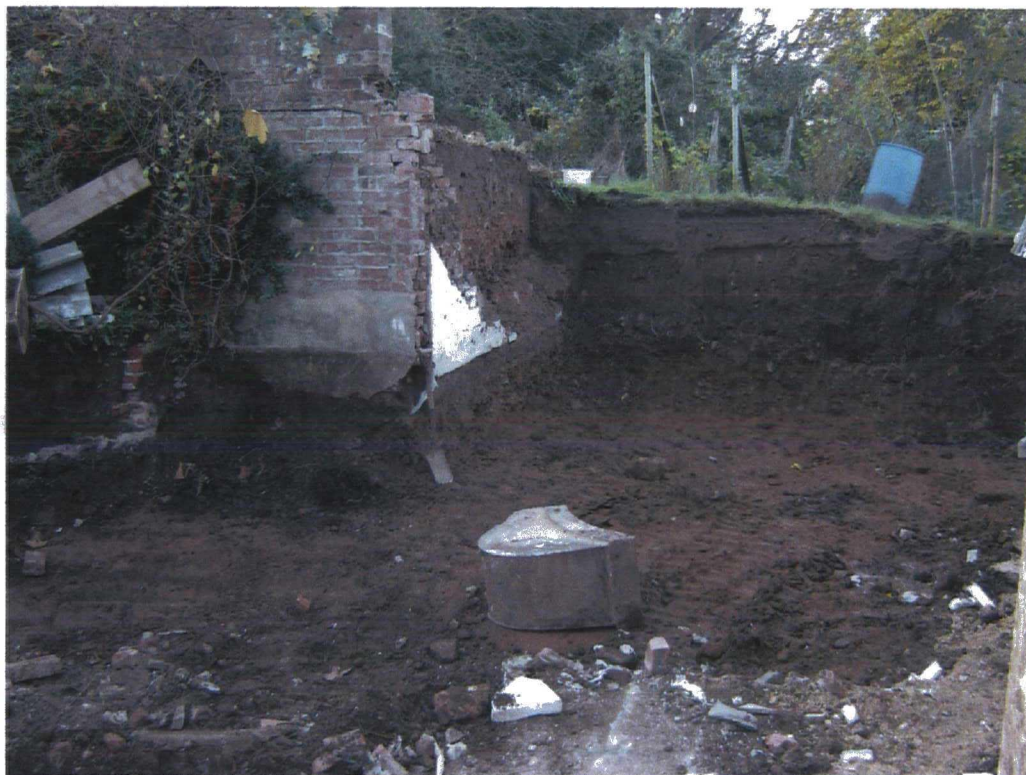
Plate 2 General view of site looking west during ground reduction.

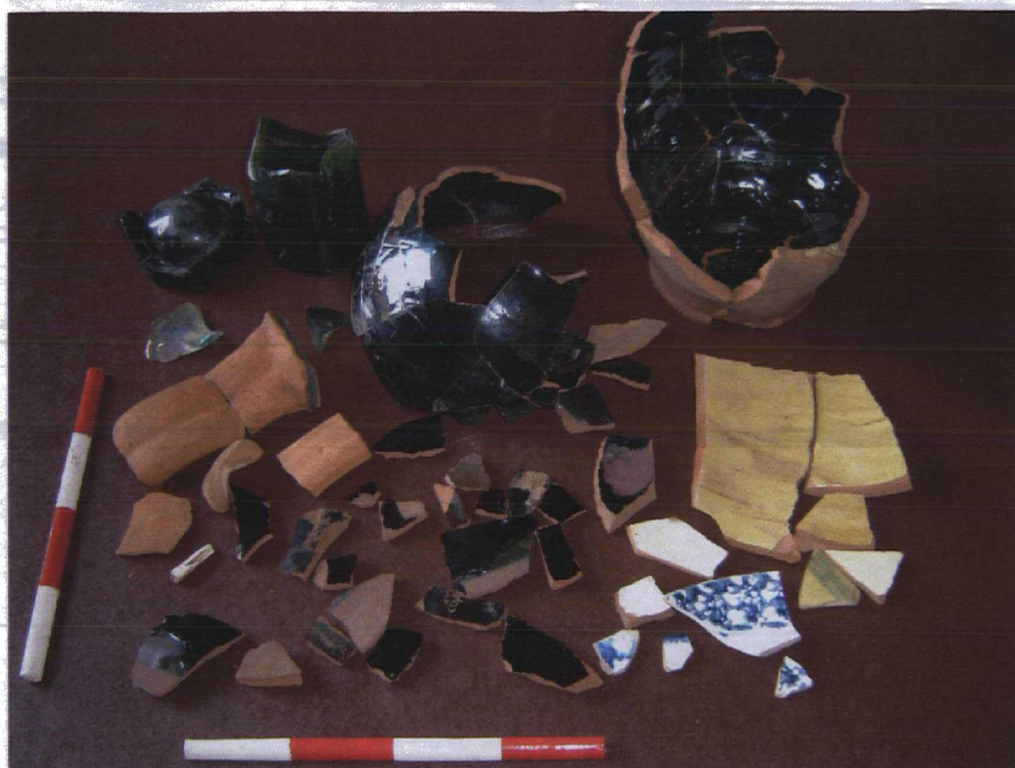
- 5.5 Within this re-deposited material a partially complete late 18th century back coarseware ceramic flask was encountered, unfortunately by the bucket of the machine (Plate 3). This suggests that a midden type deposit is, or was, close by. From the amount and spread of the post-medieval/Victorian material it appears quite possible that this material was originally spread across the 'yard' area as a simple form of surfacing. Two small sherds of undecorated Roman Samian pottery were recovered from the backfill of the service trench for the 1997 extension (Plate 4).

Plate 3 Post-medieval finds assemblage. Scales 0.2m.

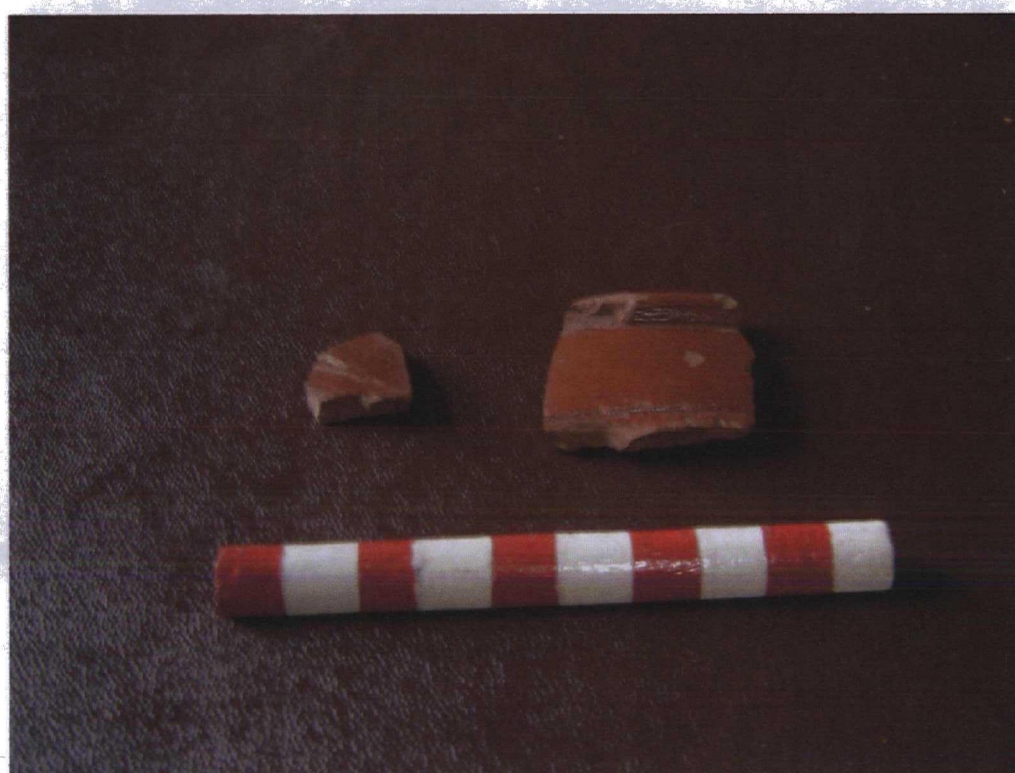
- 6.1 The small amount of mainly late post-medieval/Victorian artifactual material was recovered during the ground reduction; unfortunately all of it appears to have been re-deposited. The earliest material was two sherds of Roman Samian pottery one of which was a rim fragment, probably from a 16cm diameter bowl (Plate 4).
- 6.2 As already mentioned, a partially intact coarseware flask was heavily fragmented during machining and was found along with fragments of two substantial ceramic strap handles, blue and white transfer printed plates and similar 19/20th century material (Plate 3). In addition to this the bottoms of two 19th century green glass bottles were recovered. One was completely plain whilst the other was a two-piece mould made bottle with a manufactures mark of WE in the base and a vendors/product name ofDGSON HARROGATE on the side.

Plate 4 Roman Samian pottery. Scale 0.1m.
