**27 WOOD STREET
NORTON
NORTH YORKSHIRE**

**ARCHAEOLOGICAL EVALUATION
NGR SE 7942 7129**

An Archaeological Evaluation was undertaken at Wood Street Garage, which is located on the north side of Wood Street, Norton, North Yorkshire, in advance of a proposed development.

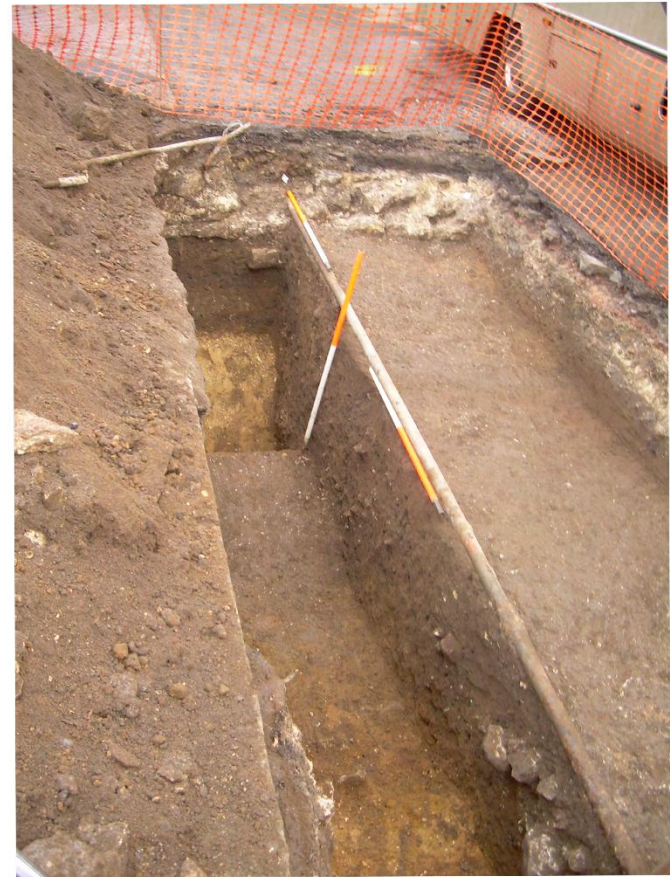
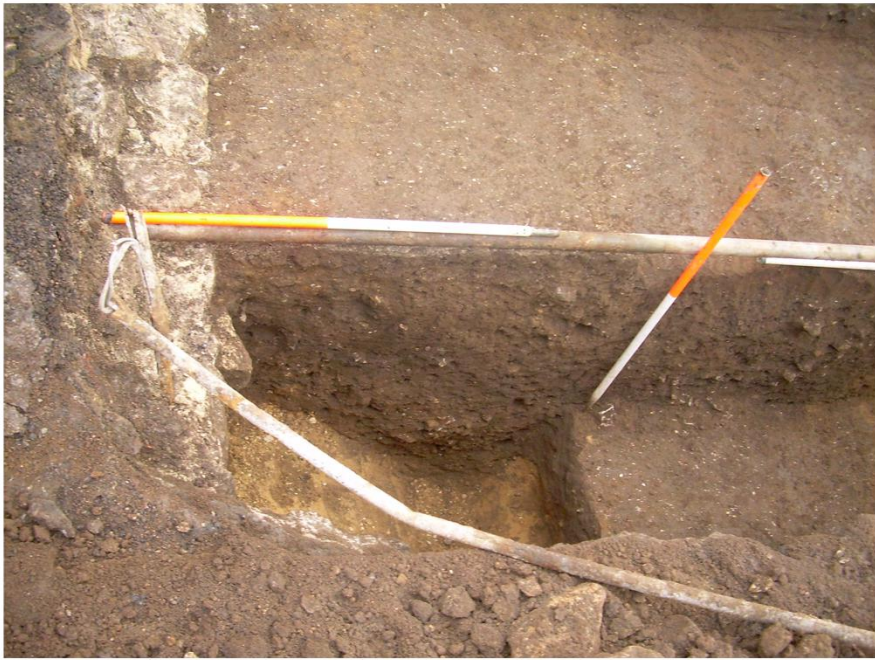
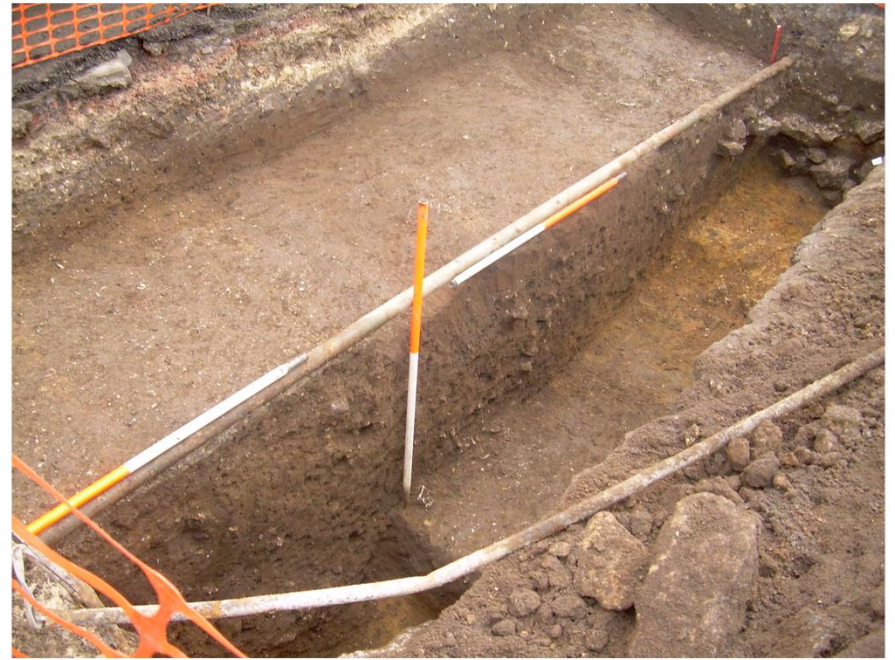
6.2.3 The natural deposits were cut by a massive east-west aligned ditch (2016 – Pls. 4-6) that was at least 5m in width and 1.20m deep. Ditch 2016 had a V-shaped profile with a slot in the base. Deposits 2015, 2017 and 2018 were recorded on the ditch's southern edge, Deposit 2017 being distinguished by a high content of sub-angular limestone rubble. Deposit 2018 contained Greyware, calcite-gritted and Samian sherds ranging from 1st to mid-3rd century in date (Appendix 2). The central part of Ditch 2016 was filled by a homogenous deposit of brown sandy silt (2013) which contained Greyware, calcite-gritted, Oxidised coarseware, Samian and amphora sherds of 1st/2nd century date (Appendix 2). The northern side of Deposit 2013 was overlain by an extensive layer of brown silty sand (2012), with more stony material with a similar matrix (2014) on the southern side. Between them Deposits 2012 and 2104 contained Greyware, calcite-gritted, Parisian and fineware sherds of 1st/2nd century date (Appendix 2).

Plate 4. Ditch 2016. Facing North-east.

Plate 5. Ditch 2016. Facing East.

Plate 6. Ditch 2016. Facing South-east.

- 7.2 The projected line of the Roman road from Norton to Settrington runs obliquely across Wood Street, passing close to the southern boundary of the site. There can be little doubt that Ditch 2016 was the northernmost of the roadside ditches associated with the Roman road. It is possible that the rubble deposit (2017) at the trench's southern limit was part of the foundation of the road.
