Fingill Mill, Darley, North Yorkshire: An Archaeological Building Assessment

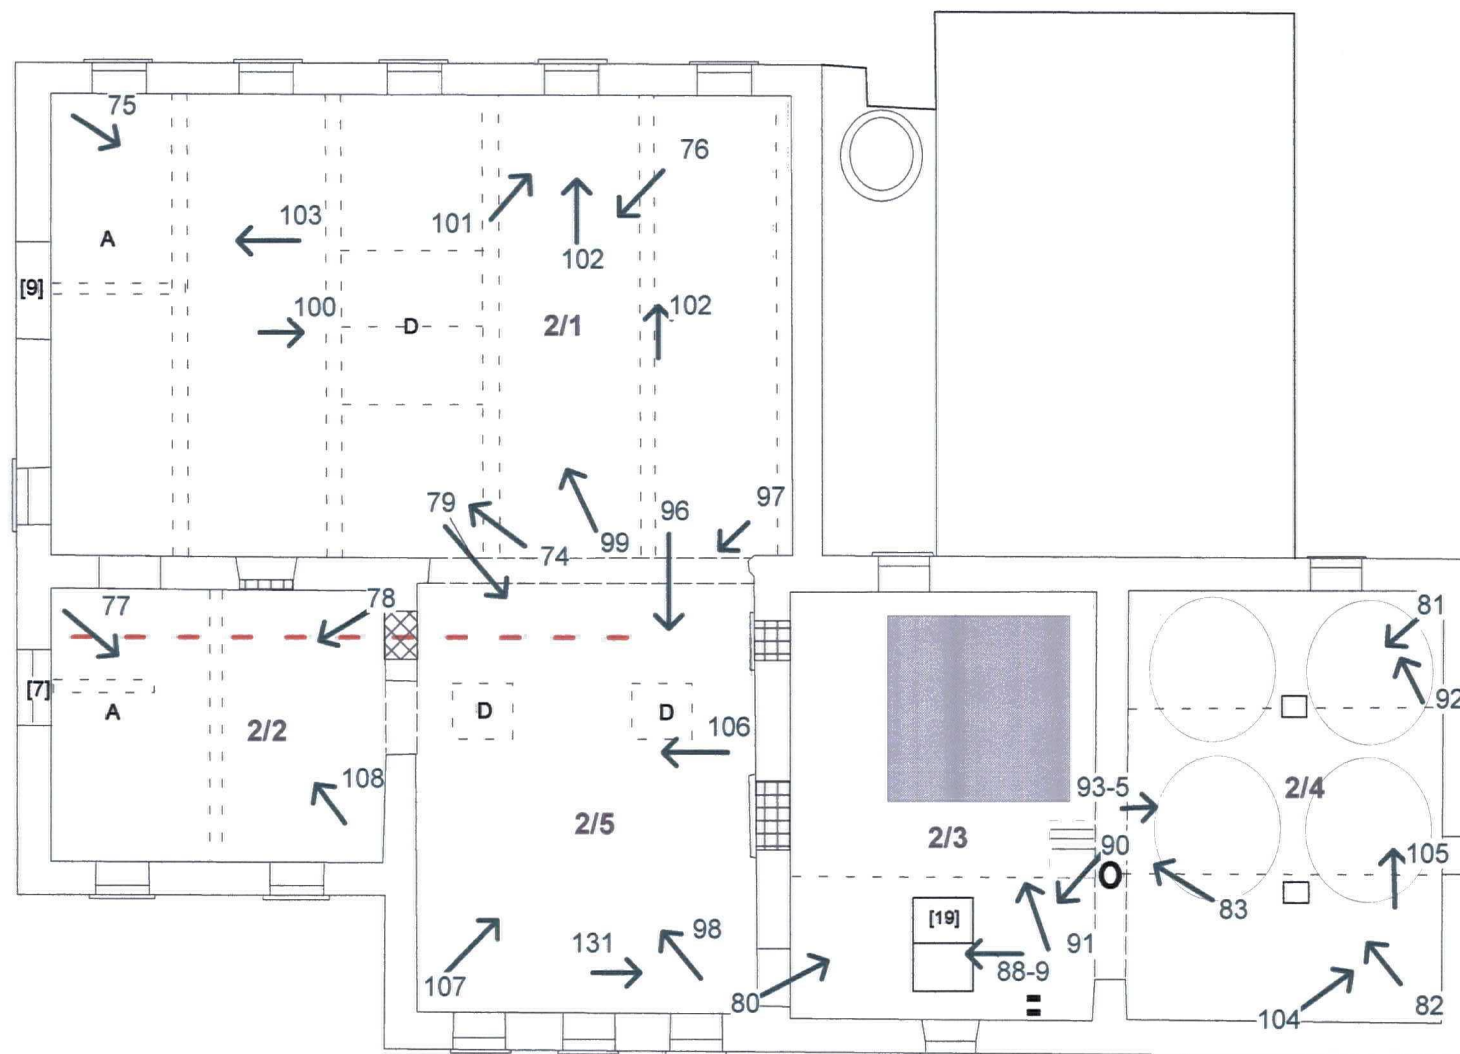
**Figure 9: Floor Plan
Level 2**

- 21 → Photo position, direction and location No.
- 0/1 level/room number
- drive shafts
- - - possible drive shafts
- ▨ bearing boxes
- ▣ probable bearing box with cast iron frame and location bolts
- ▧ blocked openings
- modern feed store
- - - reflective ceiling plan
- removed floor
- cast iron column (re-used)
- A - sliding hoist
B - removed firedoor (lies adjacent)
C - inserted loading door
D - skylights
- [9] Original, phase 1 loading door
[19] Trapdoor
