**Gaza Barracks, Catterick Garrison,
North Yorkshire**

archaeological building recording

Report 1679

June 2007

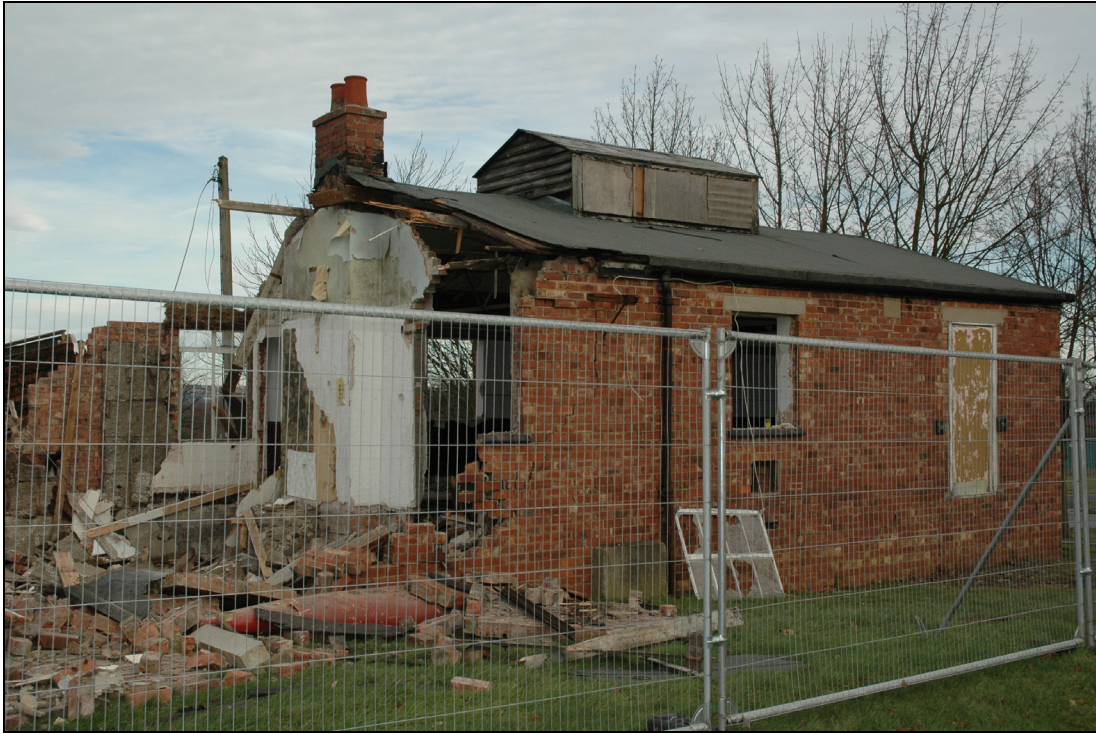
Figure 3
Building 14, during demolition, looking south-west

- 4.2 This building was in the process of demolition when it was recorded. It was a small red-brick accommodation block of a standard form; a single-storeyed single-span gabled structure with metal-framed windows and a pair of fireplaces or stoves on an internal wall. The window and door lintels were concrete and the low-pitched roof was felted. There was a wooden ventilator box on the roof of the western part of the hut.

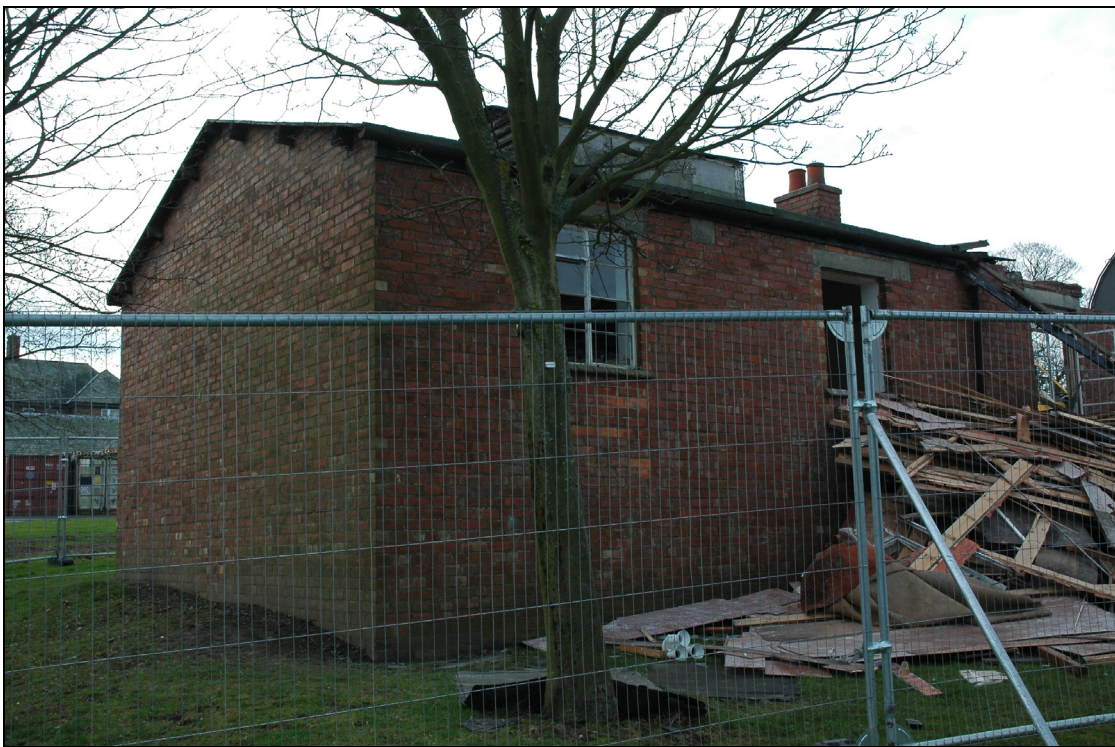
Figure 4
Building 14 during demolition, looking north-east

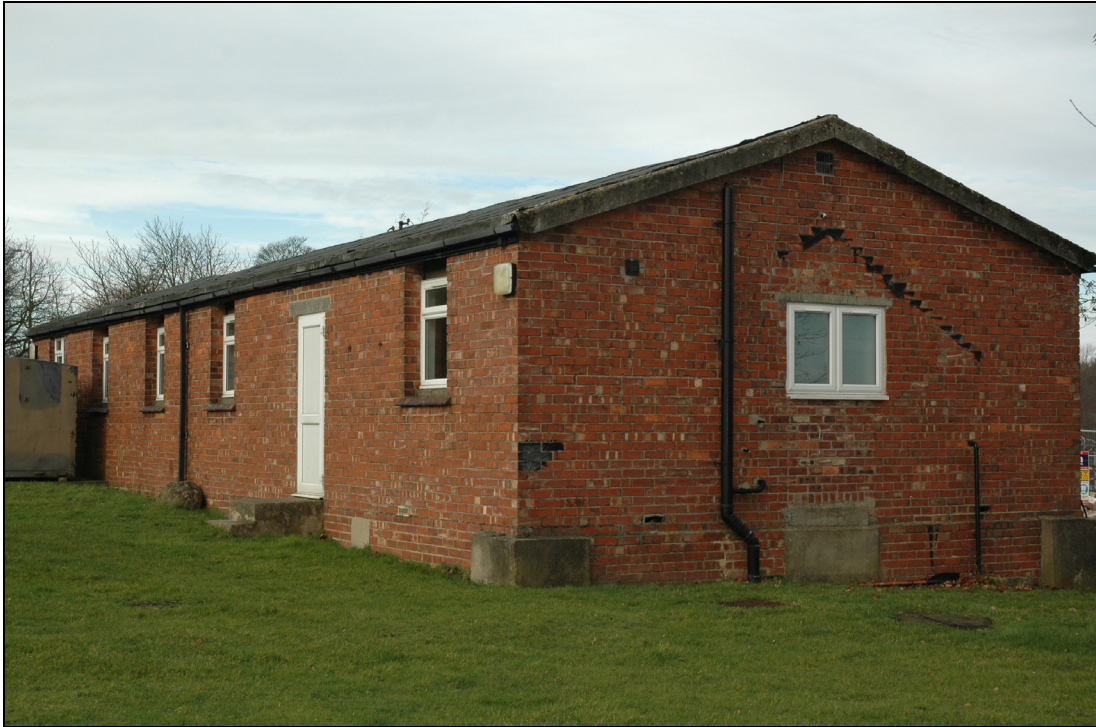
Figure 5
Brick hut, building 15, looking north-west

- 4.3 A smaller version of building 14 to the north. This hut had been in use by the Catterick Detachment of the Yorkshire Army Cadet Corps. The north and south walls had six bays, with the original windows replaced by double-glazed uPVC units. A vehicle door in the west gable had been filled and replaced with a standard door; both openings had concrete lintels. There was another door towards the east end of the south wall and a small window in the east gable. Paint marks on this wall showed that a gabled shed was once attached to the wall here.

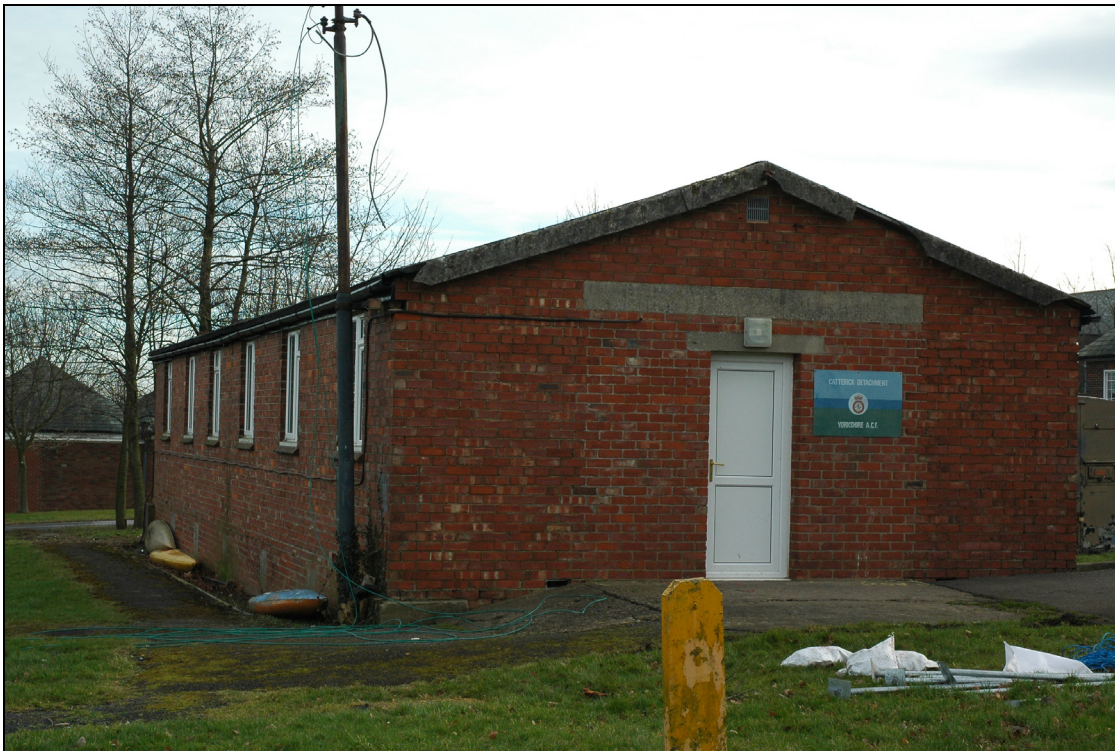
Figure 6
Brick hut, building 15, looking south-west

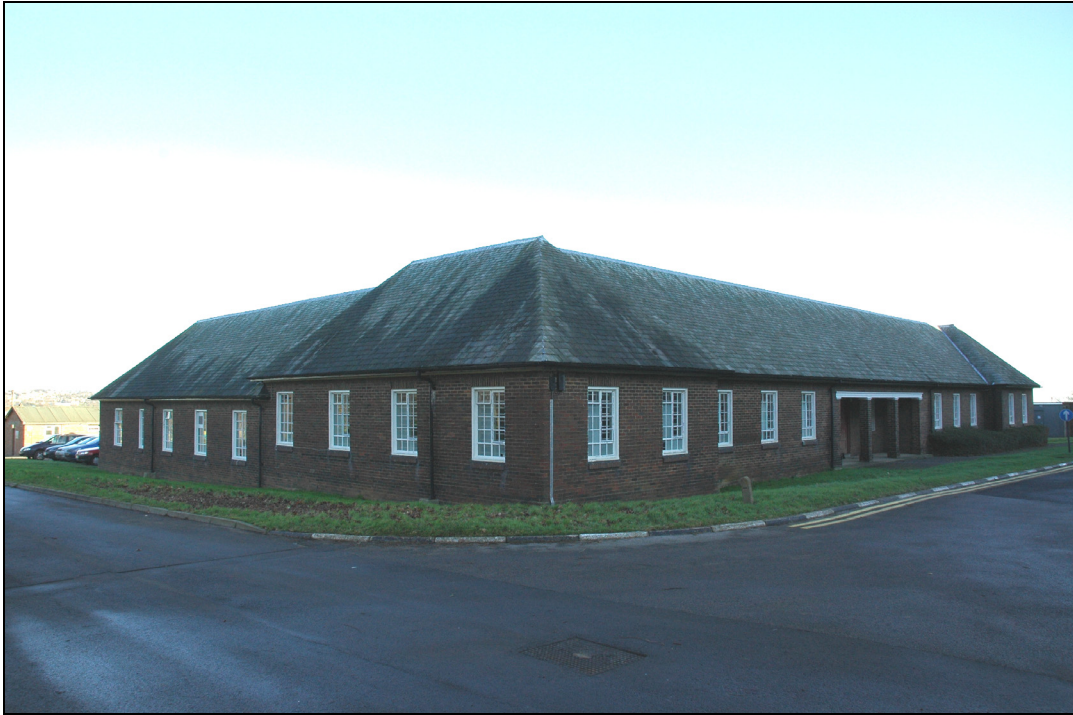
Figure 7
QM Stores, Building 16, looking north-east

- 4.4 This was a single-storeyed brick structure of three ranges set around a yard. The walls were built of brownish brick and the hipped roof of green Westmorland slate. There were canopies on the internal faces of the wings; that in the east range had been partly enclosed. The building was still in use as a store (Figures 9-12).

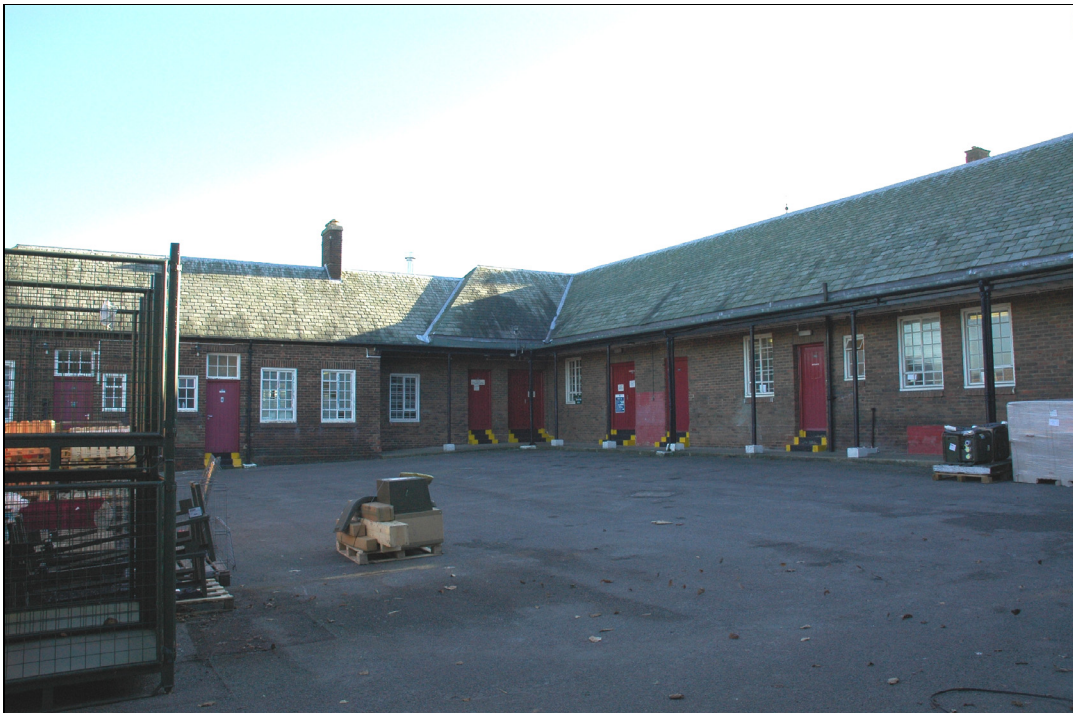
Figure 8
Building 16; courtyard, looking south-east

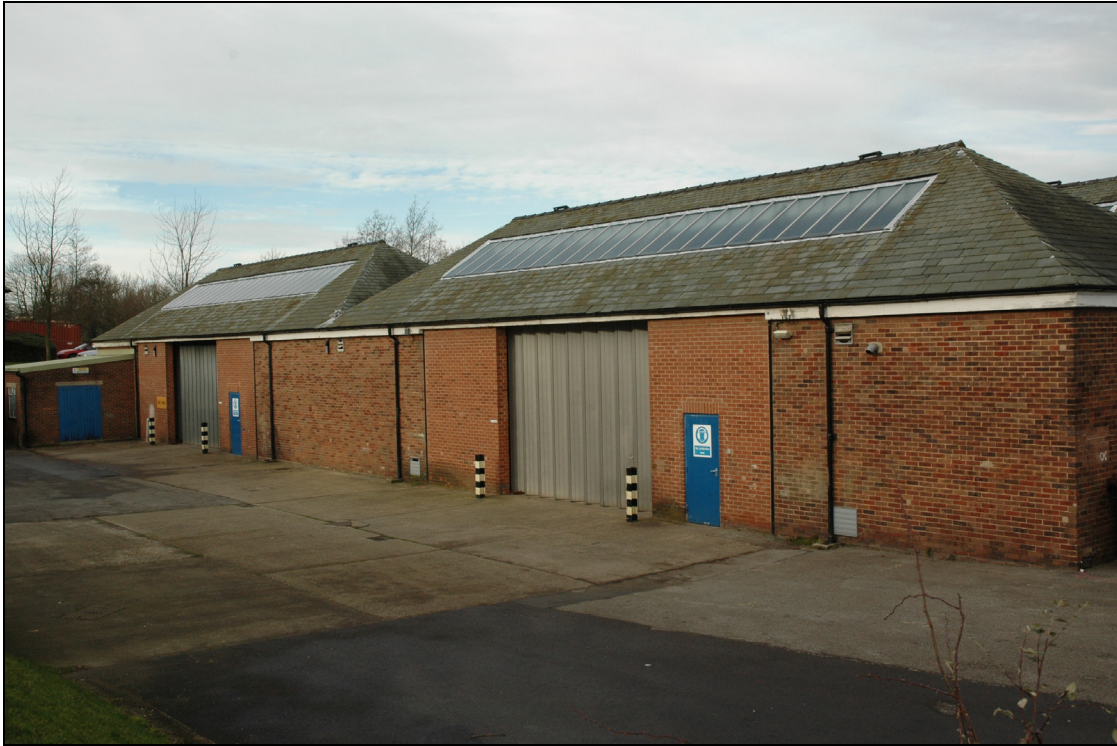
Figure 13
Garage building 17, looking west

- 4.5 An L-shaped brick building, formerly for armour and later used for wheeled vehicles. It had a slate roof in nine hipped cells, with skylights in the south slopes. The original brown brick had been altered by the insertion of red-brick leaves to reduce the size of large vehicle doors in the north and south walls. The later doors had exposed RSJ lintels and roller-shutter doors.

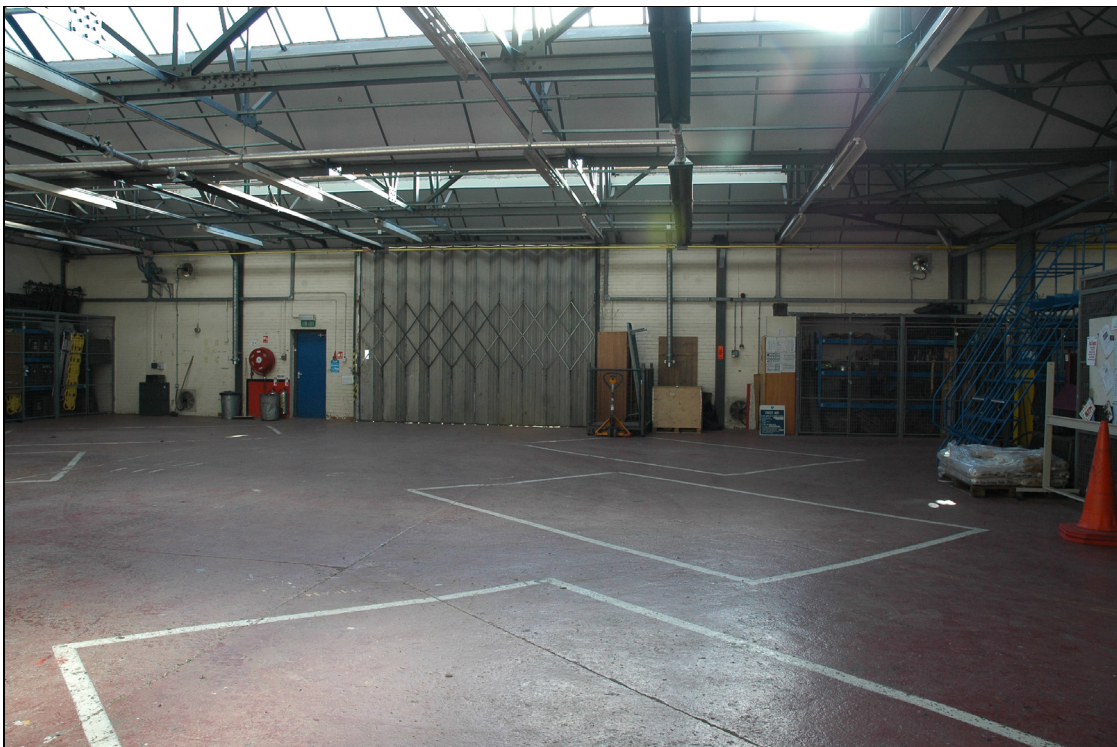
Figure 14
Interior, garage building 17

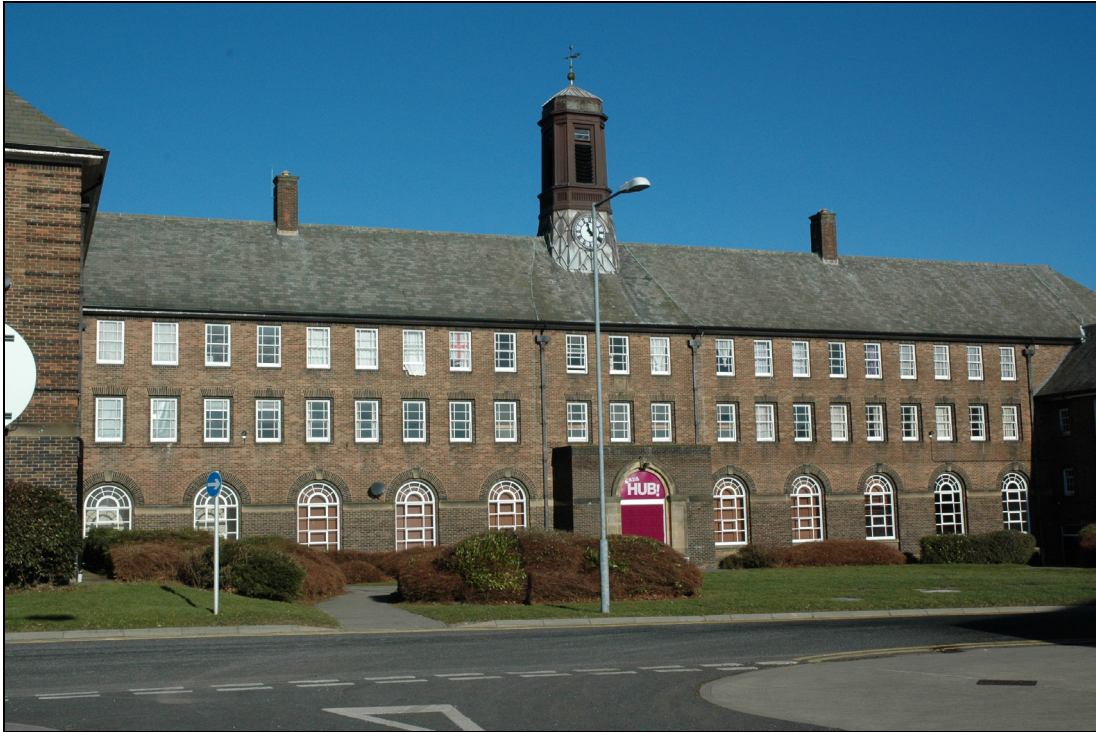
Figure 15
Sandhurst Block, 22, looking north at the central range

- 4.6 This imposing barrack block is the largest structure on the site; similar buildings are to be seen elsewhere in the Garrison, at Vimy Barracks / Druggon House and Helles Barracks to the south of Gaza, at Somme Barracks to the south-east and Bourton to the west. It is generally symmetrical in appearance, but because of the slope to the east the roof line changes across the principal (south) façade. The barrack comprises four similar east-west ranges set in a quincunx pattern round a central block, to which it is connected by narrower north-south sections. The whole building is made of the same brown brick and green slate seen in the other 1920s-1930s buildings. The plain angles have projecting brick quoins, and a modest amount of sandstone is used as dressings for entrances and other features.

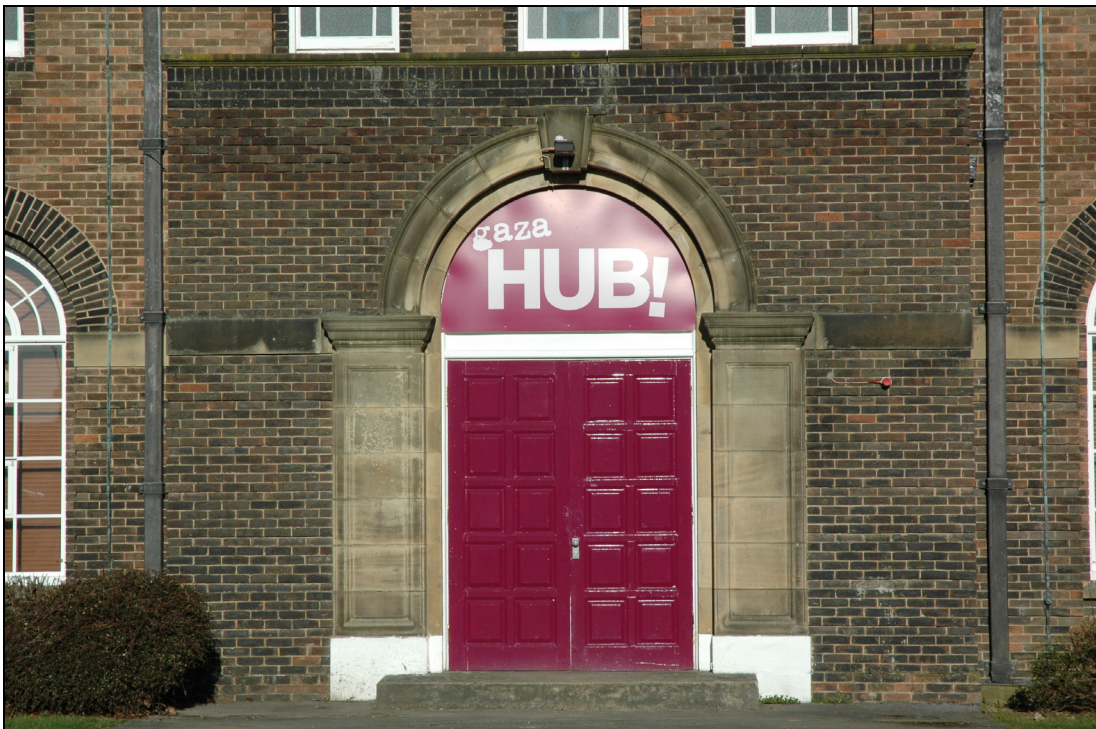
Figure 16
Sandhurst Block, 22; detail of main door

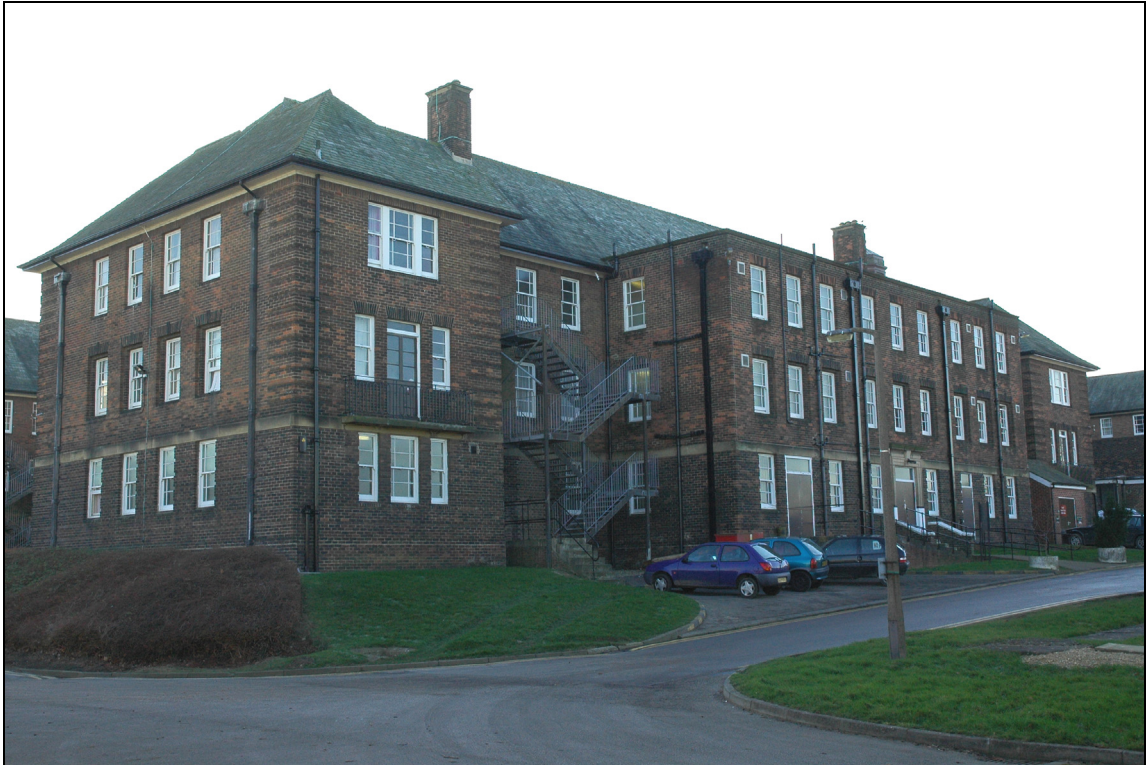
Figure 19
Building 22, looking SW at the rear of the NE range. Note the typical flat-roofed extension

end. These are four windows wide and are decorated with brick rustication below the sill band; there are balconies at first-floor level in the ends of the cross-wings. The roofs here are hipped. In the middle of each north face there is a projecting flat-roofed extension of nine bays, with a central door. These appear to be for bathrooms and lavatories.

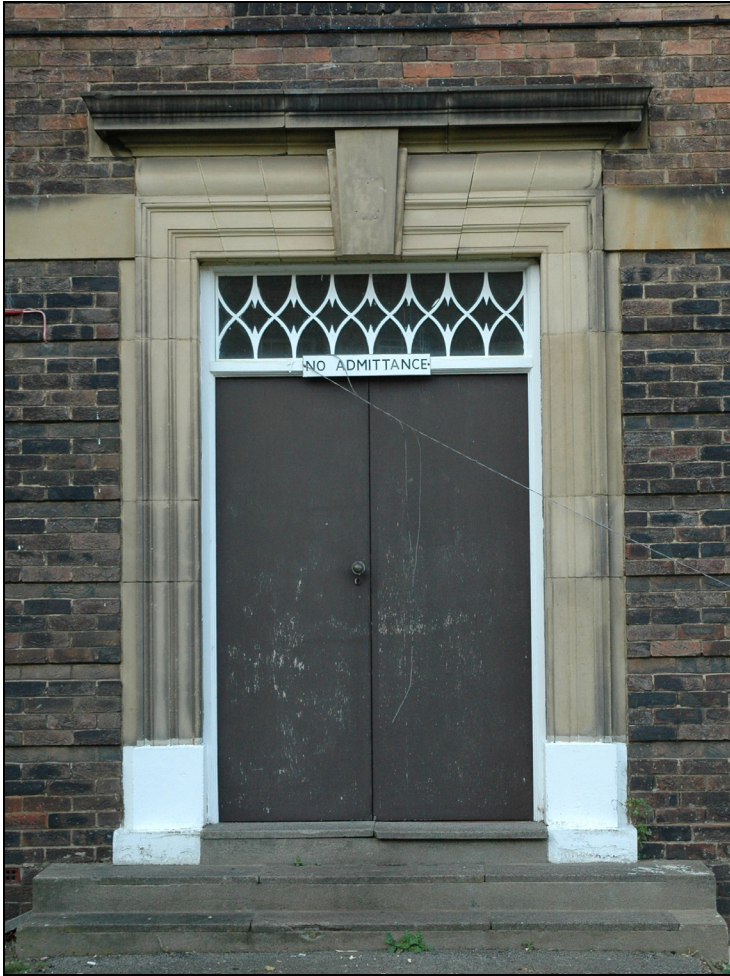
Figure 21
Building 22: central door on S face of the NE range, showing typical architectural details

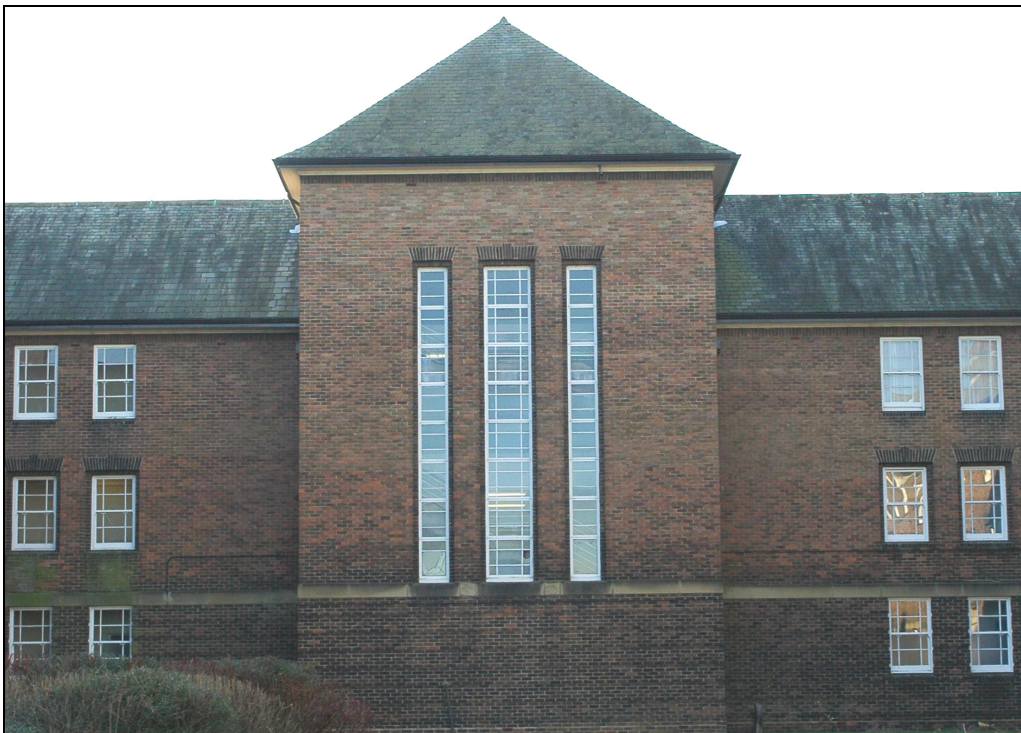
Below:
Figure 22
Staircase window in the east end of the central block of building 22

- 4.8 The central block is longer than the outer ones, as it houses staircases at either end. The form of the steel banisters and tall narrow windows here are a nod to the Art Deco style of their time (Figures 22, 24). The south, main face of the block has 21 windows on the first and second floors, while the ground floor has five tall arched windows on each side of a central stone porch with a broad round-headed door. Above there is a wooden cupola of wood and lead, with a clock. As in the outer blocks, there are two chimney stacks. At the rear there is a bathroom extension like those on the other blocks, but here of only seven bays. Below this is a flat-roofed single-storey extension for kitchens and stores.

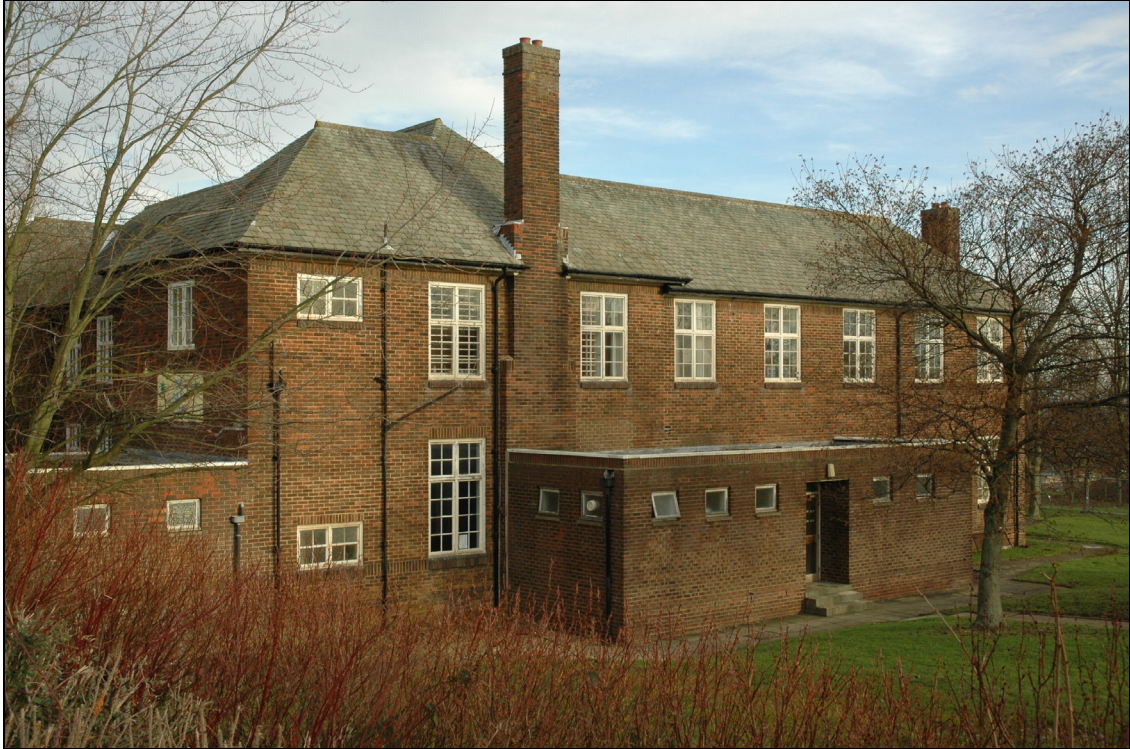
Figure 31
Building 23, the Gaza Club; looking north-east, showing flat-roofed extensions

- 4.10 This brick building could not be entered because of asbestos contamination. The exterior is similar to that of the other primary buildings on the site, though it has been added to all faces so that the original form is no longer clear. It is believed that this was formerly the gymnasium, NAAFI and junior ranks' club. The building has two storeys and is set a little below the level of the parade ground. It has two storeys and a hipped green slate roof. The plan has a pair of parallel east-west blocks joined by a north-south section near the west end. There are single-storeyed flat-roofed lavatory extensions on the east, west and south sides.

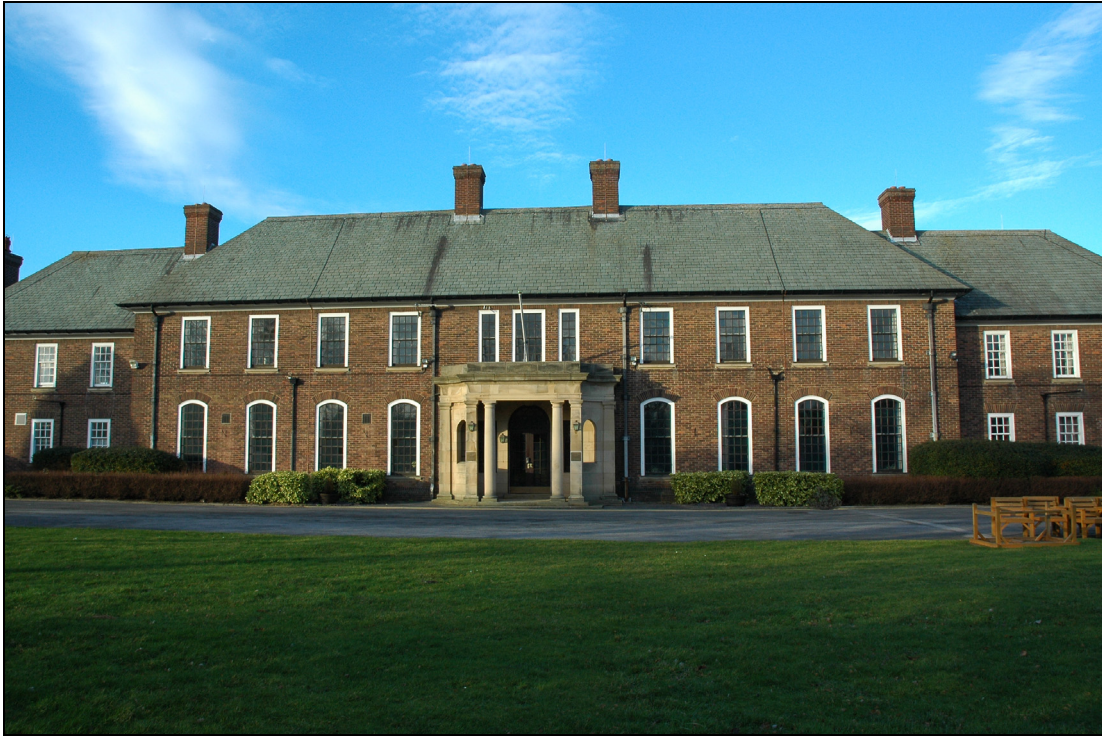
Figure 35
Principal front of building 28; the Officers' Mess, looking north

- 4.11 This two-storeyed brick building is the grandest example of the architecture of the period at the barracks. It faces south; the main face has slightly-projecting centre block of nine bays with tall segmental-headed windows on the ground floor. The upper windows have flat arches and stone sills above a brick string course. The central sandstone porch has Tuscan Doric columns and flat pilasters; the curved walls at either side have arched openings. The roof is hipped and has two big brick stacks. At each end there is a three-bay wing, slightly lower than the centre. These have casement windows with stone sills and a string like that in the main block. The roofs are hipped; there are chimney stacks in the end walls and close to the central block.

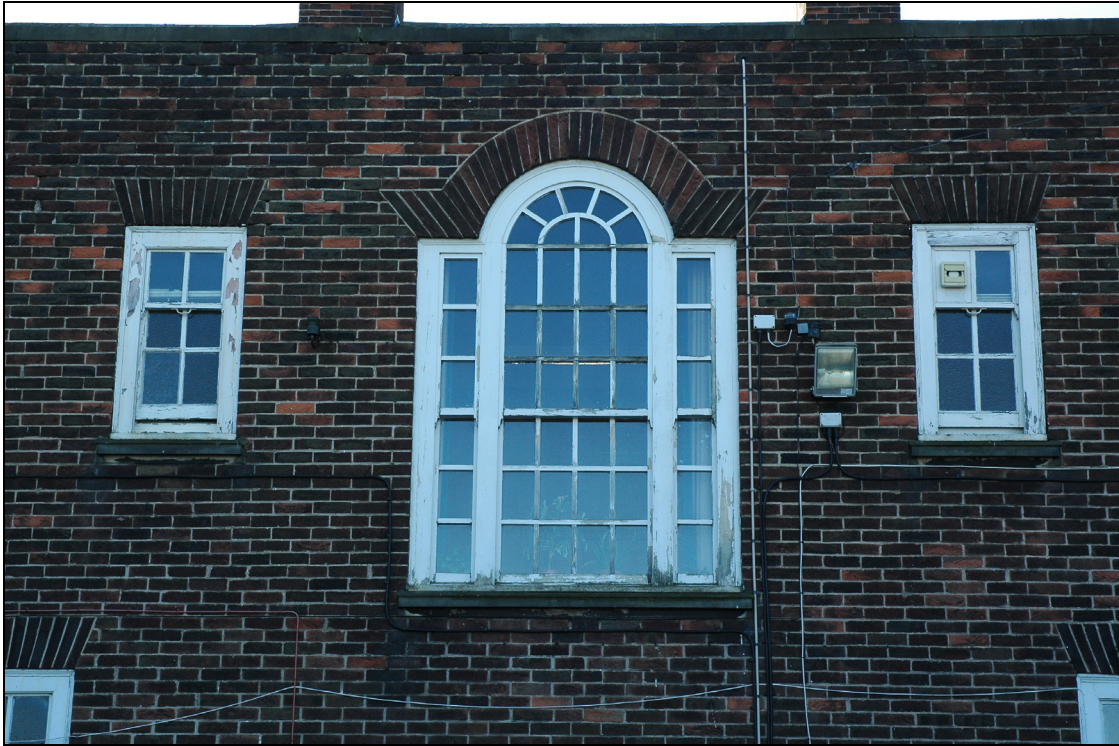
Figure 39
Officers' Mess; Venetian window on staircase

- 4.12 Two rear wings are built in the same style; they flank a yard with a low screen wall joined to small service buildings. The west wing has 11 windows and a door near its north end, where it widens to form a nine-bay square block. The west wing is narrower and has ten windows. A central Venetian window lights

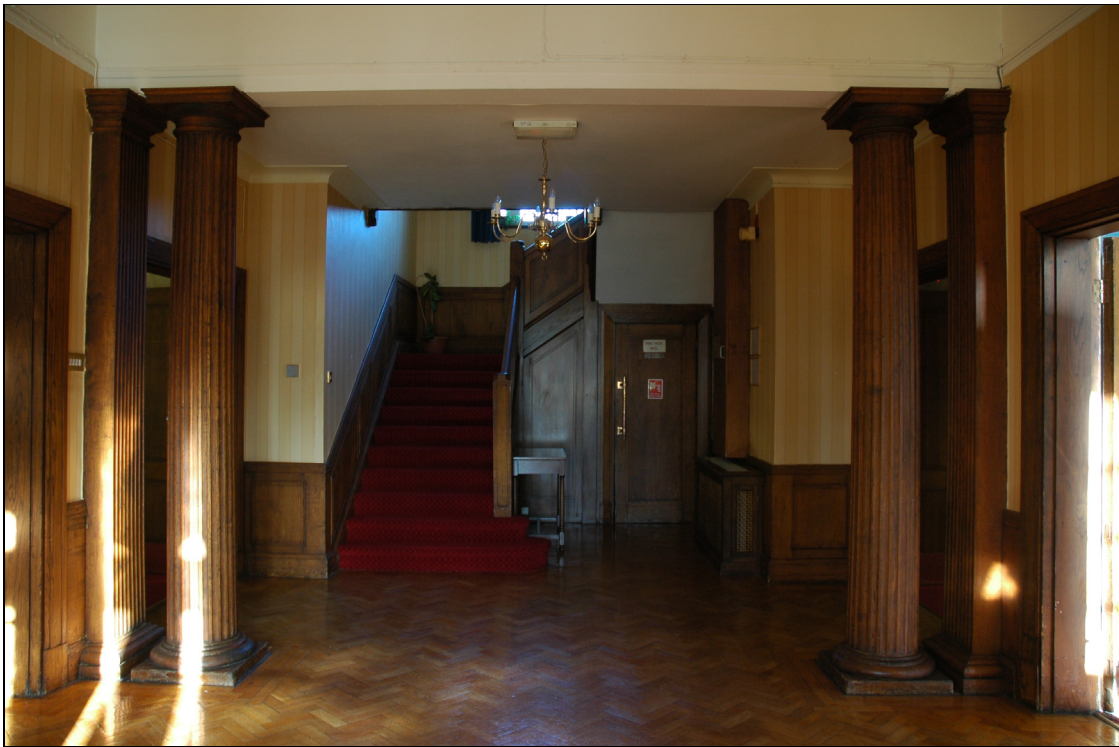
Figure 40
Building 28; the hall of the Officers' Mess

the staircase in the main block. Inside, the hall has a screen of wooden Doric columns and pilasters in front of the well stair (Figure 40).

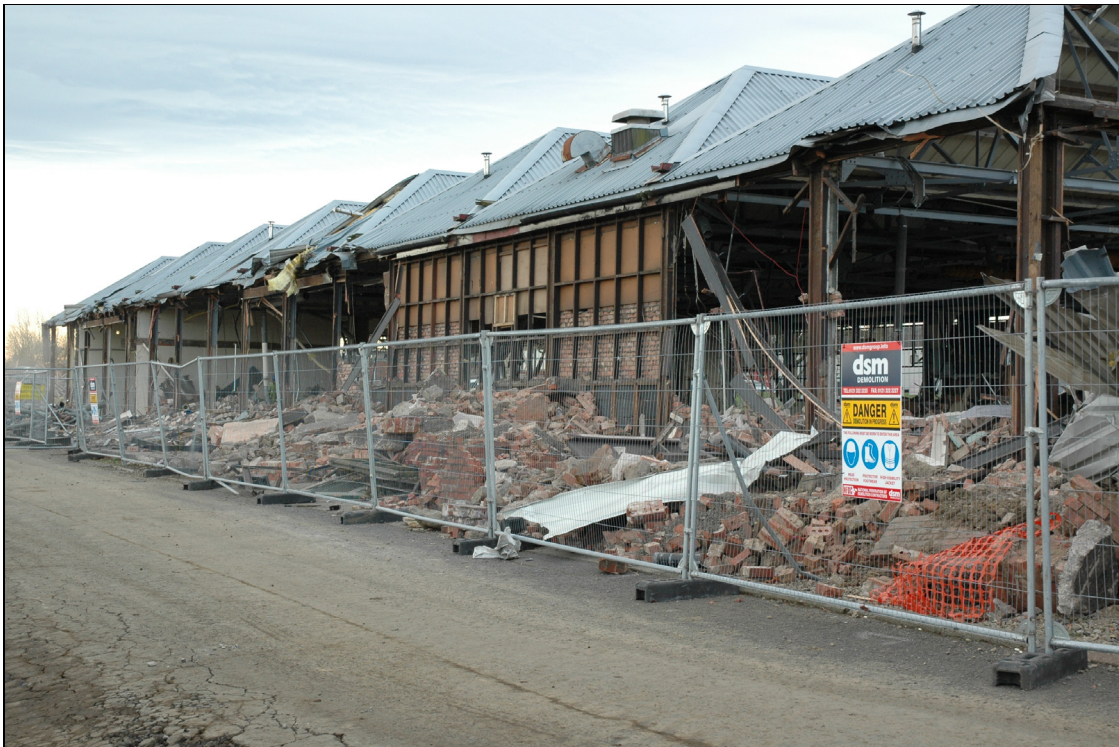
Figure 44
Metal-clad shed, building 37, during demolition. View looking south-west

- 4.13 This building, at the north-east corner of the site, was used for vehicle repairs. Fenced compounds outside store gas and were used for acetylene for welding on bays at the north end of the shed. The building was being dismantled when it was recorded (Figures). This part of the site also had concrete and steel ramps for vehicle maintenance, and fuel storage tanks.

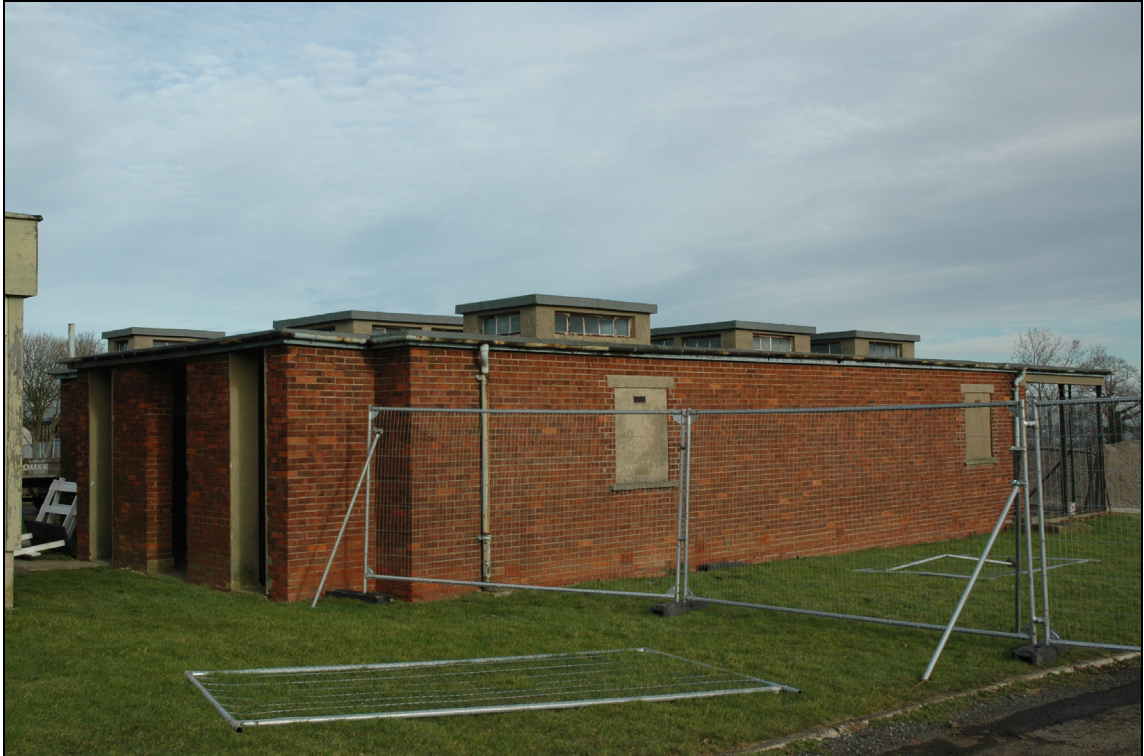
Figure 48
Brick store, building 48, looking north-east. Note the clearstorey windows

- 4.15 A small brick structure with a flat concrete slab roof. The windows had been blocked up and the interior was lit by a number of flat-topped clearstorey projections. The east end of the roof was extended to form a storage area screened with wire mesh. The function of this building is uncertain, but the overhead lighting and the location suggest that it was a store for materials or fuel for vehicles.

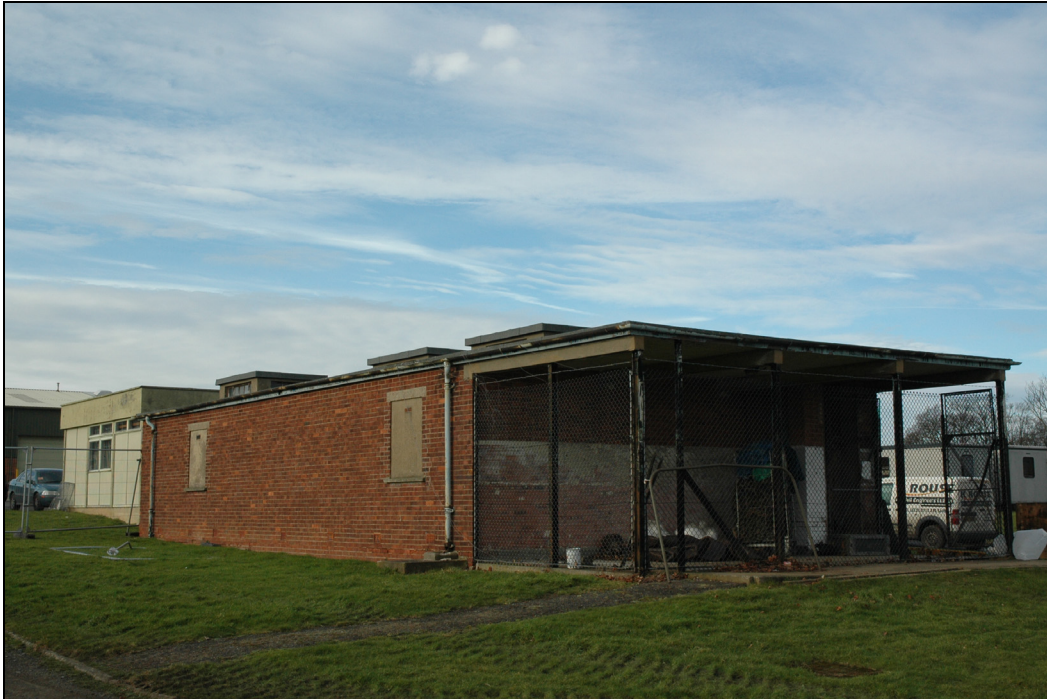
Figure 49
Building 48 looking north-west, showing screened porch used for storage

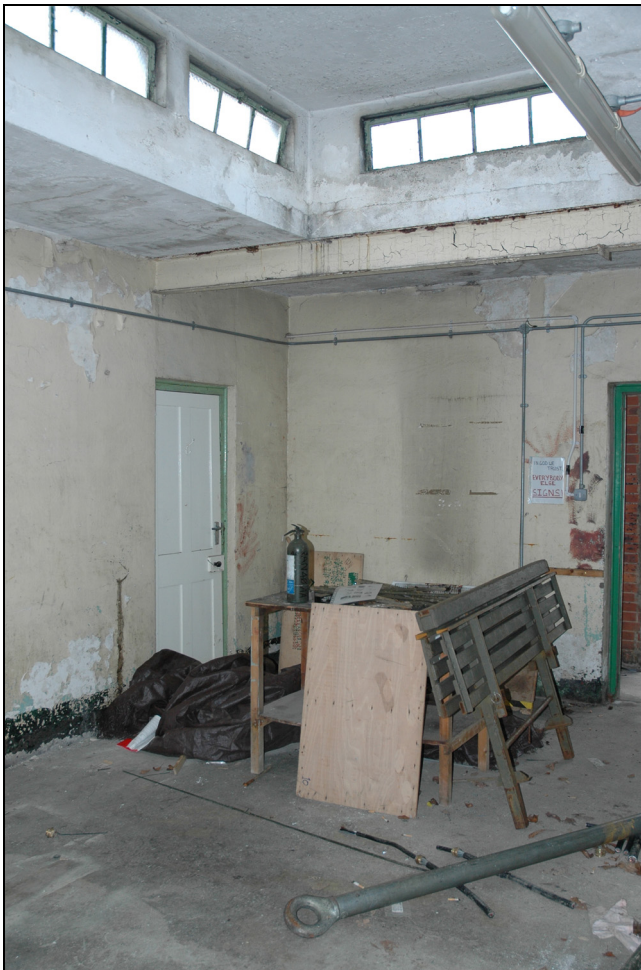
Figure 50
Interior of the top-lit main room of building 48, looking south-west

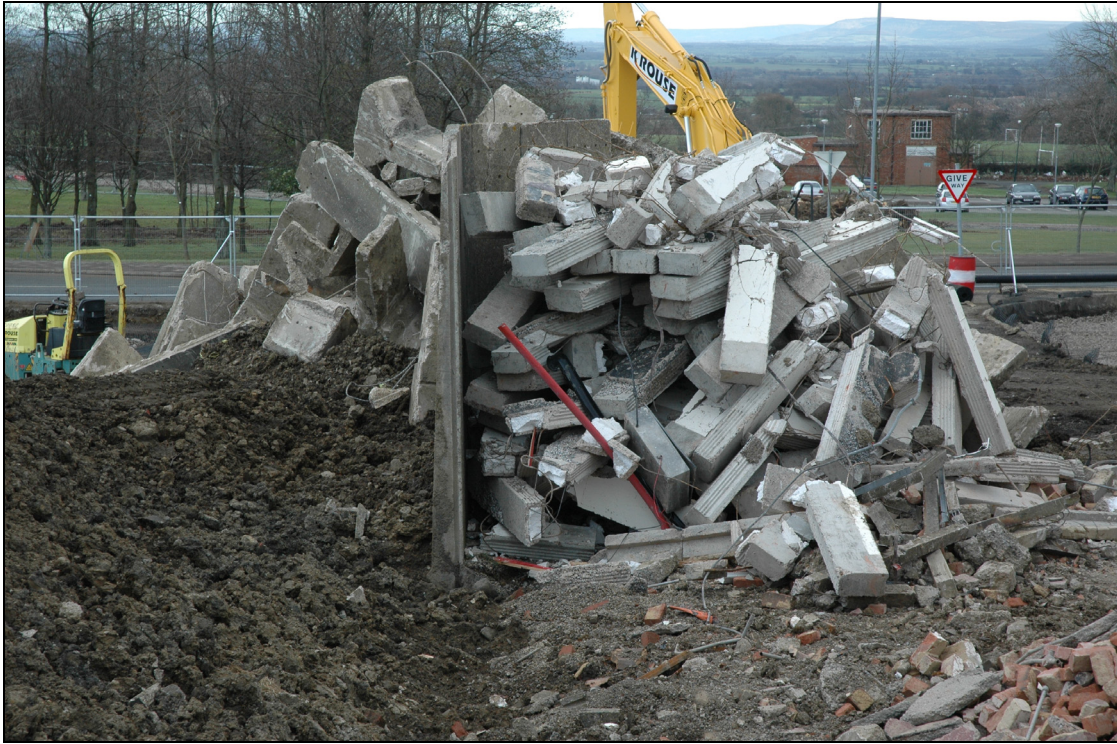
Figure 51
Demolished remains of the ammunition bunker, building 50, looking east

- 4.16 A semi-sunken building surrounded by a blast wall and an earth embankment. This building had been almost completely removed when recording began, but surviving sections of the wall and floor showed that it was built of brick and concrete; the floor and roof were insulated with beams made of expanded polystyrene in a skin of reinforced concrete.

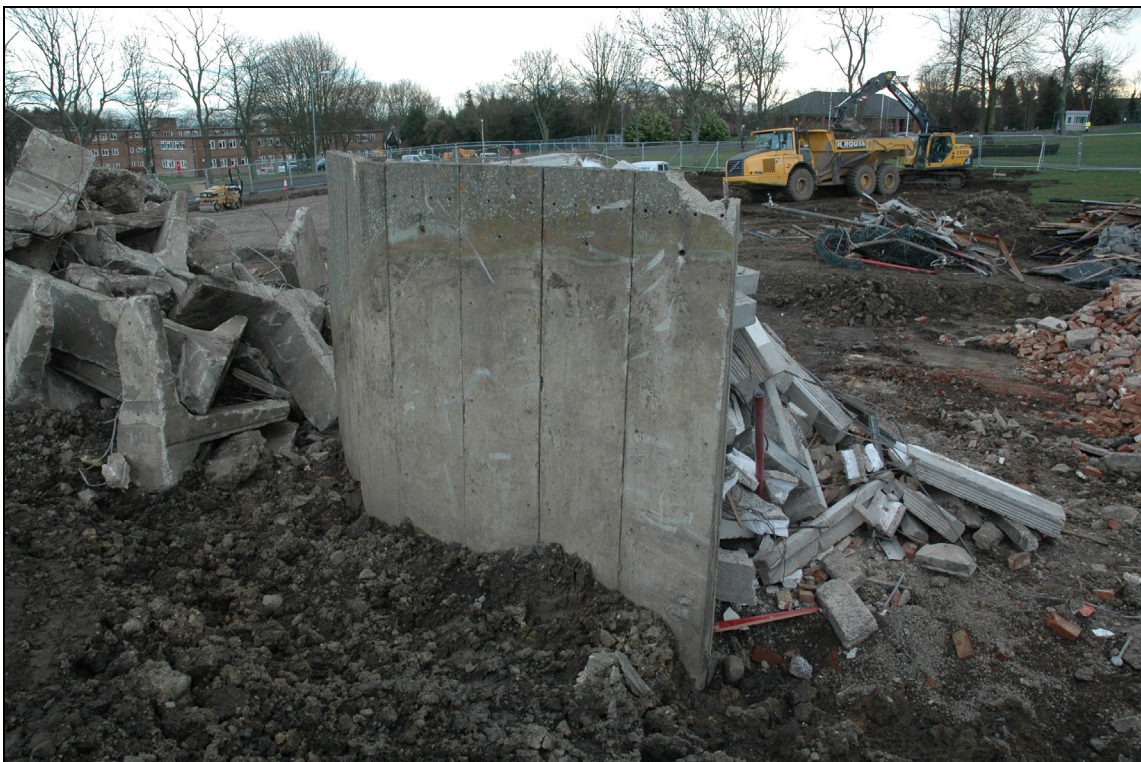
Figure 52
Bunker, 50; the turf line can still be seen on the outer face of the section of blast wall

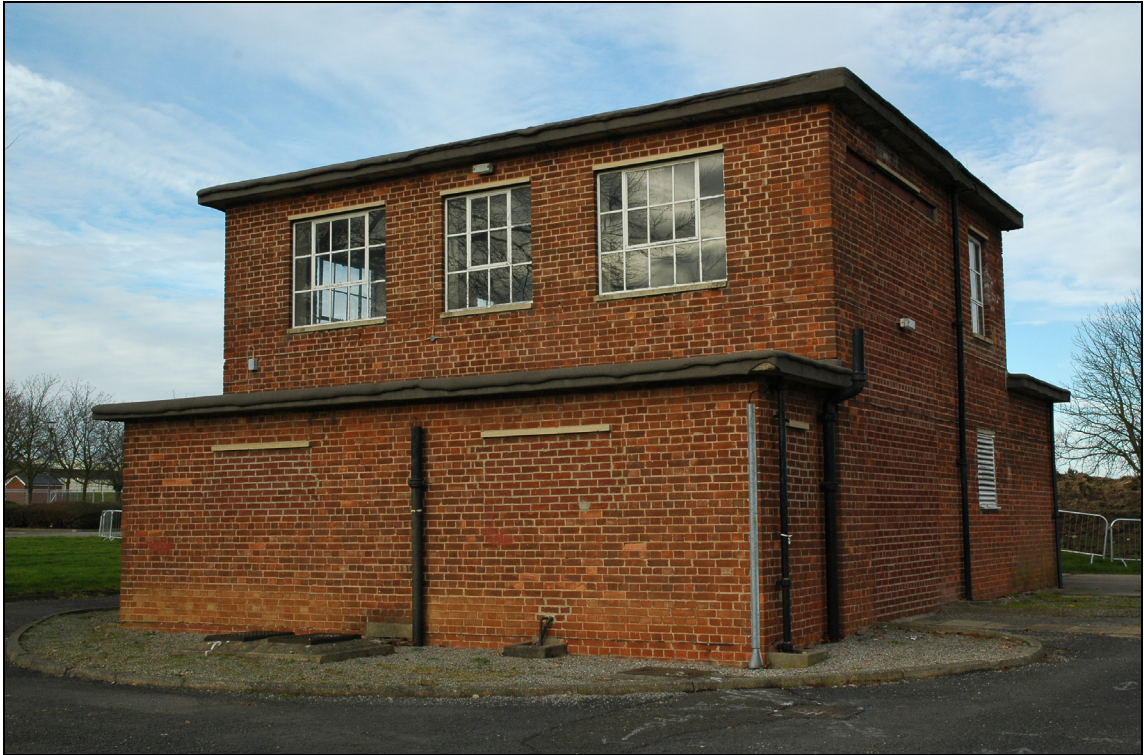
Figure 61
Pump house building 74, looking north-west

- 4.18 A utilitarian brick structure with flat slab roofs, built to house drainage pumps. The lower walls are windowless and surrounded by a variety of sheds and walled areas. The tall central section had metal-framed windows in its upper parts.

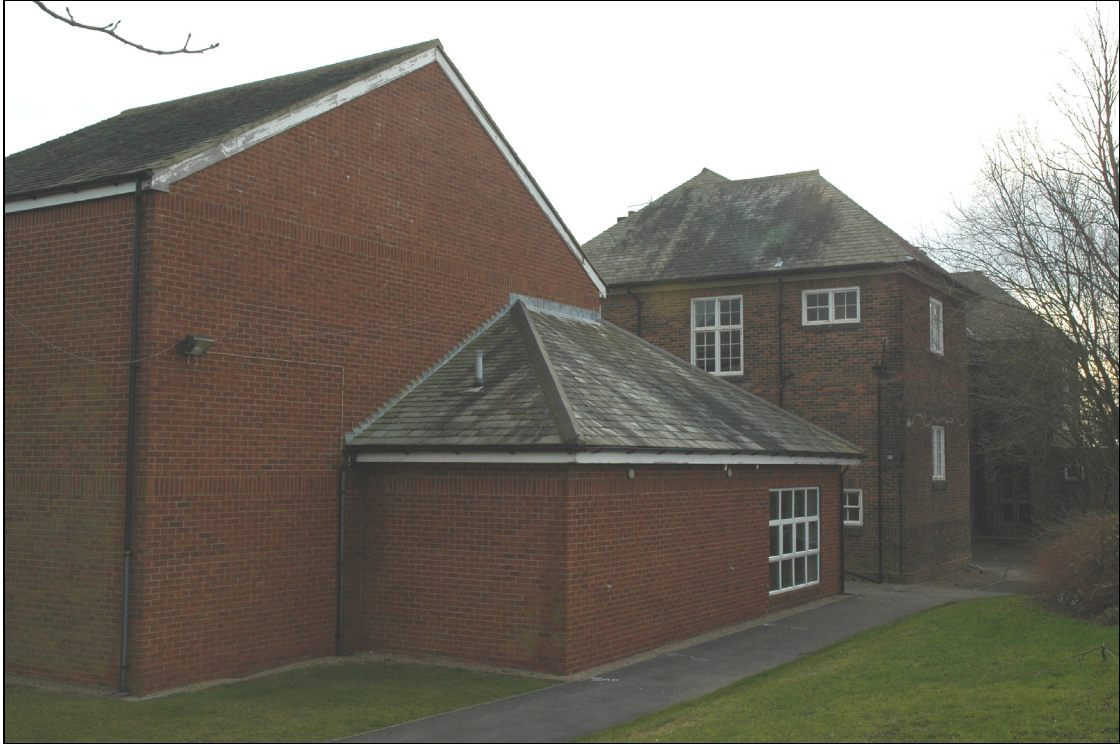
Figure 63
Squash court 104 and NW corner of the Club, building 23, looking south

- 4.19 A modern brick building close to the Gaza Club, building 23. The main section was windowless and had a pitched roof, a lean-to extension on the south and west sides provided access, lavatories and changing space.
