Archaeological Observation
Investigation and Recording
at
Robin Hood Caravan Park
Green Dyke Lane
Slingsby

Planning Reference: 07/00259/MFUL
National Grid Reference: SE 7006 7470
Site Code: WB2008.002
Deposition agreed with Malton Museum

Watching Brief Report Number: 994
February 2008

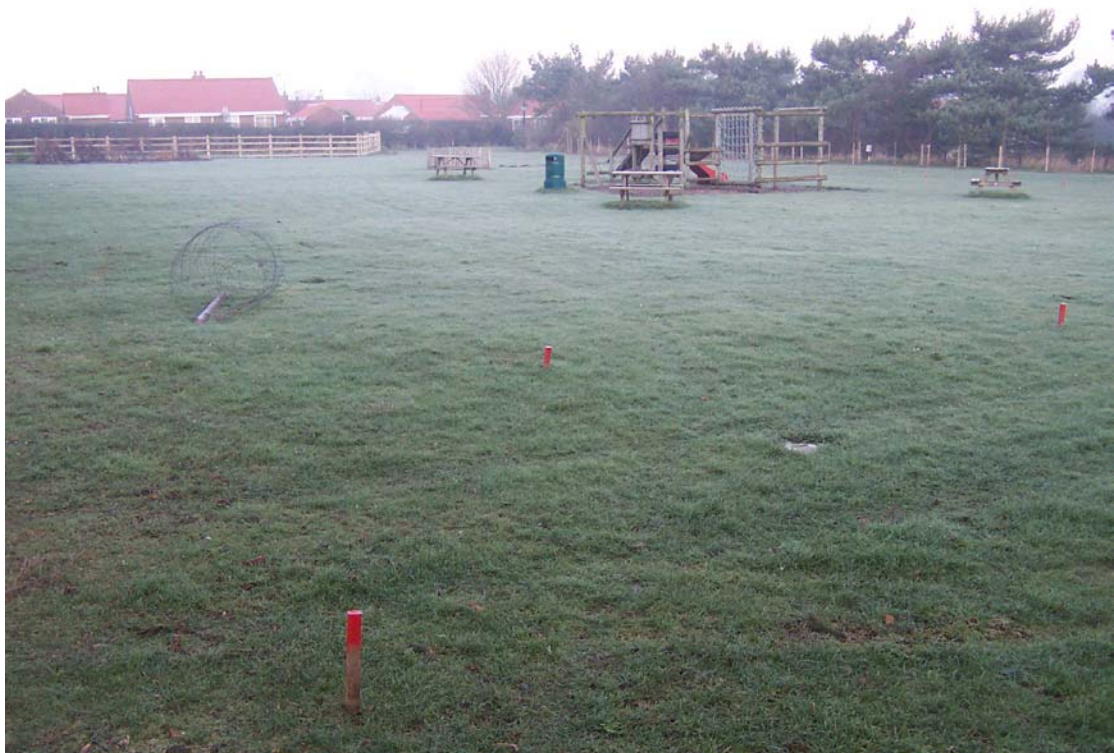
Plate 2 The area marked out for the road strip in the northern area of the site, looking northwest.

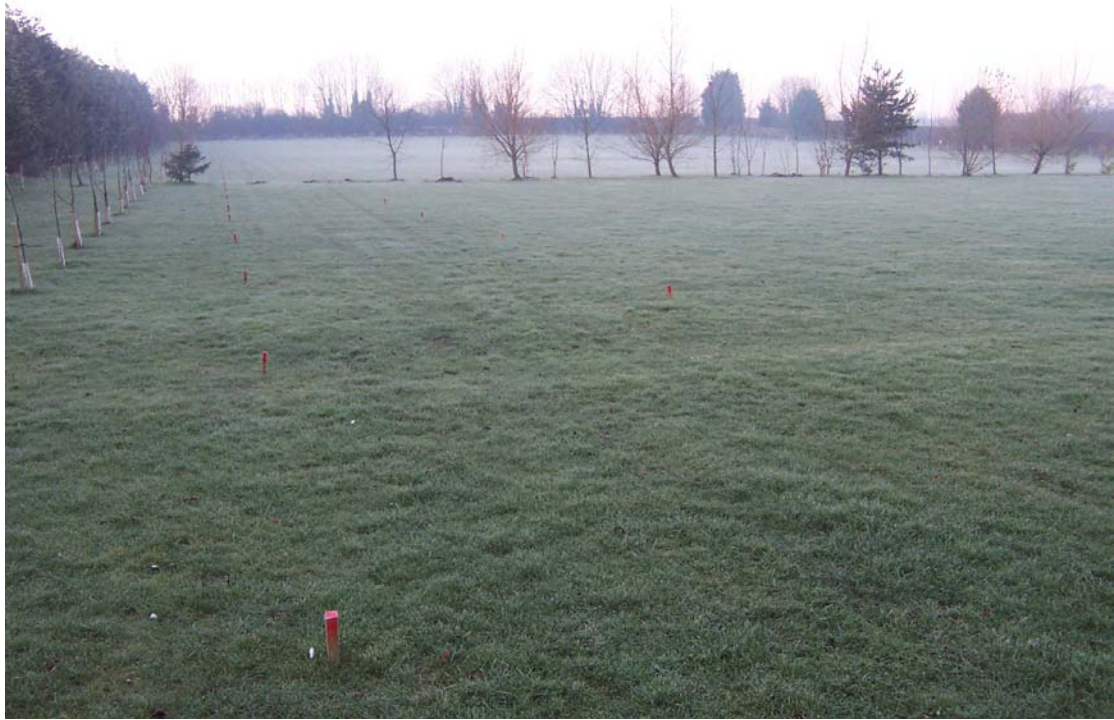
Plate 3 The area marked out for the road strip in the southern area of the site, looking south.

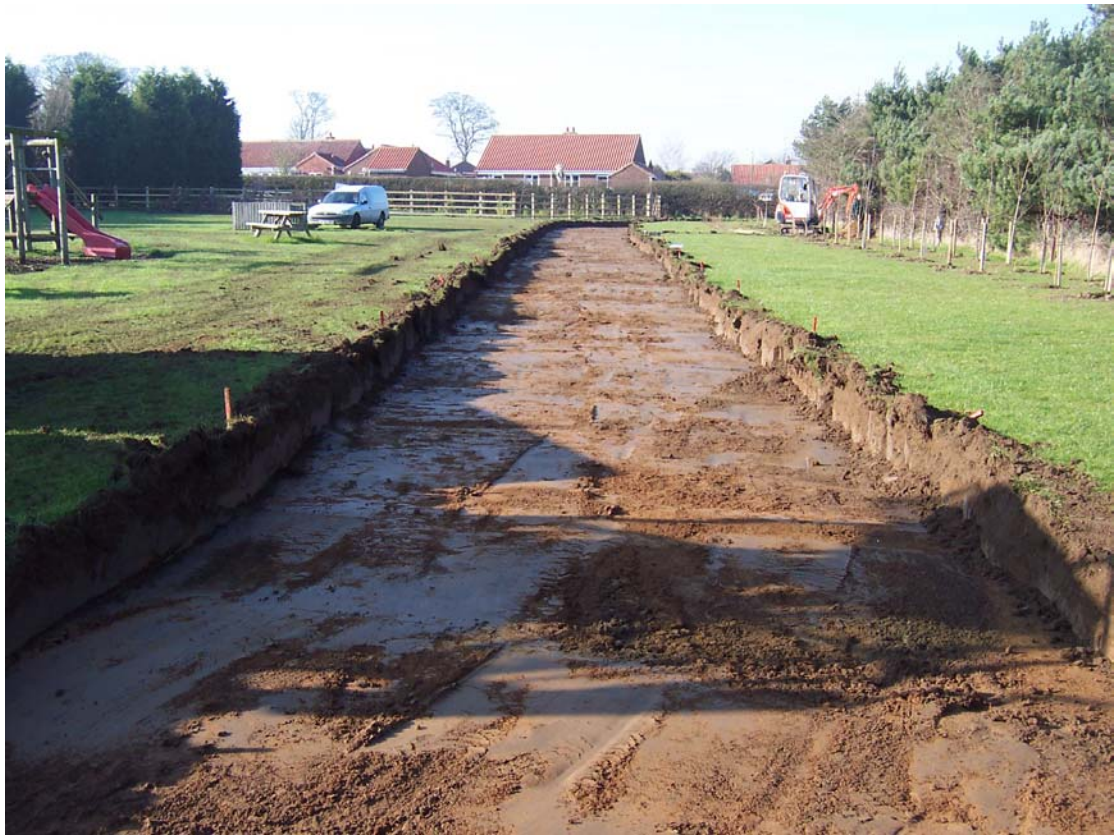
The depth for the road excavation varied; in general the depth was deeper at the north and shallower at the south as the ground rose. The ground level at the northern start of the road was 34.20mOD, the depth at the base of the road excavation, the height dropped to 33.80mOD. The base of the road excavation remained at a level between 33.70mOD and 33.90mOD within the northern area of the development until the excavation reached the extant west-east tree boundary division (*Plate 4*). At this point, the ground level rose steadily towards the B1257. Along the north-south eastern road section, the ground level rose from 34.50mOD to 41.30m; within the road base, the height rose from 34.00mOD to 41.0mOD (*Plate 5*). The road excavation got progressively shallower towards the south, as the presence of natural stone (102) was closer to the ground surface. At the far southwestern extent of the road, the intention is to build up the ground/road level by a fair margin, so at the southern entrance, the amount of topsoil removed was negligible (approximately 0.10m), essentially becoming a programme of turf removal within that particular area. The basal layer at the reduced ground level was subsoil/hillwash deposit (105) a mid-dark orange grey

Plate 4 The road strip underway at the north end of the site, showing hillwash/subsoil (105) underlying topsoil (101), looking west.

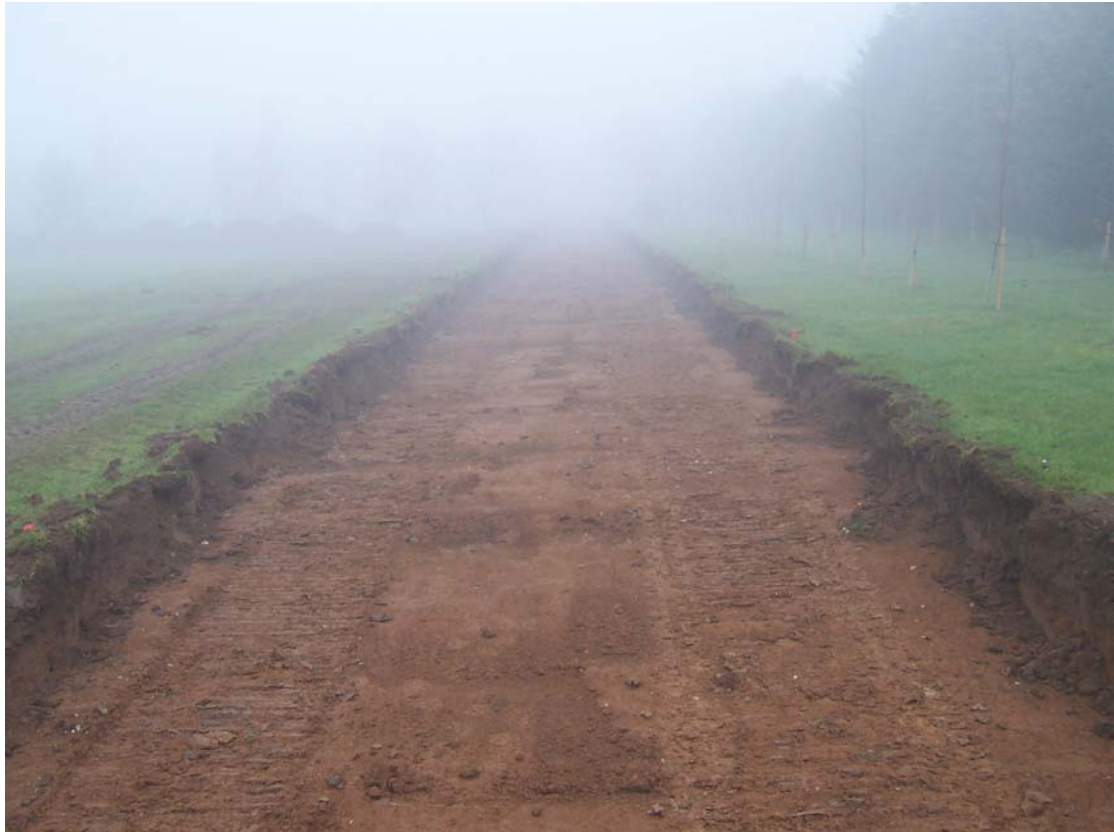
Plate 5 The road strip along the north-south longitudinal section, showing deposit (105) underlying deposit (101), looking north.

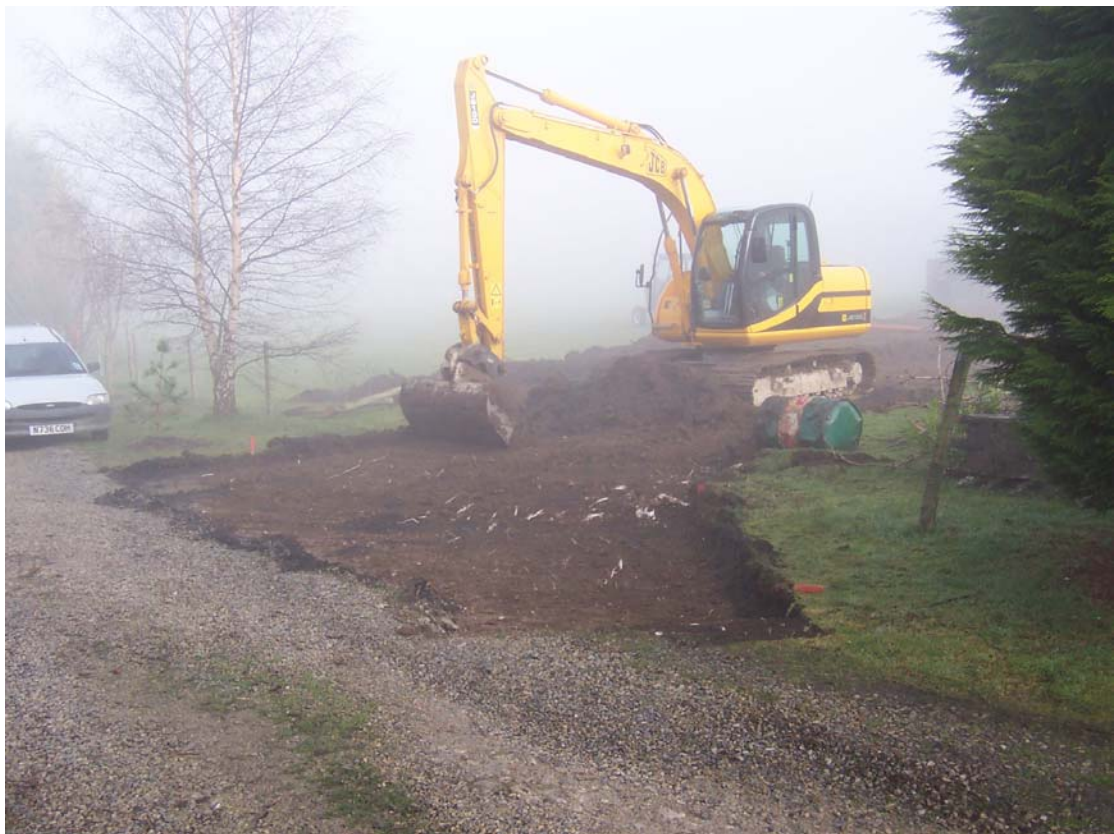
brown sand clay silt; this was sealed by the topsoil (101) dark brown friable loam viewed up to 0.20m thick. Along the west-east southern stretch of the new road, the lowermost layer visible was the topsoil (101) which extended west-east for 65m (*Plate 6*). At both the northern and southern ends of the new road, the excavation cut into the modern track deposits (103) viewed up to 0.20m thick which were sat in the track 'cut' [104] – the north-south orientated track which runs along the western boundary of the site.

Plate 6 The road strip at the southwestern corner of the site, showing topsoil (101) overlying (105), looking northeast.

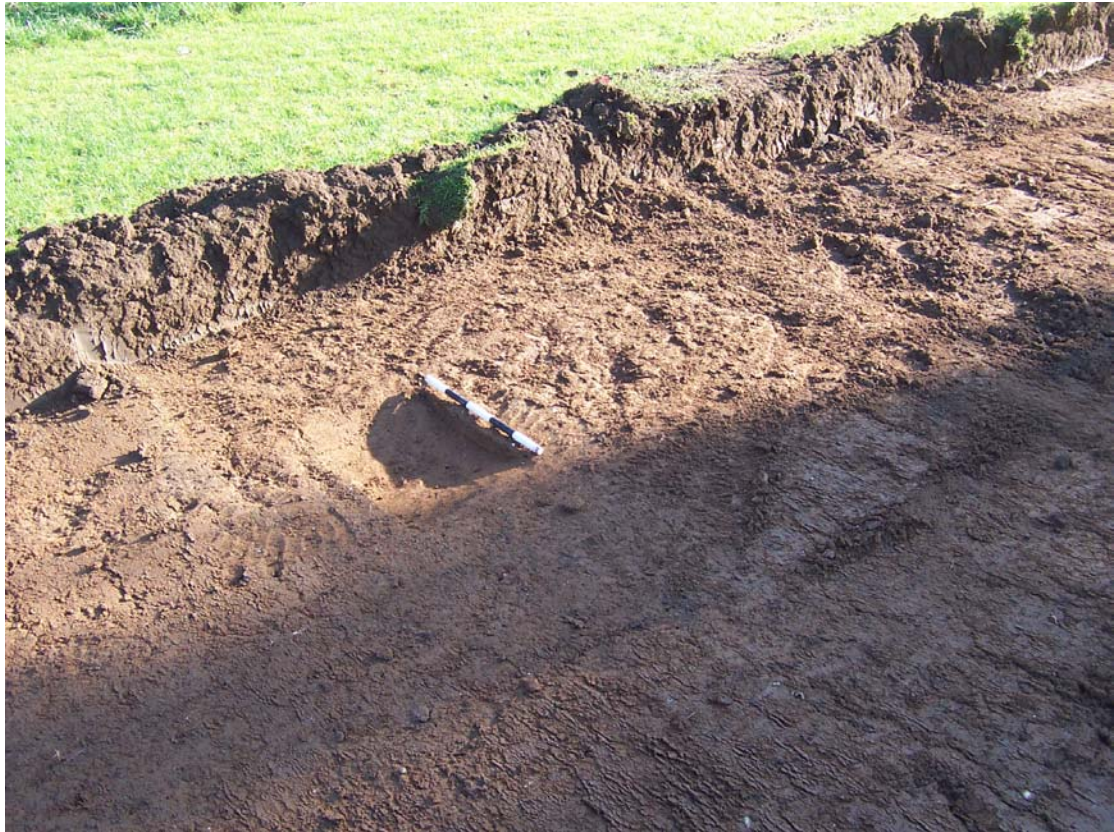
A small feature was noted cutting into deposit (105) in the northern area of the north-south orientated stretch, 14m north from the west-east tree boundary which bisects the site was small, shallow elongated pit [107]. Measuring 1.80m long north-south, 0.48m wide west-east, and 0.06m (33.72mOD) deep with a shallow and concave profile, this feature was filled by (106) mid to dark grey brown clay sand silt containing moderate to frequent chalk and charcoal flecking (*Figures 2, 3A, 4 - S.1, Plate 7*). No dating evidence was present within (106).

Plate 7 Feature [107] and associated chalk and charcoal flecked fill (106), looking southwest.

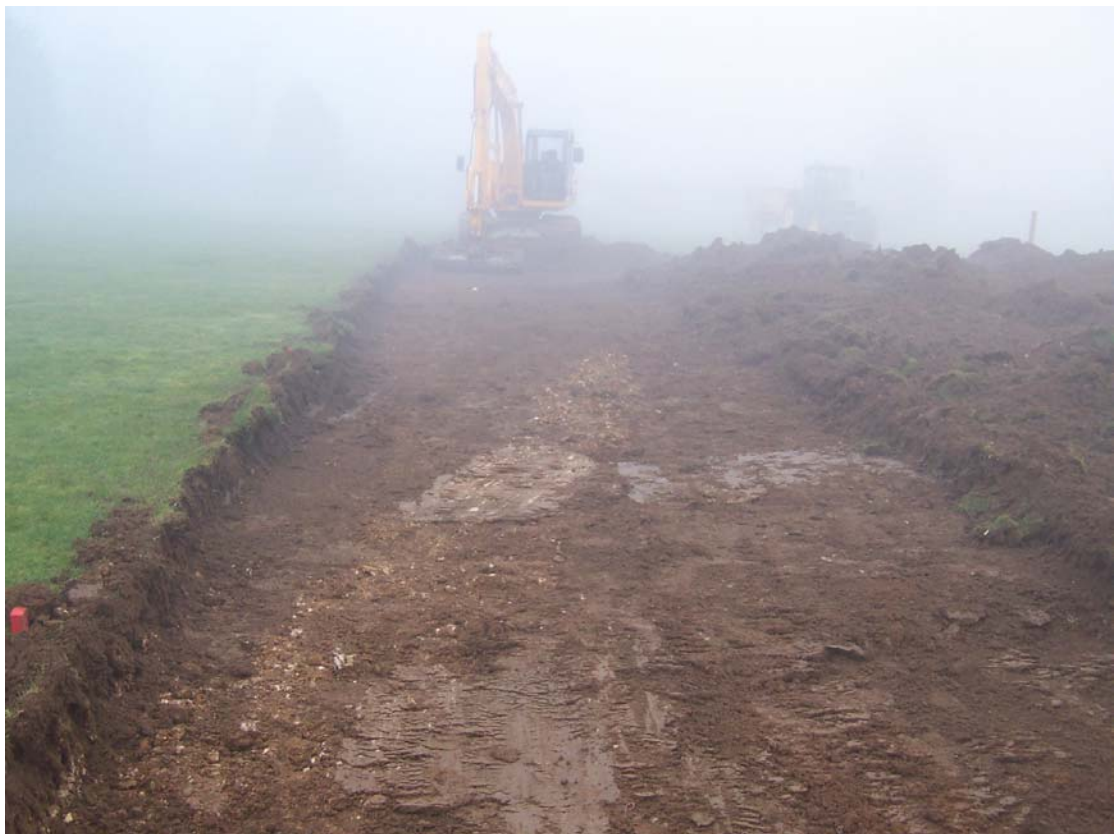
At the southeastern corner of the road strip, the excavation (as mentioned above) progressively got shallower. In this area, west-east orientated chalk drain [113] was recorded. This feature was not fully exposed along its entire length; however, an 11.50m section was exposed in plan. The feature measured 0.60m wide and was filled by (112) small to medium chalk pieces within a fine, light brown sand silt matrix (this sans silt was barley non-existent, as if upper elements of the topsoil had filtered through the chalk drain proper (*Figures 2, 3C, Plate 8*)).

Plate 8 Showing chalk drain [113] looking west.

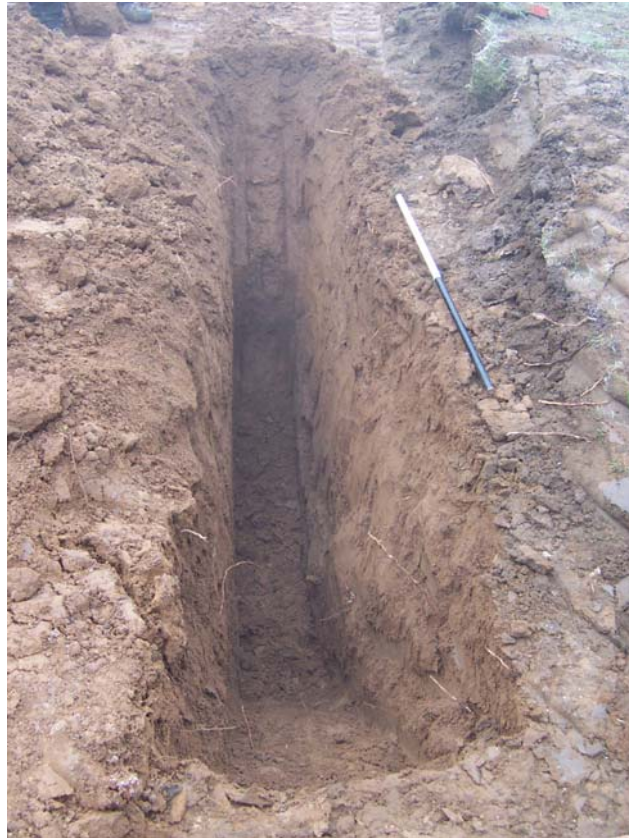
The basal layer exposed (111) consisted of mid yellow brown soft, but sharp, sands, viewed up to 0.10m thick (33.38mOD). This was sealed by (110) a mid to light grey blue white clay band, possibly waterlain, up to 0.02m thick (33.48mOD). Over this was (109) clean brown sand clay up to 0.50m thick (33.50mOD). In turn, (108) overlay (109) and consisted of mid to dark brown clean sands up to 0.50m thick sealed by the subsoil/hillwash deposit (105) a mid-dark orange grey brown sand clay silt (34.00mOD) (*Figures 2, 3B, 4 – S.2, Plate 9*).

Plate 9 TP1 in the area of the purported position of the trackway, showing deposits (105), (108), (109) and (102) looking north.

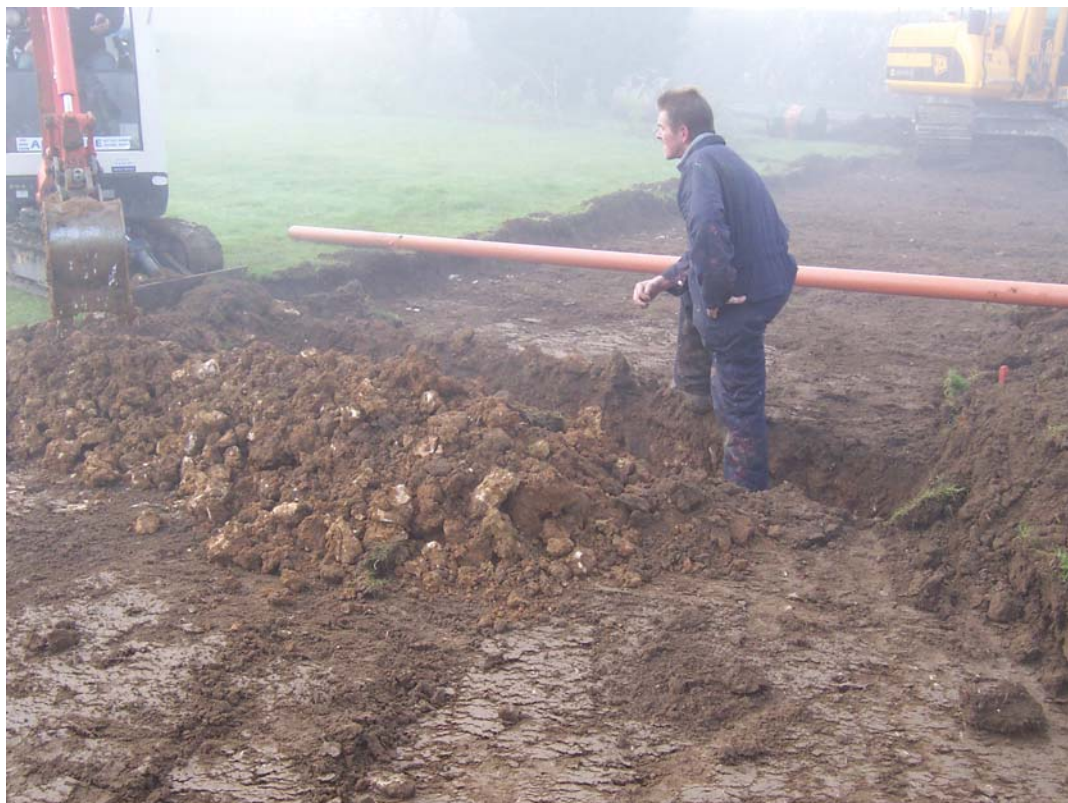
A cable trench was excavated perpendicular to the southern west-east section of the road. Cutting through the topsoil (101) viewed up to 0.10m thick in this area and a very thin amount of subsoil (105) viewed up to 0.10m thick also, the basal layer viewed in the cable trench was the natural stone (102), viewed up to 0.30m thick and continuing outside the area of excavation (*Figure 2, Plate 10*).

Plate 10 Showing the excavation of a cable trench across the southern section of the road. Deposits (102) underlying (105) were noted in this section of the works. Viewed from the northeast.
