**Whitby Abbey Lodge,  
Whitby, North Yorkshire**

**archaeological monitoring**

**Report 1854**

March 2008

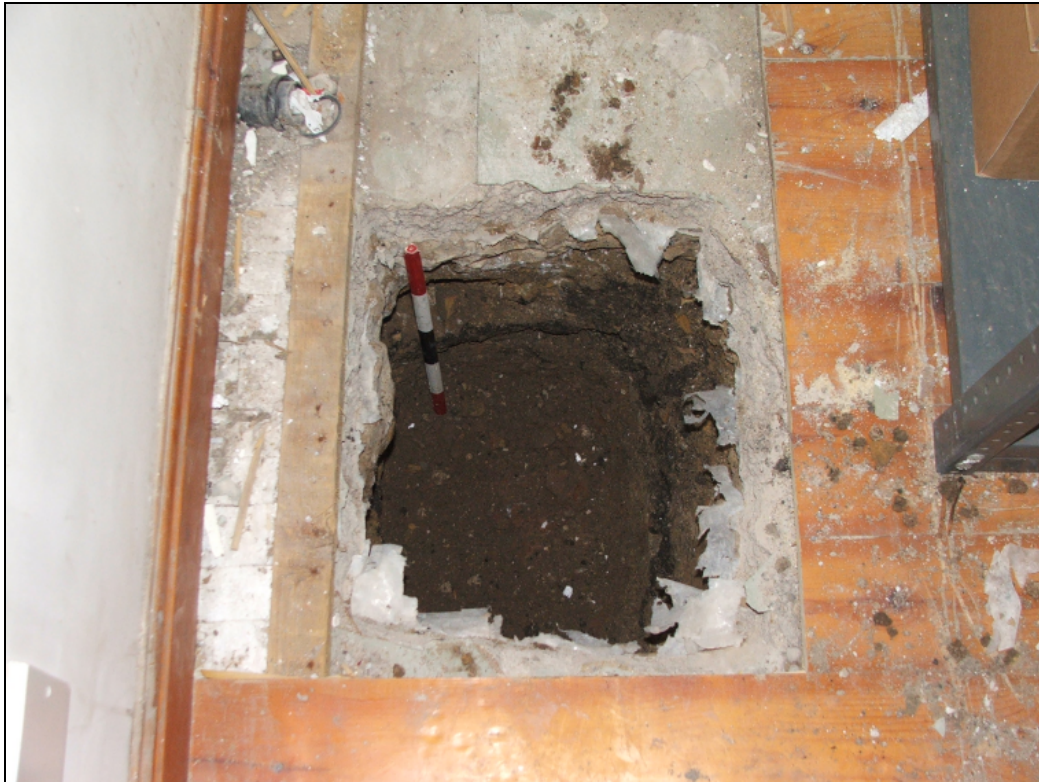
- 5.2 This pit was located in the northwest corner of the lodge. It measured 0.6m by 0.4m and was excavated to a maximum depth of 0.6m. The lowest deposit encountered comprised mixed crushed stone, rubble, mortar and dark soil [8]. This was overlain by a 0.08m-thick layer of very compact black asphalt-like material [7]. Over this was 0.15m of crushed stone, rubble and mortar mixed with sand and silt [6], into which stone flags were set forming an earlier floor surface [5]. This had been covered by a thin membrane [4] over which a concrete floor had been set [3]. This was overlain by a thin layer of polystyrene [2] onto which the present wooden floor had been laid [1].

**Figure 4:** Test pit 1, looking north

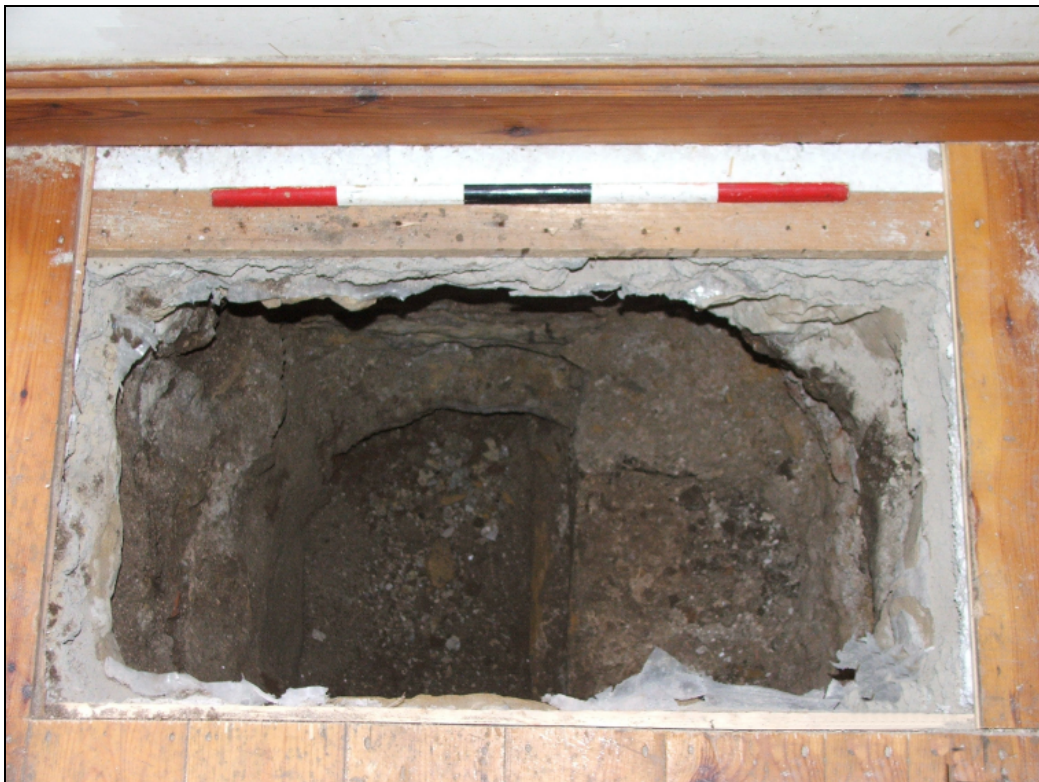
- 5.3 This pit was located in the east part of the lodge. It measured 0.7m by 0.45m and was excavated to a maximum depth of 0.88m. A stone wall [F10] was encountered across the south part of the pit at a depth of 0.55m. The full extent of the wall could not be ascertained due to the size of the pit. The wall comprised faced sandstone blocks bonded with mortar. Two courses were identified; the lower course was stepped out, presumably forming the foundation course, although the base of the wall was not reached. The pit was stepped back eastwards under the stone flag surface to inspect the east wall [F9] of the lodge. The foot of wall [F9] was reached at a depth of 0.85m below the present floor level. Five courses of this wall, comprising roughly-faced sandstone blocks, bonded with mortar, were identified below floor level. It was built directly over the earlier wall [F10], traversing it at 90 degrees. The foundations for the lodge wall were in-filled with stone rubble [12], which overlaid the early wall [F10] to a depth of 0.3m below the floor level. This

was overlain by 0.1m of dark silt [11] into which stone flags from the floor identified in pit 1 were set [5]. This was again covered by a thin membrane, [4], a concrete floor [3], a thin layer of polystyrene [2] and the present wooden floor [1].

**Figure 5:** Test pit 2 showing wall F10 on the right, looking east

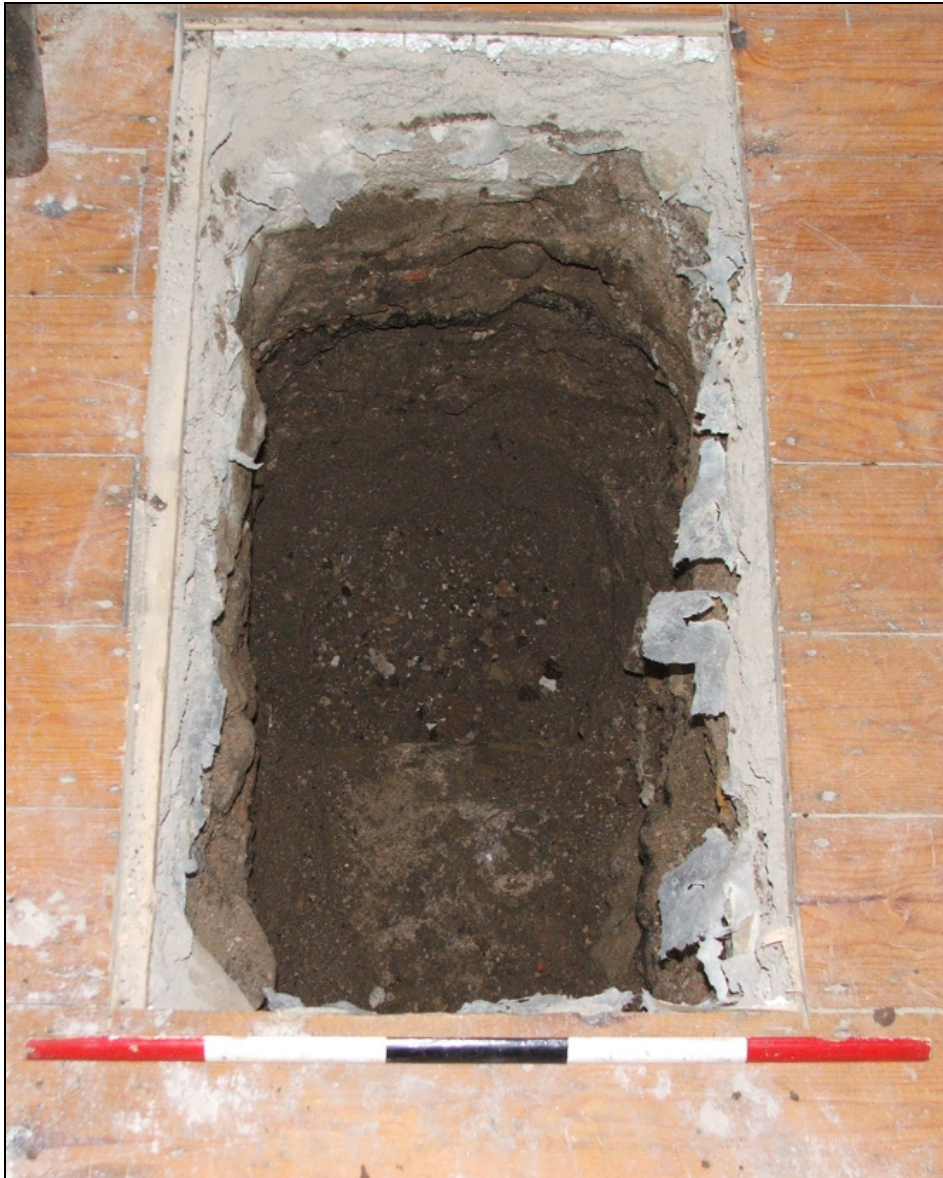
- 5.4 This pit was located in the west part of the lodge. It measured 0.7m by 0.43m and was excavated to a maximum depth of 0.8m. The earlier wall identified in pit 2 as [F10] continued through to this pit. The alignment of this wall [F16] maintains the course of the outer garden wall of Abbey House, which extends west from the lodge. In this pit only one course of the wall [F16] was reached, standing to a height of 0.2m below the present floor level. This pit was also stepped back northwards under the stone flag surface to inspect the external wall [F17] of the lodge. Three courses of mortar-bonded faced sandstone were identified; the base of the wall was reached at a depth of 0.80m below the present floor level. The foundations of the lodge wall [F17] were in-filled by, and the early wall [F16] was overlain by, deposits similar to those identified in pit 1; loose stone and rubble mixed with mortar and brown silt [15], a 0.05m-thick layer of compact black asphalt-like material [14], and further rubble and silt [13]. These were overlain by the stone flag floor [5], membrane [4], concrete floor [3], polystyrene [2] and floorboards [1].

- 6.1 A stone wall was identified in pits 2 and 3, the alignment of which is consistent with the present boundary wall for the courtyard in front of Abbey House, which extends west from the lodge. It is probable that the upper part of the wall was removed to accommodate the lodge when it was built in 1866. The wall was reached 0.55-0.65m below the present internal floor level of the lodge. A flagged floor, probably the original floor surface, was reached at a depth of 0.15m. The bottom of the foundations of the external wall of the lodge were located approximately 0.8m below the internal floor level.
- 6.2 No further features, deposits or finds of archaeological significance were identified. Undisturbed natural glacial subsoil was not reached in any of the pits.

**Figure 6:** Test pit 3 showing wall F16 at the near end, looking north
