SHERIFF HUTTON CASTLE,
SHERIFF HUTTON, NORTH YORKSHIRE

ARCHAEOLOGICAL AND ARCHITECTURAL SURVEY
OF THE NORTH-EAST TOWER

VOLUME 2: APPENDICES

Report no: 2002/158.R01
Version: Final
Date: April 2008
Author: Ed Dennison & Shaun Richardson

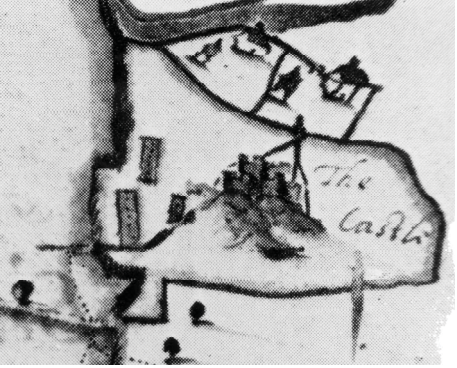
<p>1618-19 Three plans by Bernhard Dininckhof (Dinninghof) of proposed modifications to the gatehouse of Sheriff Hutton Castle (WYAS Leeds WYL100/SH/A3/2/1-3). (WYL/100/SH/A3/2/1 shown).</p>

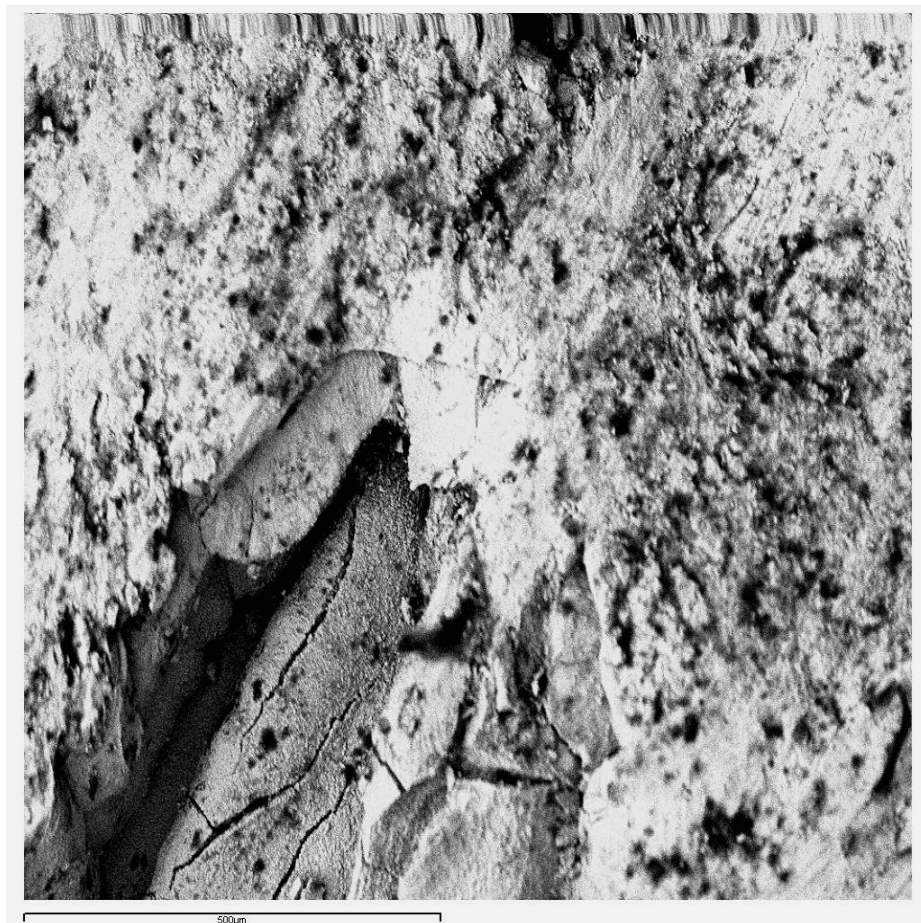
Sample 2, site 1

Sample 2 site1 was an example of the dark granular pieces received. It was broken to an approximately flat surface, impregnated with resin to prevent breakage. The photograph shows a fracture running diagonally from bottom to top.

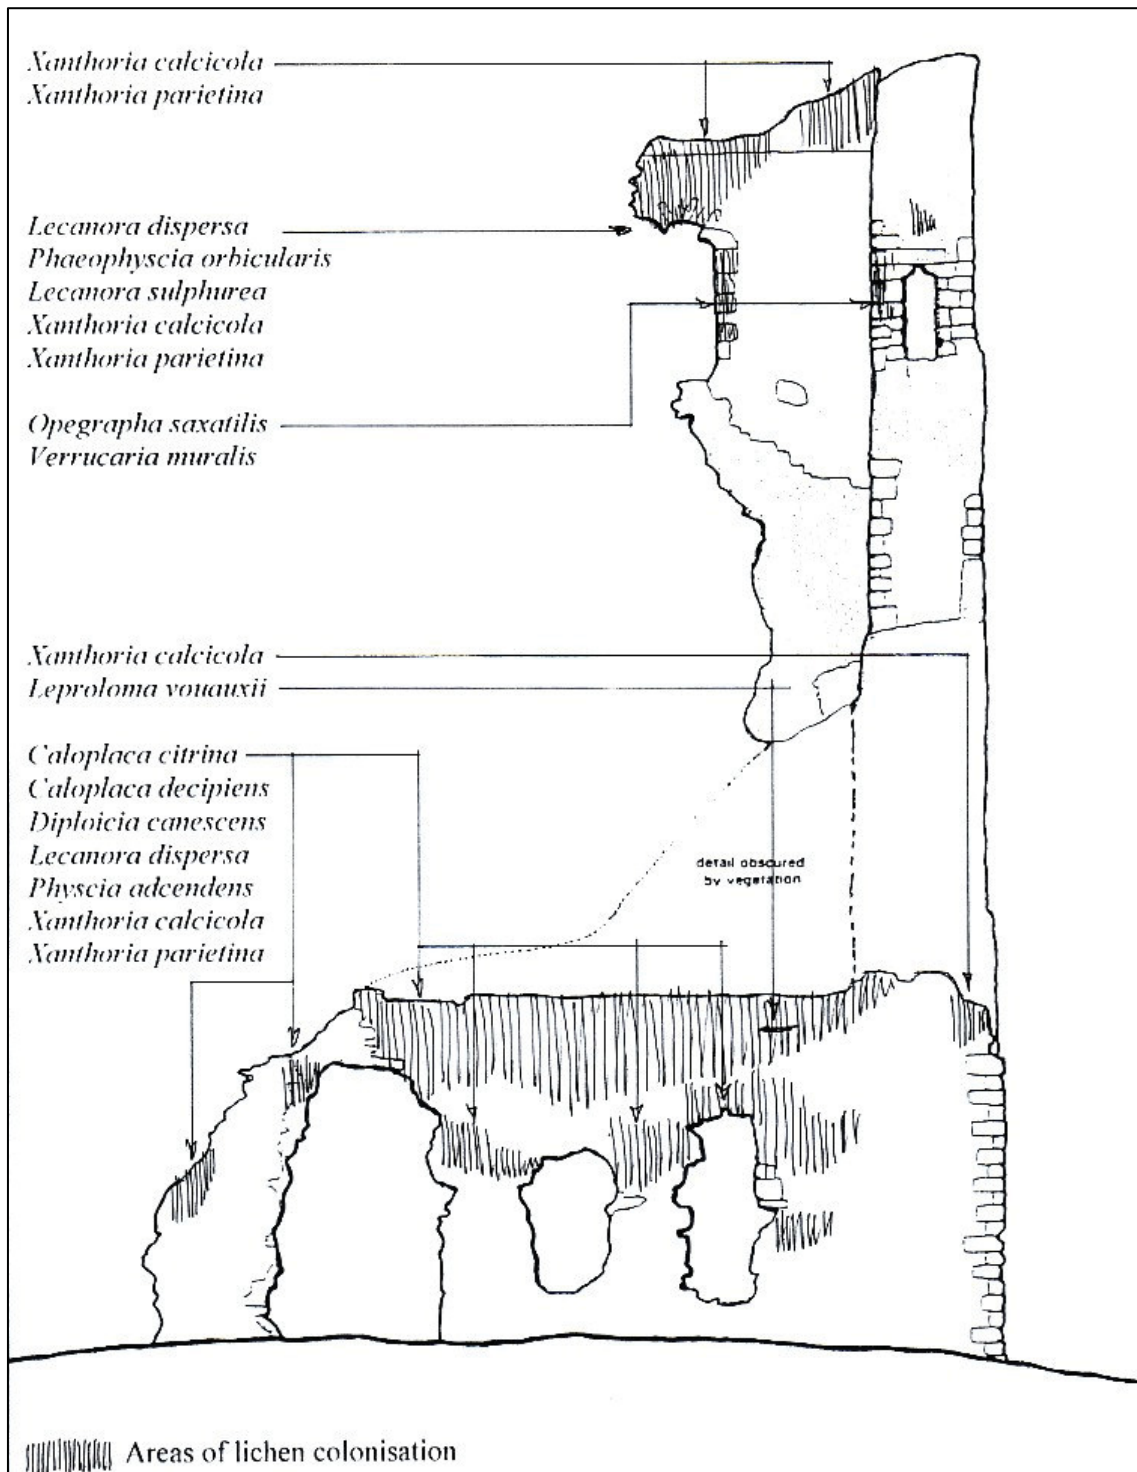
Figure 10 Sheriff Hutton Castle north-east tower: species location on the east elevation and the internal face of the west wall

In Figures 9 to 12 inclusive, which follow, the locations of significant areas of colonisation are indicated.

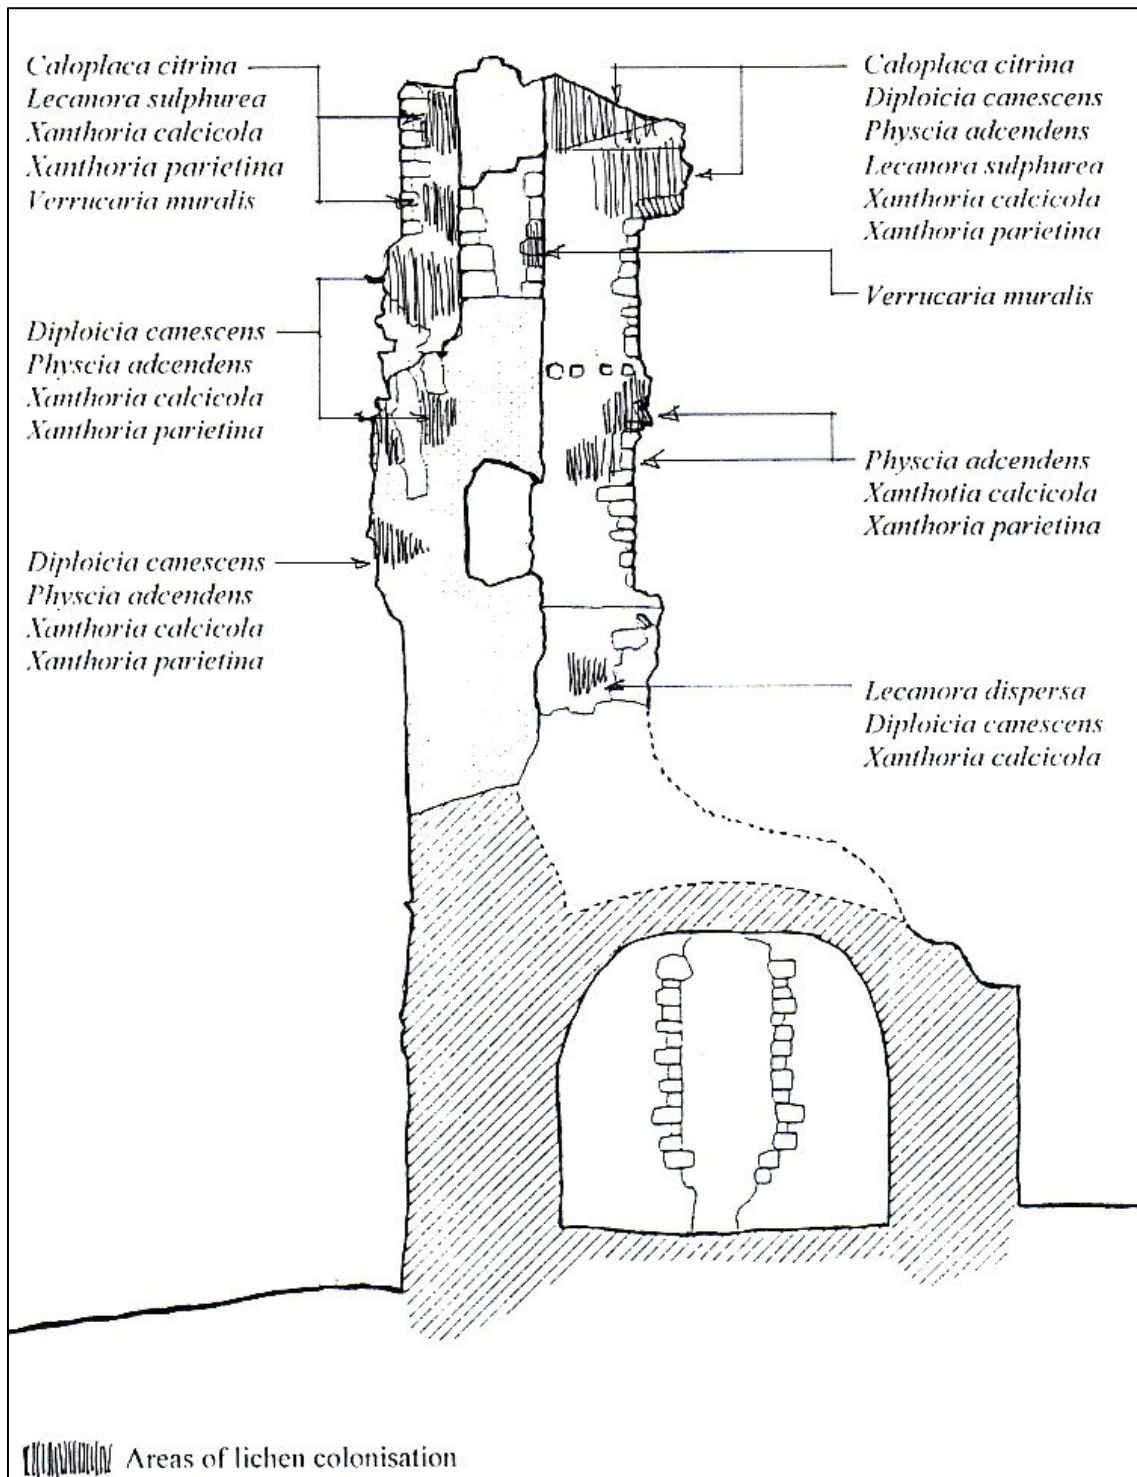
Figure 11 Sheriff Hutton Castle north-east tower: species location on the internal (south) face of the north wall

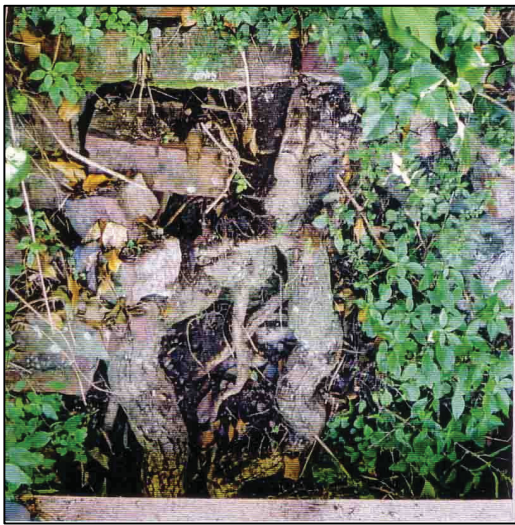
Figure 2 Sheriff Hutton Castle: main growth stems at ground level

At level 0 (600mm above ground level), the main growth stems are visible. There are two adjacent stems on the west elevation and one on the east. The stems on the west elevation are 90mm and 70mm diameter, and the stem on the east elevation is 70mm diameter and soon branches, but has been severed below the branch at some time in the past. The resulting four stems immediately disappear into the brickwork buttressing which underpins this corner of the ruin, illustrated in Figure 2.

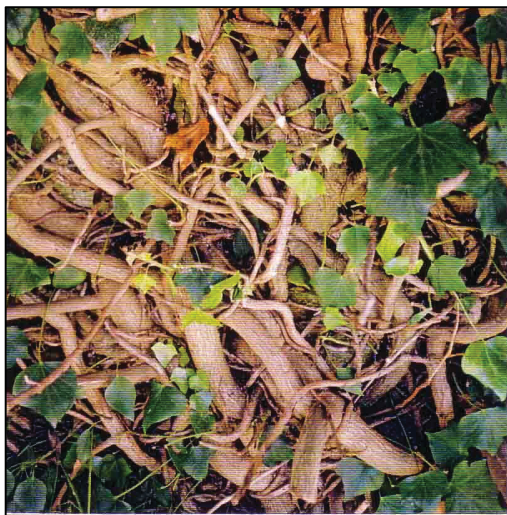
Figure 3 Sheriff Hutton Castle: lattice of intertwined ivy stems 3m above ground

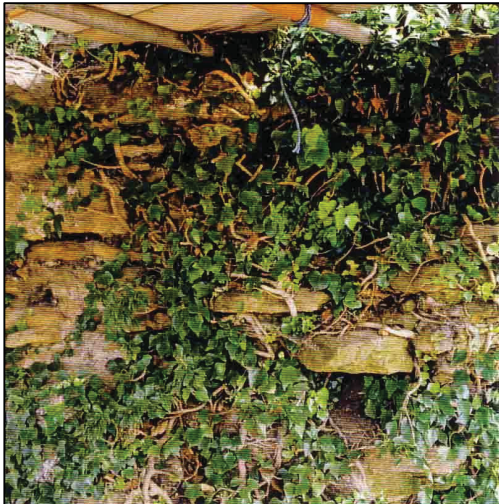
Figure 4 Sheriff Hutton Castle: ivy stems and loose masonry 7.5m above ground

At scaffold level 3 (6.3m above ground level and springing level of the vaulting) the cover is reduced to 200mm maximum. The main stems on the west elevation are 19 to 25mm diameter and those on the east 20mm diameter. The secondary stems remain intertwined on, and within, the masonry and mortar joints. At this level new growth can be seen to grow into the interstices between masonry units, as well as emerging from within the interstices. The masonry at this level is loose, most of the mortar having weathered away, illustrated in Figure 4.

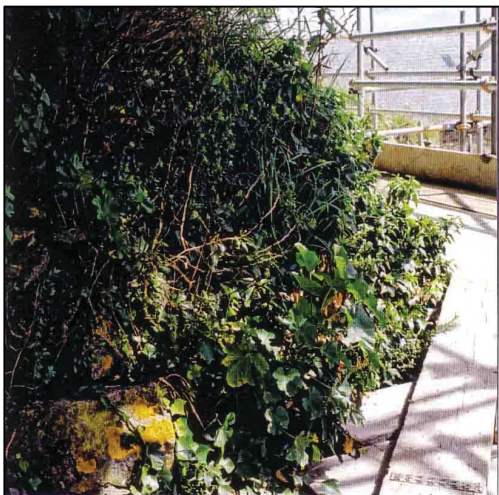
At scaffold level 4 (8.5m above ground level) the ivy growth diminishes and ends some 900mm above this level and there is no further vertical masonry in this area. At this point the herb layer which grows from the debris above the top of the stone vaulting begins, illustrated in Figure 5.
