**The Friary
Richmond
North Yorkshire**

Archaeological Evaluation

December 1997
MAP Archaeological Consultancy Ltd.

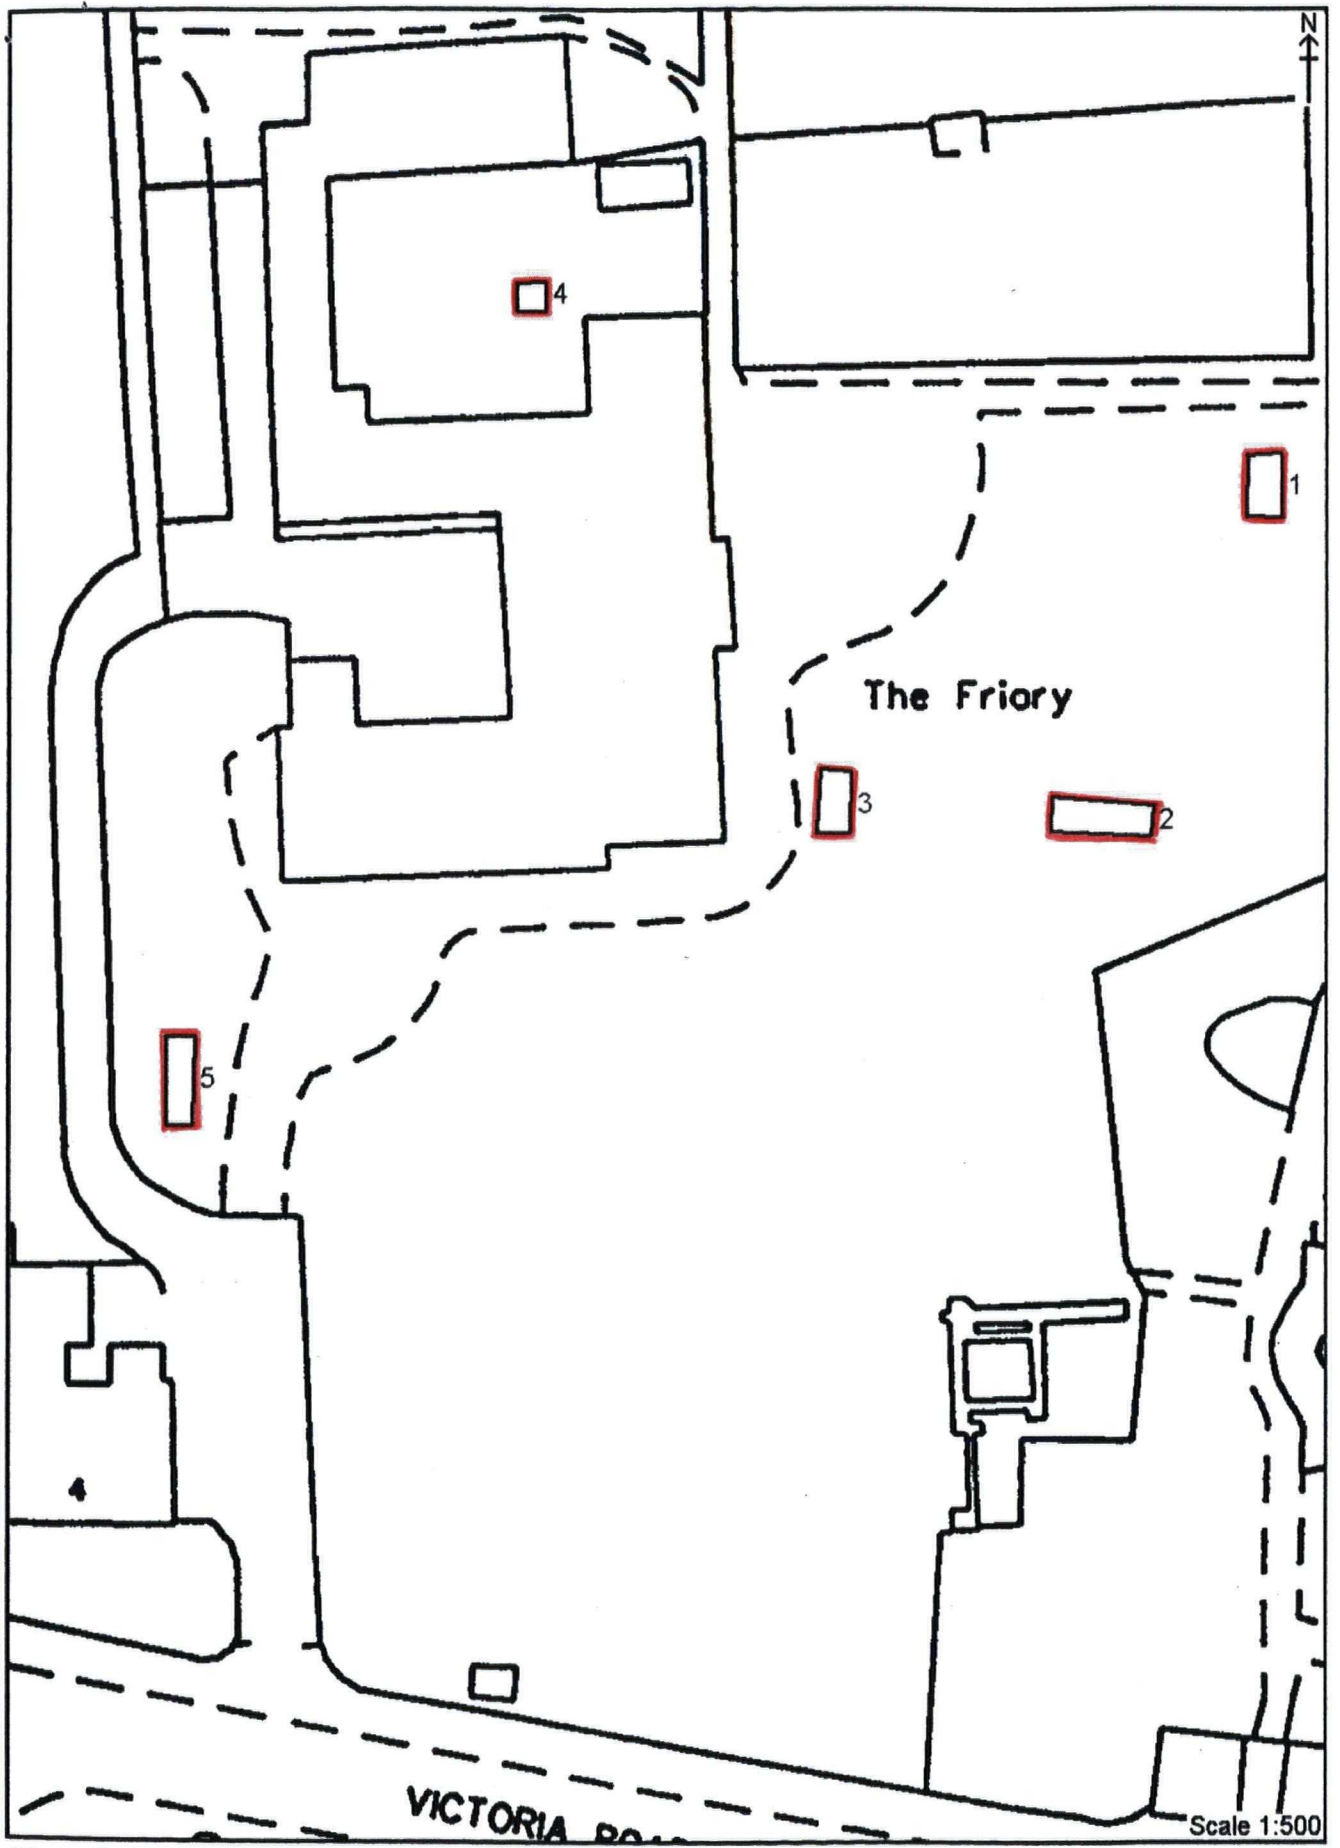
Figure 2. Location of Trenches 1 to 5.

Five trenches were laid out, four of which (Trenches 1-3 and 5) were in lawned areas to the east and south-east of The Friary and one (Trench 4) was to the rear of the building in an area of hard standing. All the trenches measured no more than 6m in length and 2m in width. In each trench the overburden was removed by machine using a toothless bucket under archaeological supervision. Excavation continued when the first archaeological deposits were encountered. Archaeological horizons thereafter were hand cleaned and features sampled and recorded at appropriate scales. Plans were drawn with reference to surrounding property boundaries and buildings. Archaeological features were recorded on proforma record forms (Appendix 1). Plans and sections were drawn at 1:20 and 1:10 respectively (Appendix 3). A photographic record was also maintained (Appendix 4).

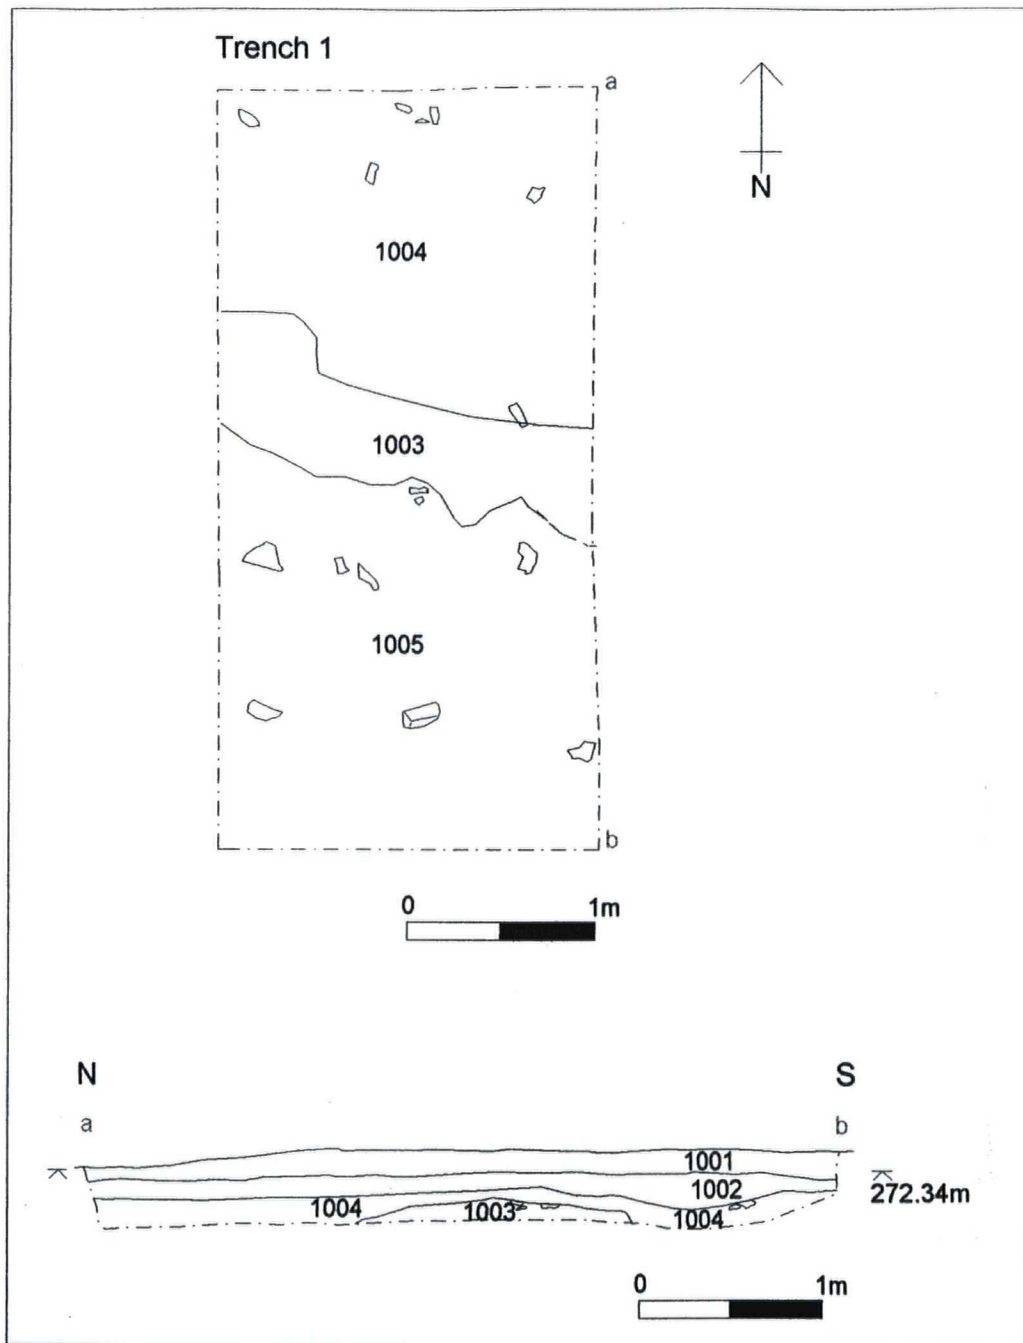
Figure 3. Trench 1 - plan and section.

Situated in the north-eastern area of the Friary Grounds, excavation showed that beneath the topsoil and subsoil (contexts 1001 and 1002) was a deposit of silty sand with limestone (context 1004). Excavation ceased at a depth of 0.40m. At this depth context 1004 was still visible in the north of the trench but was separated from a deposit very similar to 1004 (context 1005) by a ridge of natural sand (context 1003). The nature of contexts 1004 and 1005 suggested that they represented demolition dumps.

Finds from this trench consisted of pottery and animal bone from context 1003, animal bone from context 1004 and 13th -14th century pottery from context 1005.

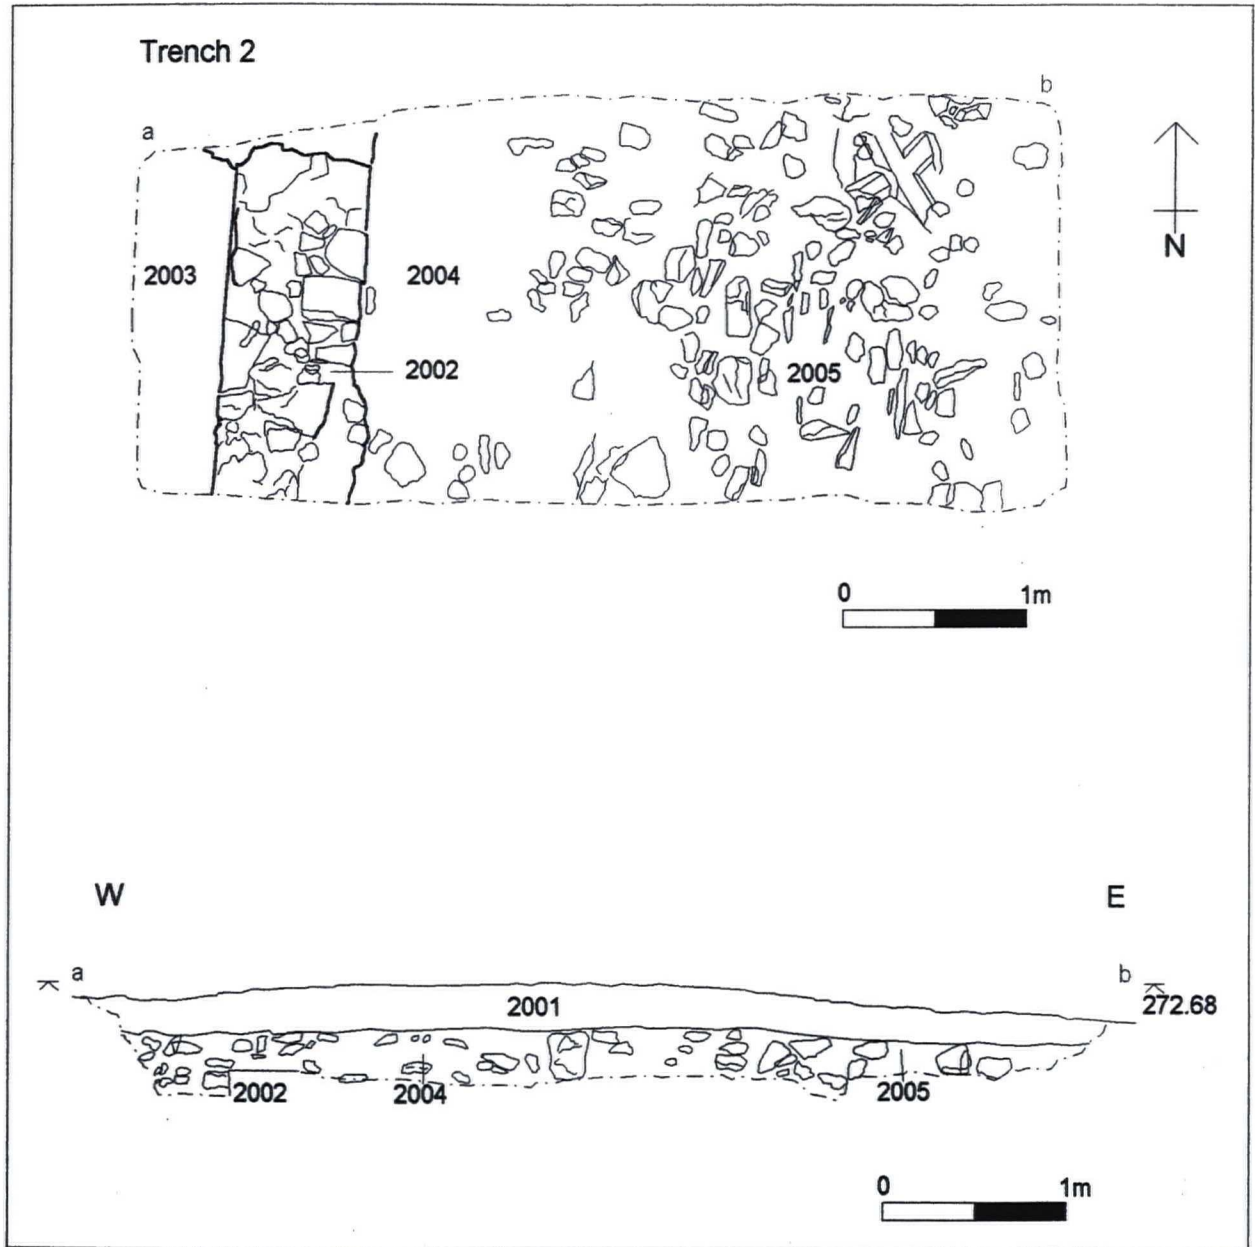
Figure 4. Trench 2 - plan and section.

Removal of the turf and topsoil (context 2001) immediately revealed contexts 2002, 2003, 2004 and 2005 at a depth of 0.42m from present ground level. Context 2002 represented a linear structure aligned north to south, constructed of limestone with a rubble core. On the western face traces of plaster were seen adhering to the stonework.

To the west of wall 2002 was a deposit of mortar with small limestone inclusions. As this deposit butts up to the wall it is likely that it represents an associated floor surface. On the eastern side of Wall 2002 was a similar deposit (context 2004). The absence of any cut for a foundation trench for Wall 2002 in either contexts 2003 or 2004 suggests that Wall 2002 was not inserted into these deposits, but was contemporary.

In the eastern portion of the trench was a fairly substantial deposit composed of limestone blocks (context 2005). The angle of deposition (c. 30°) suggests that it represents tumble from a wall, but it is not possible to say for certain that this material came directly from Wall 2002.

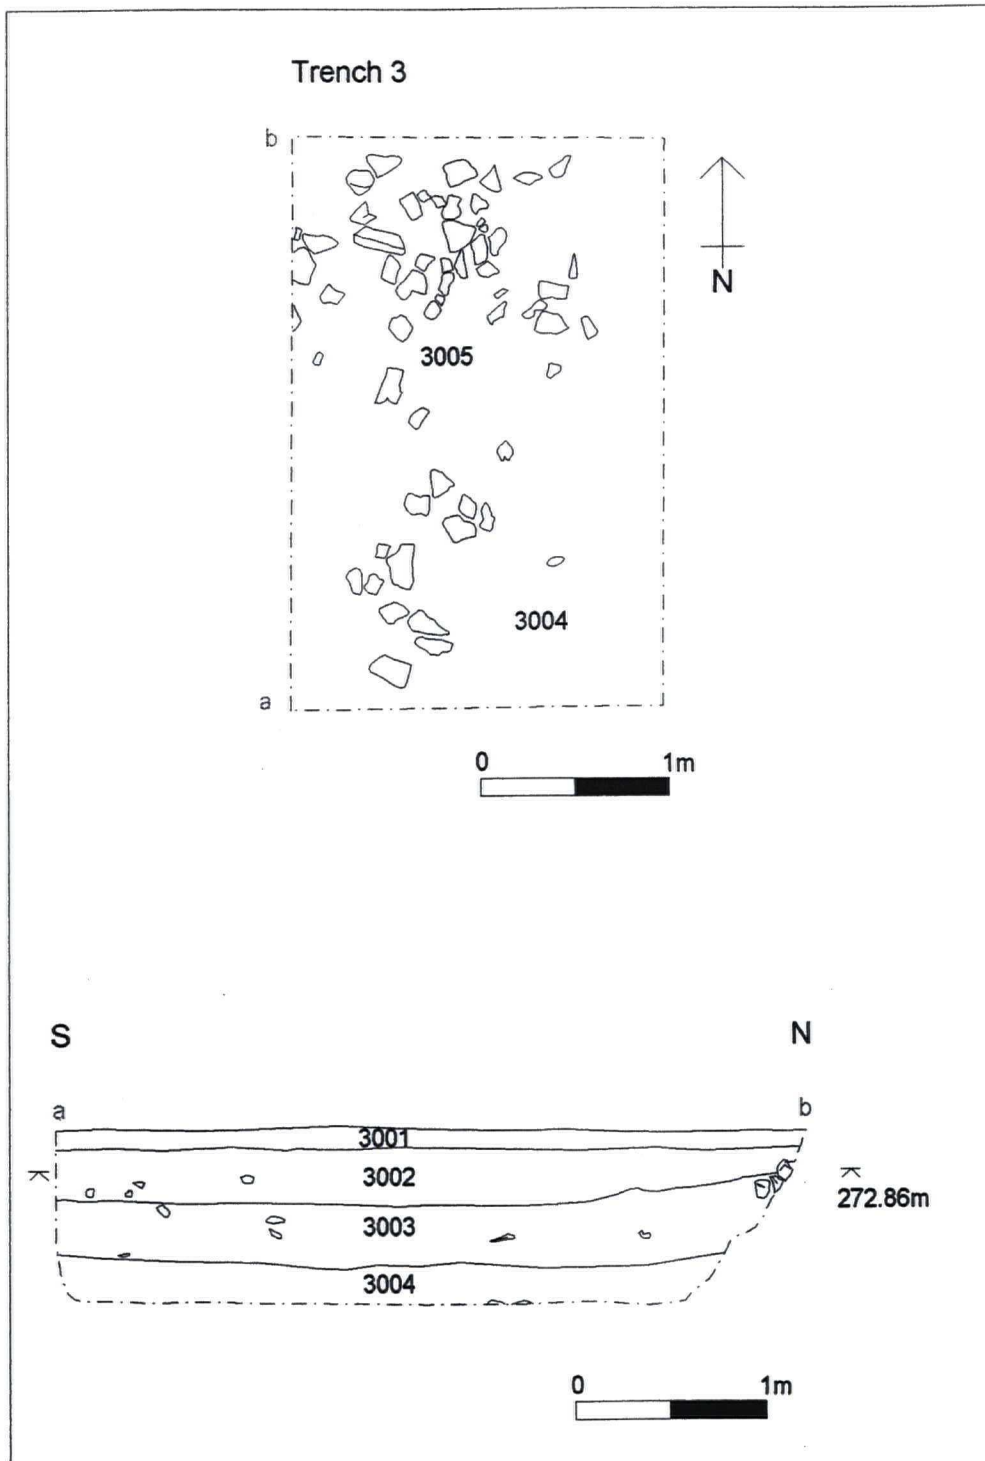
Figure 5. Trench 3 - plan and section.

Excavation in Trench 3 provided the deepest stratigraphical sequence within the test trenches (0.98m). A series of contexts were recorded (contexts 3001-3004) which represented modern path make-up (3001), a possible demolition layer (3002), further demolition or levelling (3003) and a deposit of natural silting (3004). This final deposit covered an area of limestone paving (context 3005). Excavation ceased at this level.

Finds from this trench were confined to context 3004 and consisted of brick/tile, shell, animal bone and pottery of 14th-16th century date.

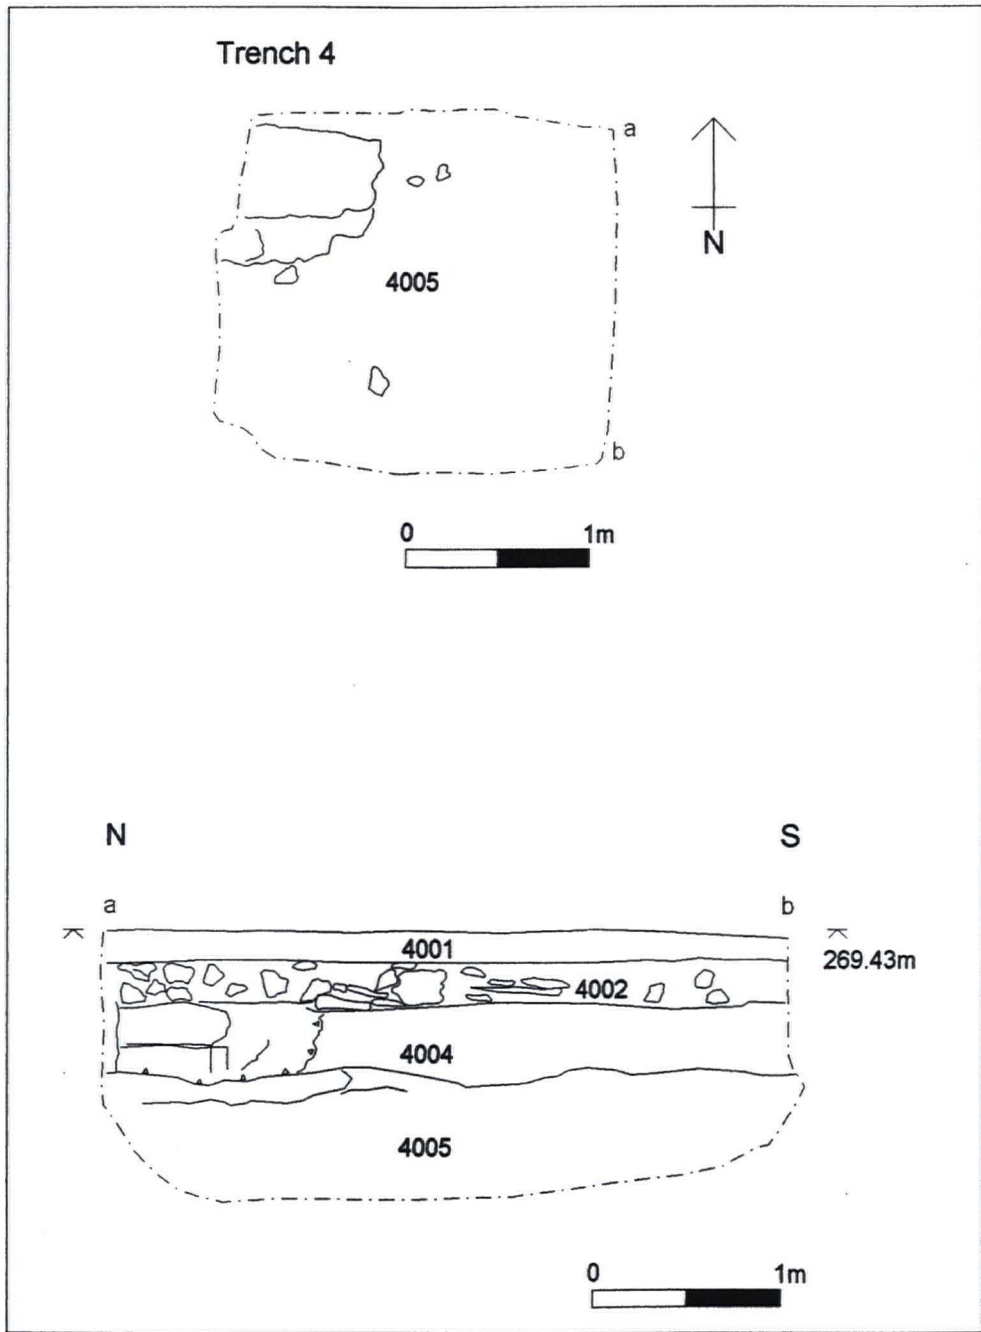
Figure 6. Trench 4 - plan and section.

Trench 4 revealed that beneath the modern concrete were two courses of limestone mortar bonded walling set into a foundation trench (context 4003). This wall lay directly upon a deposit of dark silty sand (context 4004) which may represent an old turf line.

Excavation ceased at 0.70m at context 4005, a deposit of dark silty sand which may represent household waste redeposited in a yard area. Approximately 0.34m had been removed of this deposit, sufficient to determine its nature. The true depth of 4005 is unknown and the absence of finds makes accurate dating difficult.

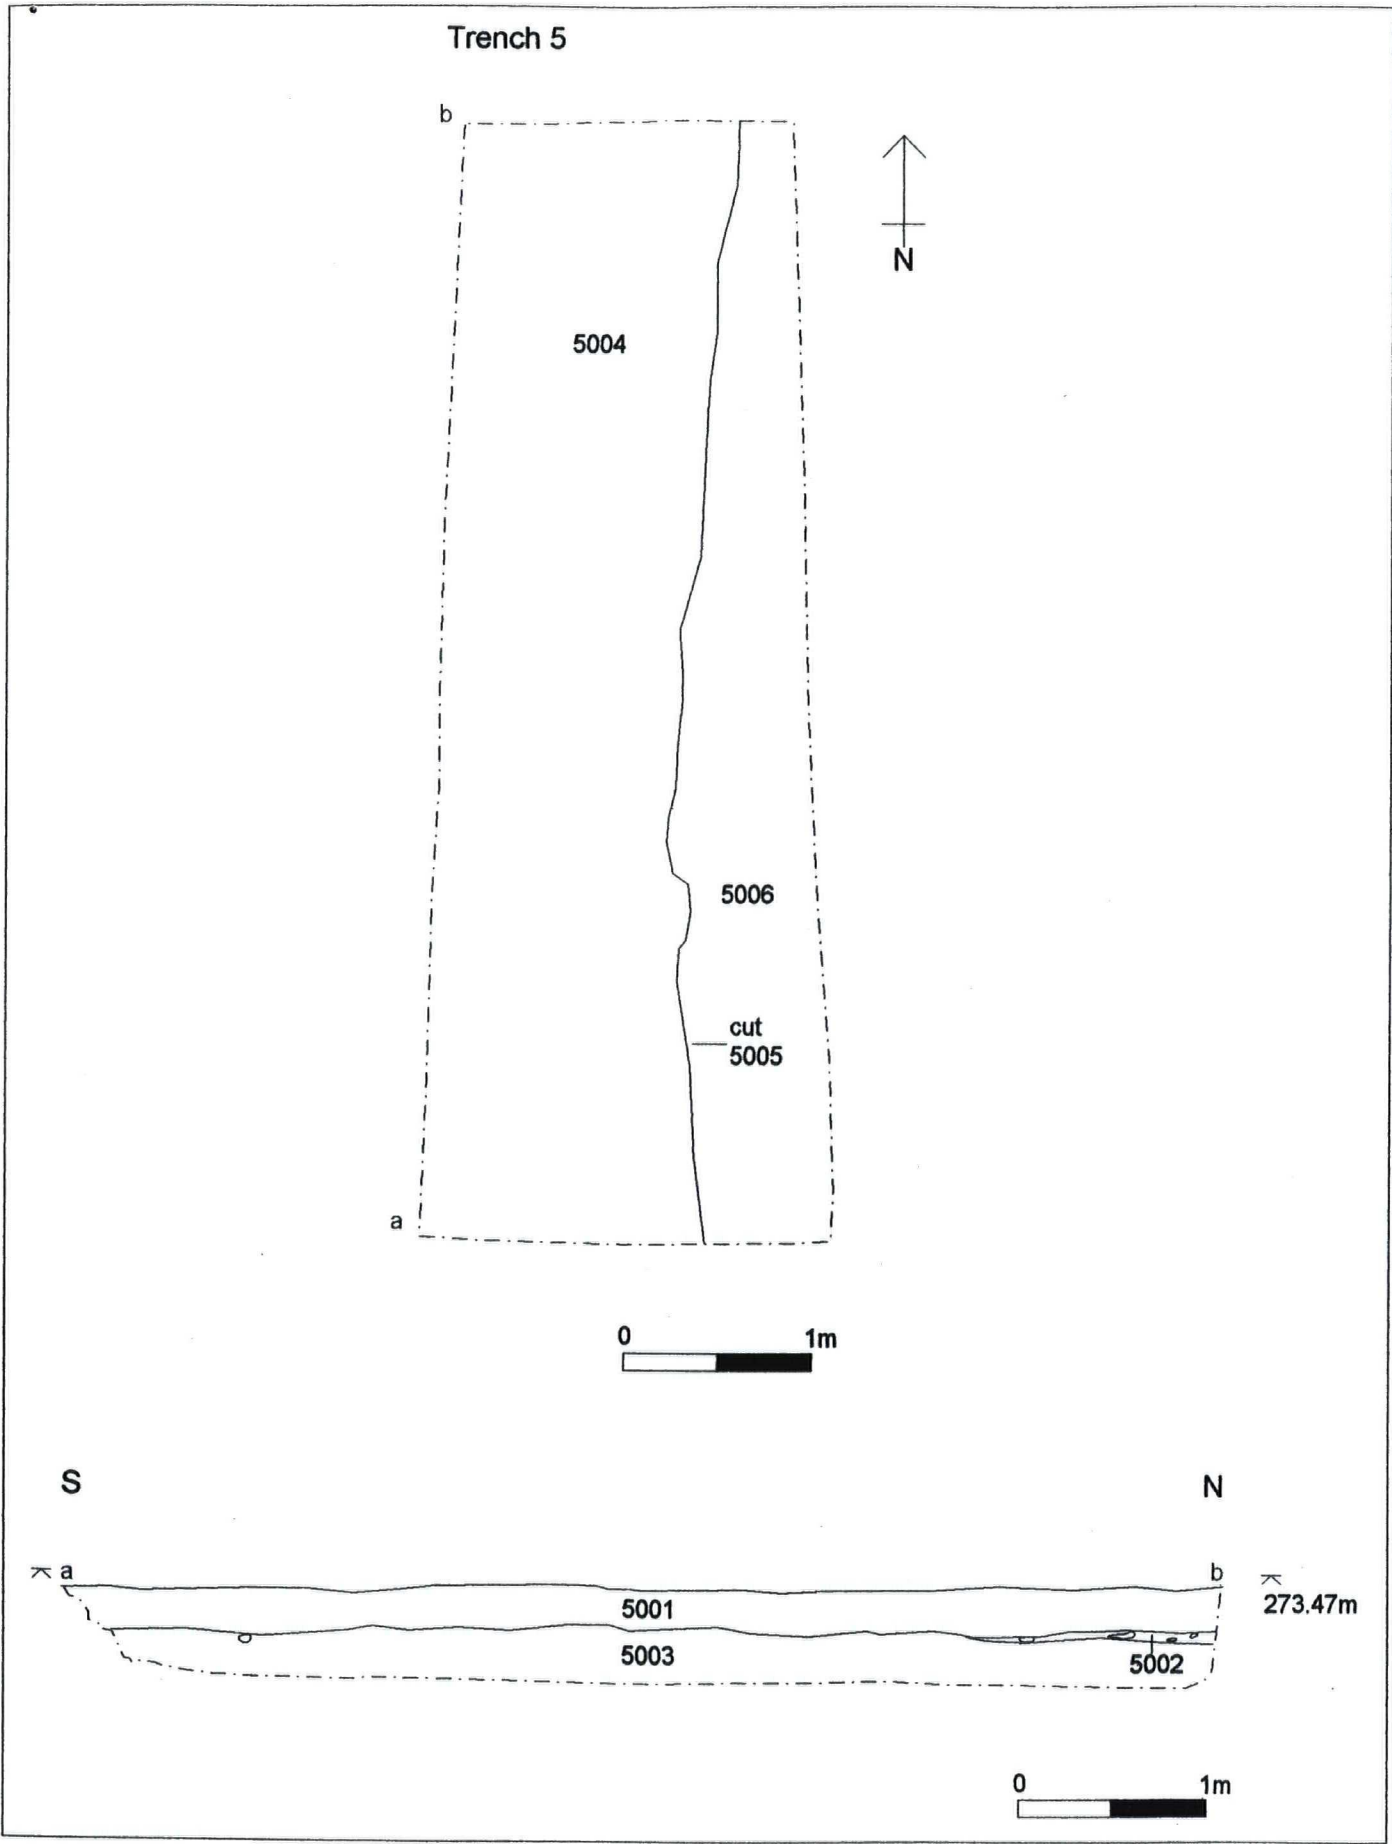
Figure 7. Trench 5 - plan and section.

Below contexts 5001 and 5002 excavation located a linear feature (context 5005). Aligned north to south it cut through deposit 5006 (natural) and was filled with a silty sand (context 5004). Although it was not excavated medieval pottery of 12th - 13th century date was recovered from the uppermost fill (Appendix 2).

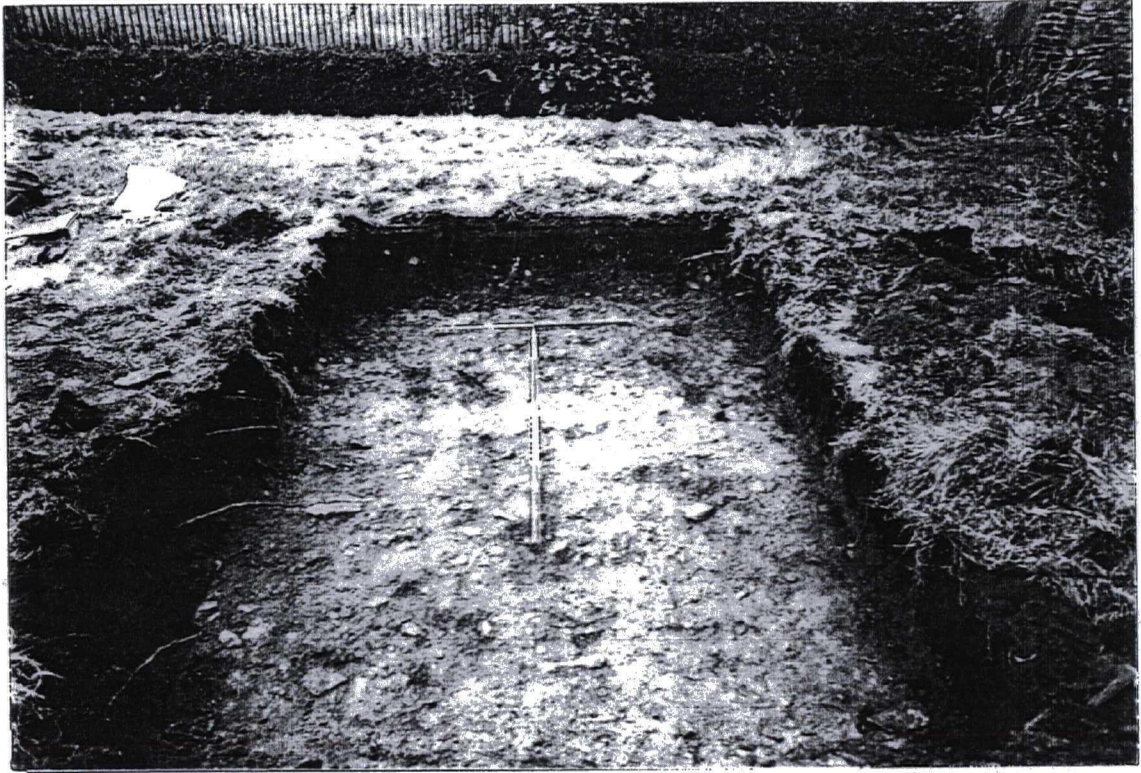
Plate 1.
Trench 1. Facing north.

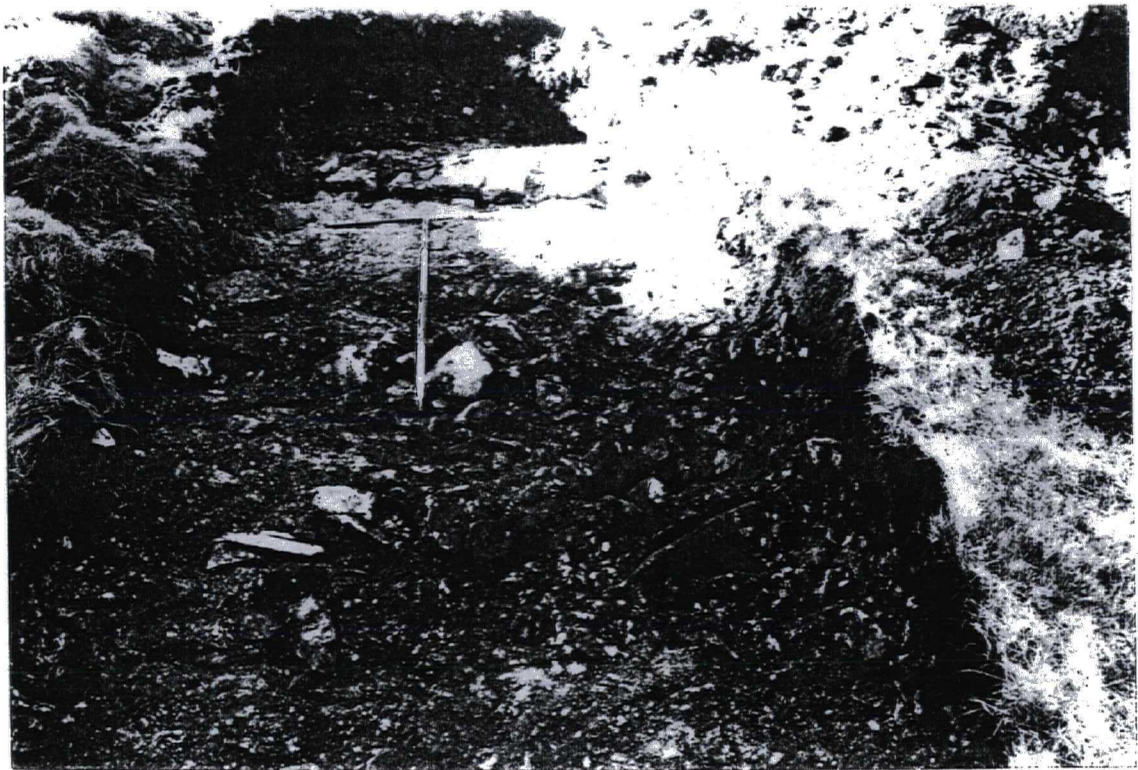
Plate 2.
Trench 2. Facing west.

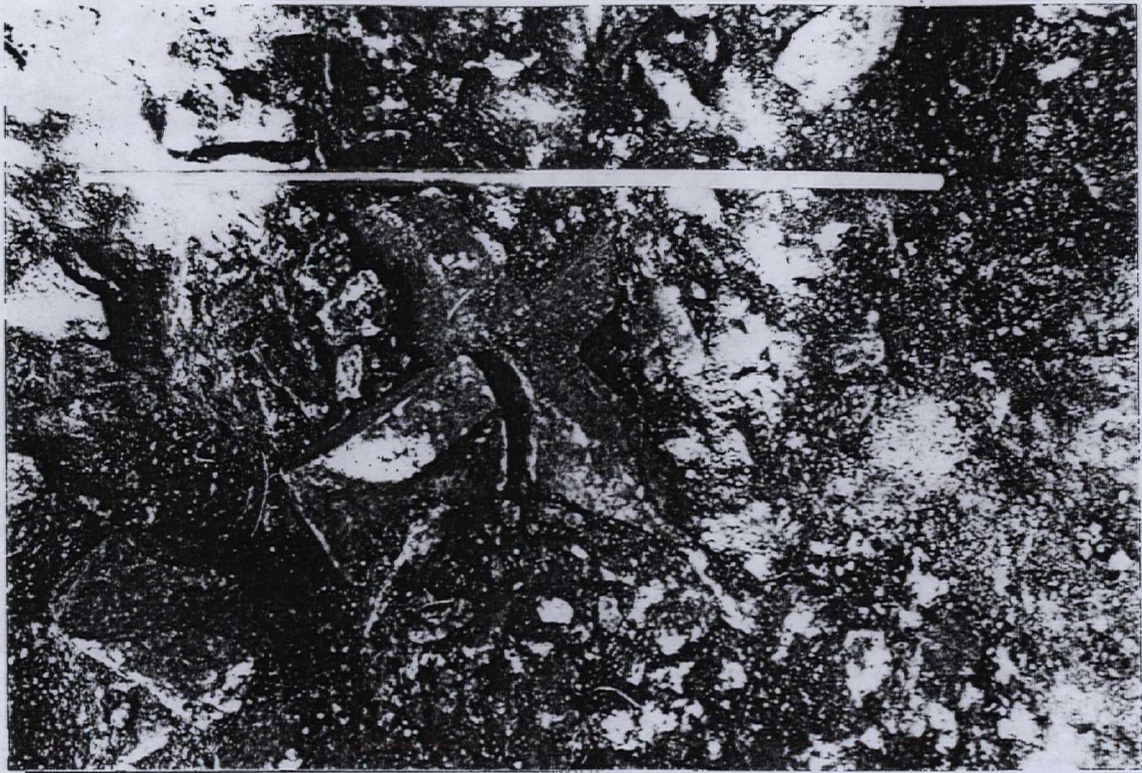
Plate 3.
Trench 2. Architectural fragment.

Within deposit 2005 excavation located a piece of worked stone, possibly part of a window mullion (SF 1). No other finds were recovered from this trench.

There is evidence of medieval activity in Trenches 1, 3 and 5. The high quality of wall construction in Trench 2 and the presence of the architectural fragment suggests a prestige building, and one most probably part of The Friary complex. A number of demolition deposits recorded within the trenches also indicated the possibility of further buildings within the grounds of the Friary.

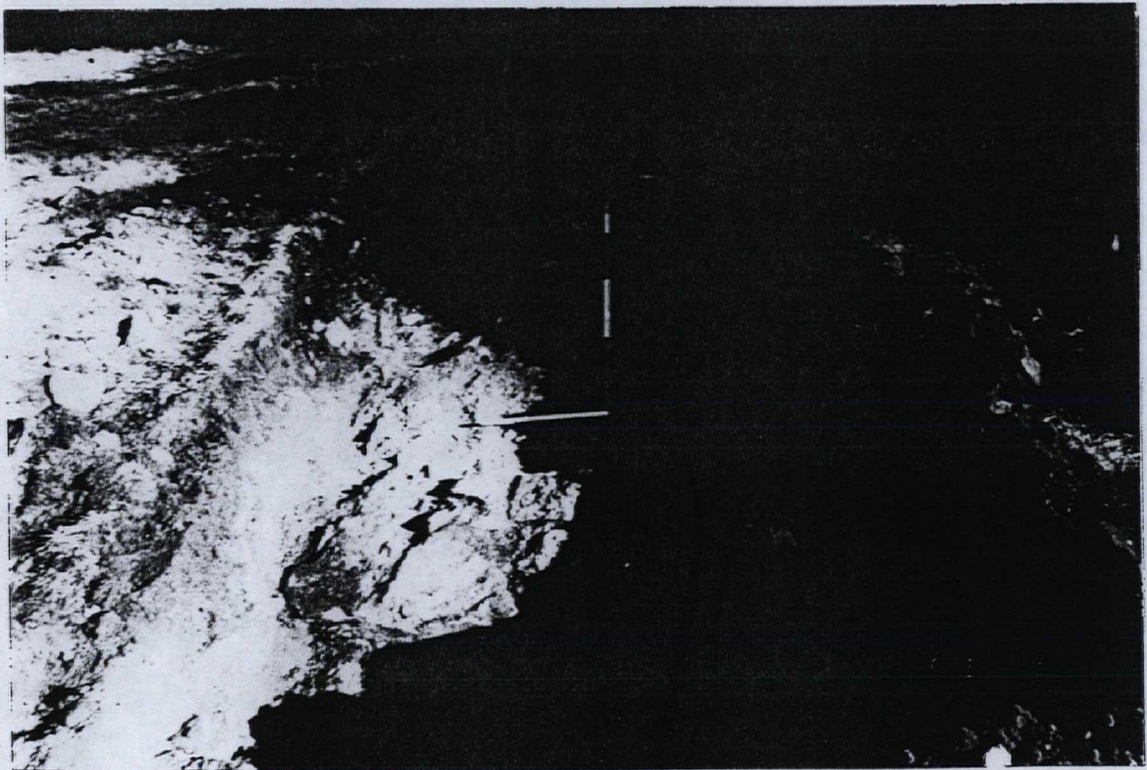
Plate 4
Trench 3. Facing south.

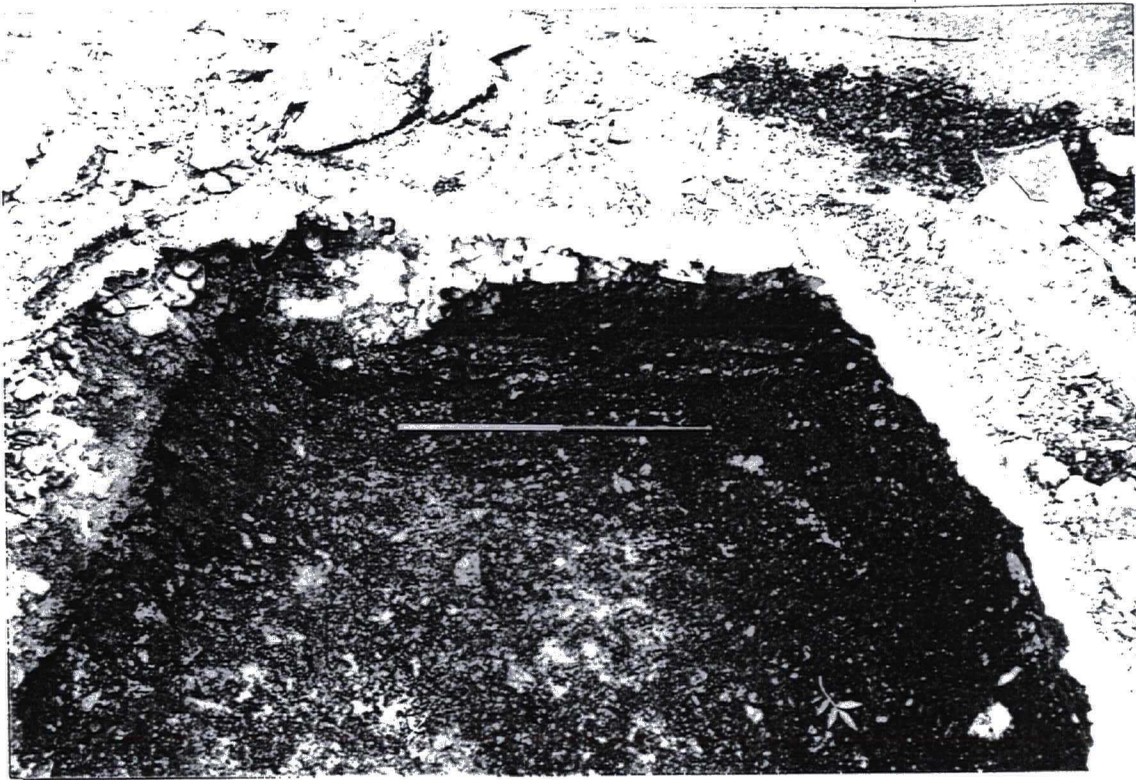
Plate 5.
Trench 4. West facing section. Facing east.

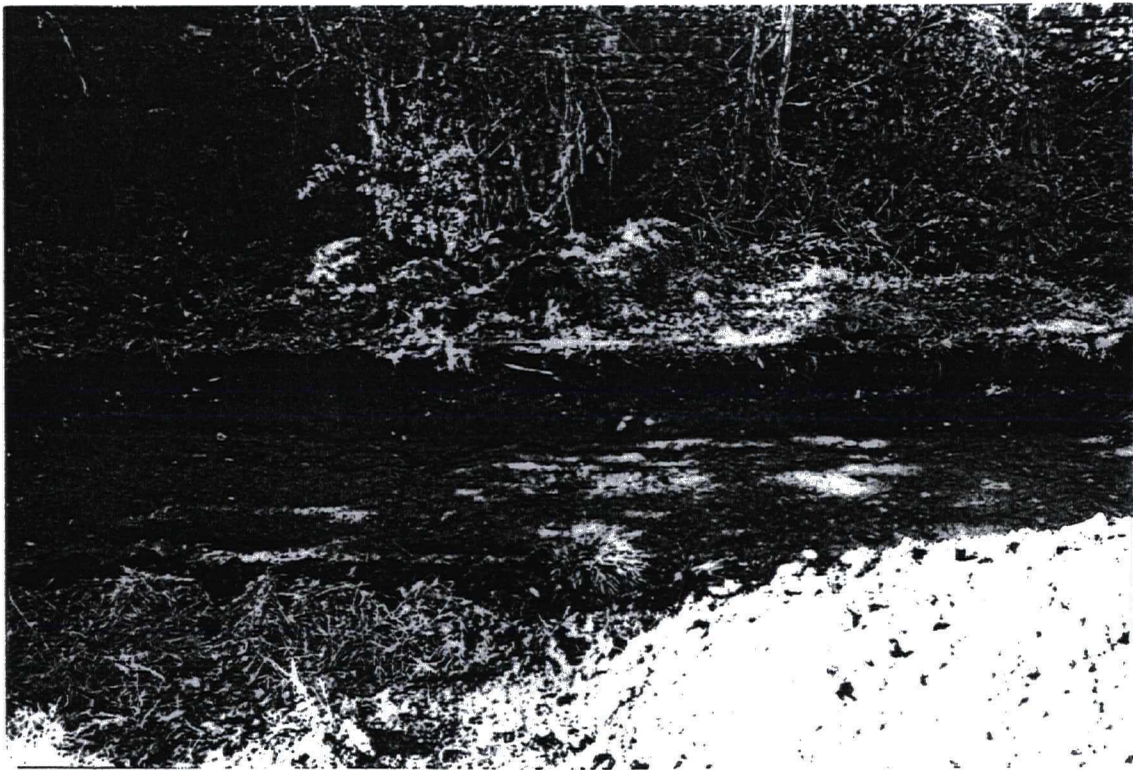
Plate 6.
Trench 5. Facing west.
