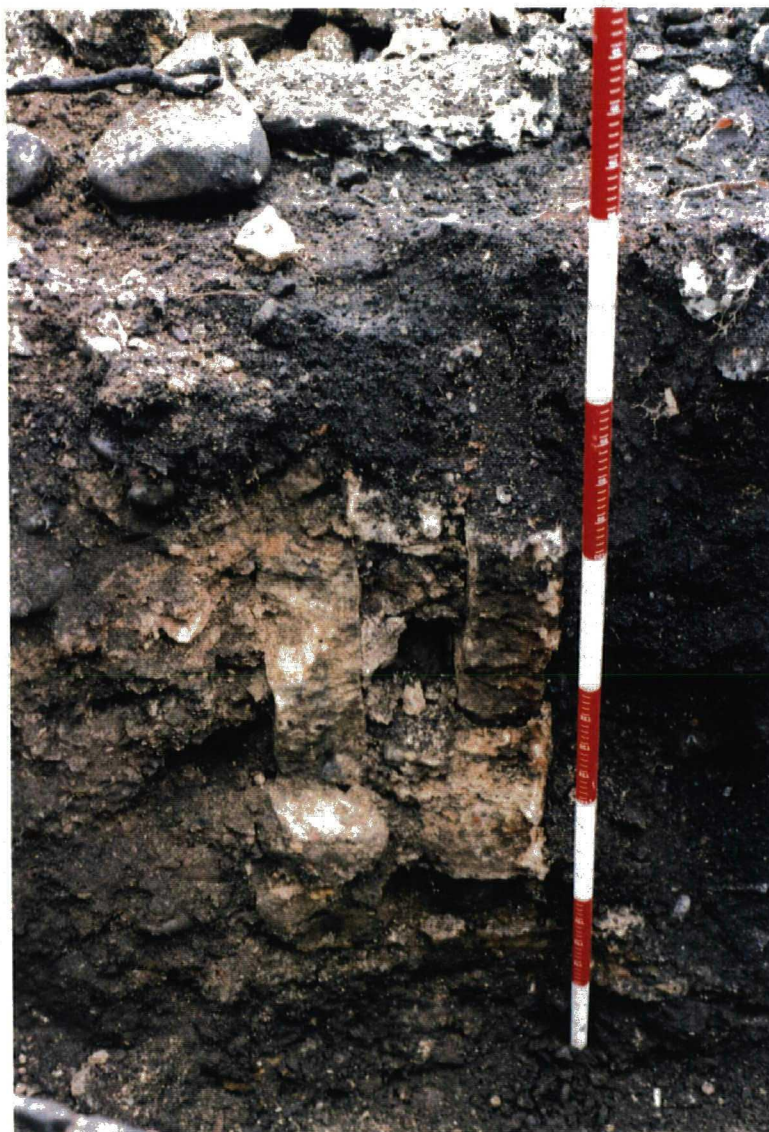
PLATE 4

Detail of magnesian limestone wall, feature A,  
as revealed within the section of area / trench B,  
facing north.

the lower two courses of a magnesian limestone wall, this structure has two skins with a rubble core, the outer west facing aspect of the wall has been roughly dressed, the inner east facing aspect has been rendered with a lime based plaster. The structure has been constructed on clamp brick foundations which were set directly upon the natural sands and gravels.
