CHAPEL OF ST. MARY MAGDALEN
RIPON. COUNTY MONUMENT:110

ARCHAEOLOGICAL WATCHING BRIEF

FEBRUARY - MAY 1989.

CHAPEL OF ST.MARY MAGDALEN
 ARCHAEOLOGICAL WATCHING BRIEF
 ENGLISH HERITAGE 1989

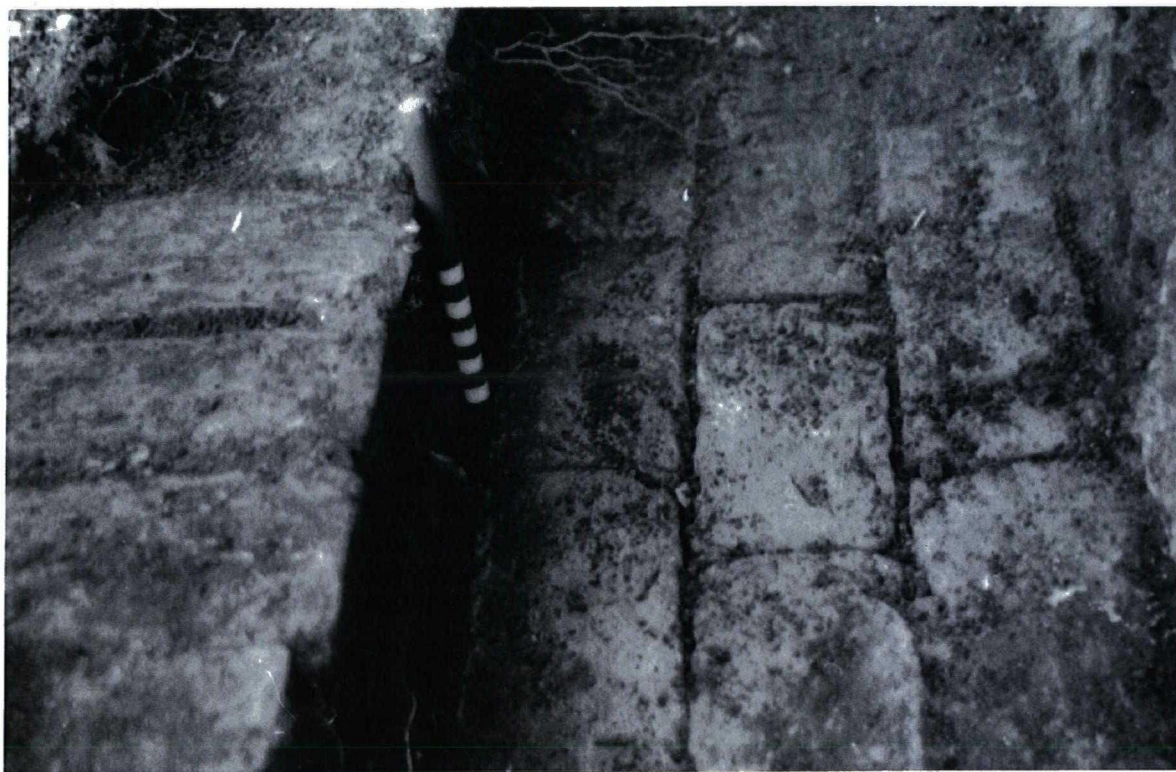
2.

The brick box trench identified immediately beneath the concrete apron was most probably constructed during the late 19th century to reduce what otherwise would have been a high external ground level in relation to the lower internal floor level, this would have the effect of reducing rising damp in the masonry wall of the Chapel.

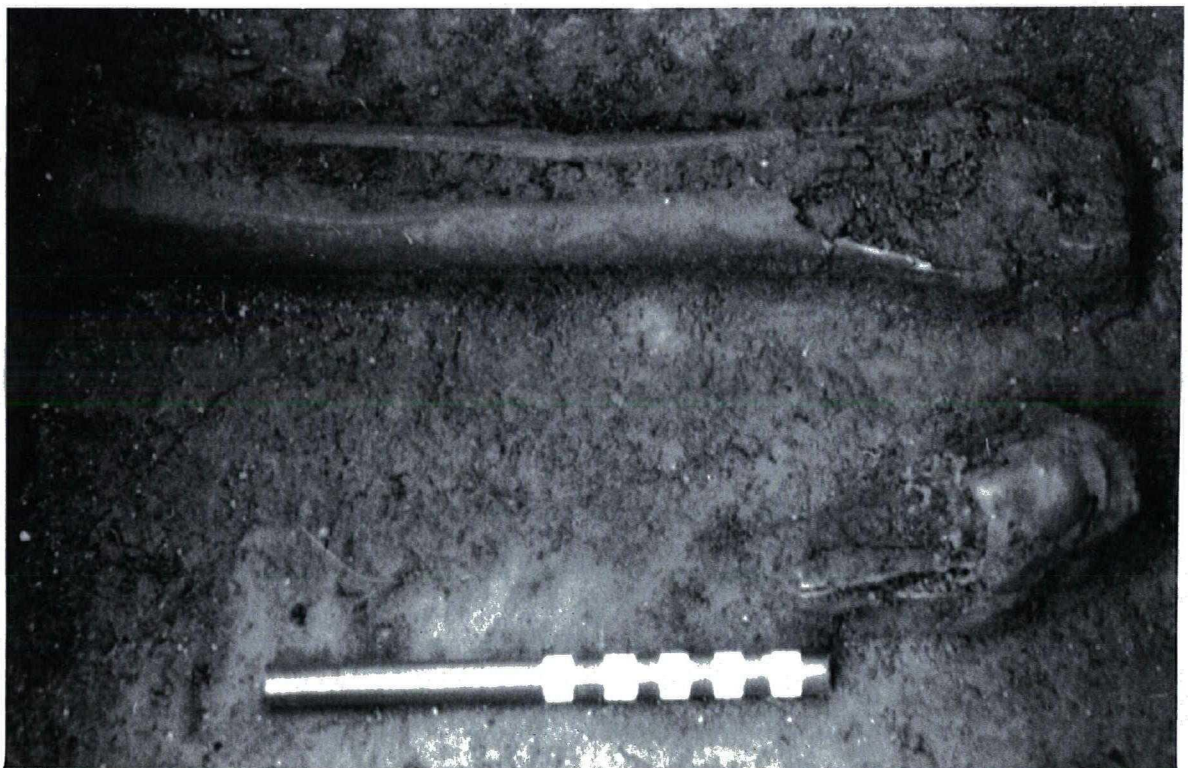
5.

Only the fibular and tibia of the left leg were revealed, recorded and removed, the lower right leg having been disturbed during the trench excavation.
