St. John's Terrace,

Skipton Castle,

Watching Brief

ARCHAEOLOGICAL WATCHING BRIEF AT ST. JOHN'S TERRACE, SKIPTON CASTLE

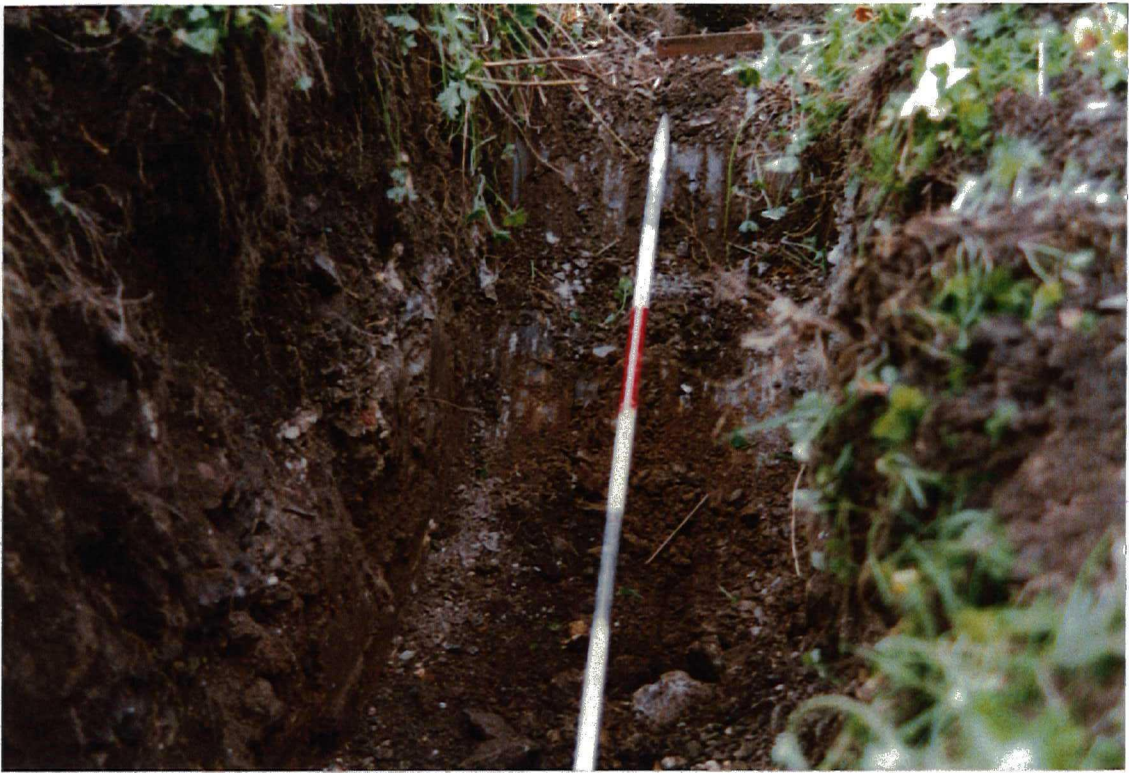
PLATE 1 ST. JOHN'S TERRACE, TRENCH A

Trench A, on the south-west side of the scarp (Plan 2, Plate 1), was 320 cm. long and 75 cm. wide, with a maximum depth of 110 cm. Beneath approximately 20 cm. of topsoil was a thick layer of stones and rubble containing some dressed stone, along with brick, glass, ash and lime mortar. Towards the outer edge of the trench, this layer overlaid brown clay which appeared to be the natural ground surface at a depth of approximately 85 cm.

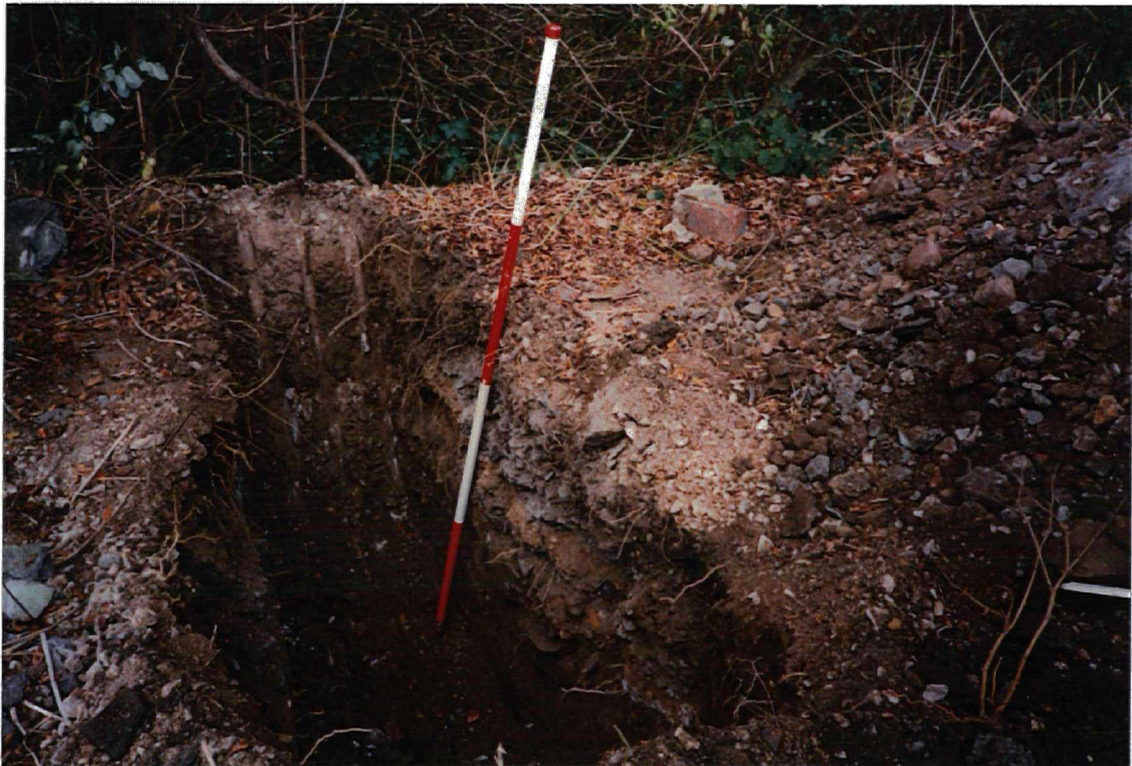
PLATE 2 ST. JOHN'S TERRACE, TRENCH B

Trench B, on the north-west side of the scarp (Plan 2, Plate 2), was 310 cm. long, 80 cm. wide and a maximum of 120 cm. deep. Here the topsoil overlay 30 cm. of grey rubble filled soil with pieces of tarmac and brick within it. Below this was a narrow (8 cm.) band of loose orange sandy clay which in turn covered a further layer of brown loamy soil with rubble, which reached to a depth of 100 cm. A fragment of clay pipe was recovered from near the bottom of this layer. From the bottom of this layer to the base of the trench the subsoil was a hard brown clay containing limestone fragments and traces of mortar. The stones were spread across the clay surface.

has gradually accumulated over the last two centuries. The limestone fragments embedded in the brown clay in Trench B could represent an attempt to provide a hard surface at the edge of the steep drop to the river at a time before the main build up of rubbish on the site. In the absence of dating material from this layer, it is only possible to say that it occurred in or before the nineteenth century.

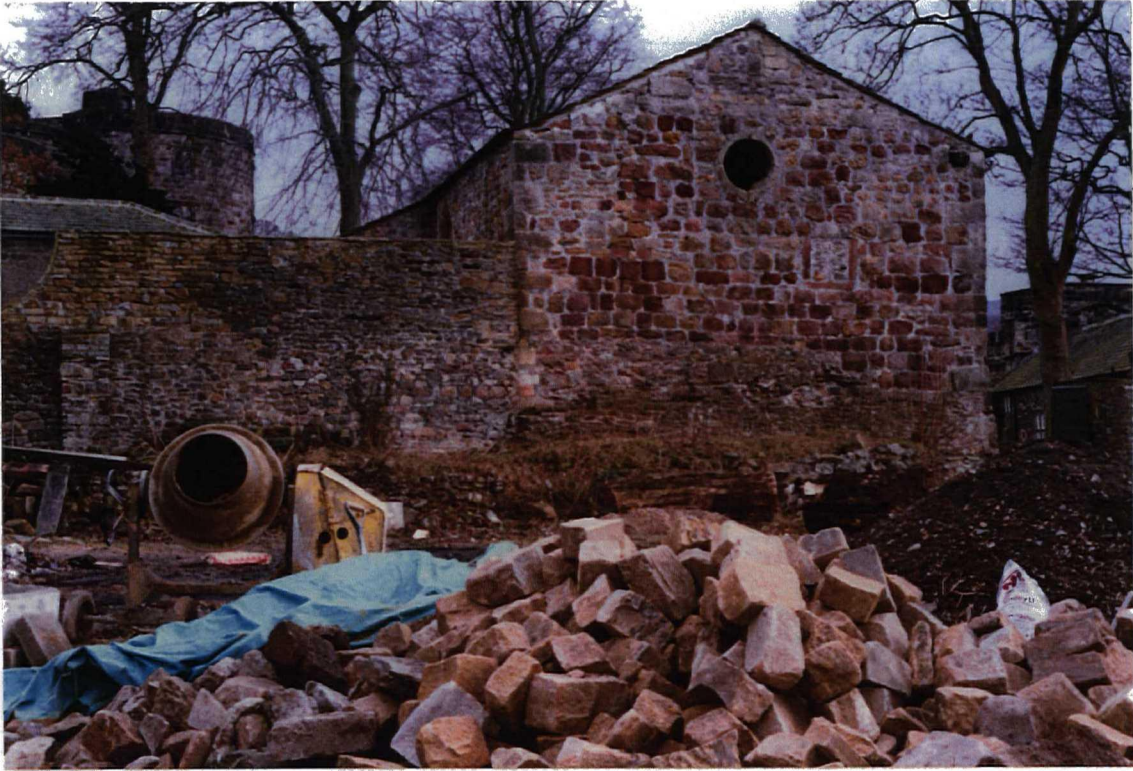
PLATE 3 ST. JOHN'S TERRACE,LOOKING EAST, BUILDERS RUBBLE

It was proposed in the autumn of 1995 to clear the area of the rubbish and builders rubble which had accumulated on it (Plate 3), and enclose it within a new perimeter wall on the edge of the escarpment, in order to create a picnic area for visitors to the castle. Because of the proximity of the site to the medieval castle, an archaeological watching brief was required to oversee the works and record any archaeological remains.

The reduction of the ground levels within the terrace area (Plates 3 & 4) also revealed modern builders rubble and spoil beneath the uneven surface of the terrace. Rubble and builders waste, including a layer of lime mortar, was interspersed between sandy loam buried topsoil layers.
