Trial Hole No. 1

The excavation of the strip foundation trenches

SUMMARY OF ARCHAEOLOGICAL FEATURES

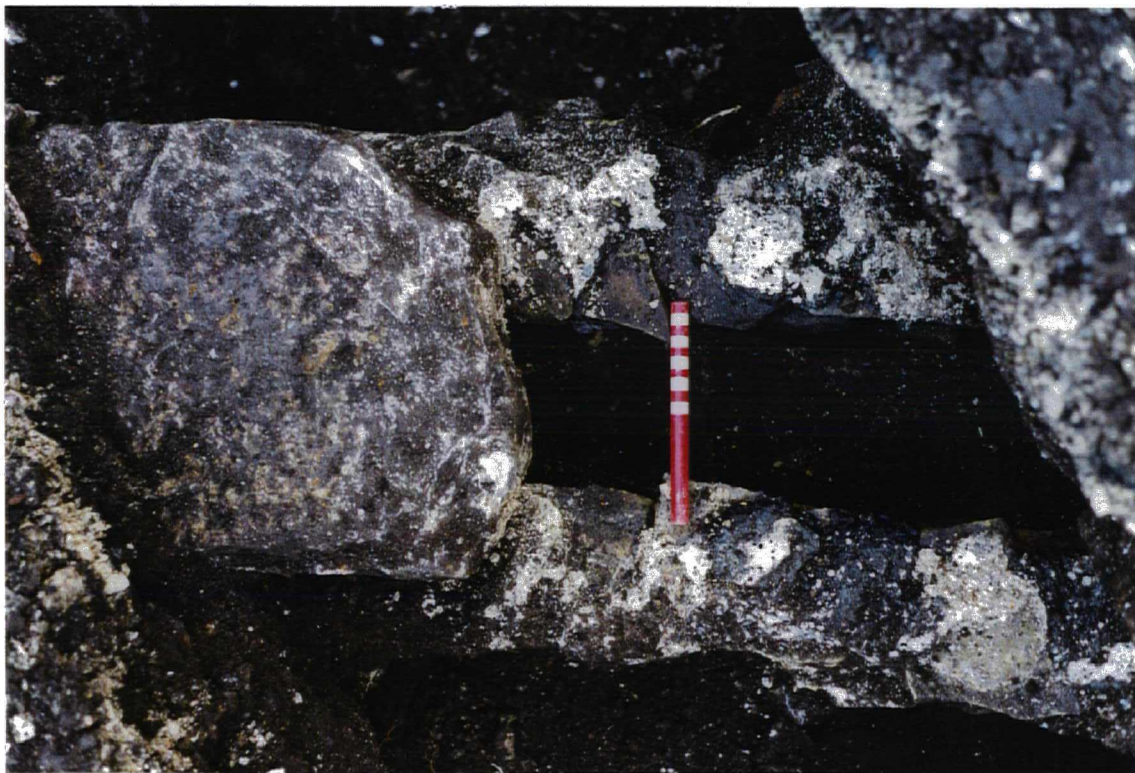
PLATE 2

Vertical shot of the drainage culvert, feature E

Within the central section of the trench a sandstone box culvert was identified (Feature E) this drainage structure was 19th century in origin and appeared to drain into a subterranean chamber situated within the centre of the study area. This structure was constructed upon a 19th century buried topsoil/landfill (context 6004).
