The recent archaeological watching brief conducted by Mr.K.J.Cale on behalf of Mr.& Mrs.D.Goldie at 4/6 High Street, Skipton, has provided further evidence of the nature, layout and development of those property parcels that front on to the High Street, the similarities between the archaeology exposed during this investigation with that excavated by D.Williams at Canal Yard are striking.

Kevin John Cale  
May 1996

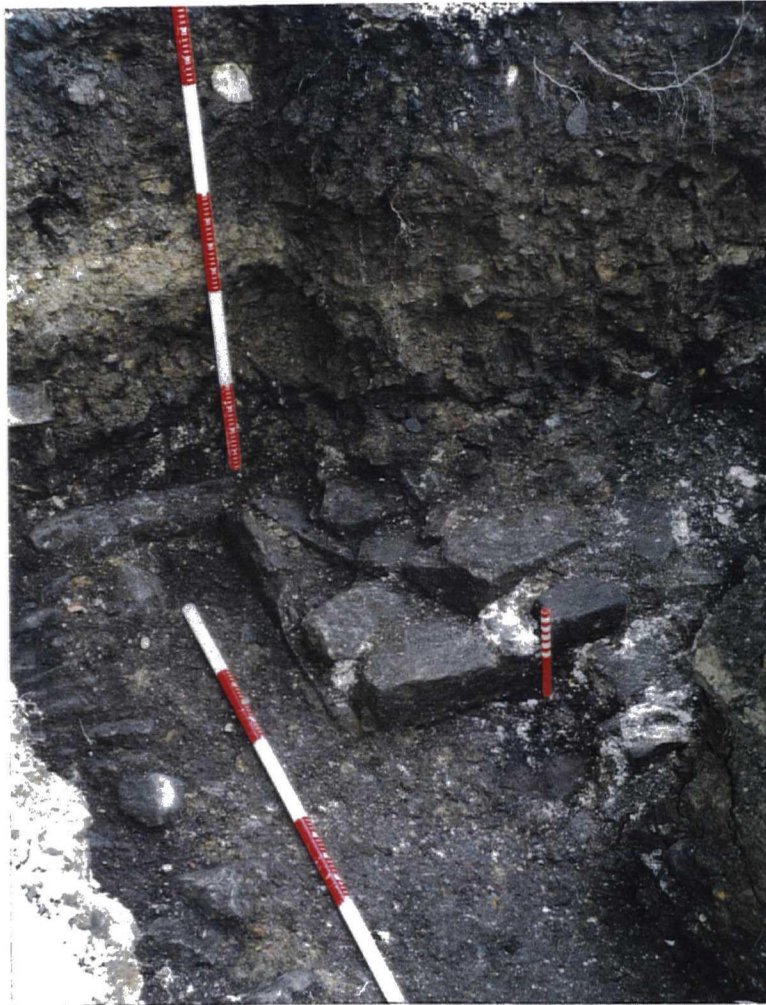
**PLATE 3**

The lower courses of a 17th century building and related cobble surface, features H and I

The lower courses of a sandstone blockwork and cobble wall identified in the south western corner of the study area within Trench A and D, the full extent of this structure was not exposed.

The wall appeared to be double skinned with a rubble core, with load bearing capabilities. The roughly hewn masonry fragments were bedded within a white-grey coloured lime based mortar. The south and east facing aspects of the wall were stepped, each of the three wall courses differed in form and nature.

The lower course consisted of sandstone slates that were tightly grouped and bedded level within a sandy loam, a buried ground level that contained post medieval pottery.

The second course of masonry consisted of roughly dressed blocks of sandstone that were bedded level within mortar and had a well defined south and east facing vertical aspects. It would appear that this course of masonry had originally continued to the east and south of the structure, but these elevations of the structure had been largely demolished and removed. This medial course of stonework would appear to have been butted by a cobble surface (Feature I), this surface was identified as emerging from the base of the north facing section of Trench A and whilst the relationship between this surface and the building can not be exactly determined comparative levels would indicate the two features are contemporaneous.

The third and upper course of surviving masonry consisted of roughly dressed, irregular shaped sandstone fragments and water worn cobbles that were randomly placed the width of the wall.

The cobble surface was identified within the base of Trench A emerging from the base of the north facing section, the surface was comparable in form with Features A, C and D identified to the east.

At it's western extent the surface butted against the southern return of the Post Medieval building, Feature H. The western extent of the surface can not be clearly determined, as this area of the trench has been heavily disturbed during the 19th century by the excavation of ash pits, these had been excavated through the surface and had resulted in the displacement of the cobbles, unfortunately this disturbance had destroyed the relationship between this surface and Feature C situated within the western extent of the trench.

The surface sloped gently downwards to the west on a constant and gradual gradient.

The cobble surface was imbedded into a buried top soil that contained 17th century pottery, it would appear that the surface is near contemporary with the Post Medieval building and as such may pre date the similar cobble surface identified to the east.

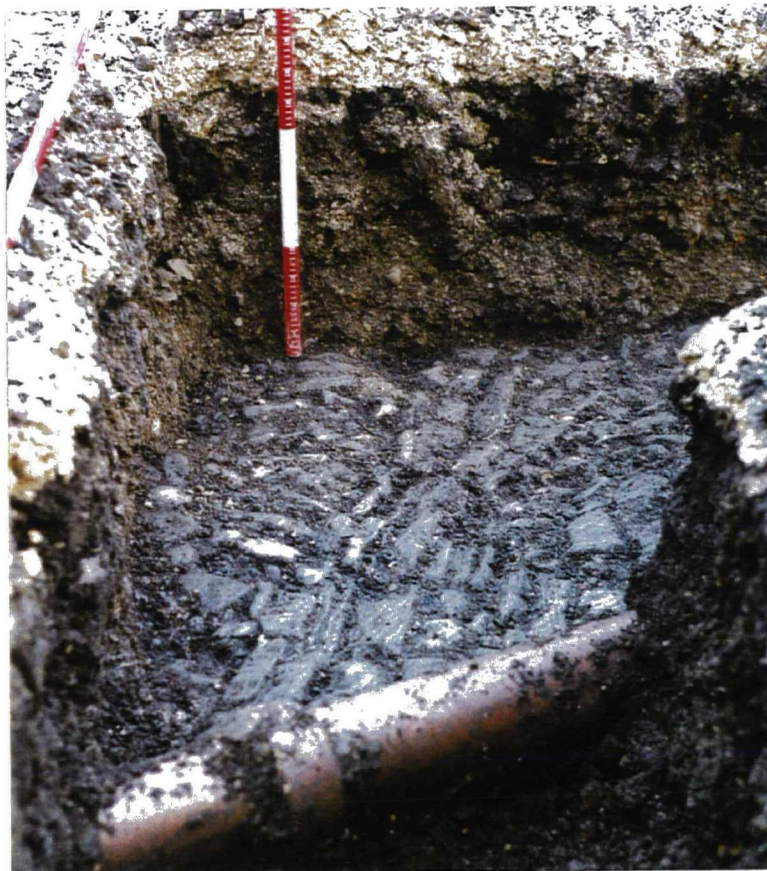
**PLATE 4**

A cobble yard surface with drainage culvert, feature D

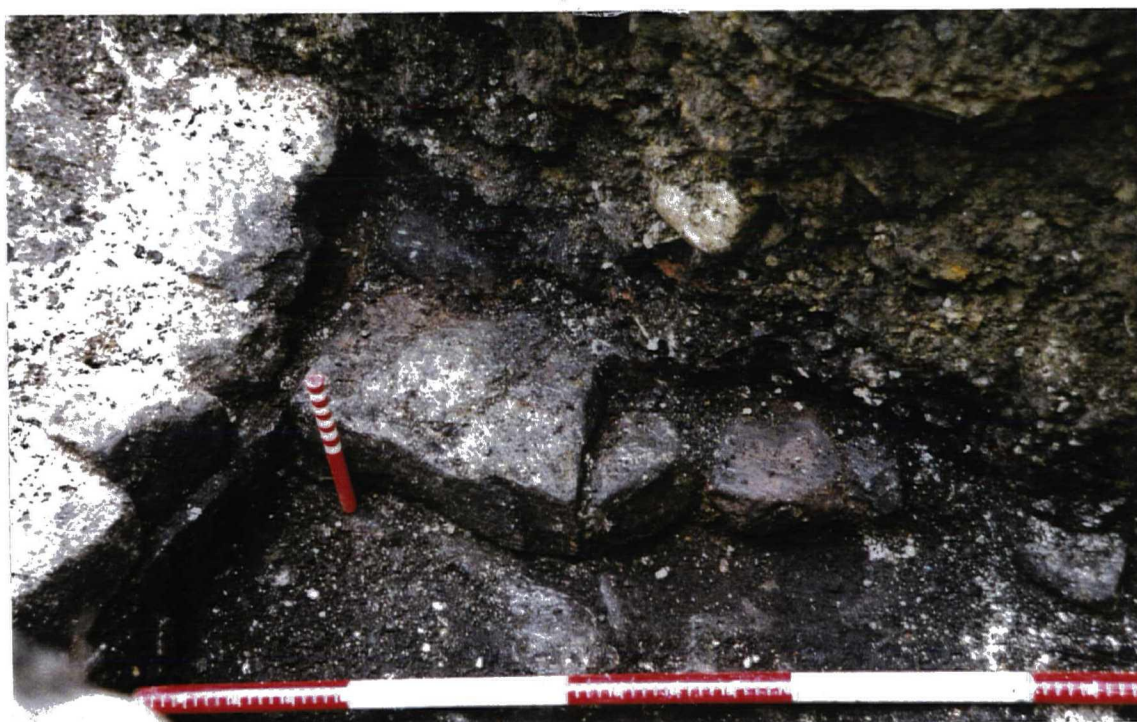
PLATE 6

An 18th century hearth, feature G

The roughly dressed sandstone and cobble plinth like feature was identified as emerging from the base of the west facing section of the foundation trench, the full extent of this structure was not exposed.

The exact form and dimensions of the structure could not be accurately determined, however it is suspected that the structure consisted of a single layer of tightly grouped stones, arranged so as to butt to the lower course of the wall (Feature F), forming a plinth like feature with a relatively level upper surface. The structure was dry jointed.

A number of stones within this feature were reddened this suggests that this surface has been subjected to intense heat and the structure may have functioned as a hearth.

The structure is bedded on a buried topsoil that contains post medieval pottery. No associated floor levels were identified adjacent to the structure and it could not be determined as to whether the hearth was an internal/external feature.

From the comparative level of the adjacent structure (Feature F) and the stratigraphic sequence it is evident that the hearth is near-contemporary with the 18th building that formerly occupied this corner of the study area.

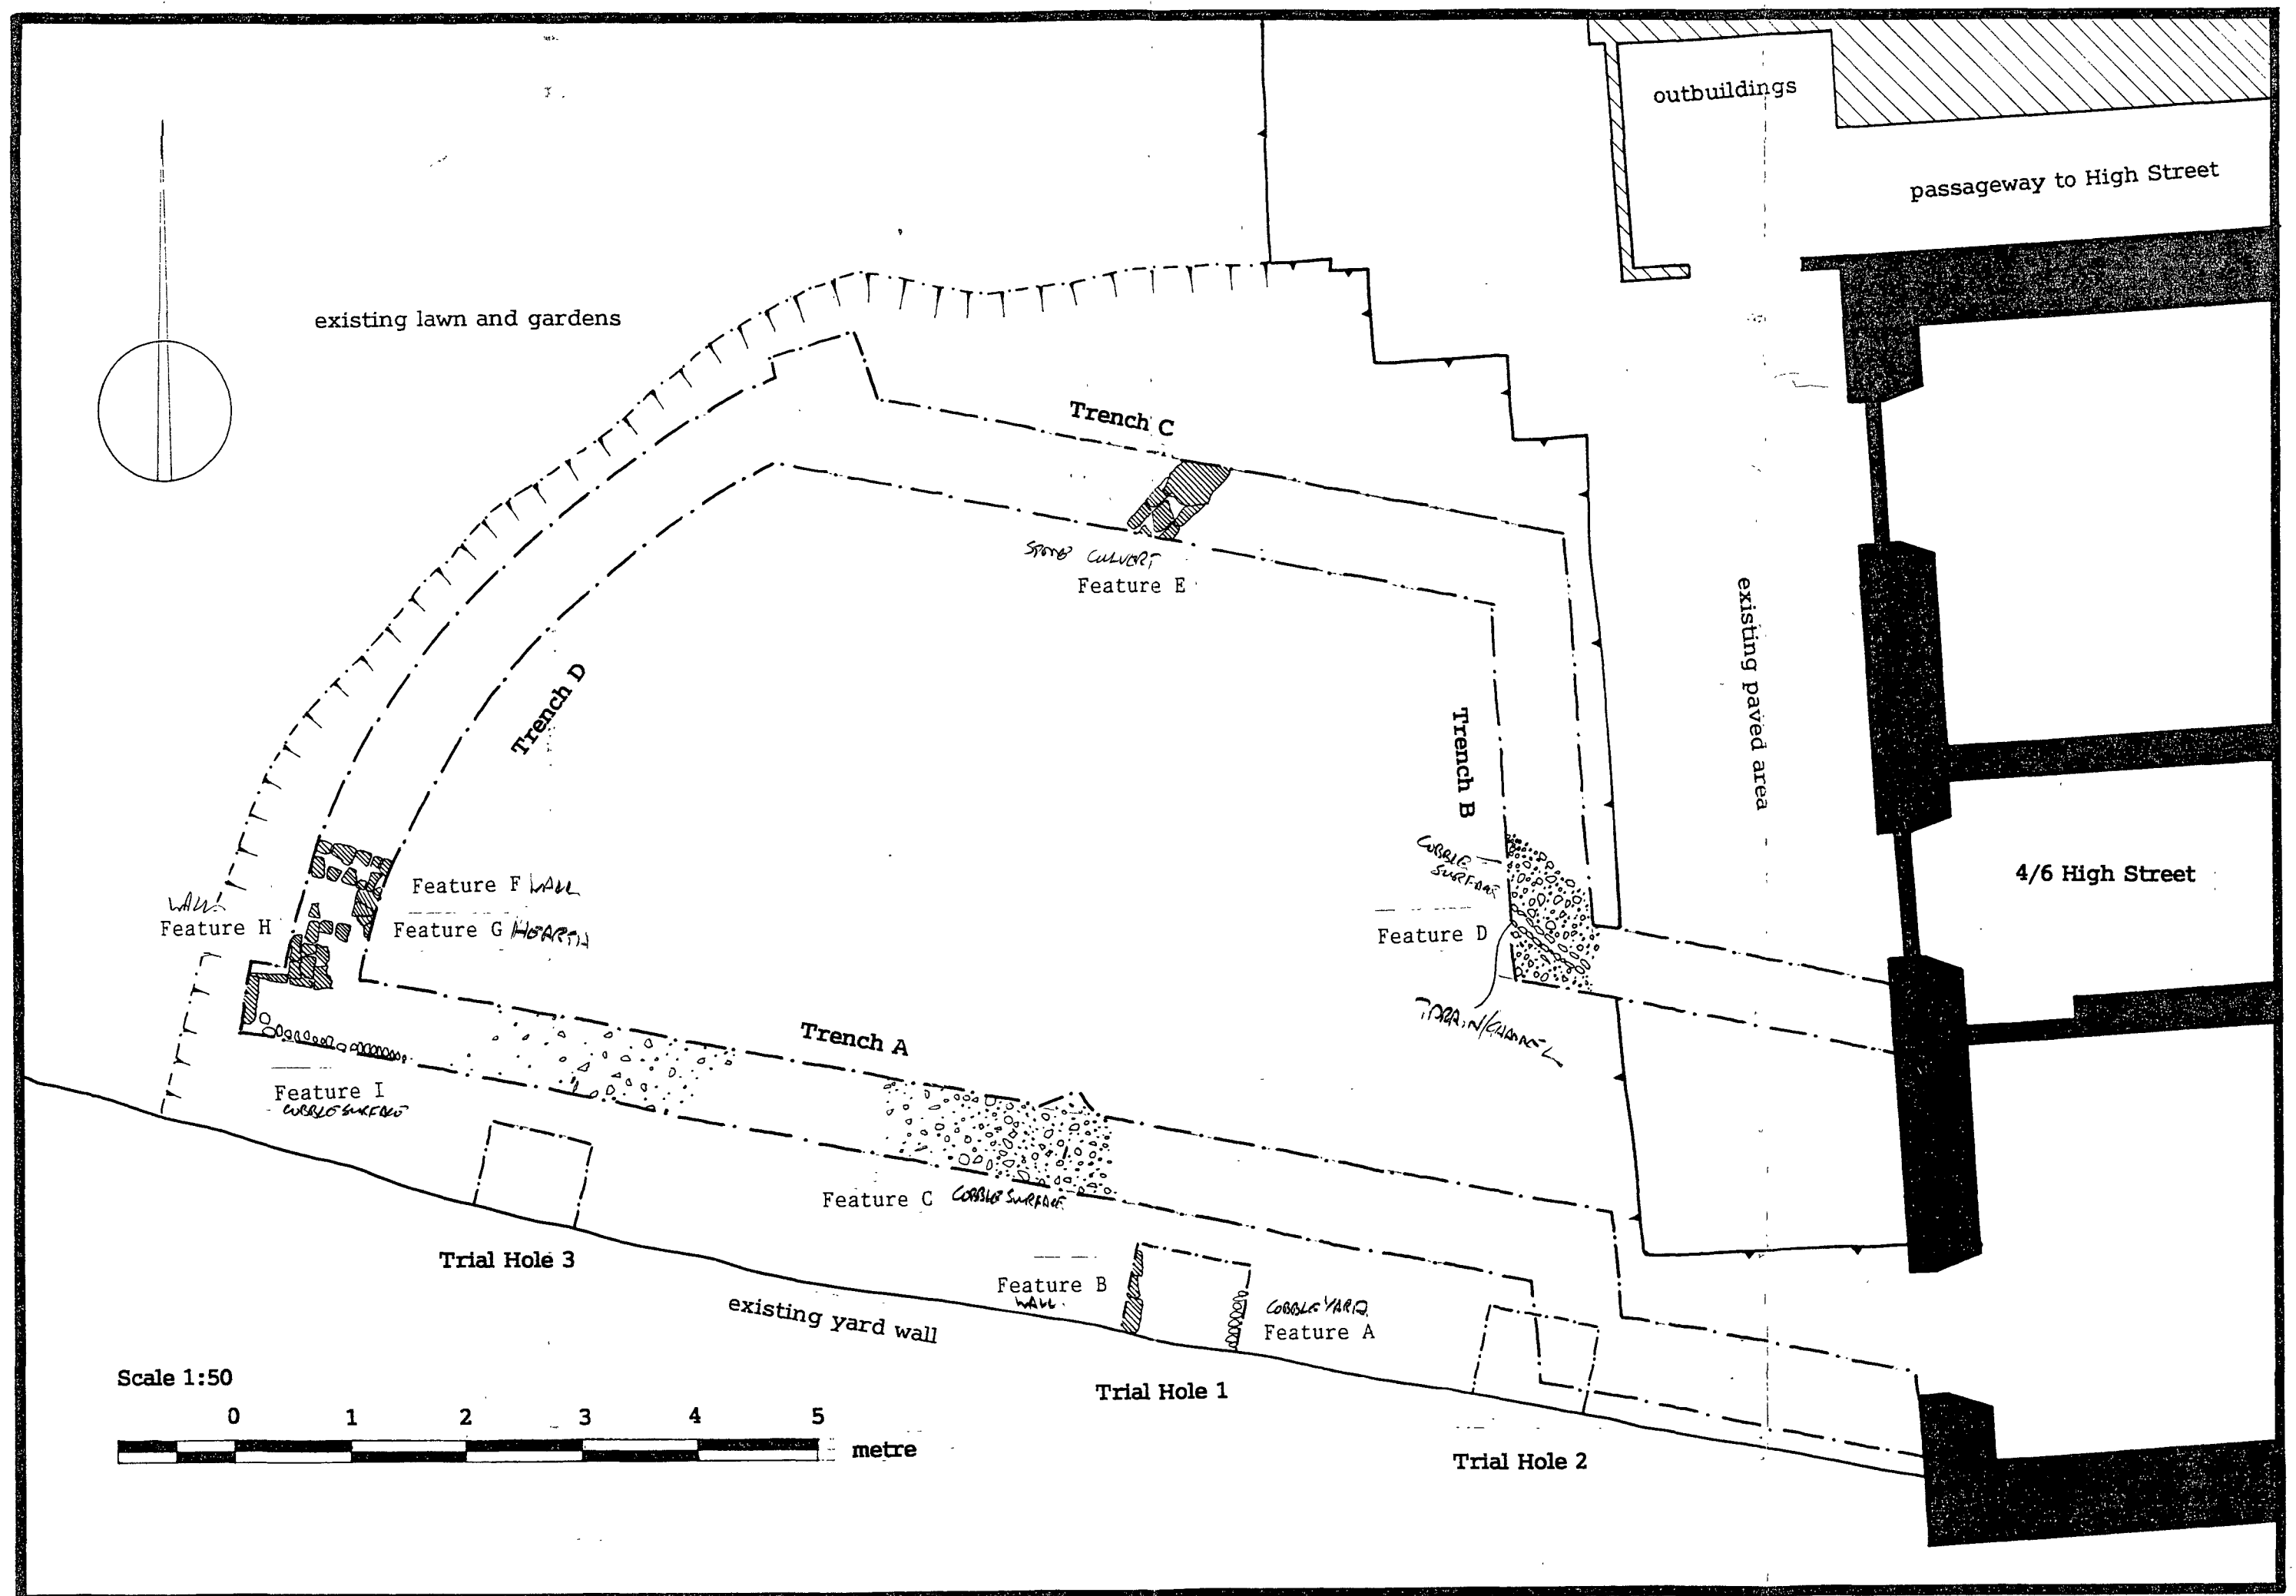
FIGURE 3

SITE PLAN

Context No: 6003  
Fig Nos: 3  
Plate: 2

Context No: 7004  
Fig Nos: 3, 4  
Plate: 5

Context No: 7005  
Fig Nos: 3, 4  
Plate: 6

Context No: 4011  
Fig Nos: 3, 4  
Plate: 3

**Context No:** 4010  
**Fig Nos:** 3, 4  
**Plate:** 3
