ARCHAEOLOGICAL WATCHING BRIEF

SELBY, NORTH YORKSHIRE

YORKSHIRE WATER

REPORT ON ARCHAEOLOGICAL WORK IN SELBY FOR YORKSHIRE WATER, 1995-96

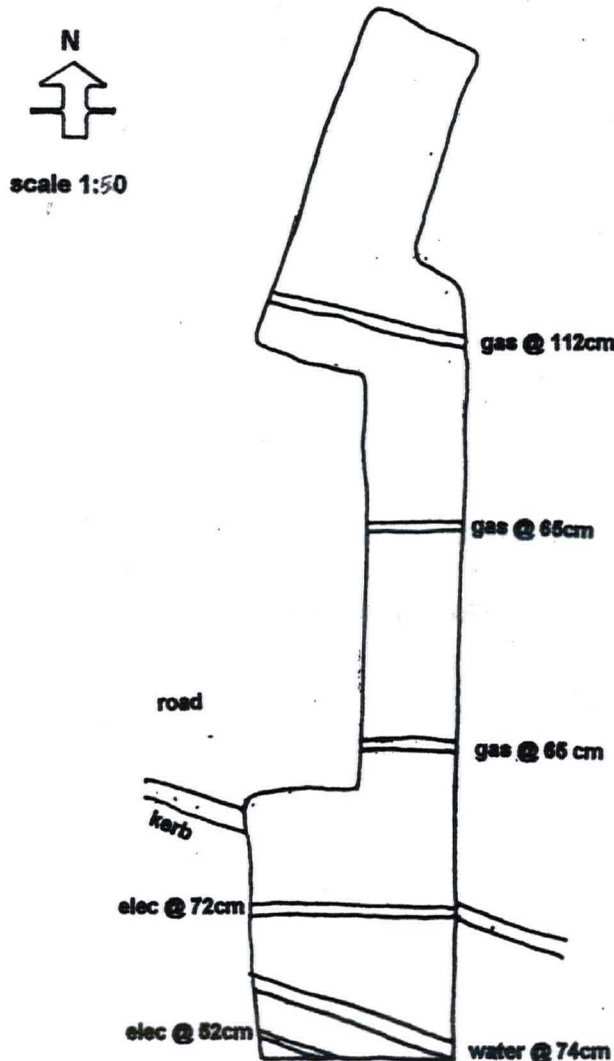
H1

Trial hole, corner of Church Hill and Ousegate.

Depth between 65 and 151 cm

Context Nos

1001 tarmac

1007 mixed sandy brown loam with brick and modern debris

1013 orange sand in patches among 1007, modern

1053 fine grey silt at northern end from 87 to 151 cm below the surface

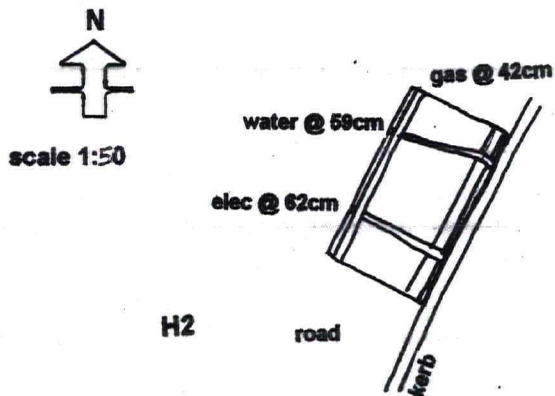
H2

Trial hole, southern end of Church Lane

Depth max. 115 cm

Context Nos

1001 tarmac

1007 mixed brown stony sandy loam with much brick, tile, some modern
pottery

1013 orange sand within 1007, modern

1059 limestone hardcore within 1007, modern

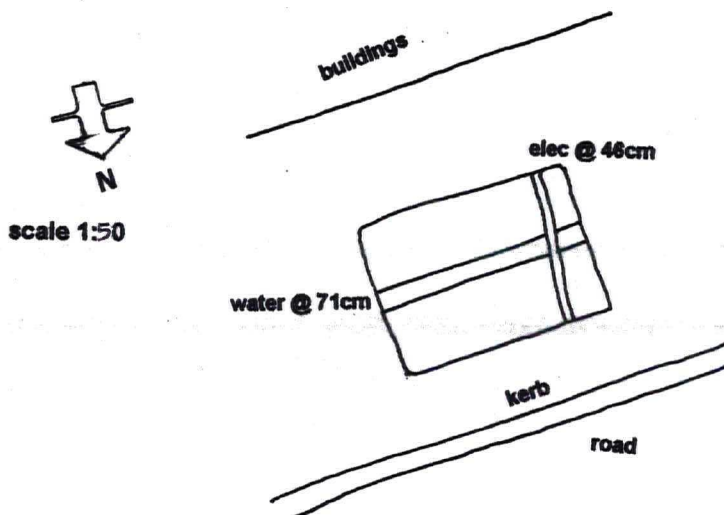
H3

Trial hole, Church Hill, in footpath

Depth max. 98 cm

Context Nos

1001 tarmac

1007 mixed brown stony sandy loam

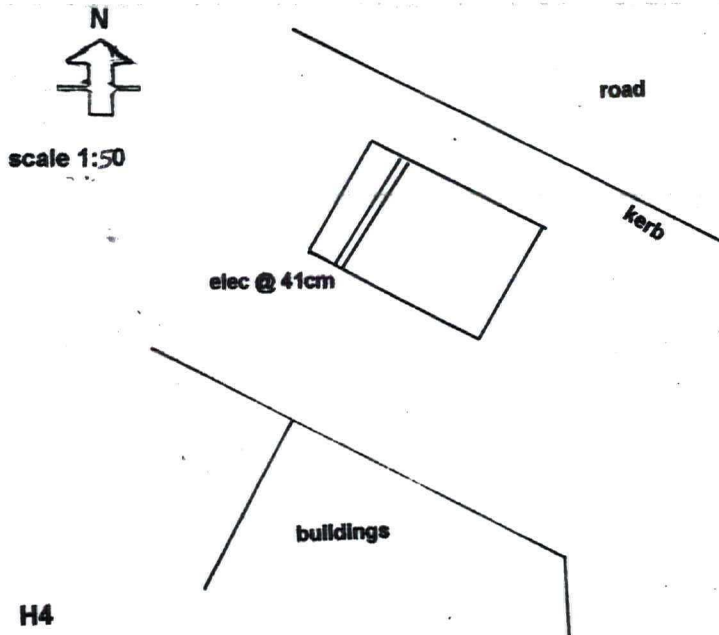
H4

Trial hole, Ousegate outside No 52, in footpath, dug at night

Depth max. 98 cm

Context Nos

1001 tarmac

1007 mixed dark brown stony loam with brick, tile and modern pottery

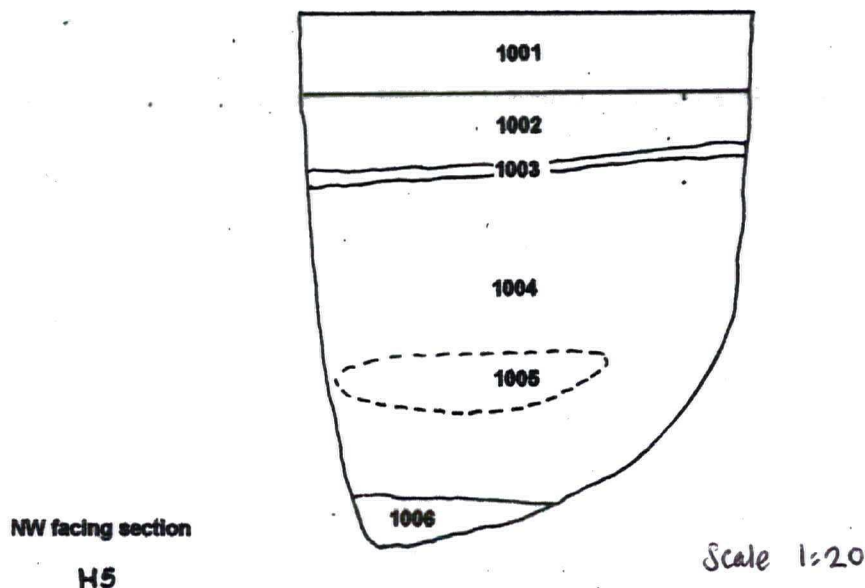
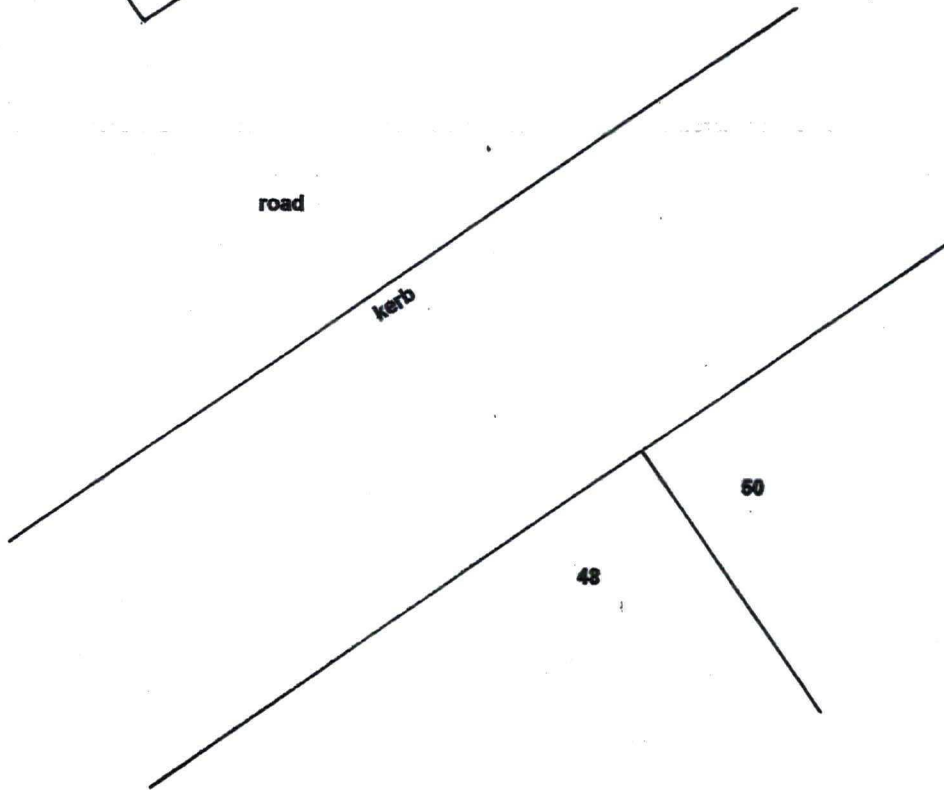
H5

Trial hole, Micklegate outside No 50, dug at night

Depth max. 145 cm

Context Nos

1001 tarmac

1002 brick layer 14 cm thick

1003 black cindery loam 10 cm thick

1004 dark grey to black organic silt containing bone and post-med. pottery, 82 cm thick

1005 lens of dark brown plant material, largely straw manure, containing leather and medieval pot, within 1004

1006 fine silty grey/beige sand below 1004 to base of hole

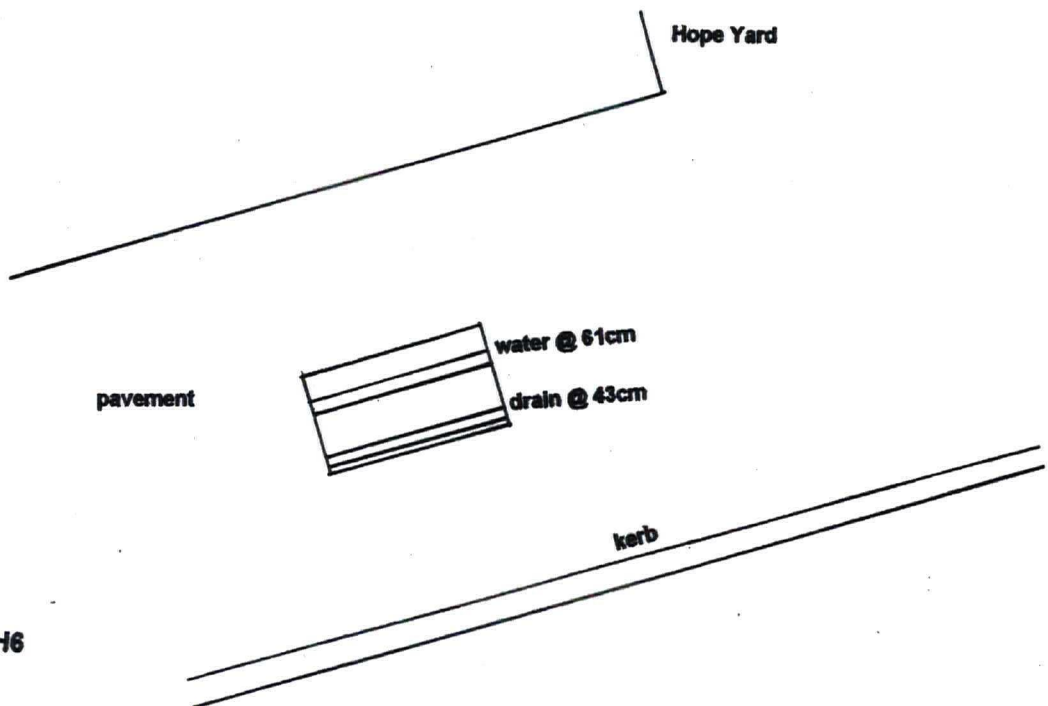
H6
Trial hole, Micklegate outside No 49, dug at night
Depth max. 82 cm
Context Nos
1001 tarmac
1026 mixed brown stony loam with brick, tile, some bone, medieval green
glaze fragment (part of incised strap handle)

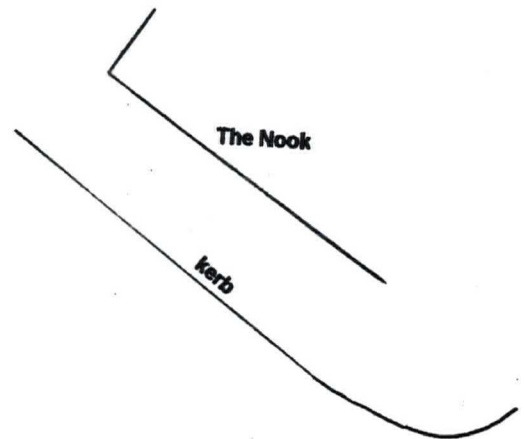
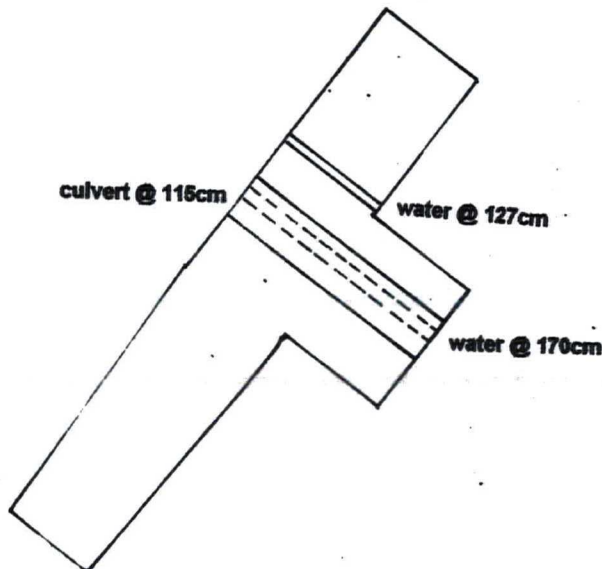
H7

Access trench, junction of Water Lane, Church Hill and Ousegate, dug at night and extended several times

Depth between 150 and 180 cm

Context Nos

1001 tarmac 60 cm thick

1002 brick layer beneath 1001

1008 brick lined culvert, 115 to 155 cm deep, running along Ousegate/Water Lane

1009 yellowish brown sand with brick fragments, bone and 19th C. pottery, above 1008

1027 dirty yellow-brown clay beneath 1002, above 1009

1059 limestone hardcore beneath 1002, intermittent

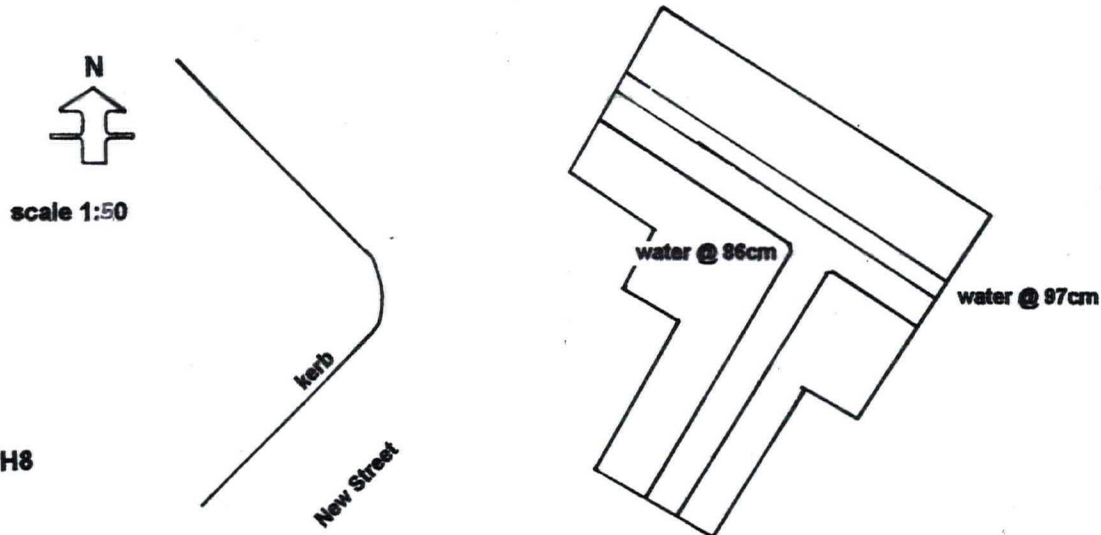
H8

Access trench, junction of Ousegate and New Street, dug at night

Depth max. 132 cm

Context Nos

1001 tarmac

1007 disturbed brown stony sandy loam with cow horns, beneath 1001,
above 1009

1009 dirty yellow sand beneath 1010 to base of trench

1010 greyish yellow clay beneath 1007, above 1009

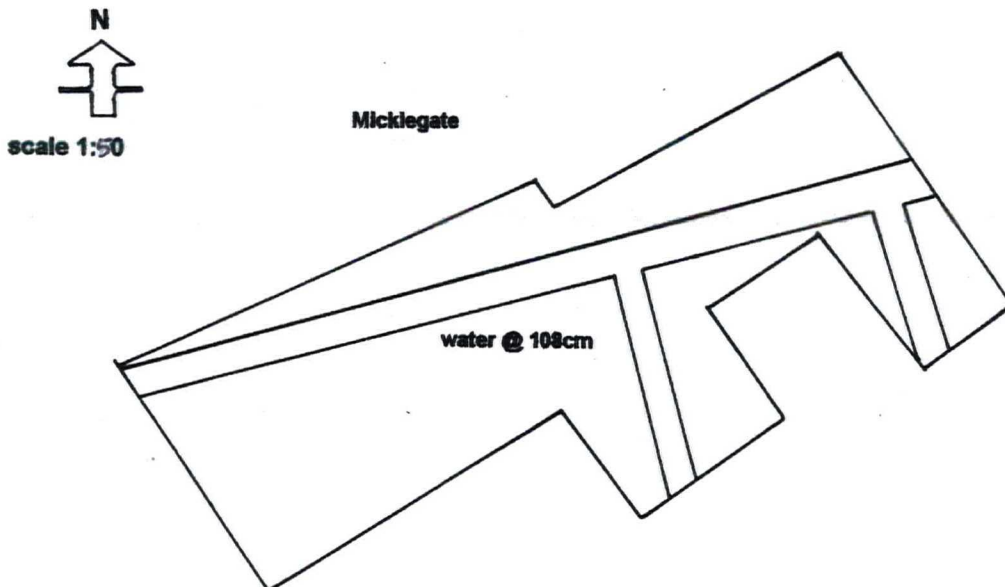
H9

Access trench, north-eastern end Micklegate, dug at night

Depth max. 145 cm

Context Nos

1001 tarmac

1002 brick layer beneath 1001

1011 mixed grey silts and sands beneath 1002, from 57 to 110 cm below
the surface

1012 compacted grey silts beneath 1011, from 110 cm to base of trench

1028 disturbed stony brown sand with brick rubble, fill of original
water main trench to 120 cm

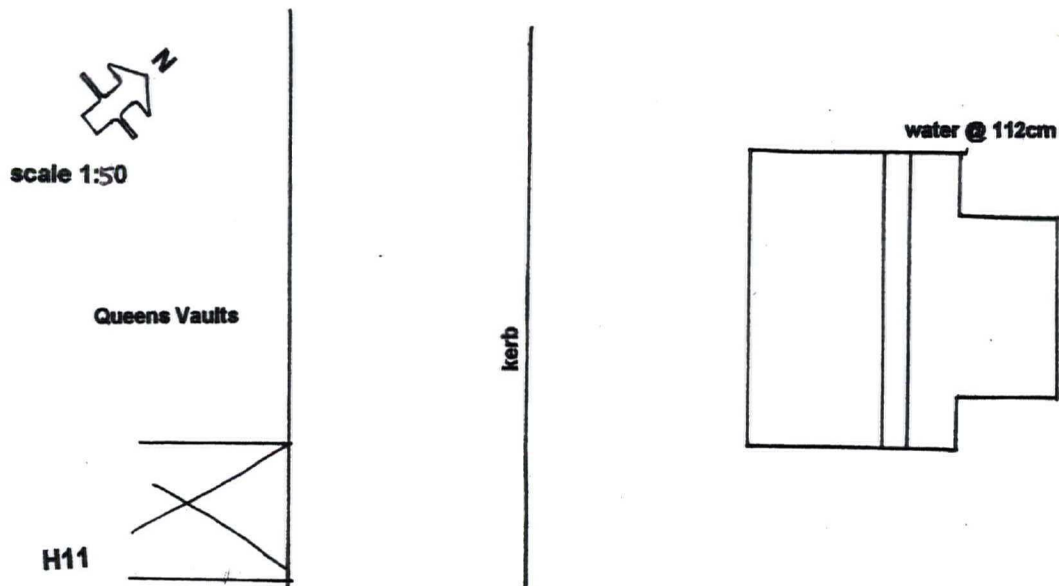
H11

Trial hole, Ousegate outside Queens Vaults pub, dug at night

Depth max. 148 cm

Context Nos

1001 tarmac

1002 brick layer beneath 1001

1025 wet dark grey silt with tile, bone, pottery and modern debris, fill of original water main trench

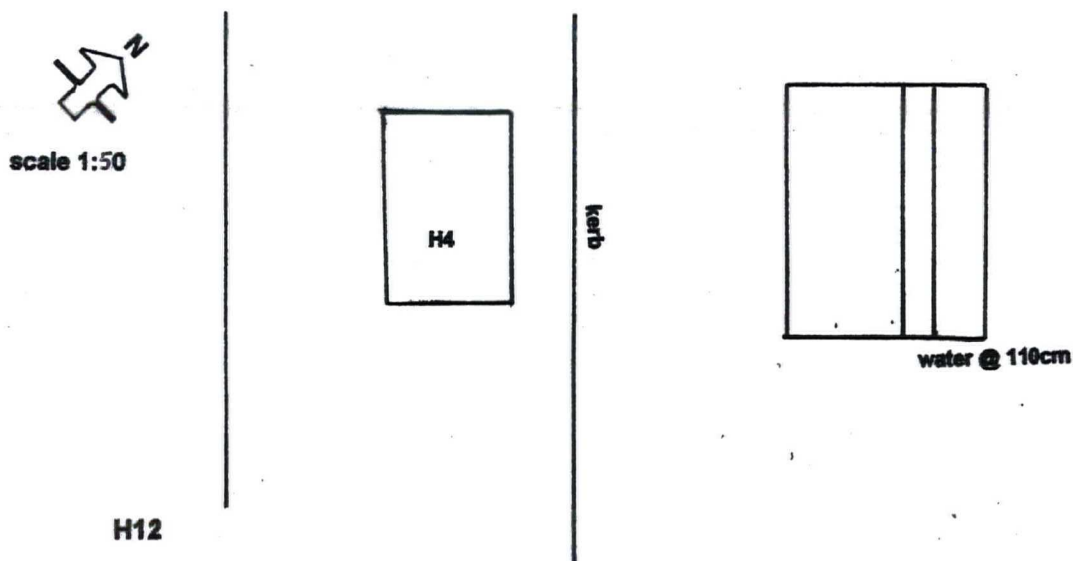
H12

Trial hole, Ousegate outside No 52 in roadway, dug at night

Depth max. 130 cm

Context Nos

1001 tarmac

1007 mixed brown stony sandy loam with some brick and tile

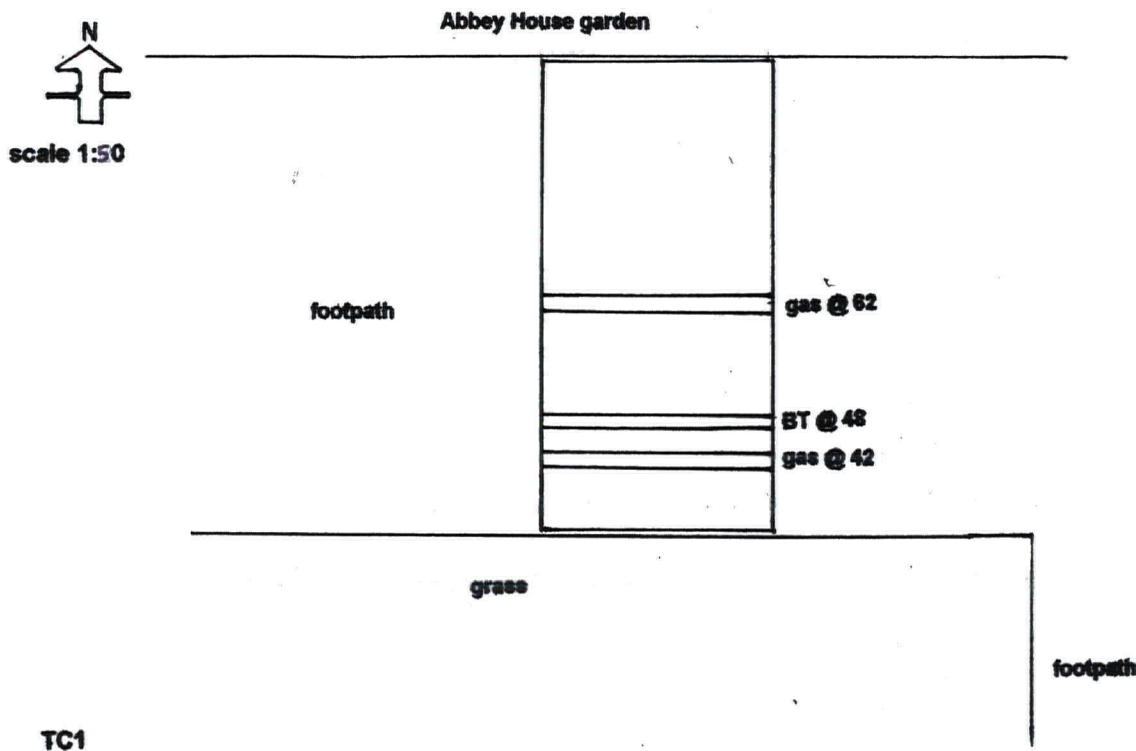
TC1

Trial Hole, outside Abbey House, Church Avenue. Hand dug. Depth 100cm
Context Nos
1061 flagstone
1062 disturbed brown stony loam, contains mod pot
1063 silty yellow sand beneath 1062, to base at 100 cm, contains services, modern pot.

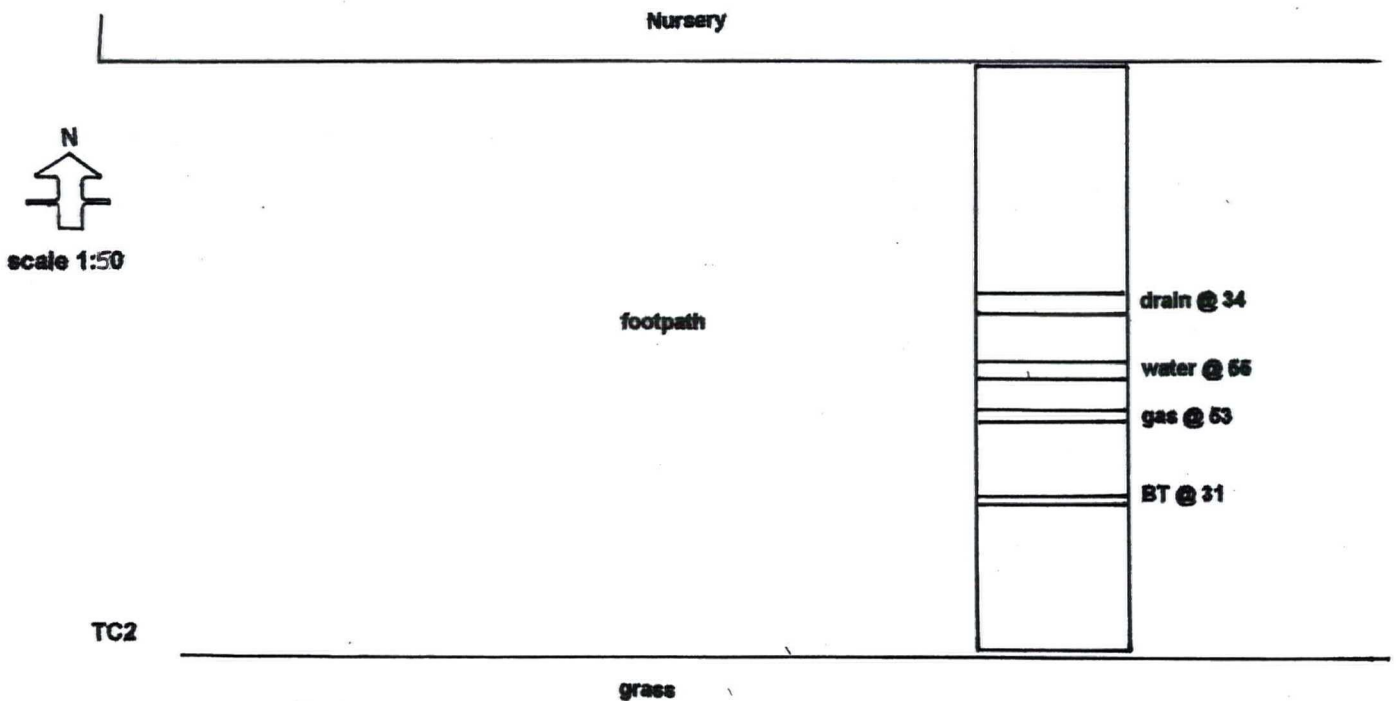
TC2

Trial hole, outside No 1, Church Ave (Nursery). Hand dug. Depth max. 101cm.

Context Nos

1064 tarmac

1062 dark brown disturbed stony loam, beneath tarmac to 34 cm below the surface, contains mod pot

1065 mortary sandy mid-brown loam beneath 1062 to base at 101 cm, contains various services

1066 pale yellow gravel, fill around drain at 34 cm below the surface

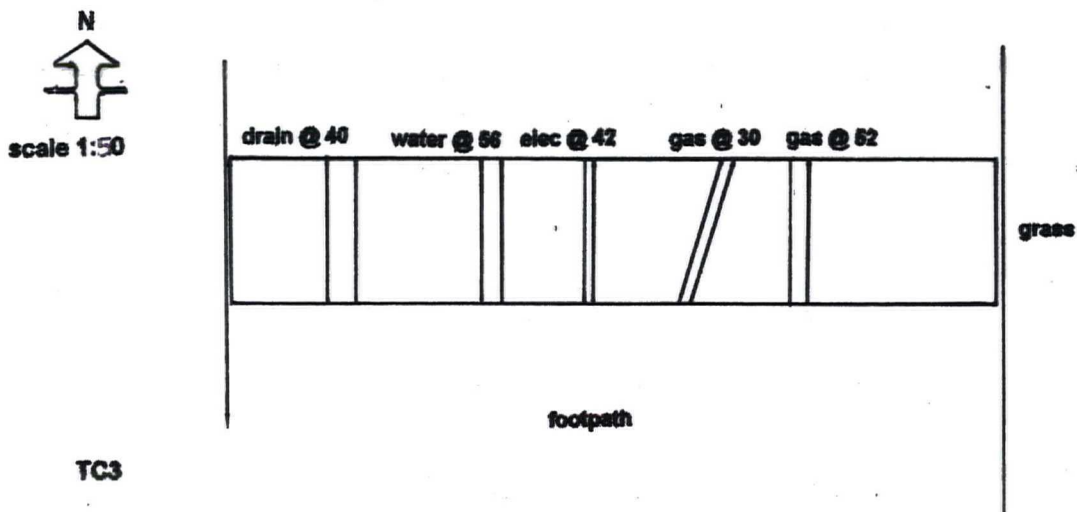
TC3

Trial hole, outside No 6, Abbey Place. Hand dug. Depth 104 cm.

Context Nos

1064 tarmac

1065 mortary stony mid-brown loam, beneath tarmac to 56 cm below the surface, containing various services and brick and mortar fragments

1067 pale yellow sand around services, from 56 to 79 cm below the surface.

1068 dark brown to grey silt with frequent small angular stones, from 79 cm to base at 104 cm, containing charcoal fragments

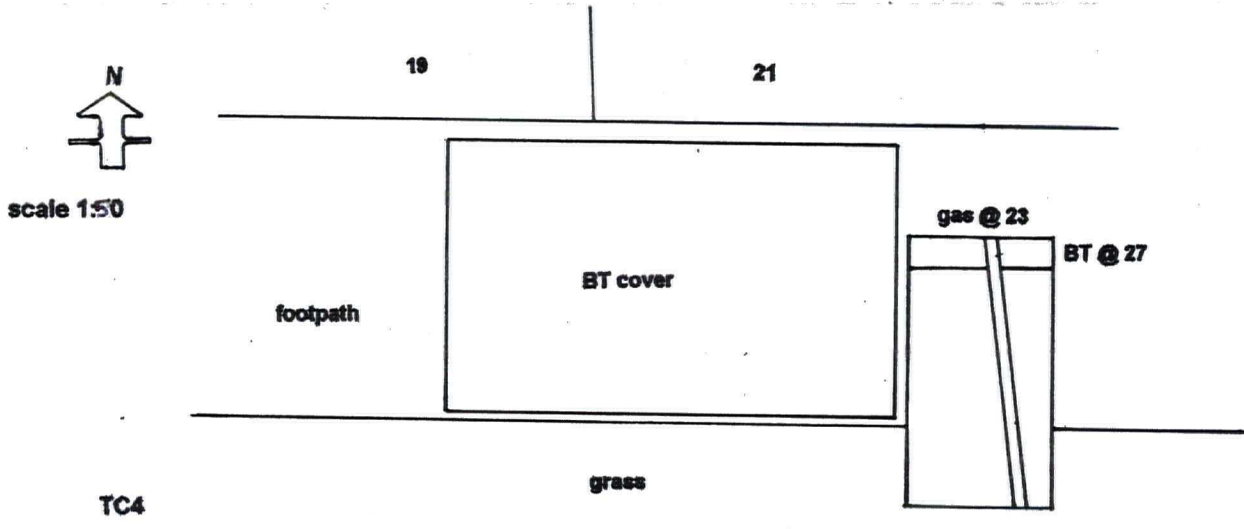
TC4

Trial hole, outside No 21 Church Avenue. Hand dug. Depth 60 cm.

Context Nos

1064 tarmac

1062 mixed dark brown loam with small stones, below tarmac to base at 60 cm., containing various services,

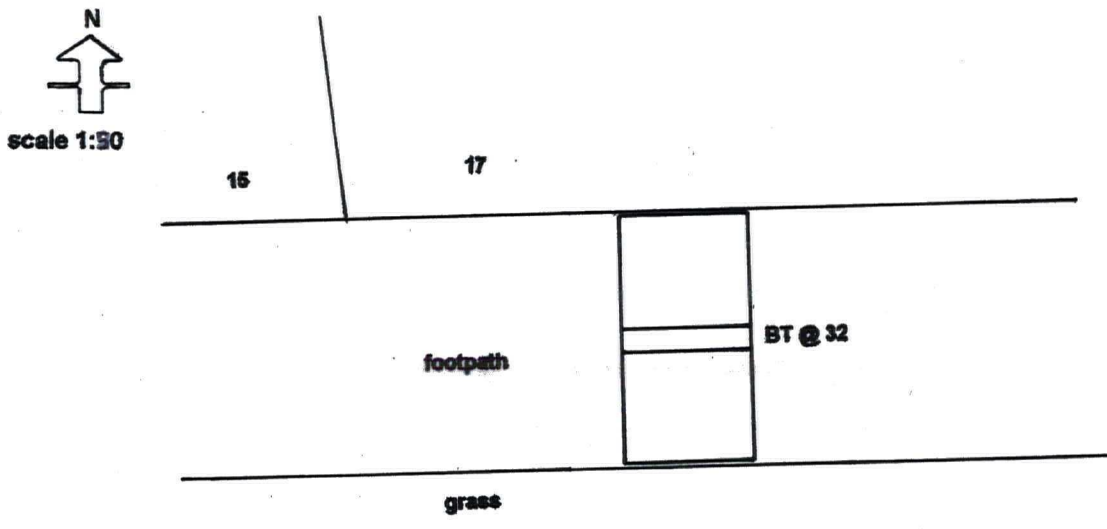
TC5

Trial hole, outside No 17 Church Avenue. Hand dug. Depth 63 cm.

Context Nos

1064 tarmac

1062 dark brown loam with small stones, beneath tarmac to 27 cm below the surface

1065 light brown sandy loam beneath 1062 to base at 63 cm, containing service and disturbed limestone block at 55 cm below the surface.

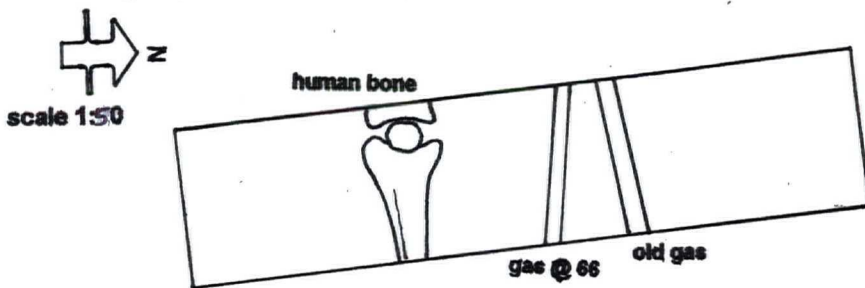
TC6

Trial hole, outside No 5, Abbey Place. Hand dug. Depth 93 cm.

Context Nos

1069 stone flags

1070 cement beneath 1069

1071 dark brown disturbed loam with stones beneath 1070, above 1072, from 17 to 32 cm below the surface, post-medieval pottery, brick

1072 mid brown sandy loam with small stones beneath 1071, above 1074, from 32 to 60 cm below the surface

1073 old gas main at 45 cm below surface, running along Abbey Place

1074 mid brown clayey silt with small angular stones, beneath 1072, above 1075, from 60 to 95 cm below the surface; fill of grave cut*

1075 yellowish brown silty sand, below 1074, from 95 to base of trench at 100cm.

*Context 1074 contained a human skeleton of which the right patella, part of the right tibia and the end of the right femur were exposed. A broken left tibia was also found not in situ. These were left in situ and re-covered with sand.

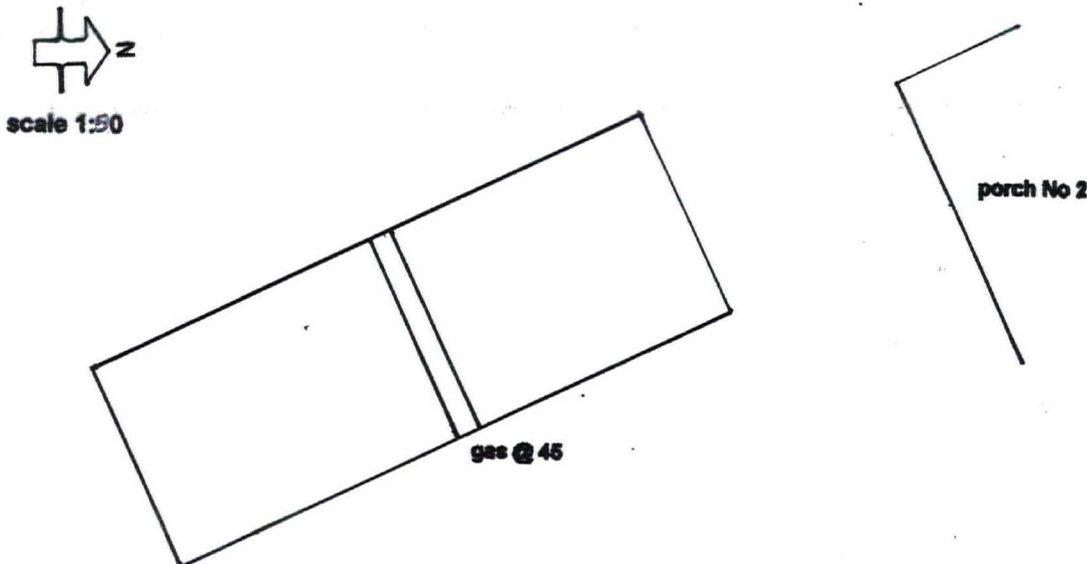
TC7

Trial hole, outside porch of Londesbrough Arms Hotel. Hand dug. Depth 80 cm.

Context Nos

1069 stone flags

1070 cement beneath 1069

1076 dark brown disturbed loam with brick and tile, beneath 1070, and above 1077 from 26 to 40 cm below the surface

1077 mid brown loam beneath 1076, above 1075, from 40 to 80 cm below the surface

1075 yellowish brown silty sand below 1077, at base of trench at 80 cm.
