**2A - 4 CASTLEGATE, THIRSK**

**WATCHING BRIEF**

**ALISON CLARKE M.A.**  
**1996**

## ARCHAEOLOGICAL WATCHING BRIEF AT 2A-4, CASTLEGATE, THIRSK

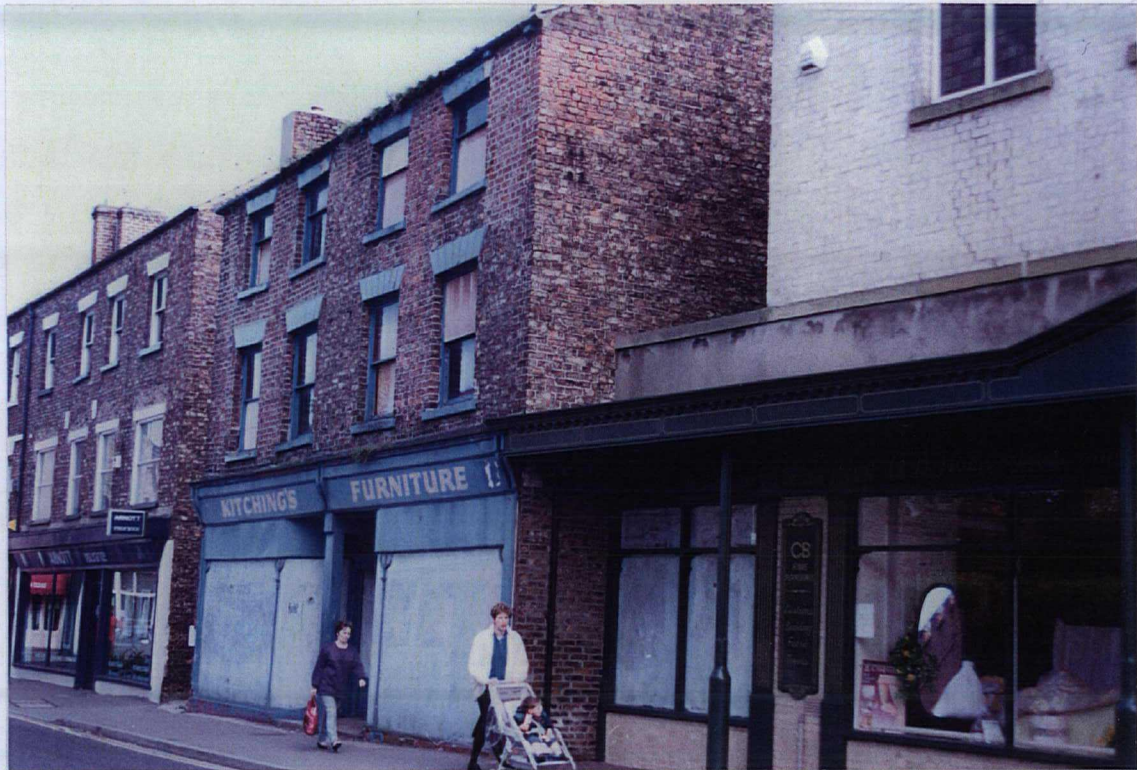
**PLATE 1**  
**FRONT OF 2A-4 CASTLEGATE BEFORE WORK STARTED**

The property at 2A-4 consisted of a single pile early nineteenth century brick building which had originally been divided into two properties. These were subsequently knocked into one and the building was used as a bakery and then a furniture shop in the recent past (Plate 1). Various extensions were built on to the rear of the property, which backs onto a cobbled yard.

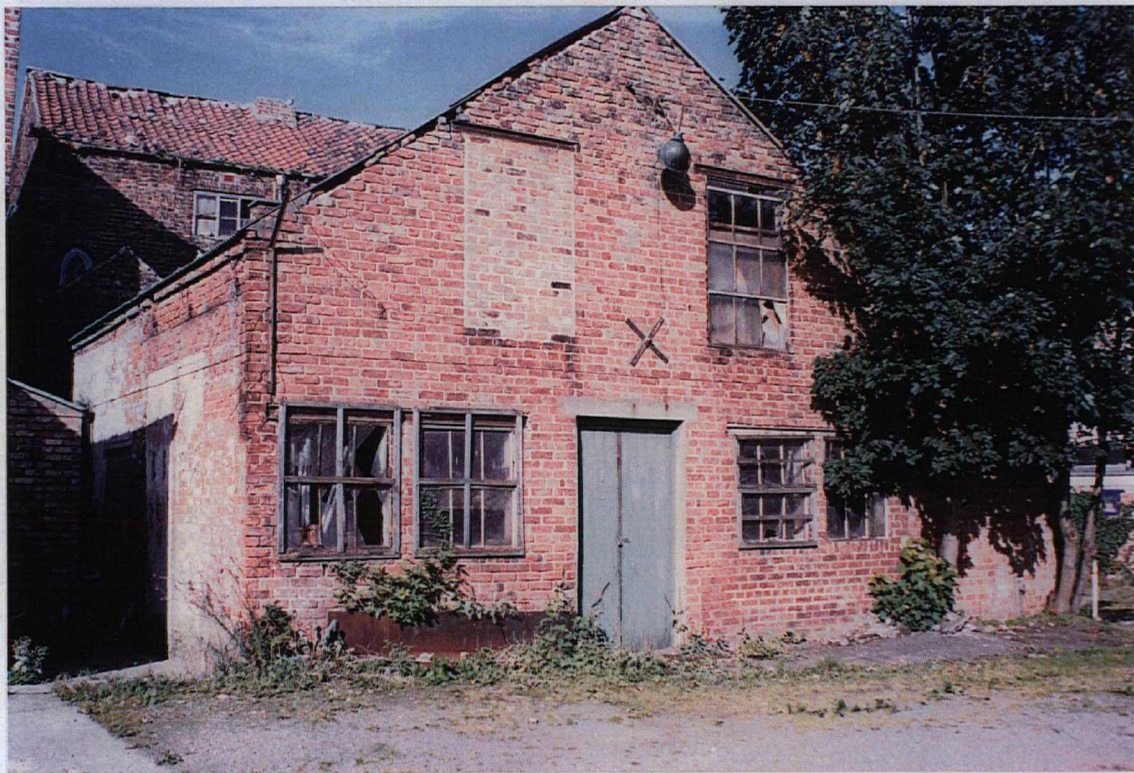
**PLATE 2**  
**REAR OF 2A-4 CASTLEGATE, SHOWING OUTBUILDINGS AND DECAY ON MAIN BUILDING**

The main building has suffered from subsidence, mainly at the rear, which was evident throughout the structure, and was in a state of decay when purchased by the present owners (Plates 1 and 2). At the time the 106 Agreement was made, the owners wished to demolish the building and build new premises on the site. In view of the potential archaeological interest of the site (its proximity to the known remains of the former medieval castle and to recent excavations which produced evidence of pre-Norman occupation of the area), it was required that an archaeologist supervise demolition work and evaluate the extent, character and significance of the archaeological remains. An evaluation report was required to assess the archaeology and to propose further work which might be required adequately to deal with the archaeology of the site.

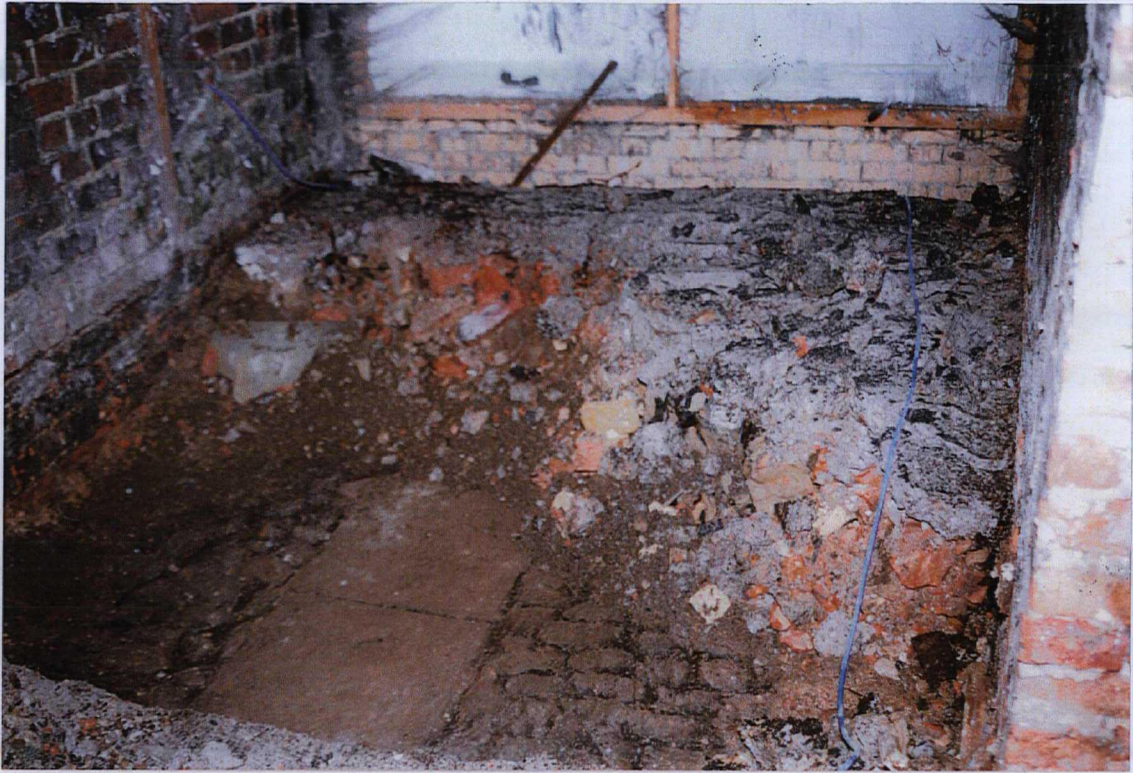
**PLATE 3**  
**PARTIALLY CLEARED COBBLED PASSAGEWAY BETWEEN 2A-4 AND 6**  
**CASTLEGATE**

On the southern side of the main building, where a former cobbled passageway extended between the site and No 6 Castlegate (Plate 3), the piling trench removed the cobbles which appear to butt up to the building, below which was a brown loamy fine sand mixed with much mortar.

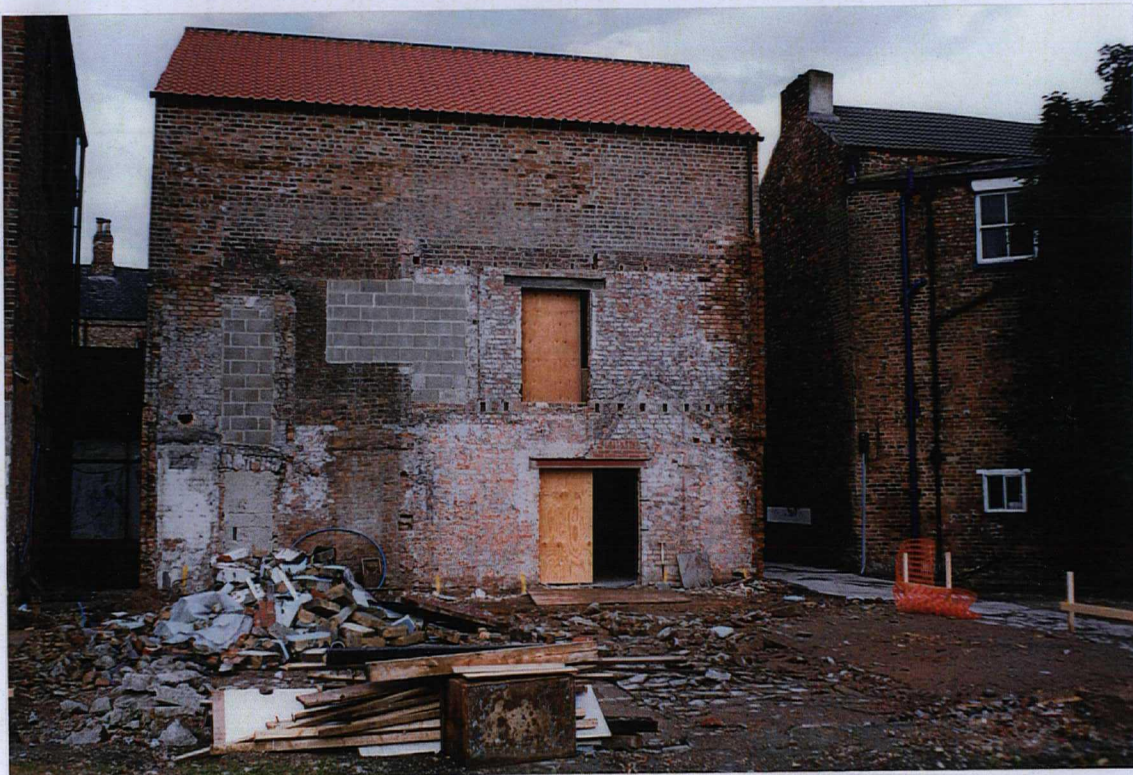
**PLATE 4**  
**REAR OF NO 2A-4 CASTLEGATE LOOKING WEST,**  
**SHOWING MAIN BUILDING AND DEMOLISHED OUTBUILDINGS**

5) After the piling was completed, all the extensions and outbuildings to the rear of the main building were demolished (Plate 4). The concrete ground surface was then cleared by machine and levelled up to 70 cm. down, to provide the base for a new building to be erected over the whole of the remainder of the site. This clearance and the subsequent excavation of foundations were watched by the archaeologist.

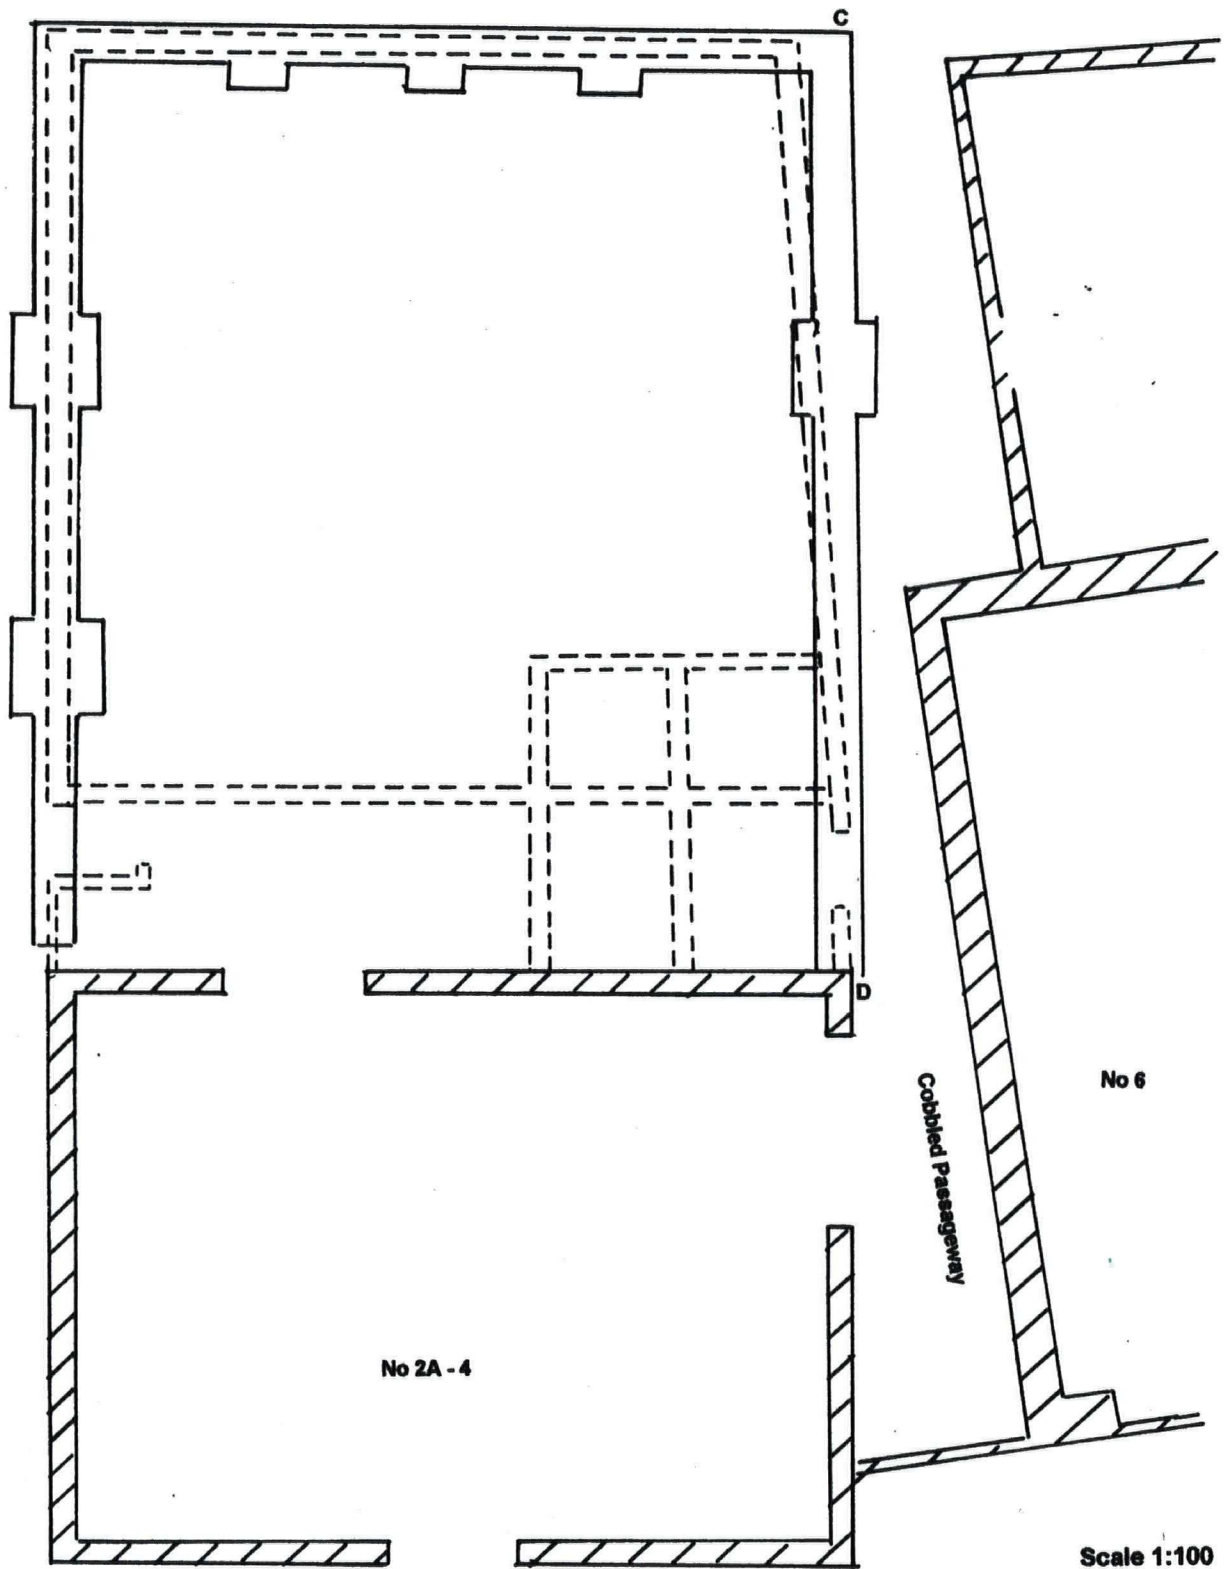
**CASTLEGATE PLAN 3 NEW EXTENSION**

7) Foundations for the new building were machine excavated around the edges of the site running back from the rear of the main building (Plan 3). Over the majority of the site these cut through an average of 40 cm. of mixed rubble and brown loamy sand into a sub-base of variable sands, fine gravel and clay up to 1.3 metres below the external ground surface.

At the western end of the site, however, nearest to the main building, the foundations trenches revealed deep deposits of very soft structureless brown silt. On the southern side of the site, these stretched for over five metres eastwards from the back of the building, and on the northern side for 1.7 metres. The underlying sands and clays sloped very steeply down beneath these deposits, and although the foundation trench on the southern side was deepened to 1.8 metres, the base of the sort silt was not reached (Plan 9). Although the deposits were clearly disturbed ground, archaeological material was scant,

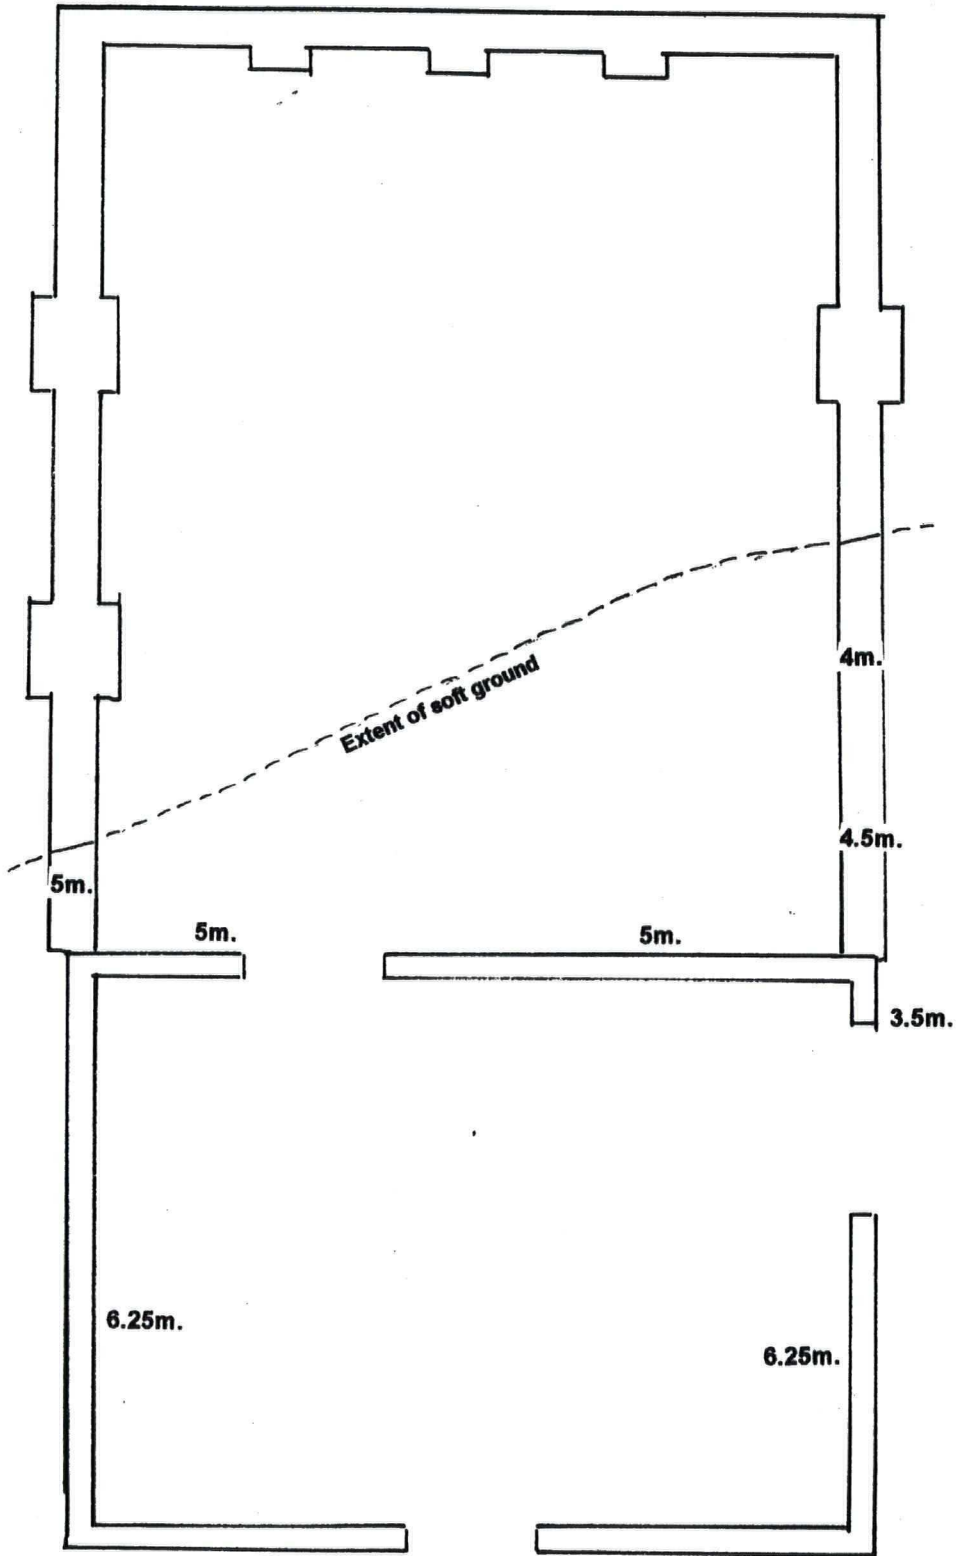
CASTLEGATE PLAN 4 PILING DEPTHS

4) Piles were sunk all around the eastern, northern and southern sides of the main building. Those towards the front (west side) reached a depth of 4.5 metres from the cellar floor before gaining solid ground. Those at the rear of the building reached a depth of 5 metres from the floor surface (i.e. 1.25 metres higher than those in the cellared area). This indicates that although the ground at the front of the building appeared to be less disturbed than that at the rear, it is nevertheless soft and unstable to a depth of over 6 metres from the ground surface (Plan 4).

8) As a result of encountering this soft ground, it was decided to pile the western end of the new building to provide firm foundations, so the total depth of the soft ground was not determined. The piles subsequently driven in this area reached a depth of 4 to 4.5 metres on the southern side and 5 metres on the northern side.

There was strong evidence that a large and deep depression had formerly occupied much of the site. The eastern edge of this depression was clearly visible in the foundations trenches for the new building behind the main building (Plan 4), but its remaining sides are less well defined. It appears to have continued to the north and south of the site, and verbal information from the builder indicated that some subsidence has occurred towards the rear of No 6 Castlegate next door to the south.

The evidence for its western edge is somewhat conflicting. The very soft structureless silts which form the fill of the depression to the east were not observed in the excavations for the foundations of the new central pillar, which would indicate that it does not extend that far to the west. However, the depth to which the piles around the building could be driven gives a different picture. The piles are driven down until they reach hard or solid ground. At the eastern end of the site, this would have occurred within 1.3 metres from the surface, where hard clean sands were encountered in the foundation trenches. In the areas where the soft silts were known to occur, the piles reached a depth of between 4 and 5 metres below the surface. At the eastern end of the building, beyond the apparent extent of the soft silts, the piles reached a depth of 6.25 metres from the surface, indicating that hard ground was deeper here than towards the rear of the building (Plan 4).

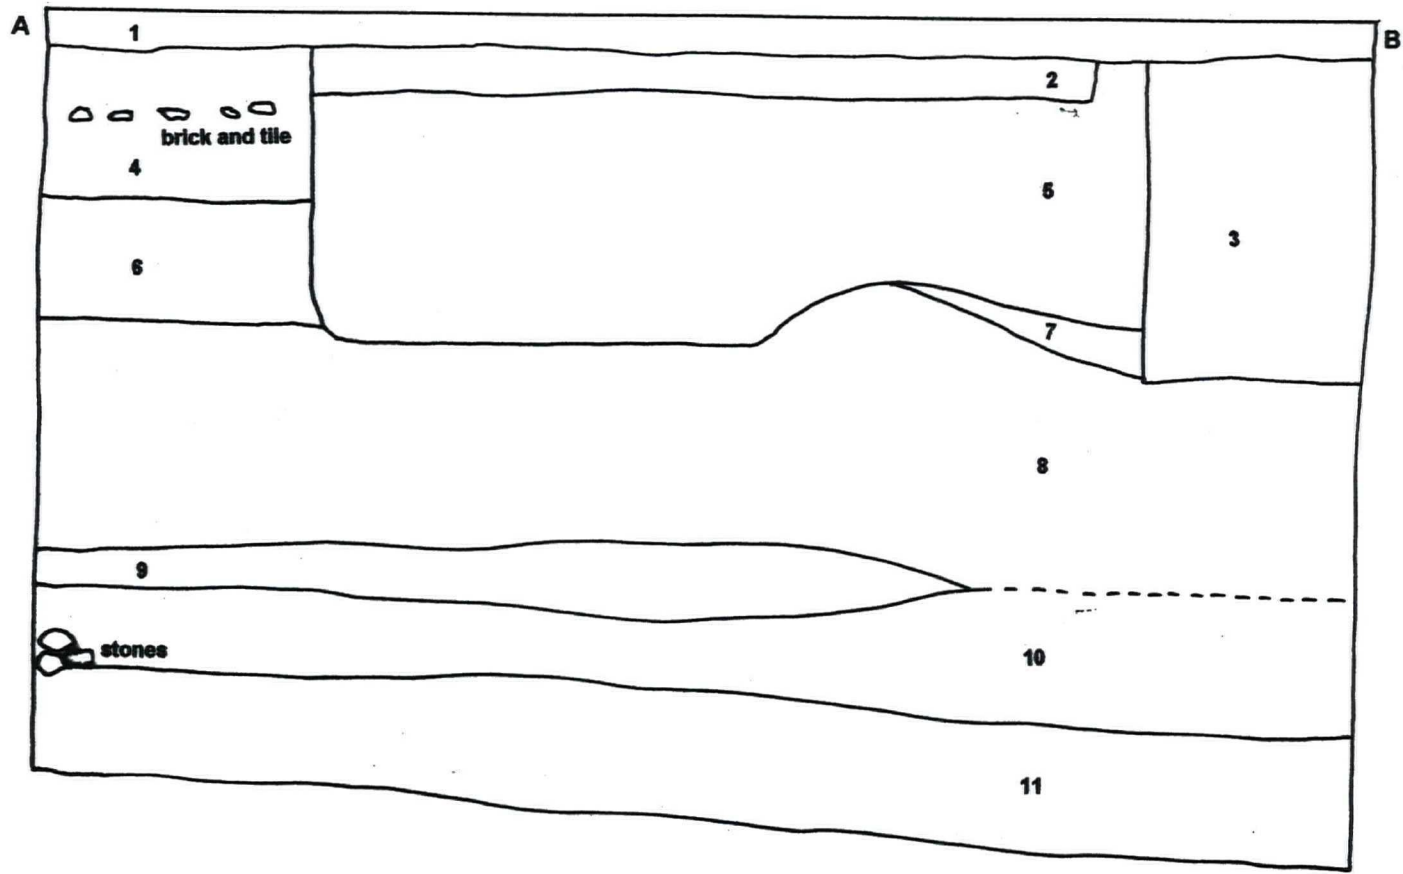
CASTLEGATE PLAN 5 EAST-FACING SECTION A - B, MAIN BUILDING (SKETCH SECTION)

The section revealed (Plan 5) showed disturbed deposits of sands and silts containing brick, tile and mortar rubble, with the remains of a coal chute to the north and associated coal dust. These deposits extended to around 90 cm. below the level of the footpath. Beneath them were layers of grey and brown silty clays and sand, stretching to 1.8 metres below the footpath and containing some cobbles and animal bone fragments towards the base. The base of the section, which was below the level of the cellar floor, consisted of undisturbed yellowy-orange silty clay which sloped down to the north and east.

- 1 Concrete
- 2 Bricks
- 3 Coal Chute
- 4 Sand with building rubble
- 5 Mortary brick-filled silt with rubble
- 6 Loamy sand with occasional tile and brick fragments
- 7 Black silt - coal dust
- 8 Grey-brown silty clay
- 9 Orange-brown gritty fine sand
- 10 Grey silty clay
- 11 Yellow-orange silty clay

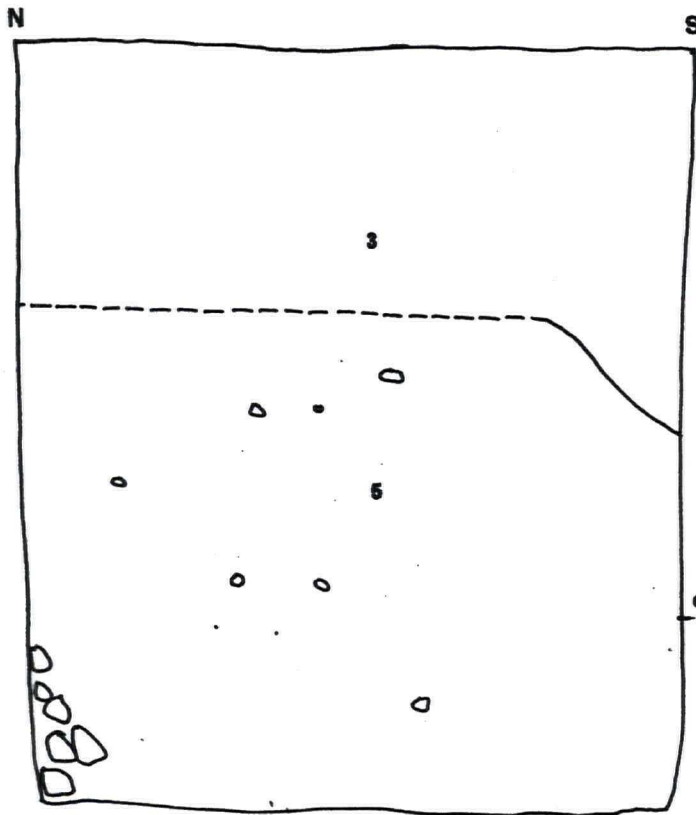
**CASTLEGATE PLAN 6**  
**WEST-FACING SECTION, CENTRAL PILLAR**  
**(SKETCH SECTION)**

3) In the centre of the building, the central pillar was removed after the cellars had been filled with hardcore. This involved the excavation of a hole immediately to the east of the cellars, around the pillar, to take the foundation of a new supporting pillar (Plans 6, 7 and 8). The fill of the majority of this hole was a fine soft sandy brown silt with occasional stones, very soft for the first 70 cm. Below 70 cm. from the floor level, the fill on the south side of the hole was a firmer clayey silt with stones, containing cobbles and occasional fragments of animal bone. Towards the base of the hole, from 40 cm. above the cellar floor level, the clayey silt extended across the hole, gradually becoming paler and less disturbed on the north side. The base of the hole was 45 cm. below the cellar floor level, at which point the soil was sandy

- 1 Brick wall
- 2 Brick rubble in sandy loam - trench for wall
- 3 Fine dark brown sandy silt
- 4 Cobbles and stones in brown sandy loam
- 5 Mid-brown clayey silt with stones
