Land off Welham Road, Norton, North Yorkshire

archaeological desk-based assessment

Report 1956
May 2008

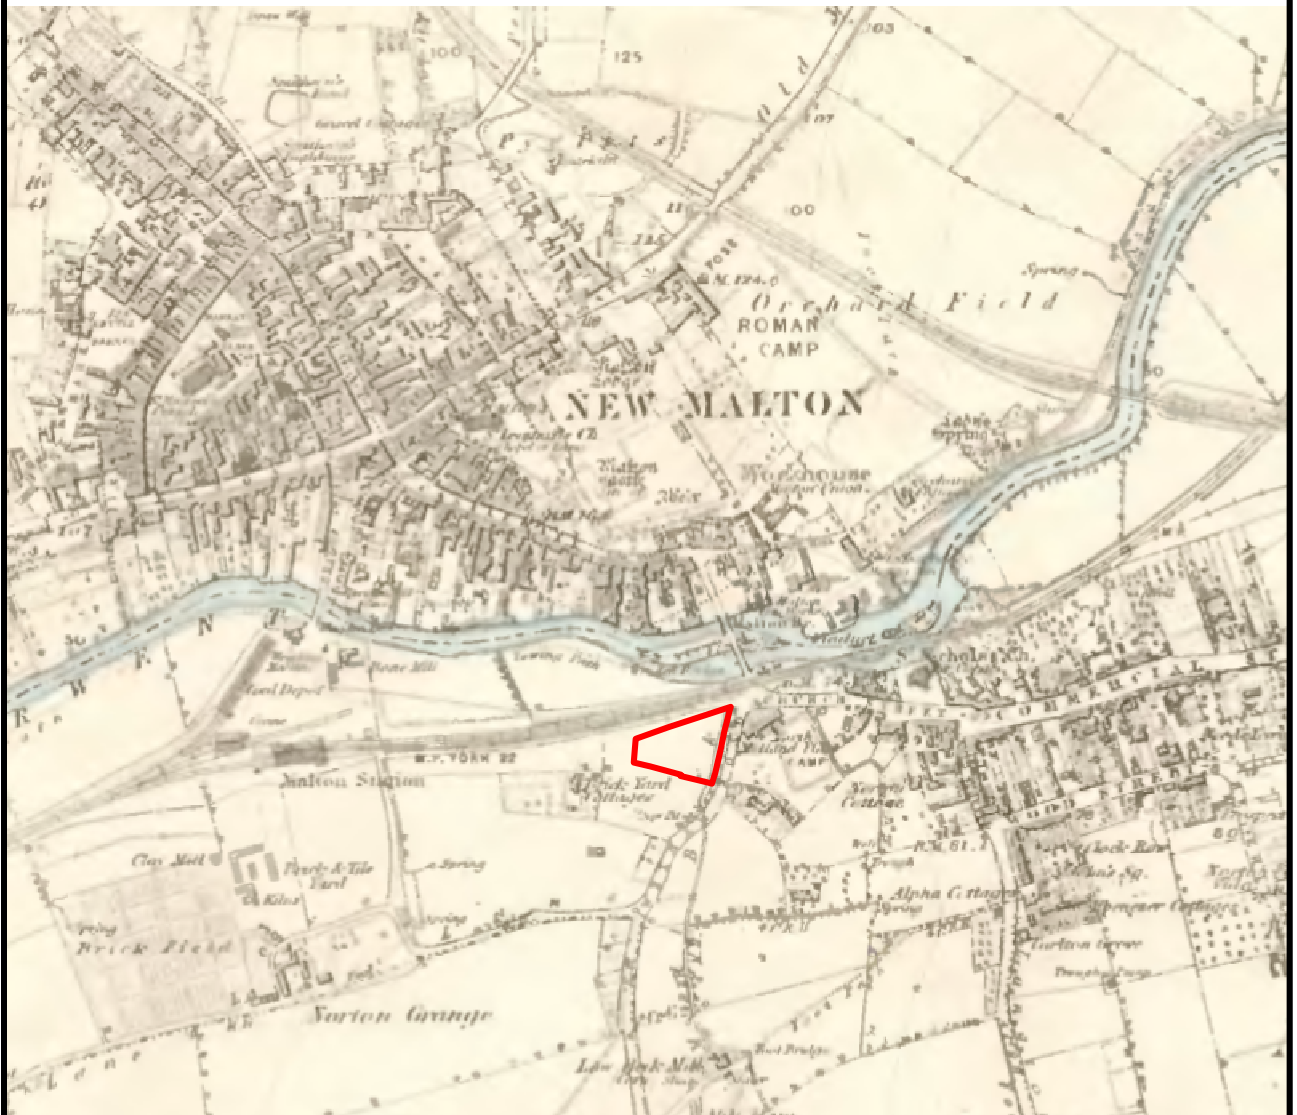
Figure 3 *Extract from the 1st edition, 6 inch to a mile, Ordnance Survey map of 1855*

- 4.29 The 1st edition Ordnance Survey (OS) map of 1855 (Figure 3) shows that the PDA is mostly unoccupied. However there is an unidentified structure on the eastern boundary of the site. The remaining area is likely to have been agricultural land. The surrounding area is very different to how it appears today; Norton is primarily focused to the south of Commercial Street with sparse development along Church Street. Little has been built on the land east of this, which are mostly fields.

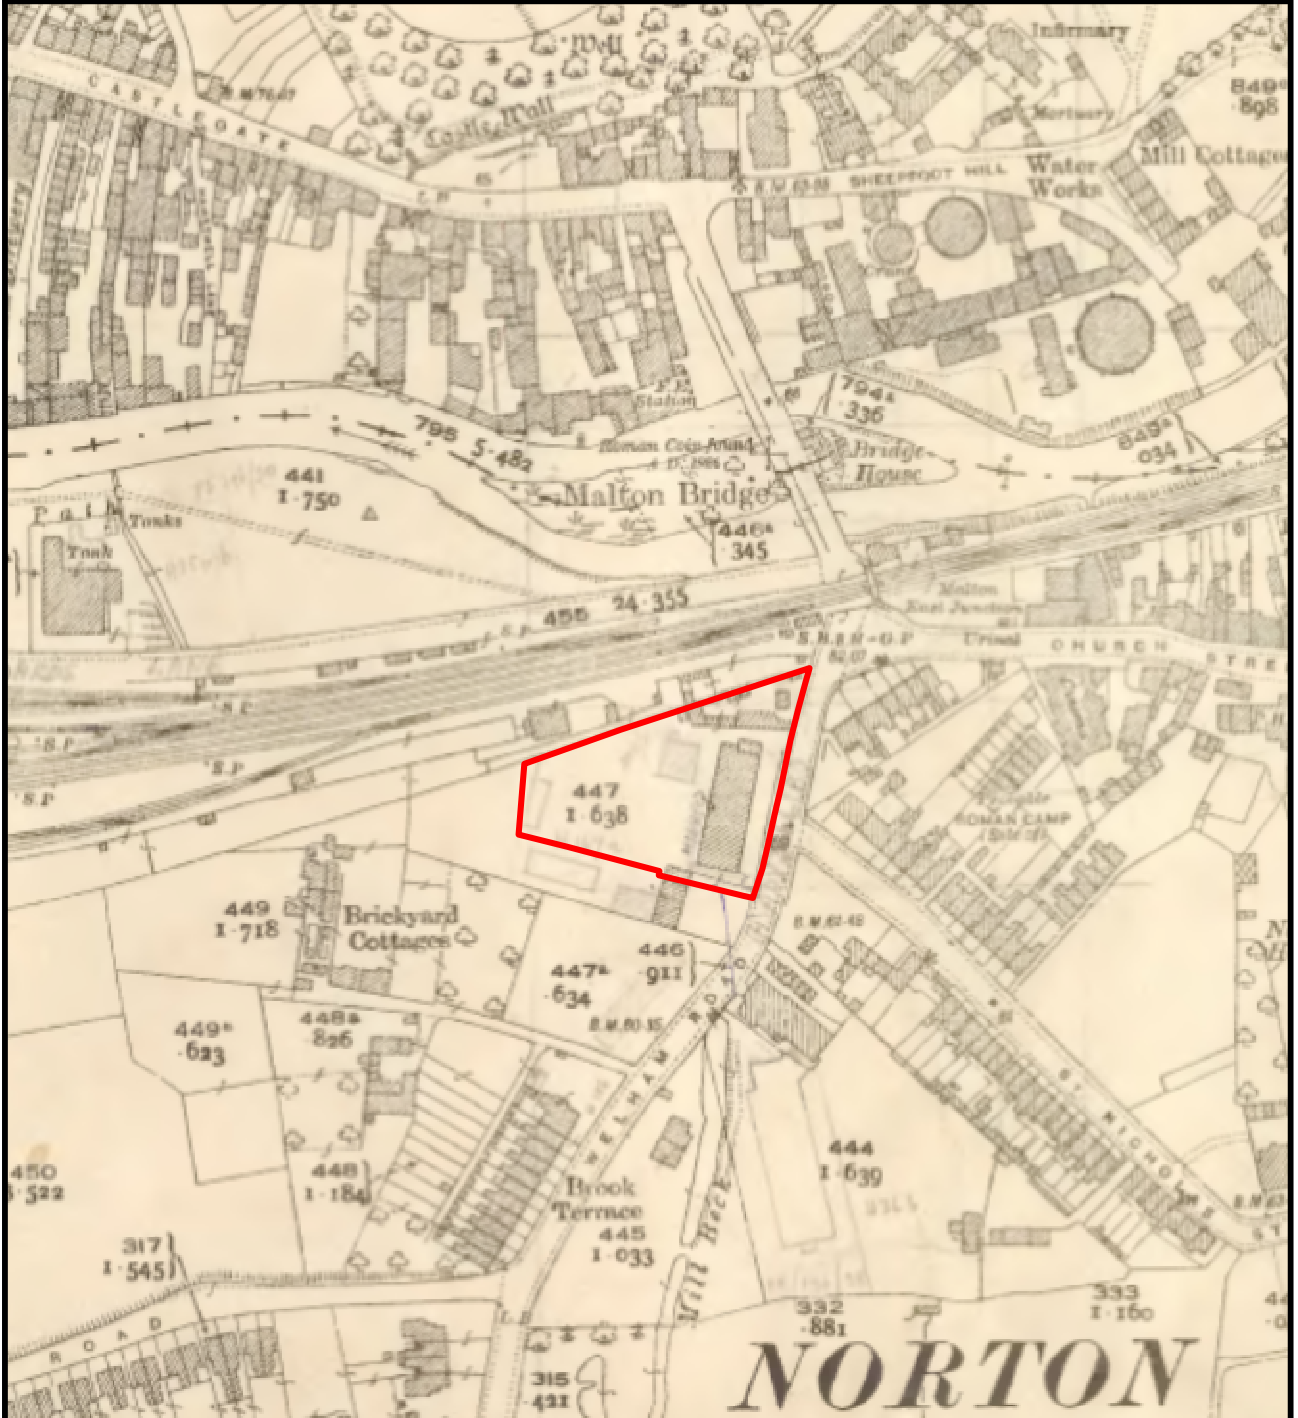
Figure 6 *Extract from the 4th edition, 25 inch to a mile, Ordnance Survey map of 1927*

- 4.31 There are no visible changes within the PDA from the 2nd edition to the 3rd edition OS map of 1910 (Figure 5).
- 4.32 The 4th edition OS map of 1927 (Figure 6) shows that much development has occurred on the site, including the solidifying of the north eastern enclosure with new buildings, and the construction of two rectangular buildings parallel to Welham Road at the eastern and southern boundaries. The surrounding area has been developed increasingly since the previous OS edition, with many more residential buildings to the east of the bridge in Norton.
