4 Cathedral Close RIPON

4 Cathedral Close Ripon

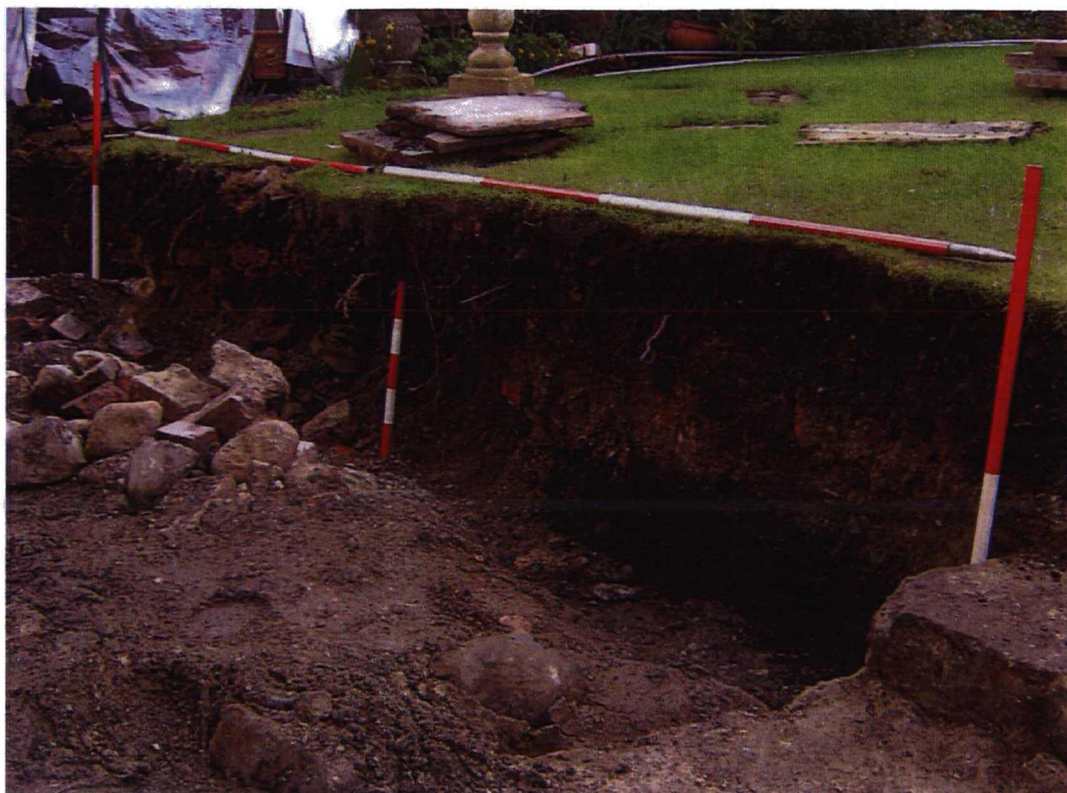
Fig. 4. The east facing section looking north, showing the edge of the masonry block, the fills of room 1 and the demolition layers beyond.

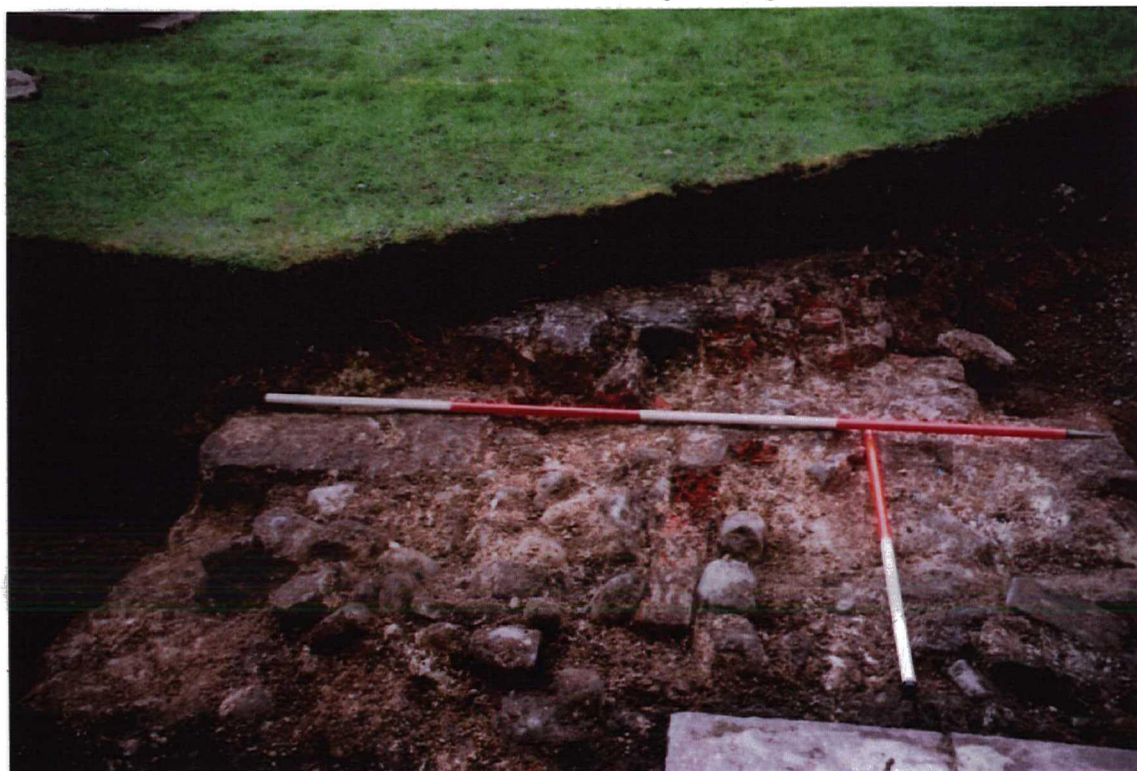
Fig 5. The masonry block during excavation

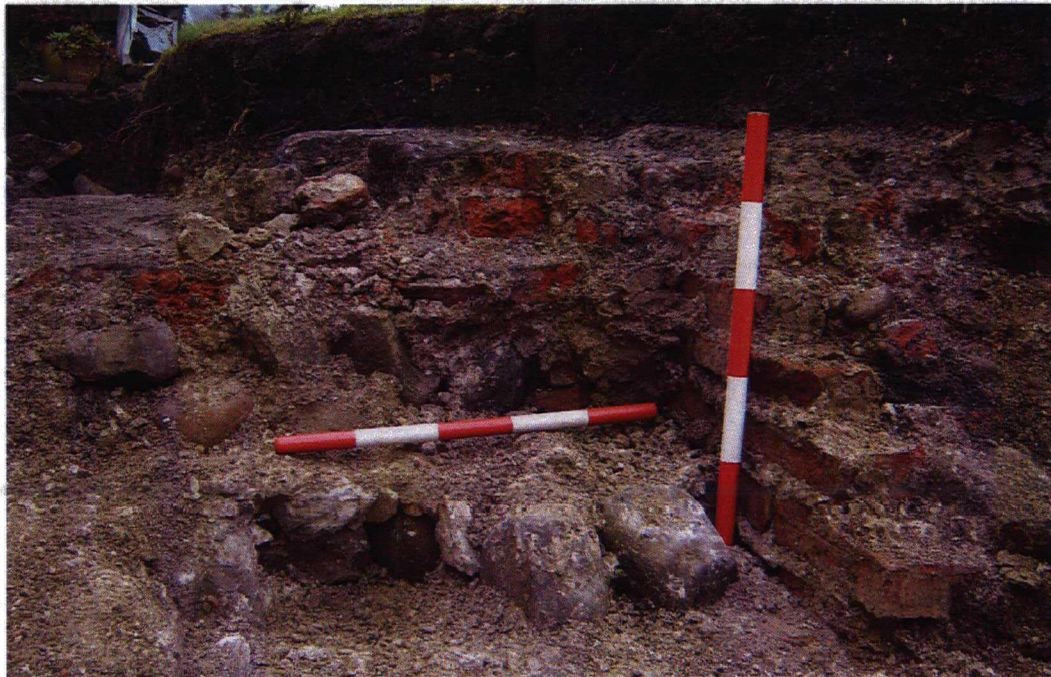
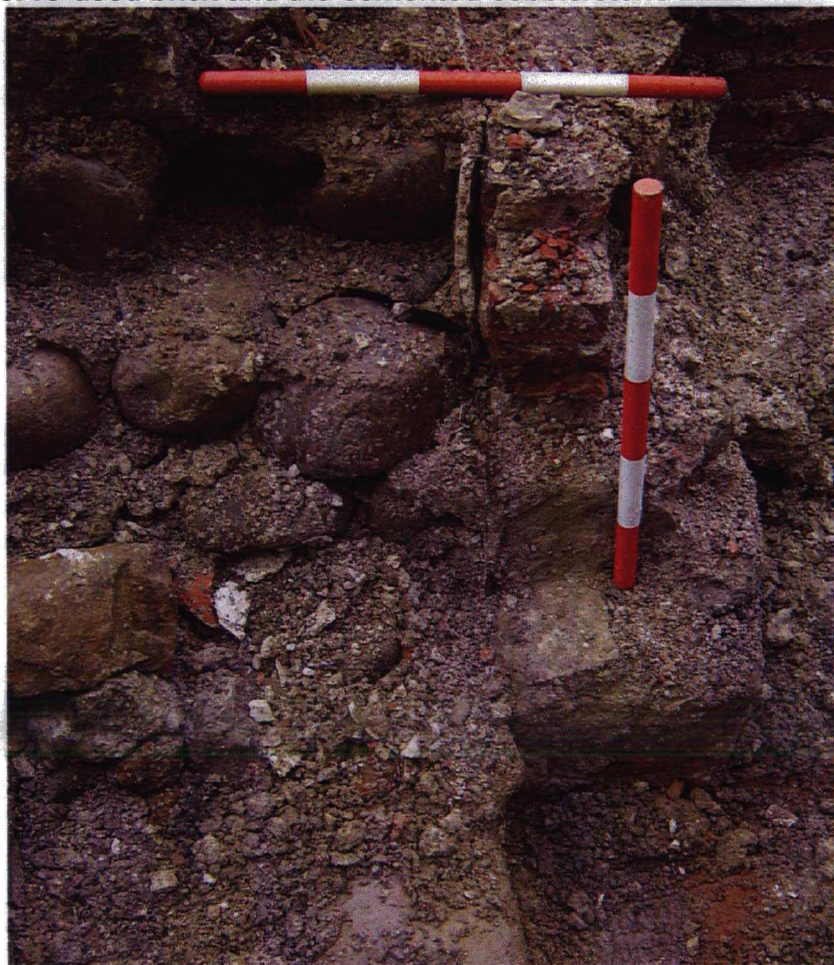
Figs 6 and 7. The masonry block under excavation, showing the crude walls of re-used brick and the cemented cobble/stone infill.

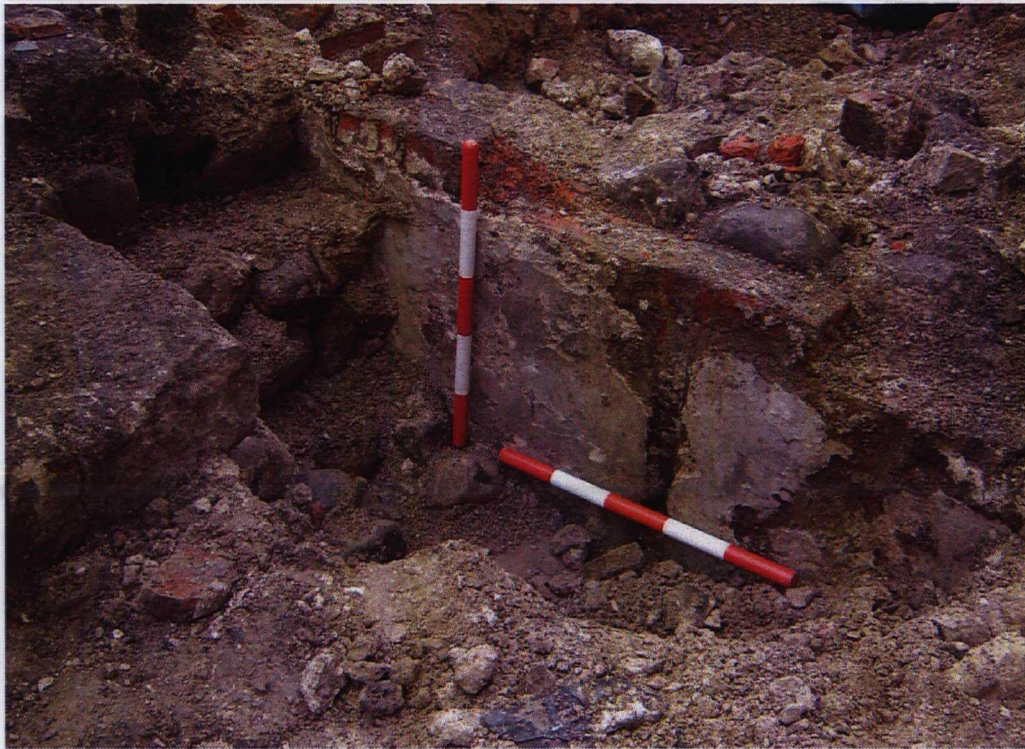
Fig 8. The south, interior side of Wall 1, showing the plaster with channeling, possibly for electric wiring.

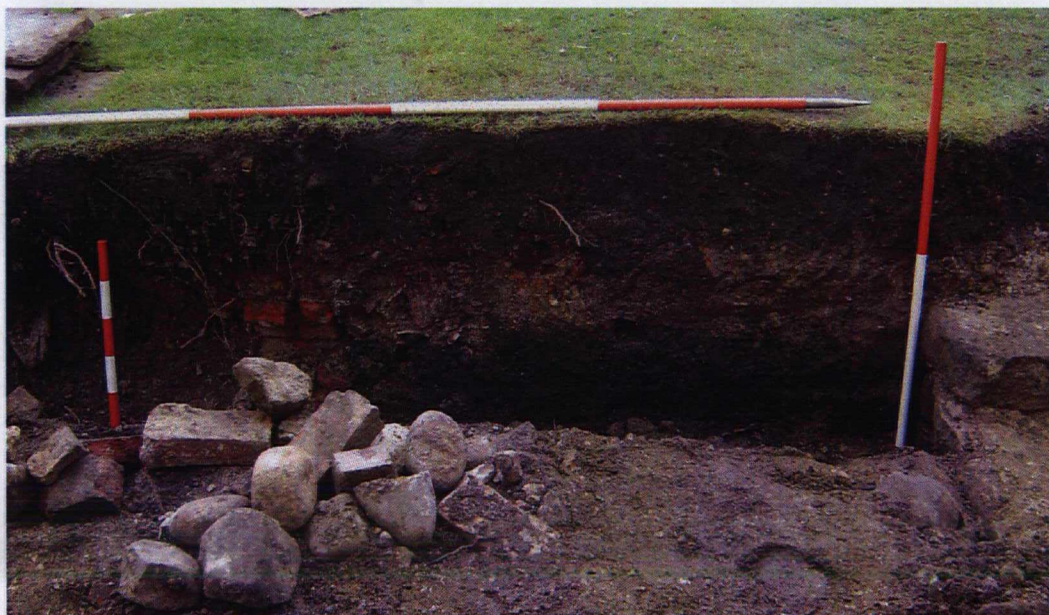
Fig 9. East-facing section showing the fill in Room 1, and the thin layer of plaster on the south side of Wall 2.
