**Land to the South of Musley Bank  
Malton  
North Yorkshire**

**Archaeological Evaluation by Trial Trenching  
SE 76360 70607**

**September 2008**

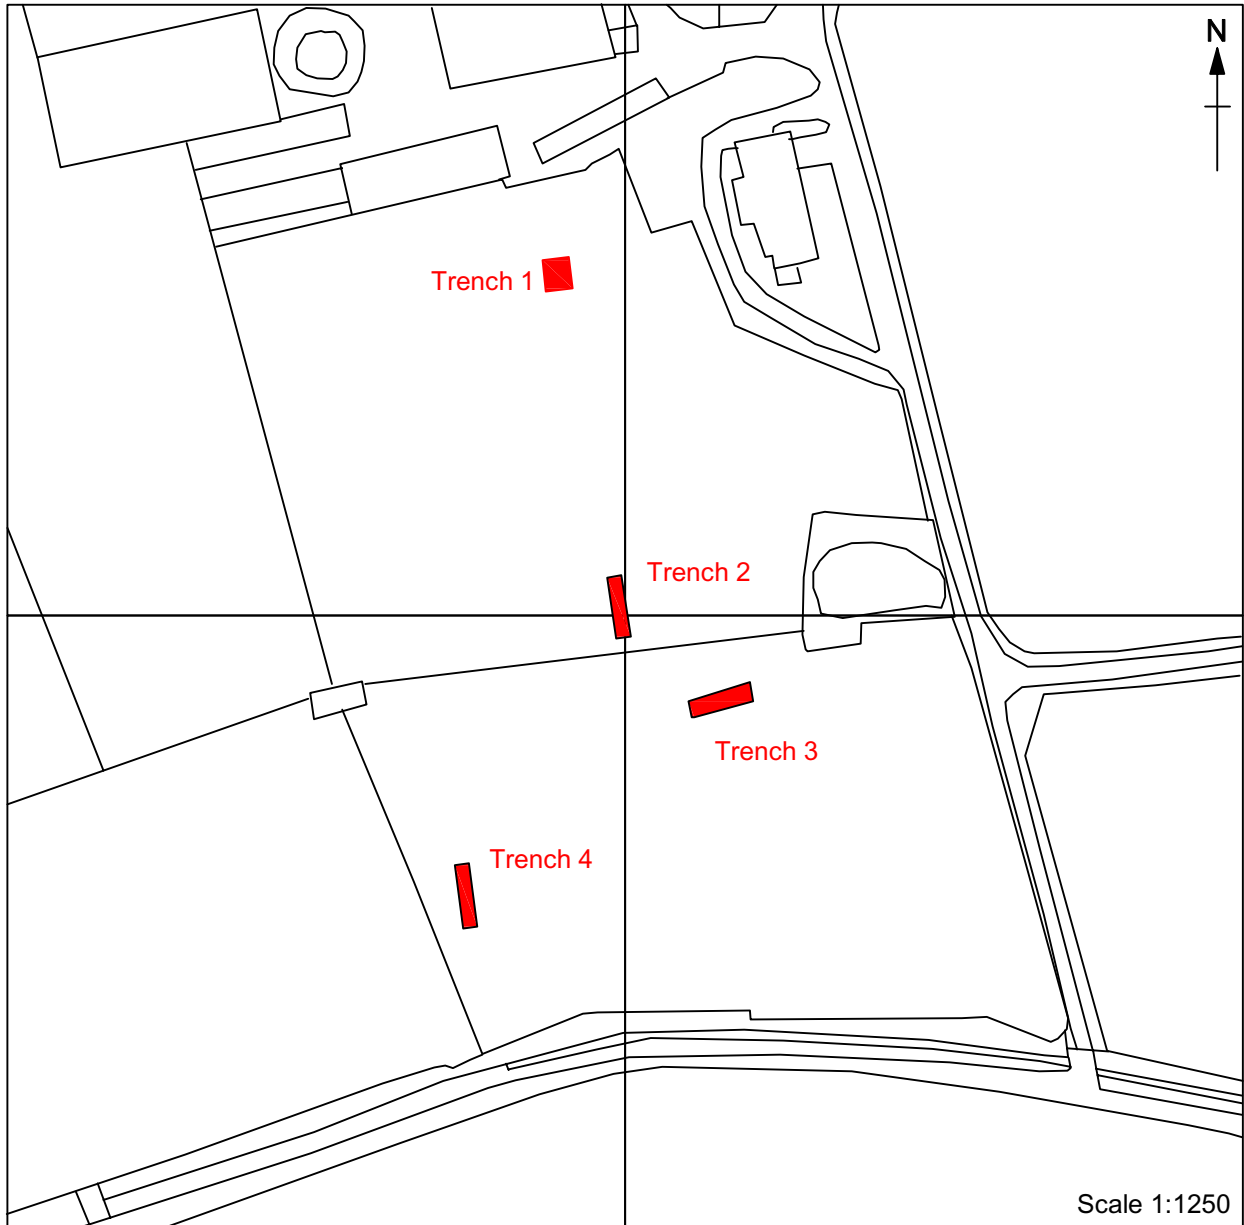
Figure 2. Plan of Evaluation Trenches 1, 2, 3 and 4.

5.1 Four Evaluation trenches were excavated covering a total of c. 80m<sup>2</sup>, as stipulated in the issued Written Scheme of Works, with the location agreed by the Heritage and Environment Section at North Yorkshire County Council and in conjunction with RF Racing (Fig. 2: Appendix 7). Trenches were located outside the corral and in the paddocks south of the Racing Stables in areas free of modern services. Excavation took place between the 19<sup>th</sup> September 2008 and the 26<sup>th</sup> September 2008. The trenches were backfilled on the 26<sup>th</sup> September 2008.

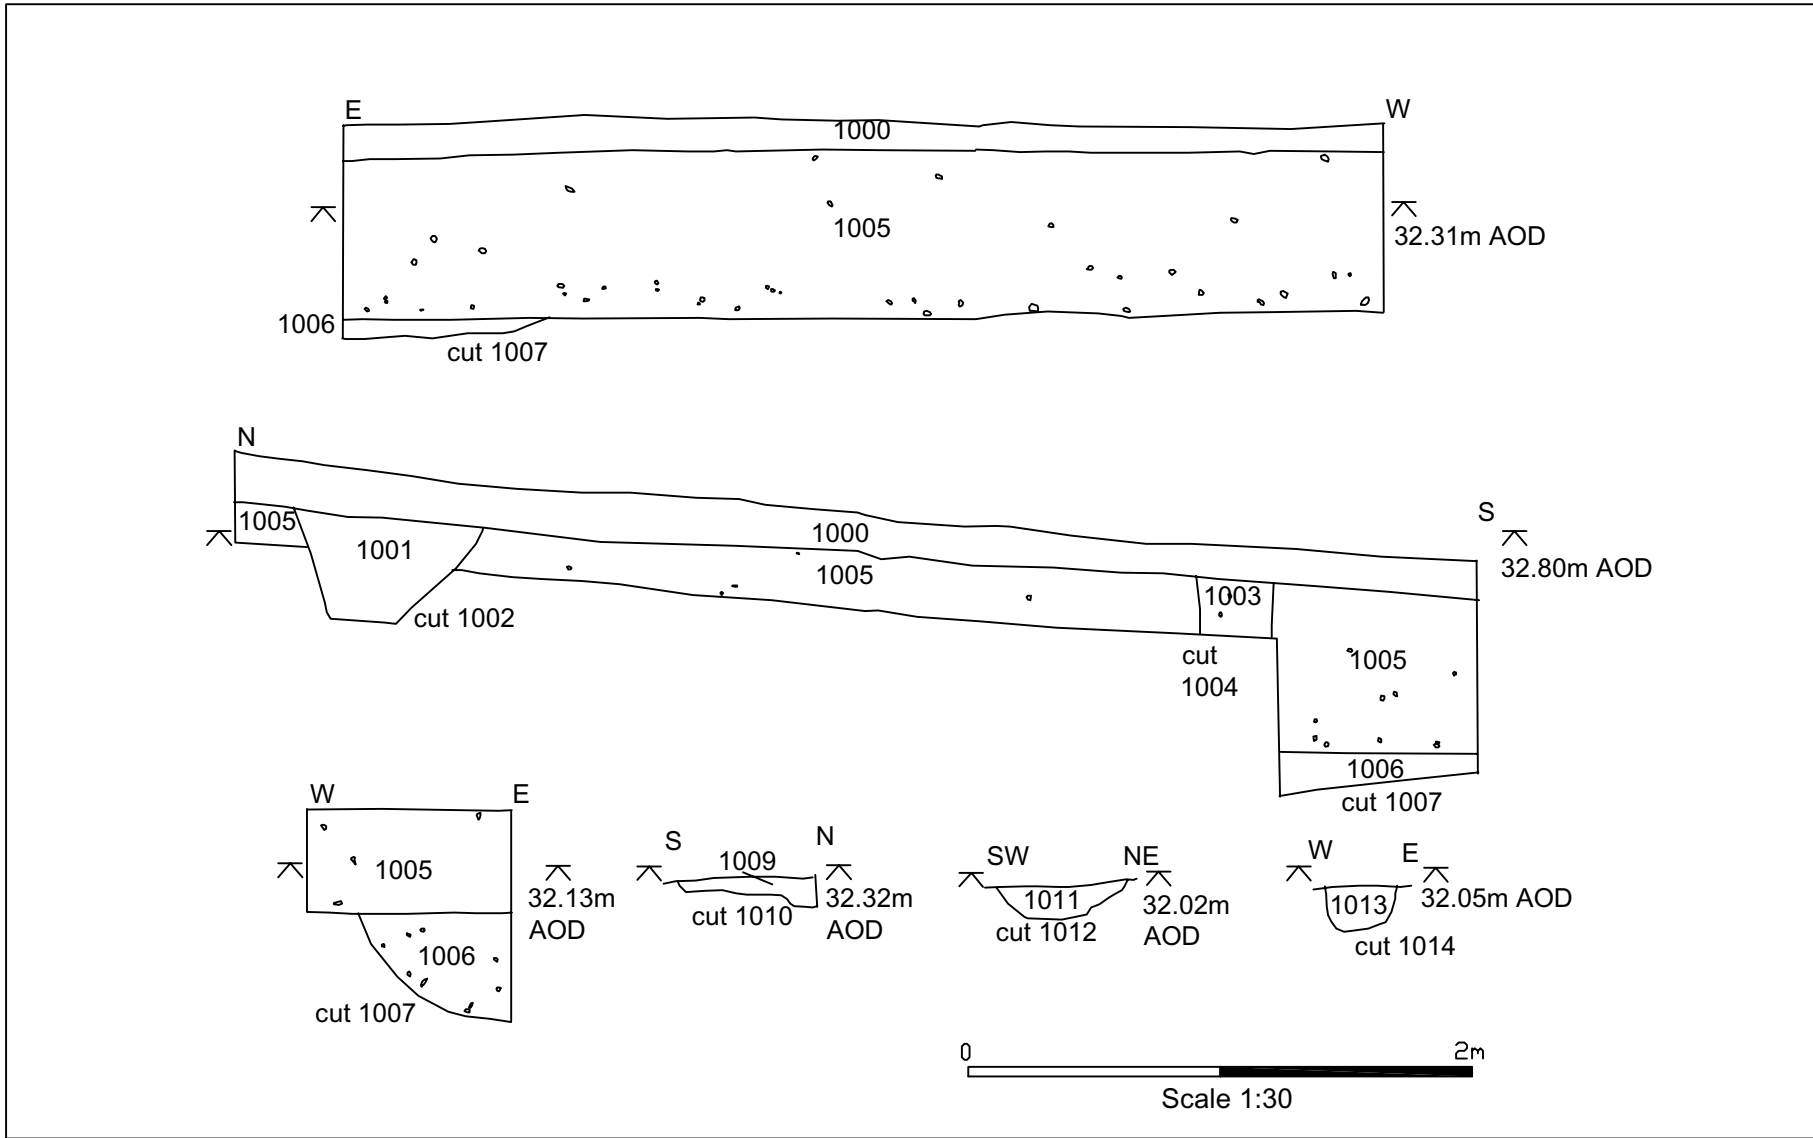
Figure 4. Trench 1 Sections.

The subsoil (Context 1005) was a brown clay silt with limestone gravel inclusions, and was 0.58m deep. A 1m wide by 4.4m long sondage was manually excavated through the subsoil (Deposit 1005) along the southern edge of Trench 1 and revealed a Phase 1 Pit (Deposit 1006/Cut 1007). This sondage was extended to measure 3.5 by 3.15m area, the subsoil being mechanically excavated down to the natural and revealing the four Phase 1 features. Two sherds of Roman pottery were recovered from Deposit 1005). The sondage was positioned between the modern water pipe trench (Cut 1002) and land drain trench (Cut 1004).

Cut into Deposit 1005 were two modern service trenches. In the south-east corner of Trench 1 was a 1.30m length of modern field drain (Fill 1003 and Cut 1004), which was aligned north-west by south-east and 0.30m wide. Along the northern edge of Trench 1 was an east-west aligned water pipe trench (Fill 1001 and Cut 1002), which measured 4.5m by 0.58m wide and 0.38m deep (base at 32.42m AOD). Three small fragments of ceramic building material and a sherd of Roman pottery were found in Deposit 1001. Both these service trenches were overlain by topsoil (Context 1000). Two sherds of Medieval Pottery, a sherd of nineteenth century ale bottle and a pantile fragment were recovered from the topsoil (Context 1000).

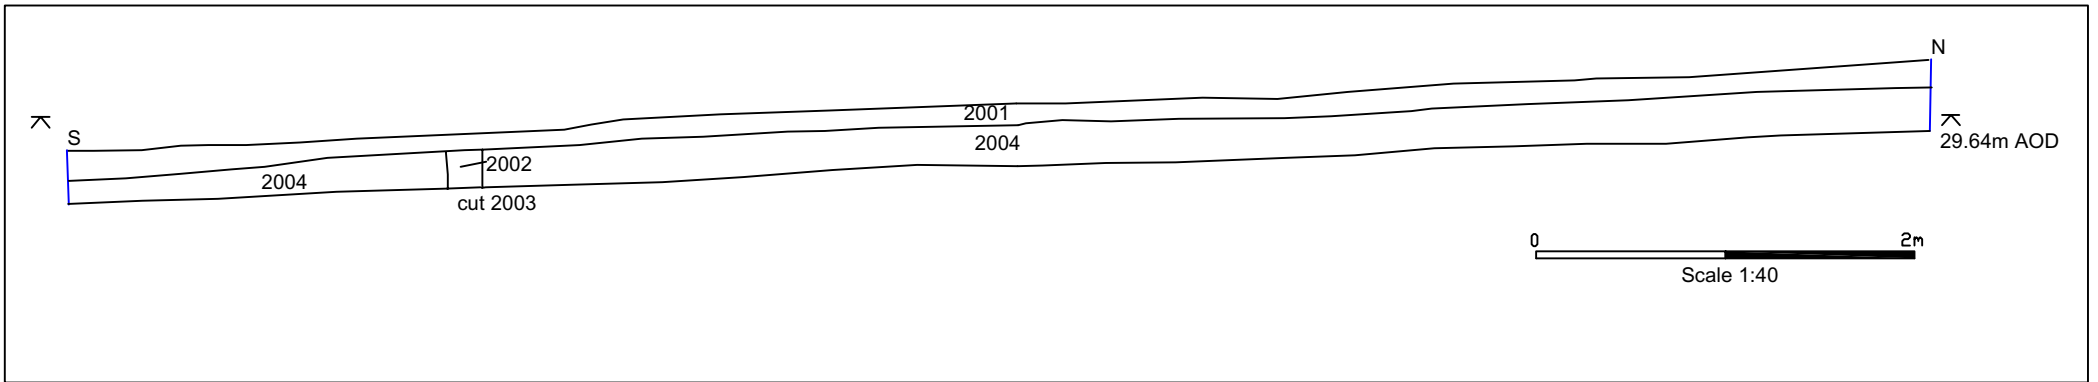
Figure 6. Trench 2 Section.

The land drain trench was aligned north-west by south-east and cut through the subsoil (Context 2004). The subsoil (Context 2004) overlay natural clay sand with gravel (Context 2005). The Natural sloped down to the south from the northern end of Trench 3 (Natural at between 29.60m AOD and 29.18m AOD). The existing ground level was at a height of between 30.01m AOD at the north end of Trench 2 and 29.43m AOD at the southern end of Trench 2. The excavated level in Trench 3 was at between 29.18m AOD and 29.60m AOD.

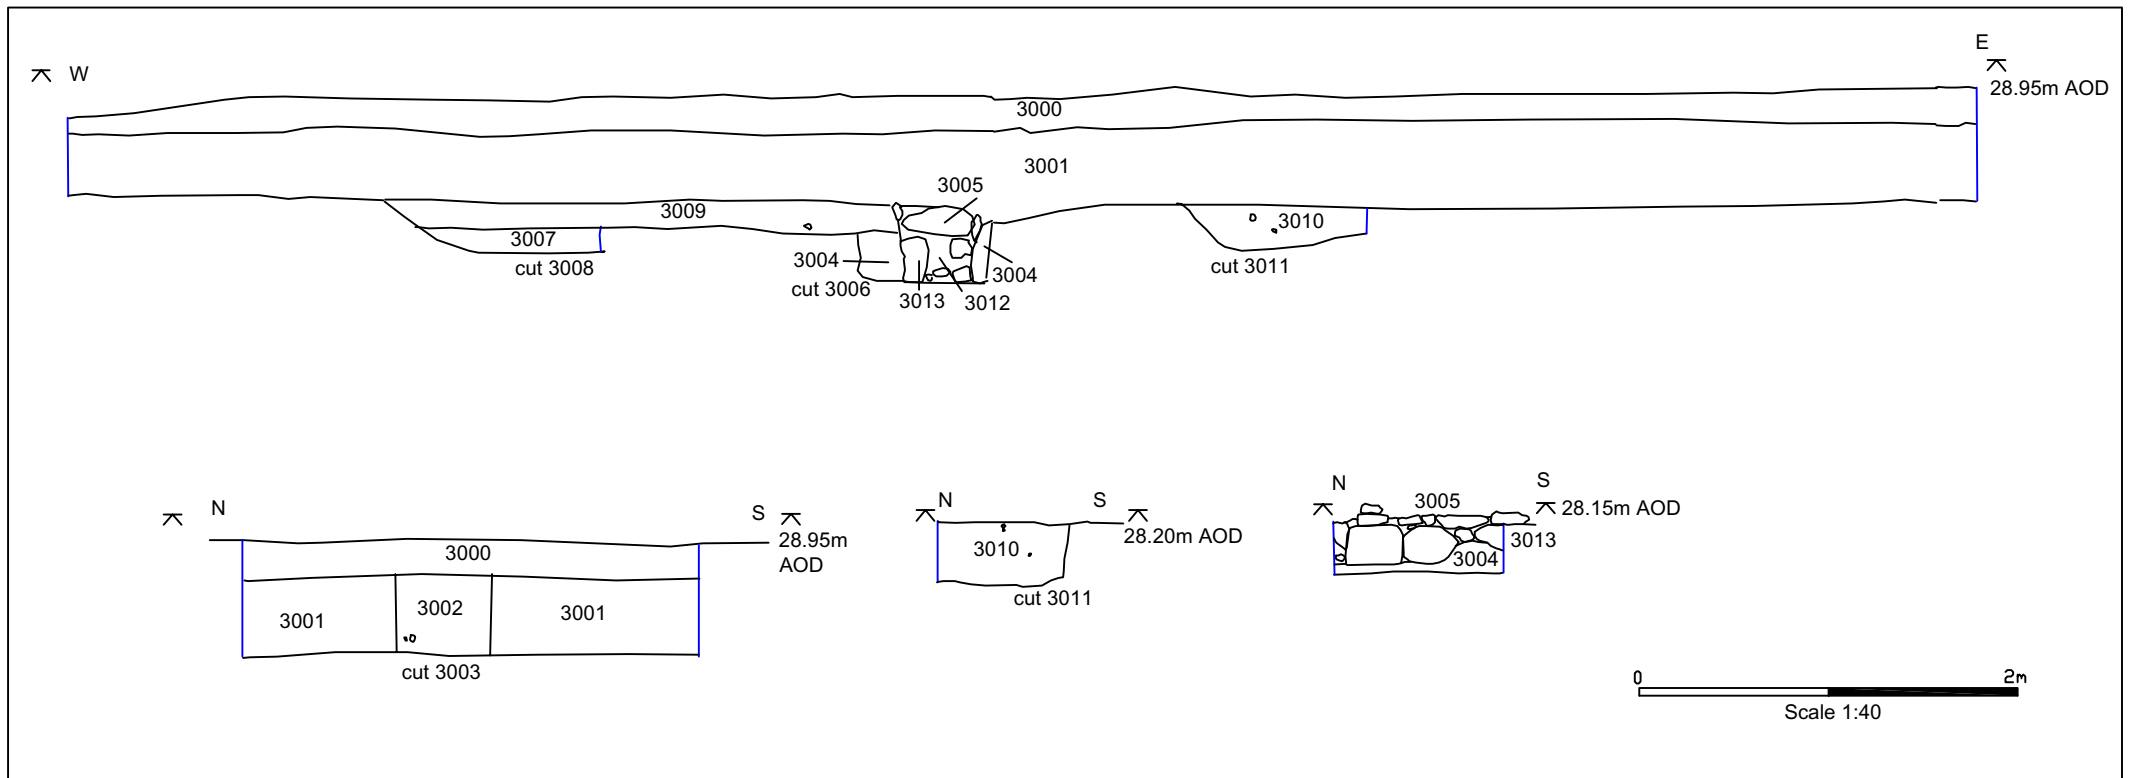
Figure 8. Trench 3 Section.

Subsoil in Trench 3, Context 3001, was a yellowish-brown, silty clay. A Disused Service Trench cut through the subsoil. This Service trench (cut 3003) contained a dark grey fill and a disused salt glazed drain-pipe (Fill 3002). Deposit 3002 was overlain by topsoil (Context 3001)

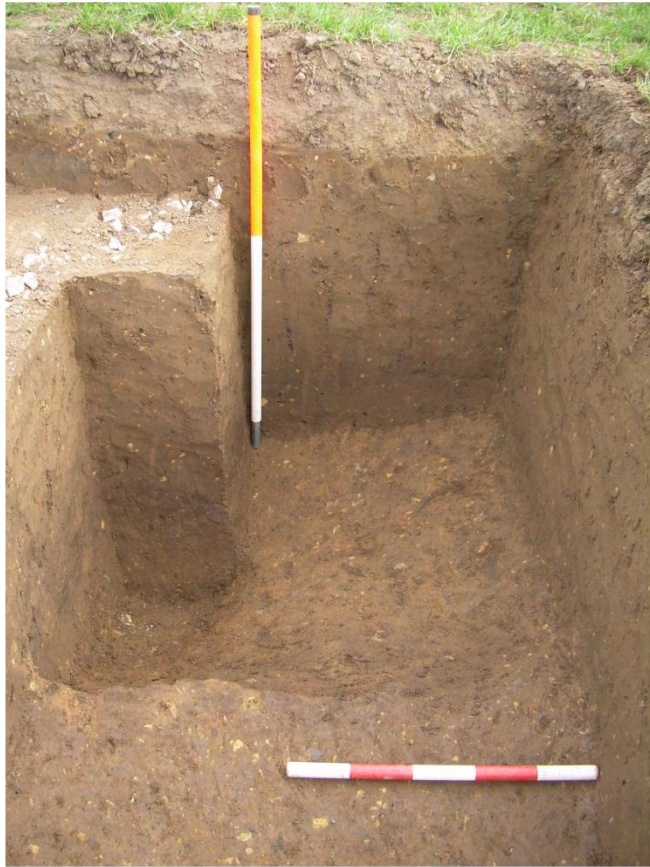
Pit 1007 was located south of Phase 2 land drain cut 1004 in the south-eastern corner of Trench 1, and measured 1m by 1m and was 0.43m deep (base at 31.55m AOD) and continued to the north, east and south. This pit was filled by deposit 1006, a grey-brown silty clay with gravel inclusions.

Plate 3. Trench 1: Pit 1007. Facing East.

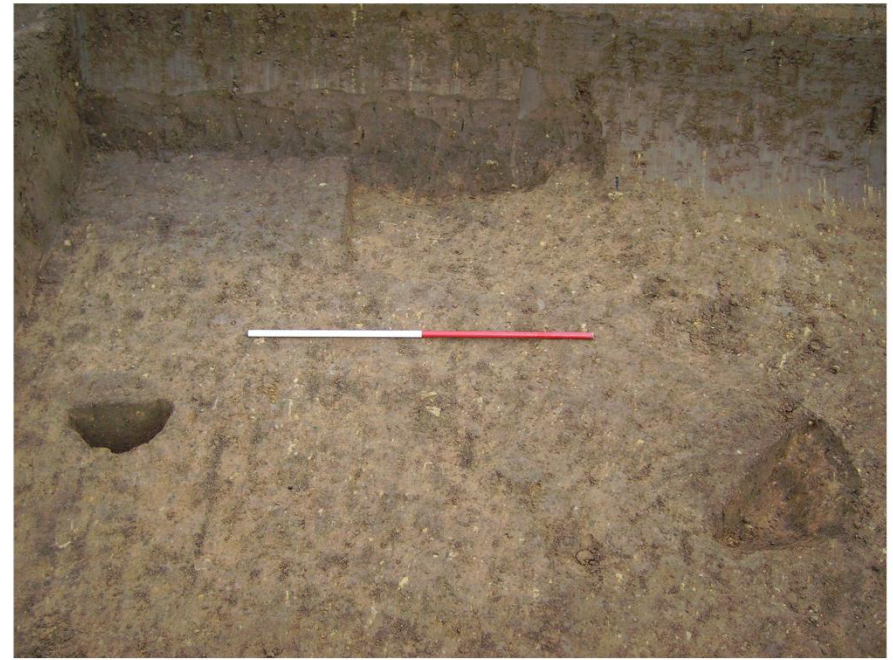
In the north-east corner of the sondage, was a pit/gully terminal, Cut 1010, which was filled by Deposit 1009, a grey brown clay silt with gravel inclusions. This feature measured 1.65m by 0.54m and a 0.75m segment of the terminal was excavated. Cut 1010 was 0.13m deep (base at 32.16m AOD).

Posthole 1012 was oval in plan, measuring 0.54m by 0.44m. This feature was filled by Deposit 1011, a grey brown slightly sandy clay with gravel inclusions. Posthole 1012 was half excavated with the south-eastern half of deposit 1011 removed, and was 0.13m deep (base at 31.83m AOD).

Posthole 1014 was located 1.30m east of Posthole 1012, and was smaller than Posthole 1012. Posthole 1014 was sub-circular in plan, measuring 0.29m by 0.32m, and was filled by Deposit 1013, a grey brown clay silt with gravel inclusions. Posthole 1014 was half sectioned, and the southern half of the fill (Deposit 1013) was excavated. Posthole 1014 was 0.18m deep and the base was at 31.81m AOD.

Plate 4. Trench 1: Cuts 1010, 1012 and 1014. Facing North.

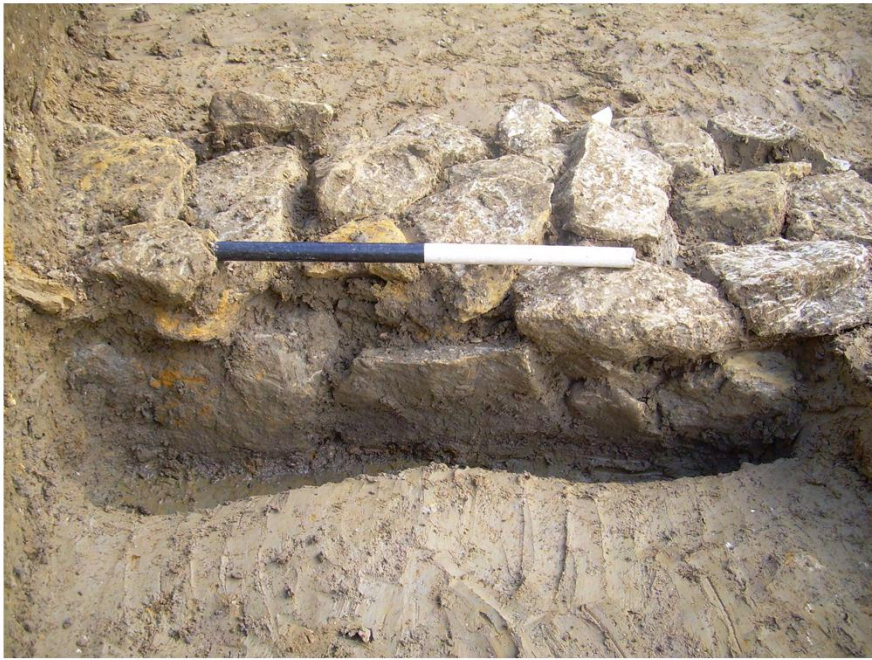
Drain cut 3006 was filled with stone packing 3005/3013 and two deposits (Contexts 3004 and 3012). Context 3004 was a grey silty clay deposit and Context 3012 was a grey clay silt deposit. A 1m wide segment was excavated through the northern half of Drain 3006. The drain cut measured 2.35m by 0.60m and was 0.24m deep with vertical sides and a flat base (base at 27.75m AOD)

Plate 7. Trench 3: Drain 3005. Facing East.

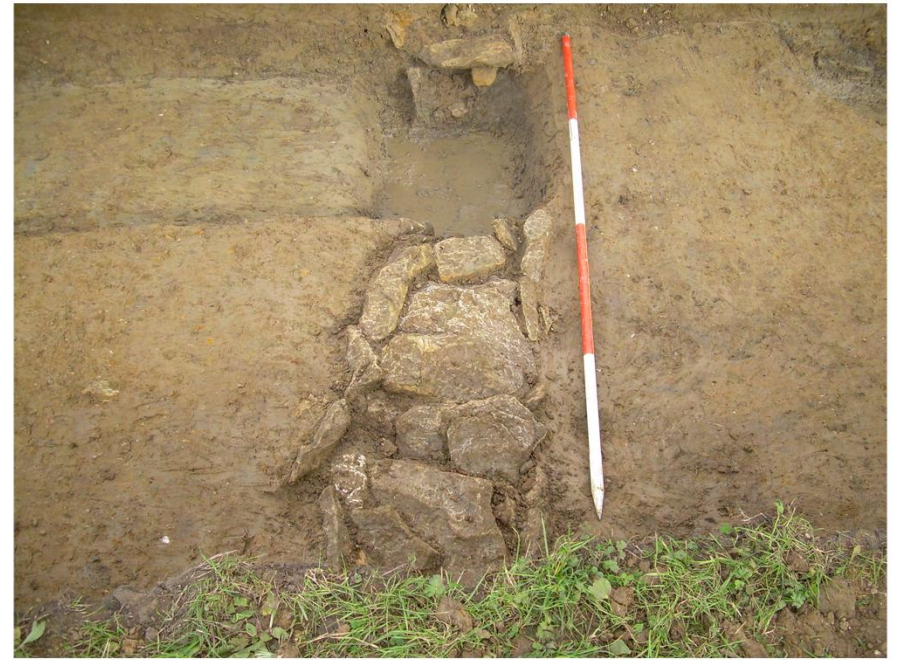
Plate 8. Trench 3: Cut 3006. Facing North.

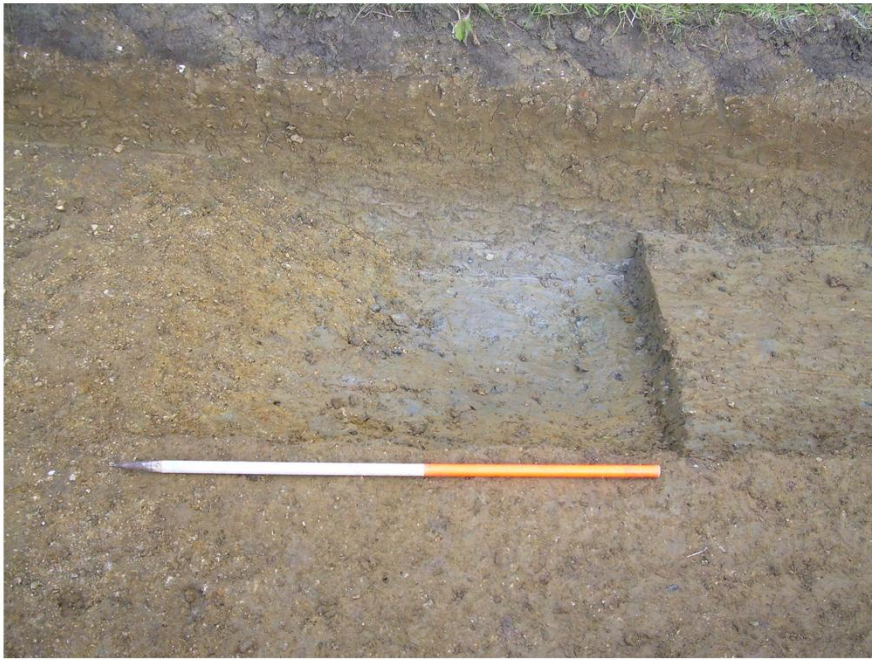
Cut 3008 was aligned north-south and was a wide linear with Cut 3006 on its eastern edge. This linear feature measured 3.31m by 2.35m and a 1m wide segment was excavated through the northern half of its fills (Deposits 3007 and 3009). Deposit 3007 was a brown clay. Cut 3008 was 0.30m deep (base at 27.93m AOD).

Plate 9. Trench 3: Cut 3008. Facing North.

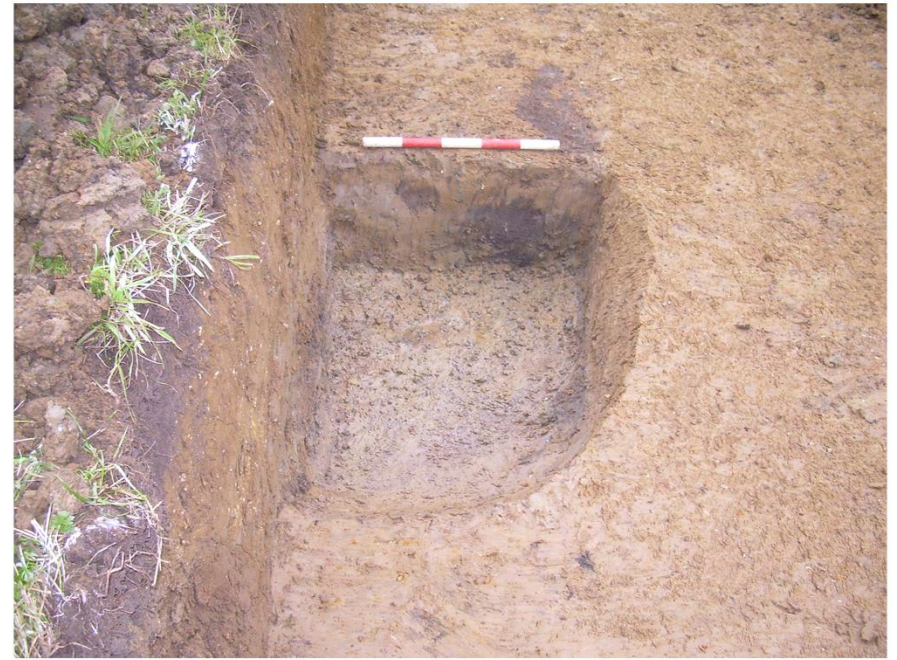
Gully terminal 3011 was aligned east-west, measuring 4.10m by 0.70m wide and was located in the eastern half of Trench 3. A segment was excavated at the terminal at the west end of this feature. Gully 3011 was filled by Deposit 3010, a brown silty clay with some darker lenses noted in the fill. The segment was 0.38m deep with a U-shaped profile (Base at 27.81m AOD).

Plate 10. Trench 3: Segment cur 3011. Facing East.
