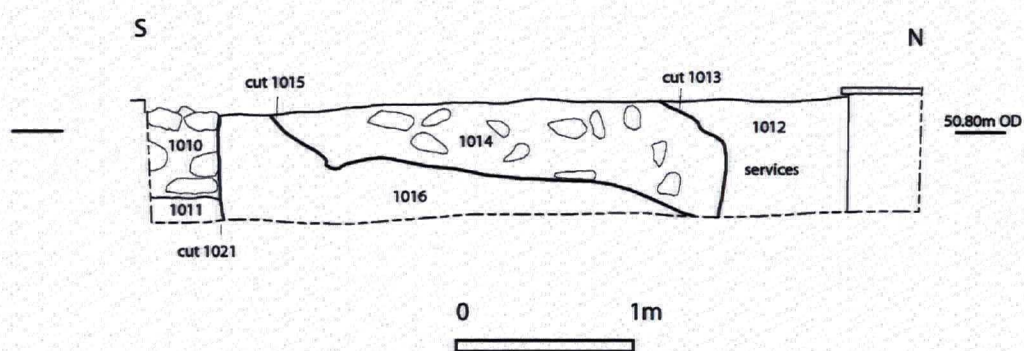
Figure 3 Section 2, East facing, see Figure 2 for location. Note wall foundations to south, rubble filled cut 1014 - in turn truncated by modern services

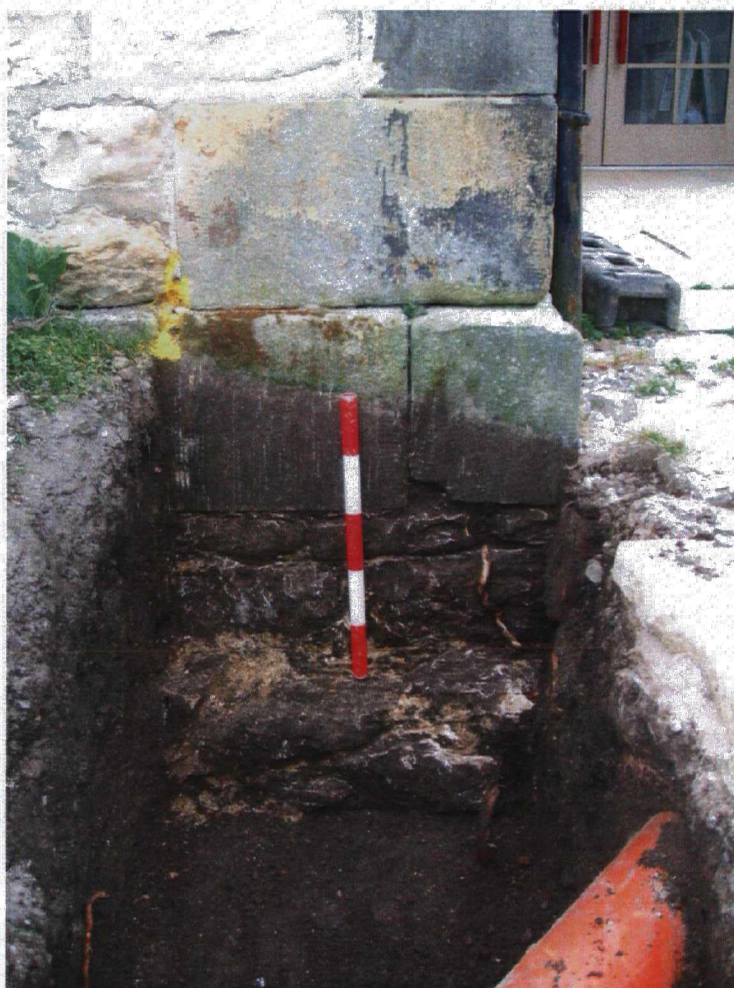
Plate 1 Foundations of SE corner of Meeting House in S foundation trench/column Pit 5, looking E

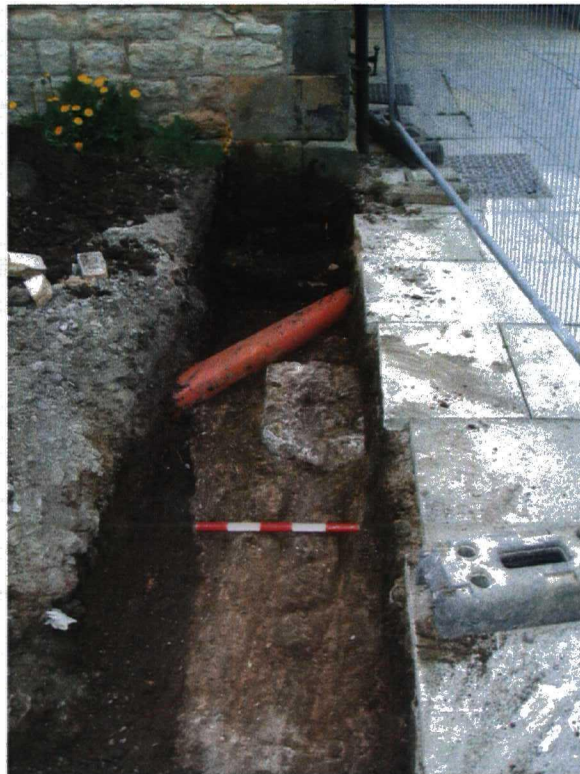
Plate 2 Wall foundations in S foundation trench, looking E

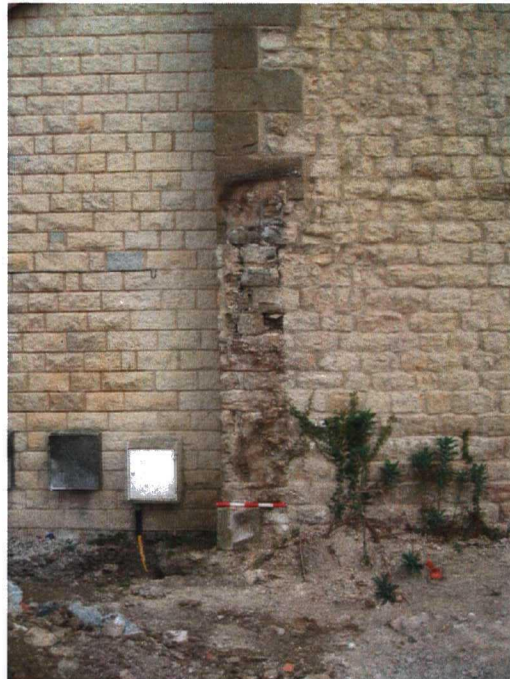
*Plate 3 Wall scar on NW corner of former Meeting House, looking E
(walling to left is 20th century extension)*

A wall scar was observed on the north-western of the old Meeting House (Plate 4). This appears to relate to a wall that ran east – west and parallel to that revealed in the area of the south-west corner of the building (see 5.2). No footings for this were observed in column pits

8 or 4 and so it must be assumed that all foundation material was both shallow and fully dug out at the time of demolition.
