Refurbishment of Overhead Electricity Line situated at Piercebridge, County Durham

archaeological monitoring

Report 2142

January 2009

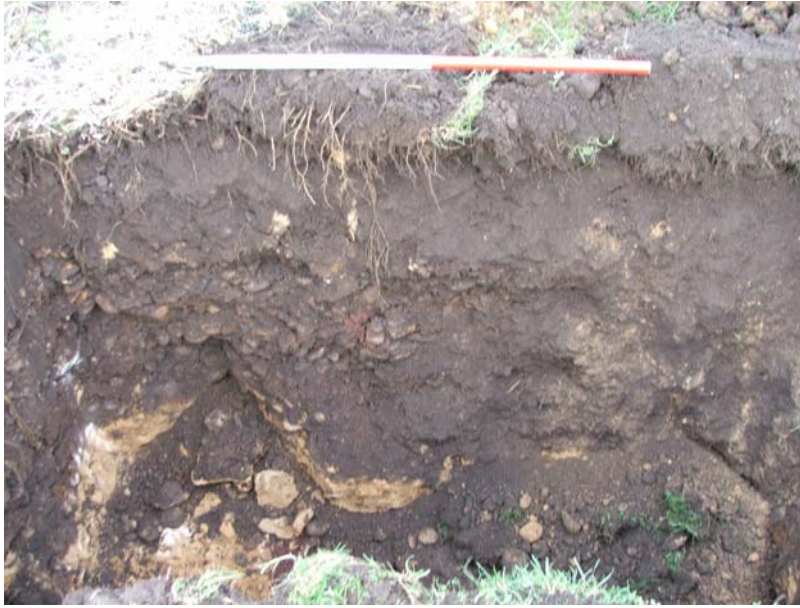
- 5.2 Trench 1 was excavated to install a replacement electricity pole for P49 and was located immediately southeast of the present pole (Figure 3). The trench was excavated to a depth of 2.5m below ground level bgl. Natural subsoil [2] was identified at 0.5m bgl and comprised well rounded river cobbles in an orange sandy matrix overlying bedrock. This was directly overlain by topsoil consisting of brown sandy silt [1]. No archaeological deposits were identified, and no artefacts recovered.

Figure 3
Trench 1, looking
northwest

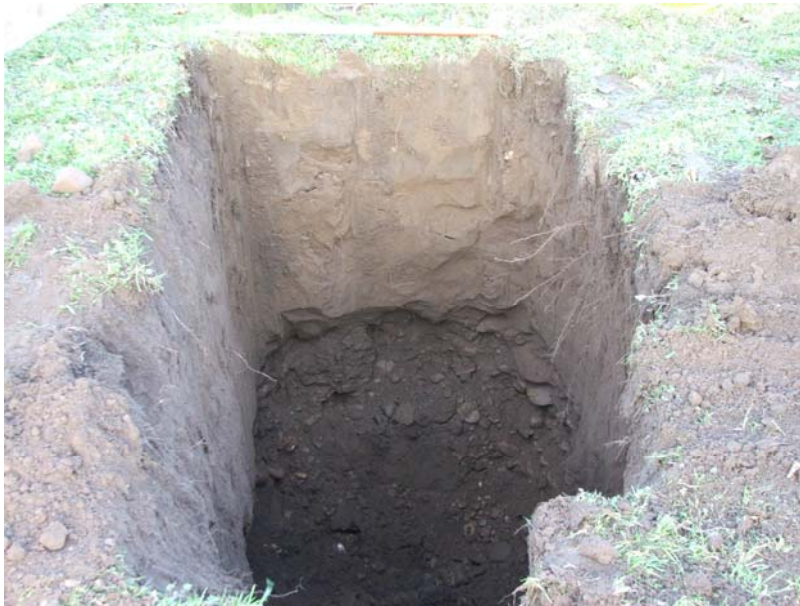
- 5.5 Trench 4 was excavated to install a replacement electricity pole for P52 and was located immediately southeast of the present pole (Figure 4). This pole is situated outside the extent of the designated Scheduled Monument. The trench was excavated to a depth of 2m bgl. Natural subsoil was identified 1.8m bgl; this was of the same composition as trench 2 [2]. This was overlain by a layer of dark brown sandy silt [3: 1.6m deep]. Above this was topsoil [1: 0.2m deep]. No archaeological deposits were identified, and no artefacts recovered.

Figure 4
Trench 4, looking
northwest

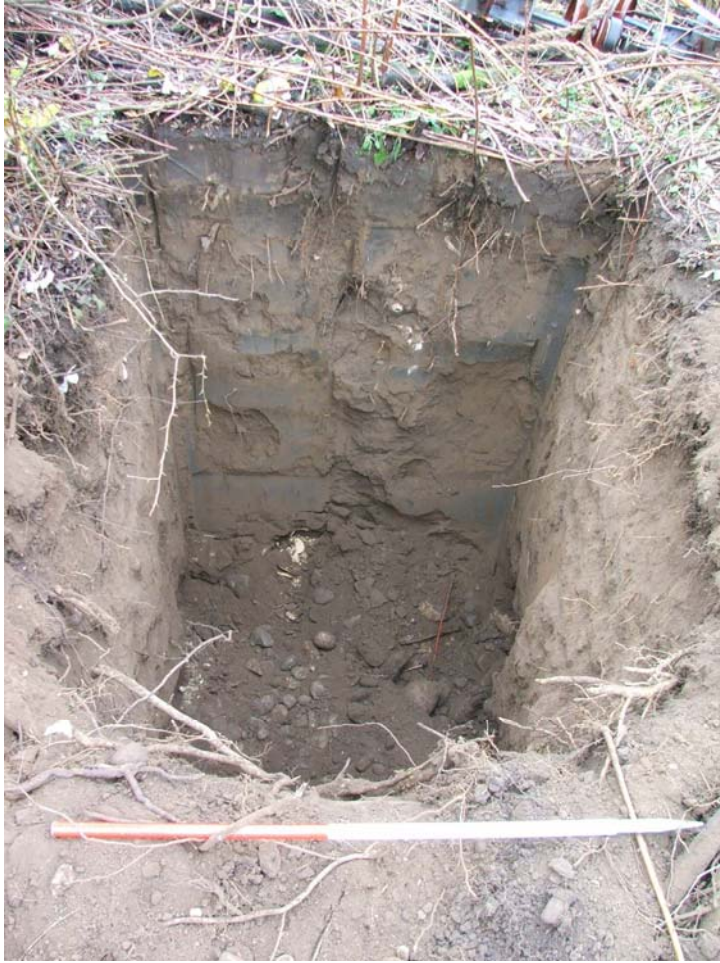
- 5.7 Trench 6 was excavated to install a replacement electricity pole for P53 and was located immediately southeast of the present pole (Figure 5). This pole lies outside the extent of the designated Scheduled Monument. This trench was excavated to a depth of 2m bgl. Natural subsoil was identified 0.5m bgl [2]; this was of the same composition as in trench 2. This was directly overlain by topsoil [1]. No archaeological deposits were identified, and no artefacts recovered.

Figure 5
Trench 6 looking
north
