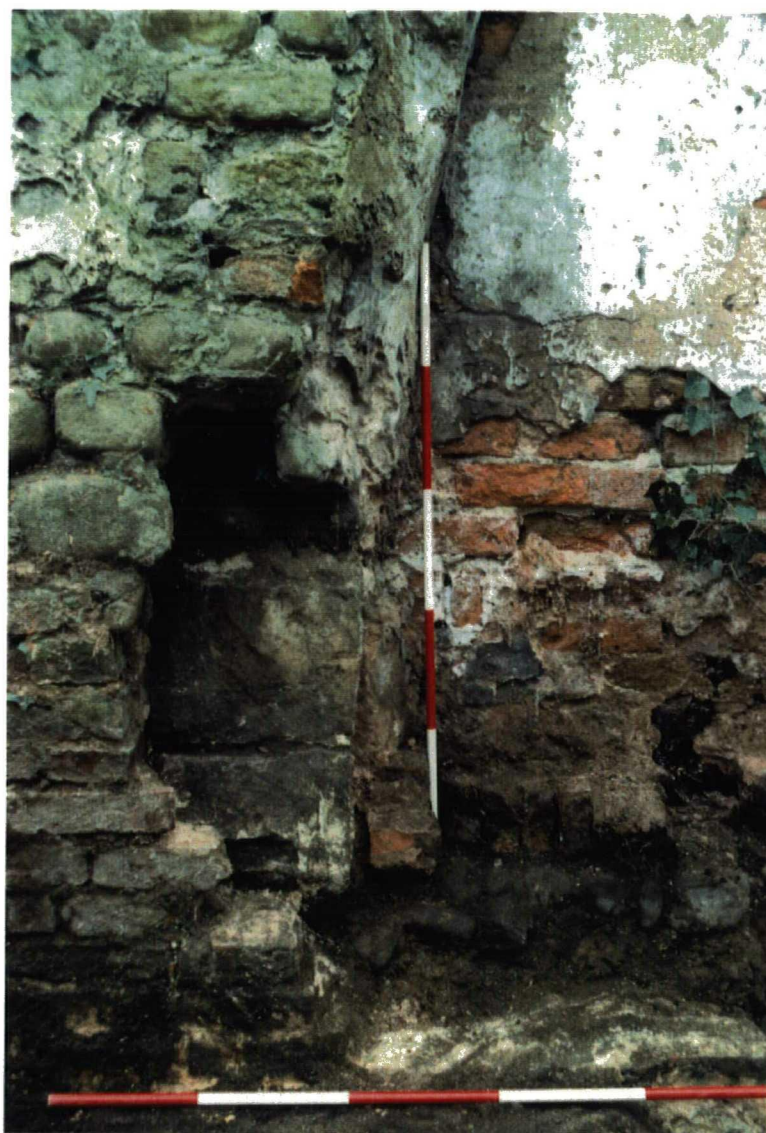
PLATE 5

The remains of a late medieval cobble yard surface and a contemporary section of magnesian limestone walling.

The cobble surface made up of a single layer of water worn cobbles measuring up to 20 cm in size, the cobbles were horizontally bedded on a relatively level plane. The cobbles were arranged edge to edge with an upward facing level surface. The layer was identified as continuing eastward, uninterrupted towards and butting up to the base of Wall Ai, thereafter the surface reappears within Underpinning Pit No's 1 and 5, however, the full extent of the surface is not known.

This layer is comparable with a similar cobble surface, context 3013 revealed during the excavation of Trial Hole No.3, and as such is thought to be part of a late medieval yard surface.

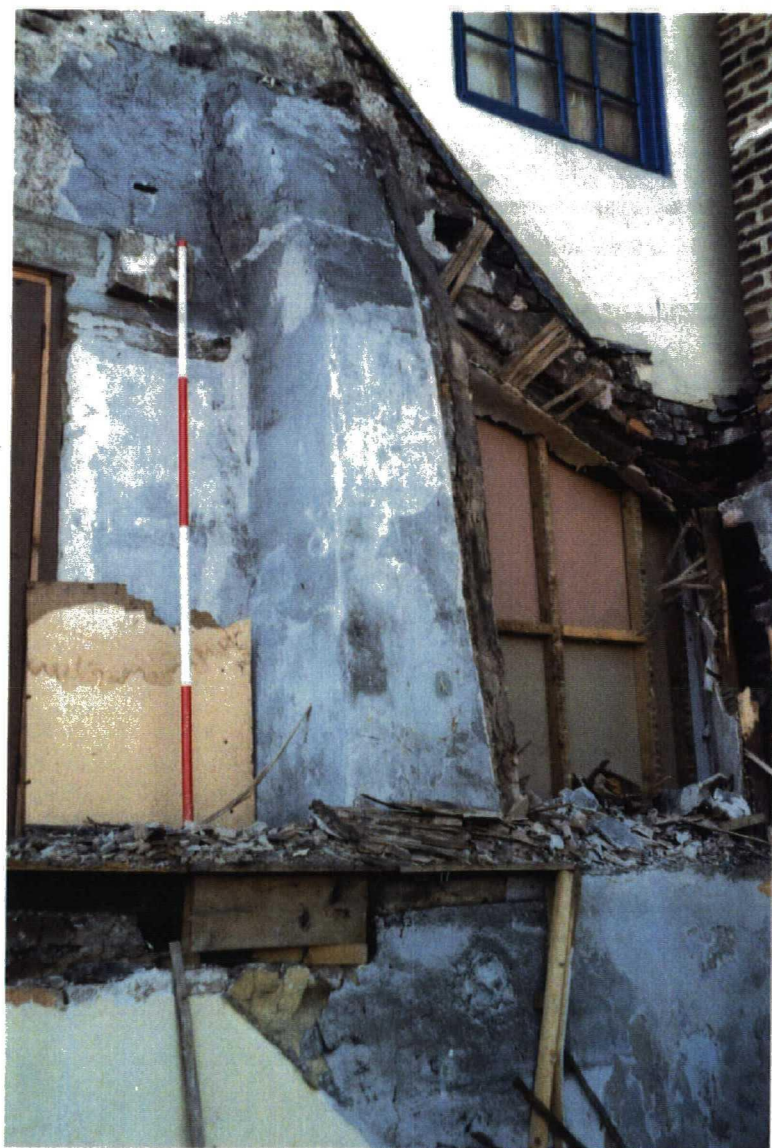
PLATE 4

Detail of the 18th Century external chimney flu.

The demolition of the extension provided a useful opportunity to inspect in some detail the recently exposed west facing elevation of the 18th Century brick built property. The construction of the 19th Century and more recent extension had, unfortunately resulted in a significant amount of disturbance and alteration to it's character. However a small number of load bearing timber beams were exposed together with a external chimney flu, associated with a blocked fireplace.

The box flu had survived subsequent alterations, having been incorporated into the internal first floor space of the 19th Century extension, in conjunction with this the flu had been plastered. The ground floor fireplace which it served had been badly disturbed during recent alterations, but it's size would indicate it served a domestic role. The survival of these features does indicate that the fireplace continued to be used well into the 20th Century, and that the ground floor of the building had originally been partitioned into shop-front and domestic areas, the latter of which may also have contained the original internal staircase, that was later replaced by that stairway recently demolished.

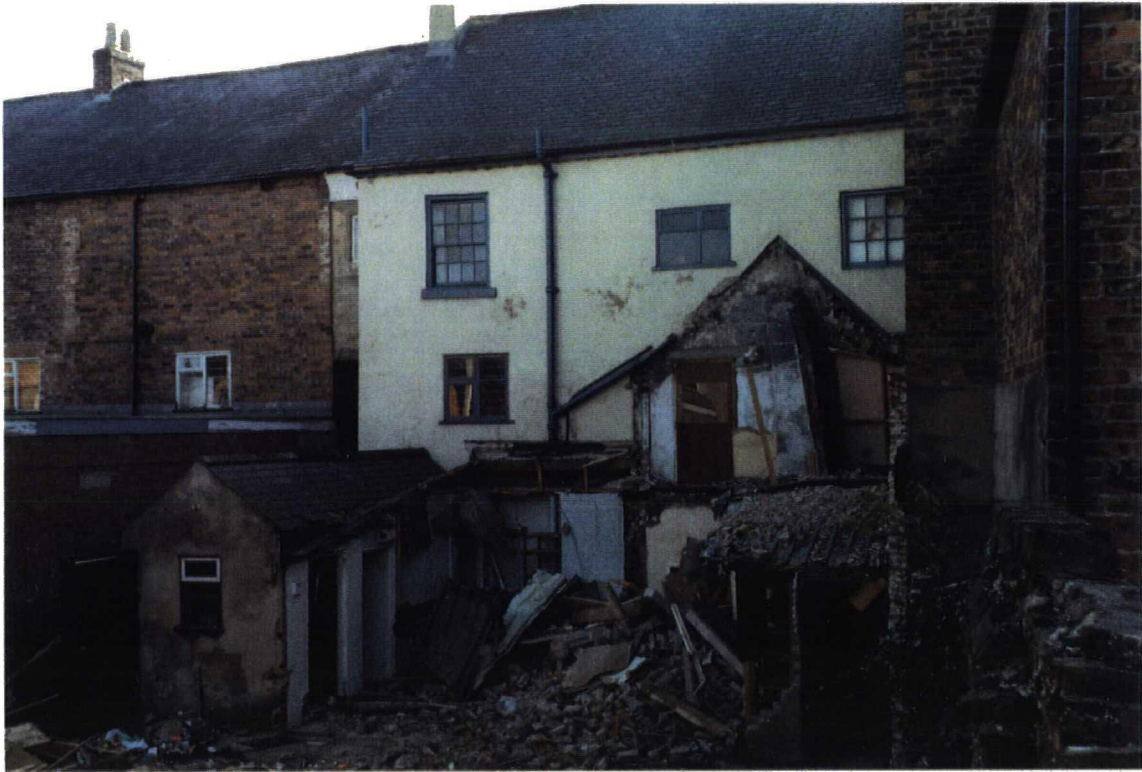
PLATE 2

The partial demolition of the former extension to the rear of the property.

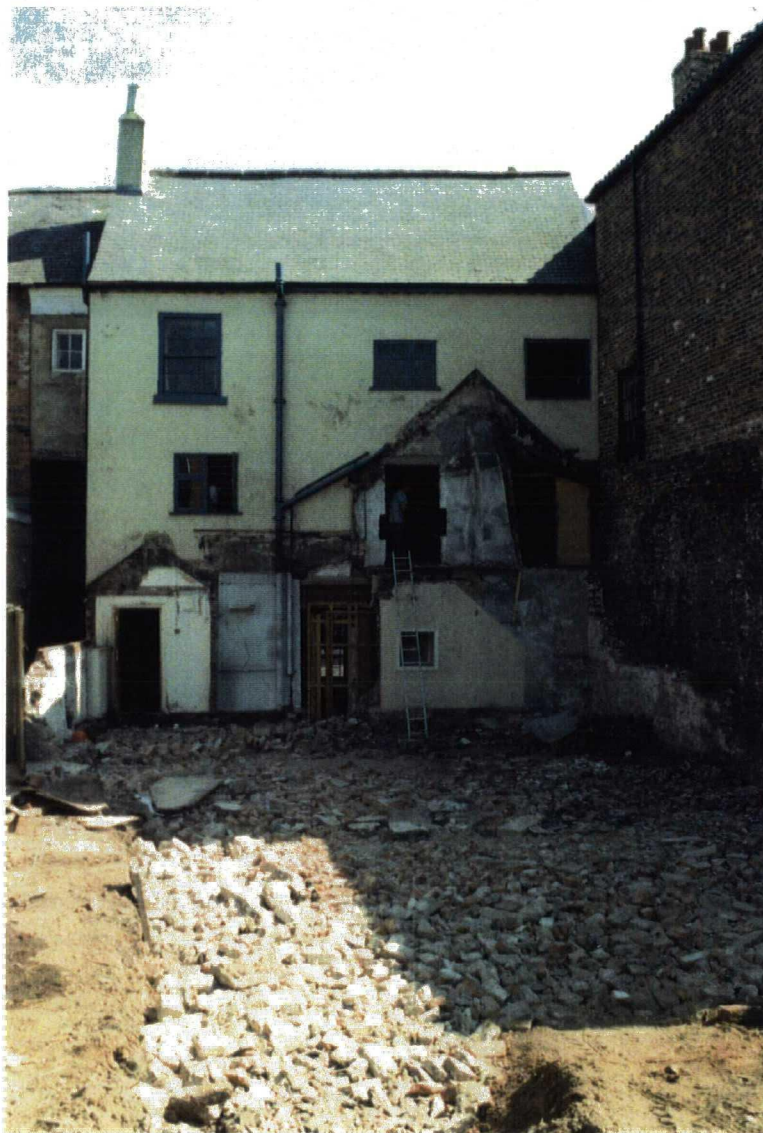
PLATE 3

The west facing elevation of the property after the demolition of the former extension.

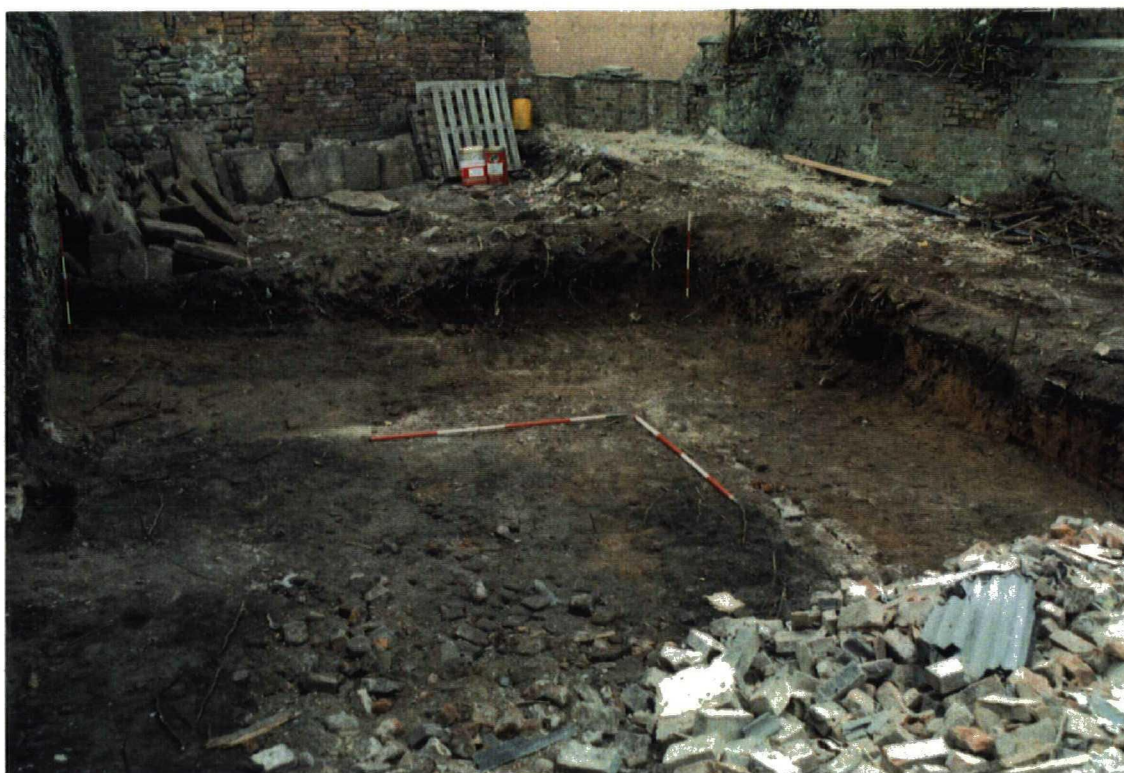
PLATE 1

The excavation of the former yard surface, revealing the alignment of 19th Century brick walls.
