**Saint Anne's Church
Catterick
North Yorkshire**

Archaeological Watching Brief

Report No. 1915

January 2009

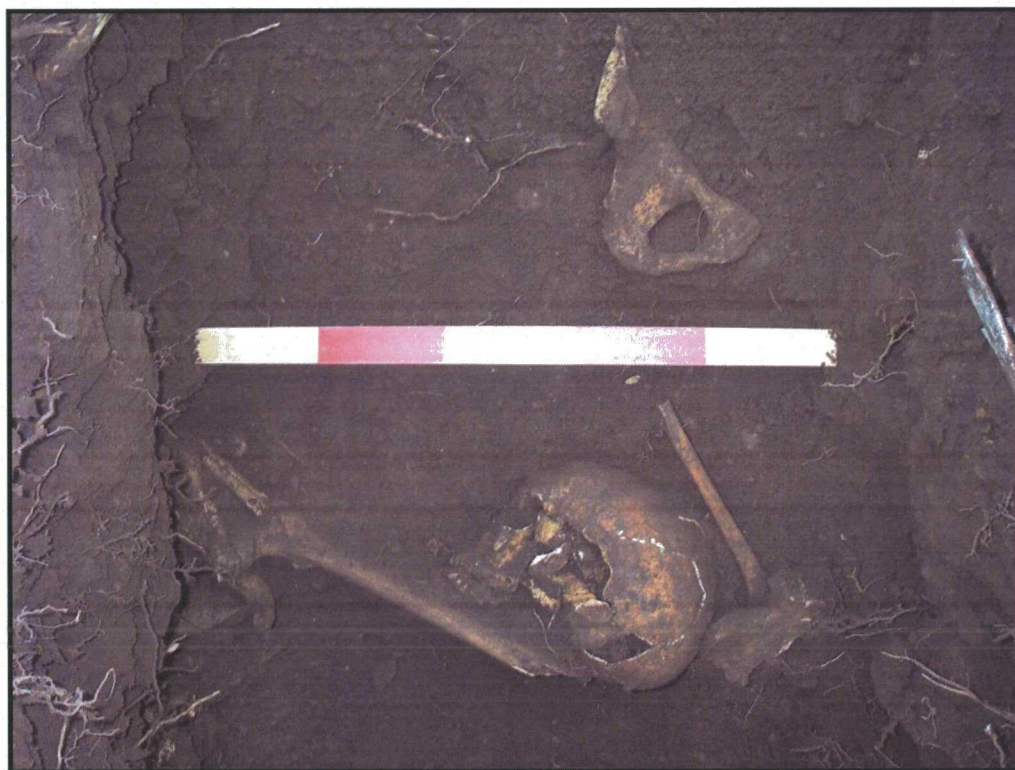
Plate 4. Disarticulated human remains

The remaining 25m of trench was dug under close archaeological supervision. Disarticulated human bone was encountered throughout the graveyard soil from just below the surface to the base of the trench (Plate 4). The exposed trench section was hand cleaned but no grave cuts were visible. Towards the northern end of the trench, it is possible that two articulated skeletons were encountered at the base of the trench some 1.30m below ground level. However, the employment of a toothed bucket to excavate the trench cause so much disturbance it was impossible to make a confident identification. Again, all the human remains were collected and reinterred.

The excavation of the pipe trench revealed a deep graveyard soil which contained disarticulated human bone throughout. The cutting of new graves through older unrecorded burials is often the cause for the distribution of bone through a graveyard soil but this appears unlikely in this case as no grave cuts were identified. Speculatively, it is possible that the graveyard has been landscaped in the past, perhaps when the current church was erected, and that these works were responsible for disturbing pre-existing graves.
