**STUDFORTH FARM, ALDBOROUGH
BOROUGHBRIDGE, NORTH YORKSHIRE**

Scheduled Monument Number 436

ARCHAEOLOGICAL WATCHING BRIEF

May 2009

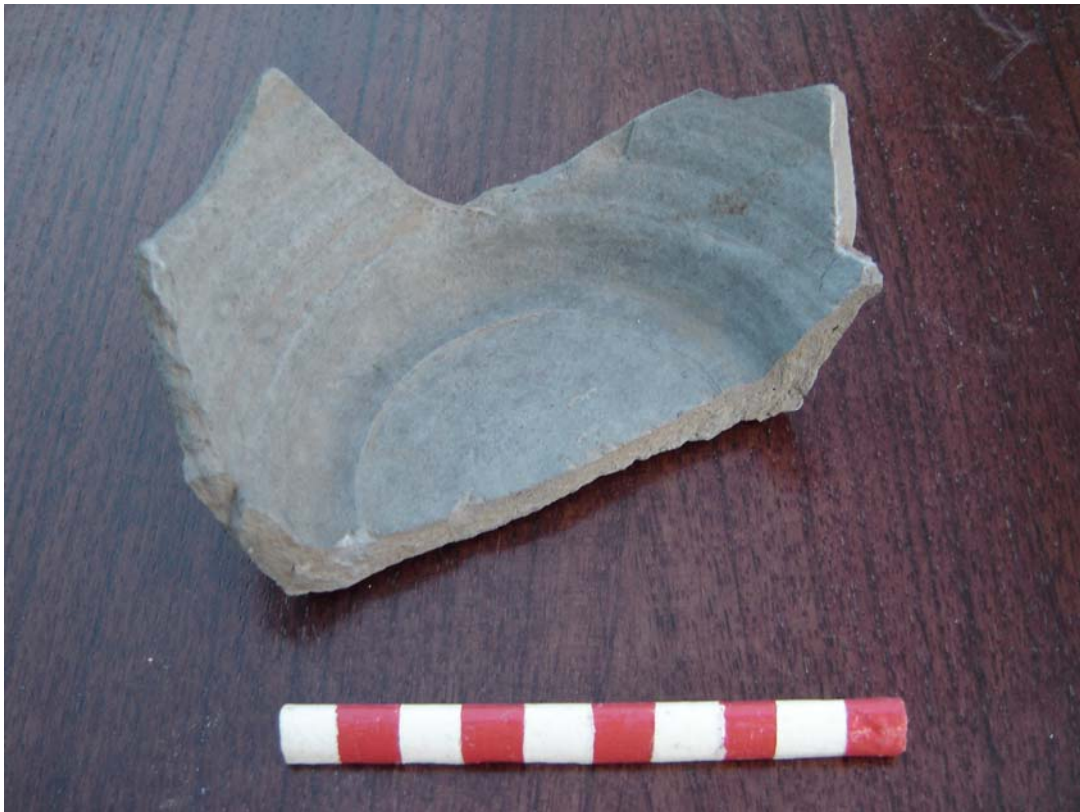
Front Cover. Base of Roman greyware jar from Studforth Farm, Aldborough.

- 5.9 This was located in the angle between southern wall of the barn and a ‘porch’ which had been butted this side to the barn. The southern wall of the barn had been cement rendered obscuring the detail of its construction but appeared to be of sandstone blocks. The ‘porch’ was of sandstone and brick construction on a layer of large cobbles and extended to 0.70m below ground level as did the main barn itself. Both structures had been built in a construction trench cut into the underlying natural sand (at c.0.40m below ground level) and had been backfilled with topsoil.
- 5.10 Piled against the both the barn and ‘porch’ walls was a 0.65m deep deposit of humic topsoil which contained numerous fragments of smashed pantiles. This deposit overlay a humic dark topsoil which contained half of the base of a Roman greyware burnished jar (see cover).

- 6.1 A single large sherd of the base of a burnished Roman greyware jar was recovered from a post-barn construction deposit. As the topsoil containing the Roman pottery had been deposited against the building after its construction, this topsoil layer is not Roman in origin. However the large size and un-abraded nature of the piece suggests that it is close to its original place of deposition. In addition to the Roman pottery a very small amount of very late post-medieval/Victorian pottery was recovered from the topsoil and backfill deposits.

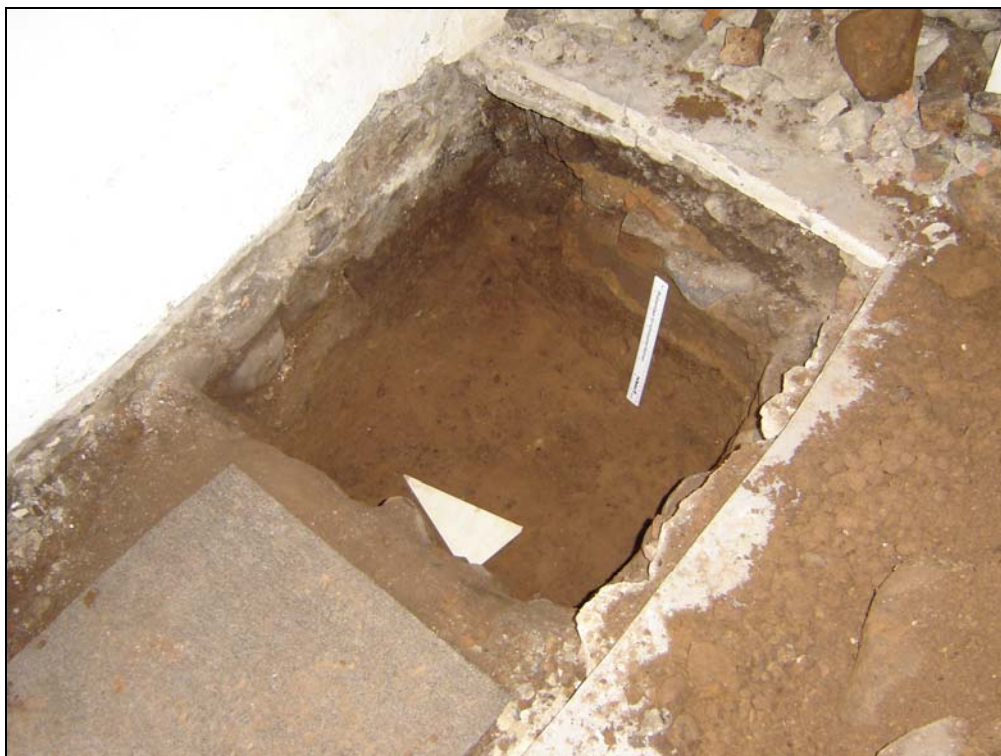
Plate 1. Test Pit 1, looking north-east. Scale 0.30m.

- 5.2 The position of this test pit was moved from the outside of the north-eastern end of the building to the inside of the barn but against the same wall. This pit examined the footings of the two storey extension which had been built at 90° to the main barn.

- 5.3 The wall in the test pit consisted of three courses of sandstone blocks and cobble construction. Butting to the wall were two successive layers of concrete floor which had been laid over a bed of mixed cobble and brick rubble. This in turn overlay a compact dark grey topsoil which had a compact pinkish orange subsoil. Below this, two further layers were recorded – an upper one of compacted yellow sand and gravel with coal ash and charcoal and a lower one of clean natural sand which started at c.0.40m below ground level.
- 5.4 These layers represent earlier ground surfaces through which the footings have been dug. The presence of coal ash in the layer directly above the natural sand would seem to suggest a date from the 18/19th century onwards origin. This would then put a later date on the deposits above that.

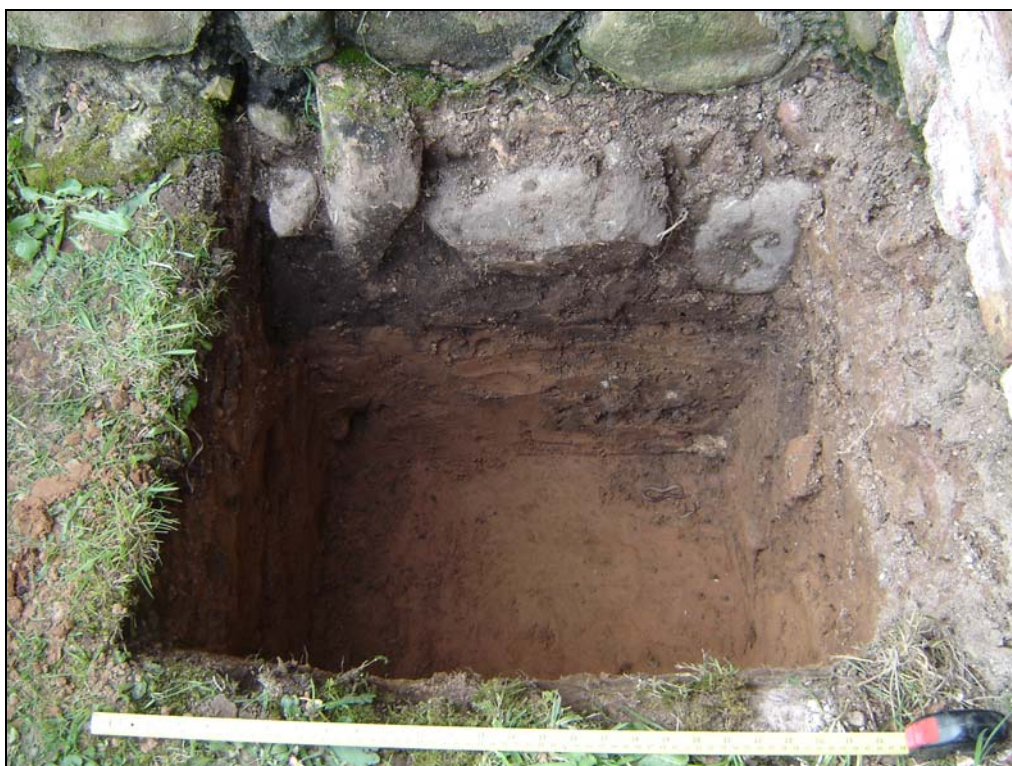
Plate 2. Test Pit 2, looking south-west.

- 5.5 This was located outside the building on its southern side in the right angle between the two wings of the barn. The extension wall of the barn is built from 19/20th century brick and constructed onto a single course of 0.22m thick cobbles. Below this was a 0.18m thick layer of dark grey humic topsoil which in turn sealed a pit/soakaway feature which was filled with loosely compacted brick, mortar and pebbles. Both of these features were cut into the underlying clean natural sand which started at 0.40m below ground level.

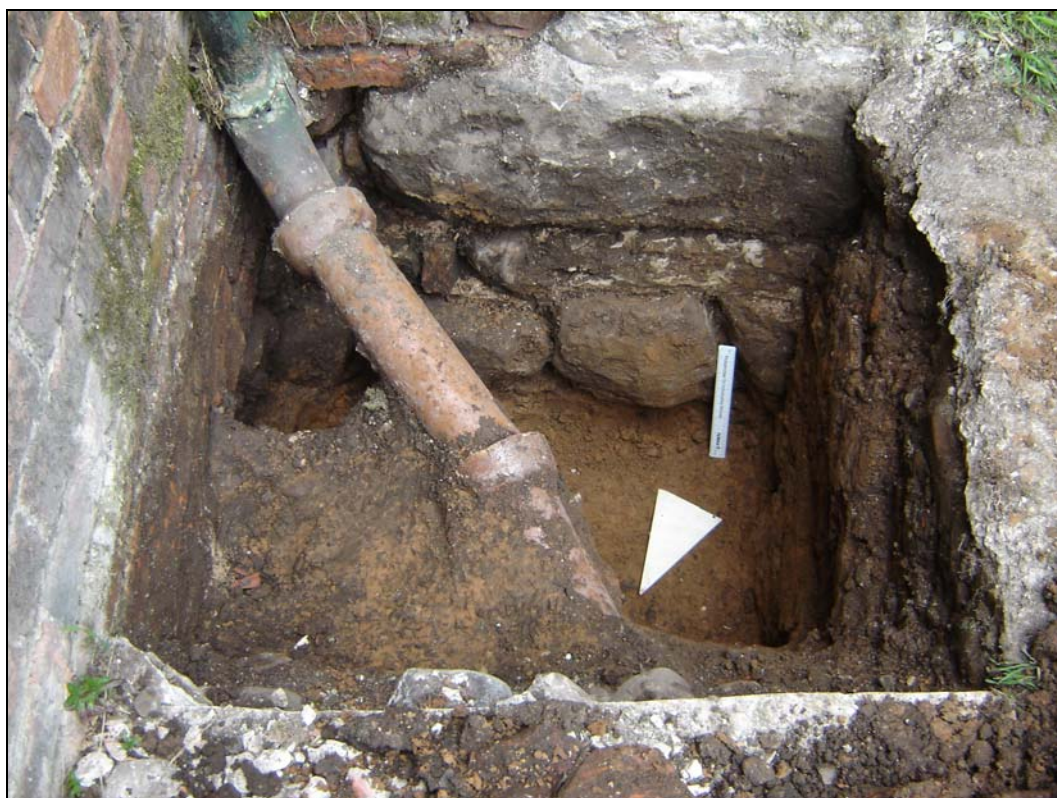
Plate 3. Test Pit 3, looking south-east. Scale 0.30m.

- 5.6 This was located in the angle between extension wall of the barn and the two storey extension on the northern side of the building. An existing down pipe limited the amount of access to inspect the test pit.
- 5.7 Here the barn wall is of brick construction on a 0.76m thick foundation of large undressed sandstone blocks with brick and cobble in filling. The footings for the wall had been built in a construction trench which occupied most of the excavated test pit and had been backfilled with a dark grey humic topsoil. The construction trench had been cut into the underlying natural sand.
- 5.8 The abutting two storey extension was constructed on a single 0.20m thick layer of cobbles; the live downpipe prevented any further inspection.
