ARCHAEOLOGICAL WATCHING BRIEF at ASKE HALL, RICHMOND, NORTH YORKSHIRE

A report to Zetland Estates

Fieldwork & report: Percival Turnbull

5th July 2009

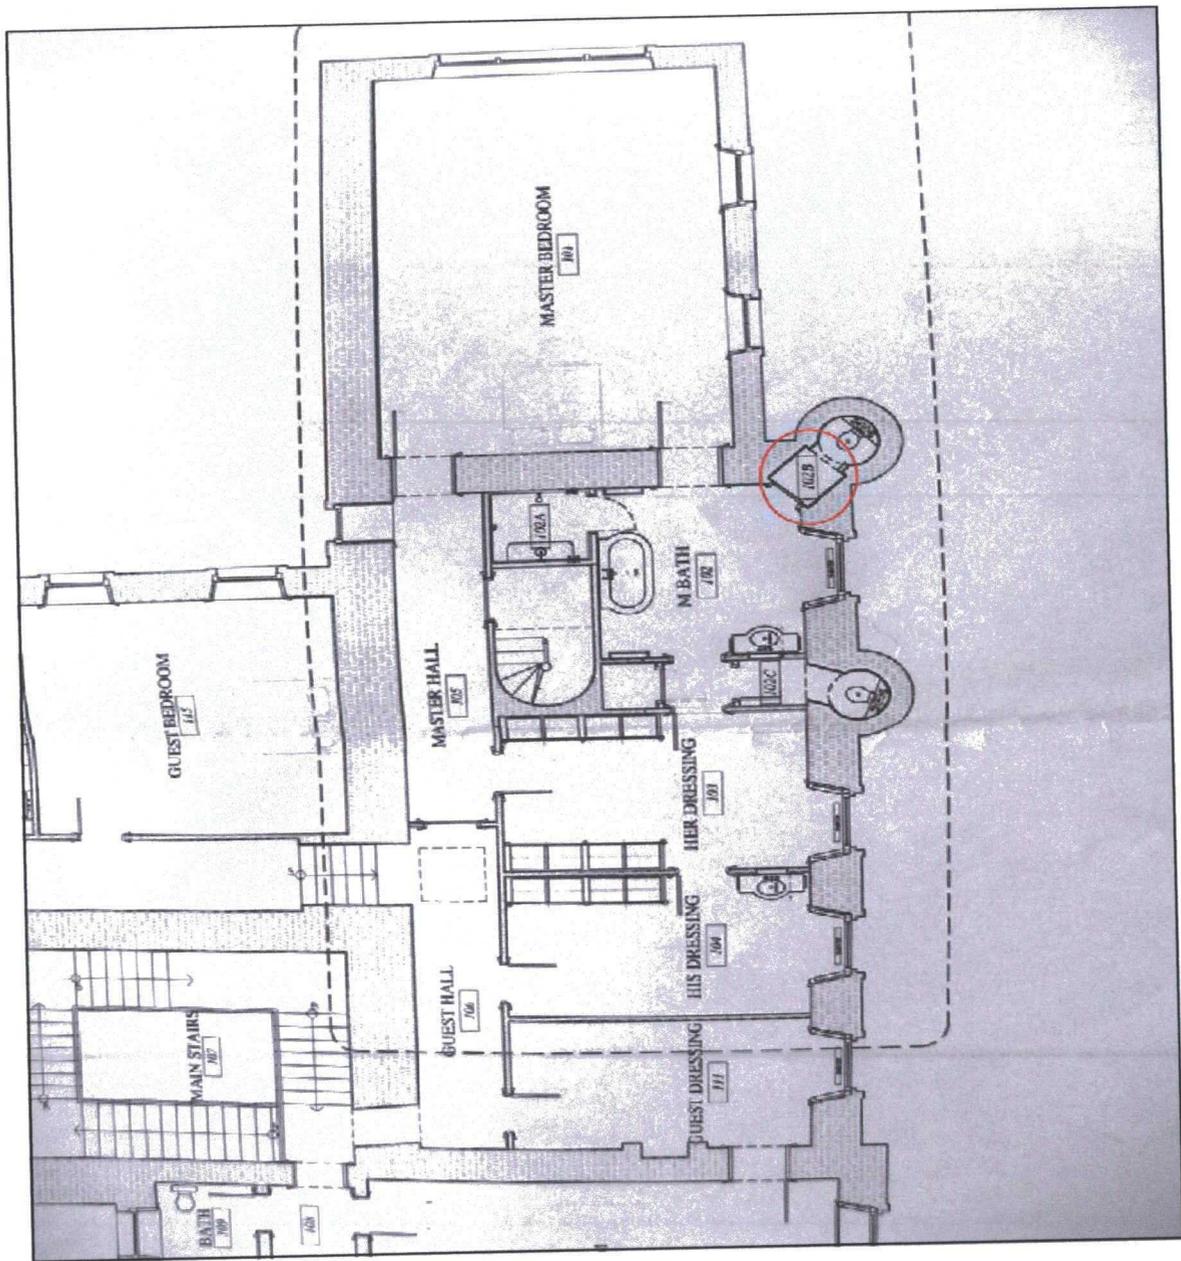
Fig. 1

Location of investigation (circled in red)

On instructions from Zetland Estates an archaeological watching brief was maintained during building works at Aske Hall, near Richmond. This archaeological monitoring was required in connection with works carried out under planning consent (Richmondshire District Council) 1/10/6Q/LBC, concerning internal alterations and refitting. Specifically, the works involved breaking into the interior of a turret on the west side of the Hall in order to provide a new lavatory (see Figs 1 and 2).

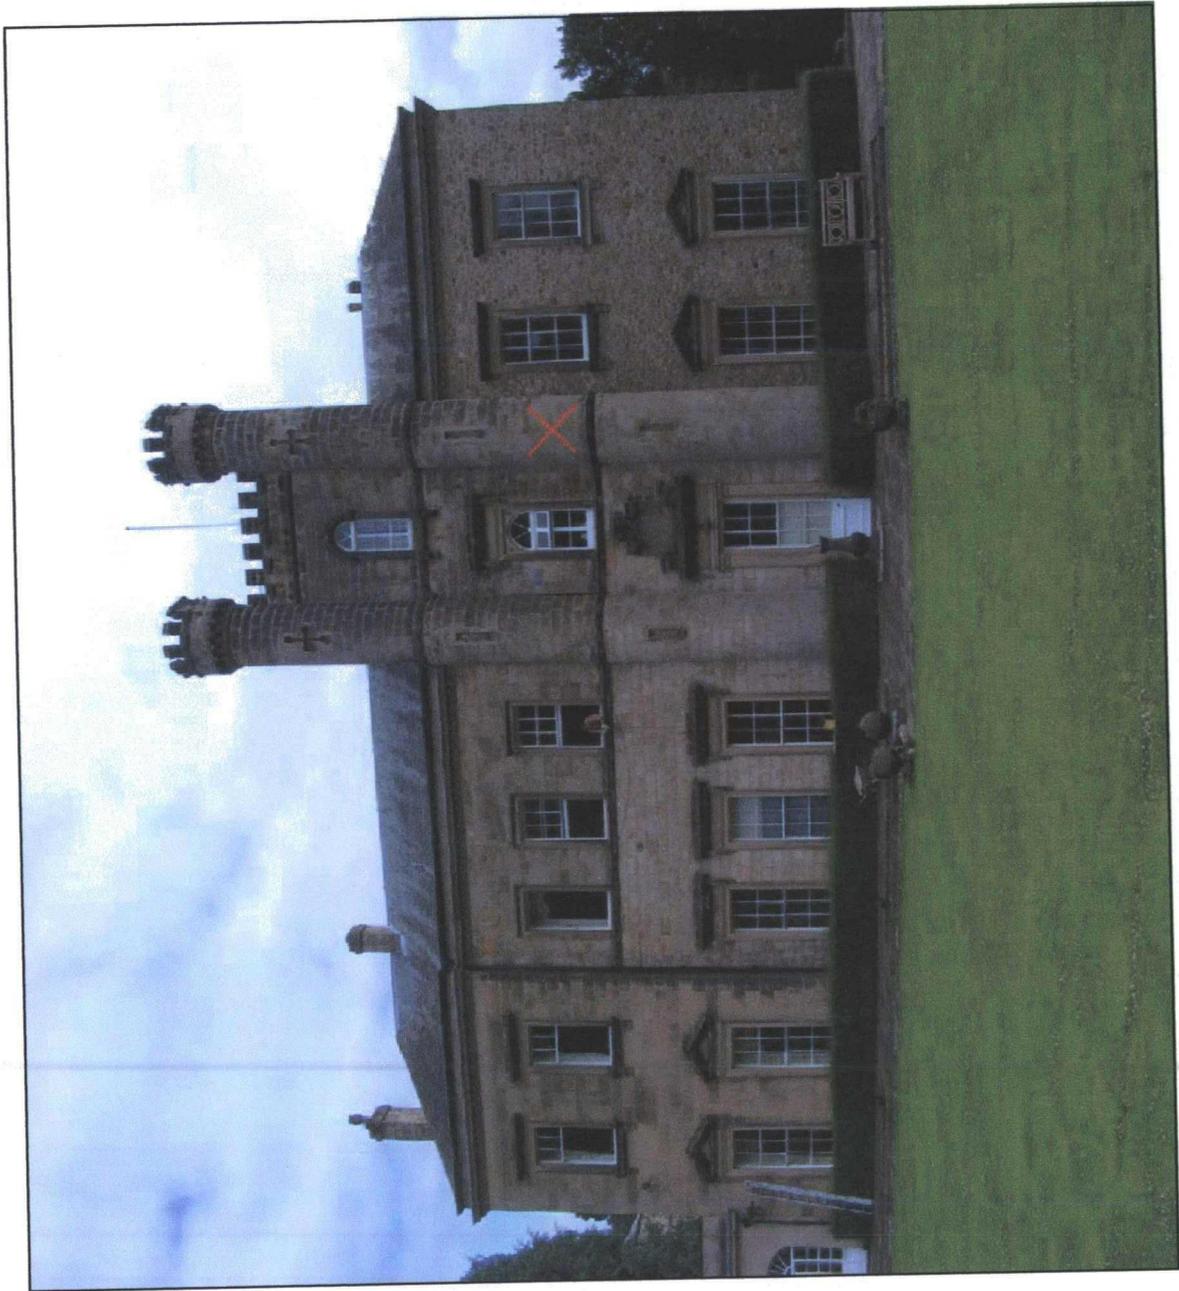
Fig. 2

Archaeological monitoring was confined to watching the breaking-through of a large hole at first floor level from the inside of the southern of the two semi-round turrets in the west face of the Hall; these turrets are those described by Worsley as having been altered by Bonomi, and are attached to the façade of the 'Jacobean' west tower.

West face of the Hall, showing location of investigation (X)

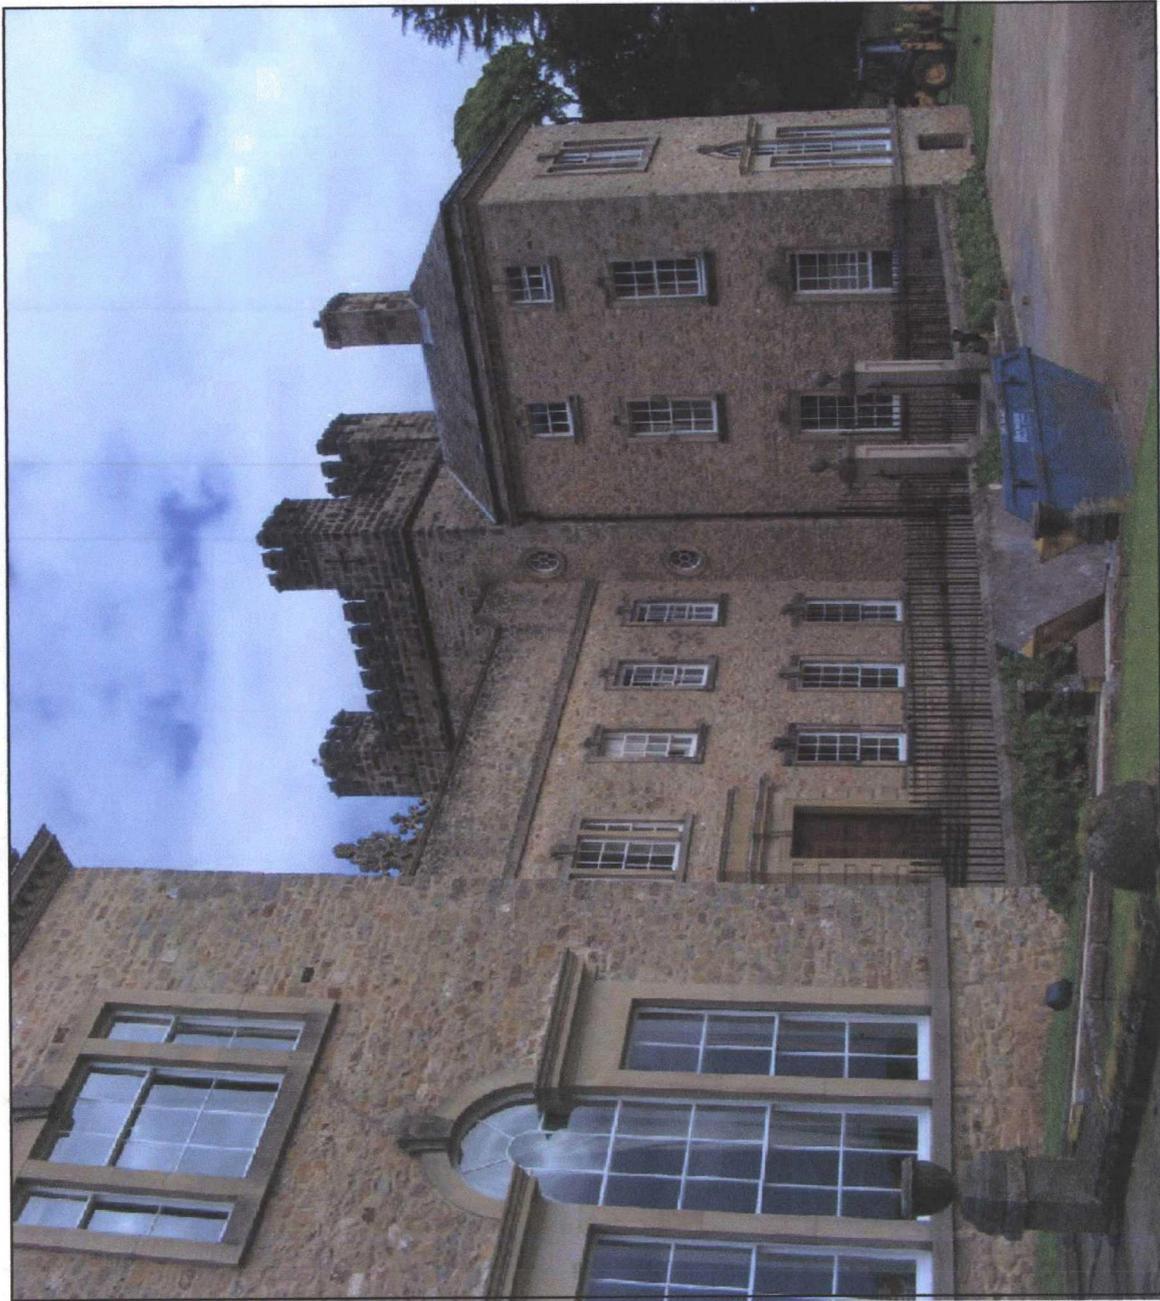
Fig. 3

The earliest part of the house at Aske is the mediaeval tower-house (visible in Fig. 3), arguably as early as the 12th century, but much more probably somewhat later. To this was added a Hall block; what survives is largely representative of the Elizabethan Hall commissioned by Walter and Eleanor Bowes (who acquired the sequestered estate after Robert Aske paid the price of his involvement in the 'Rising in the North'); it is difficult to be sure that this is not itself a remodelling of a mediaeval Hall block.

**Southface of the Hall, to show the original
mediaeval tower-house (centre).**

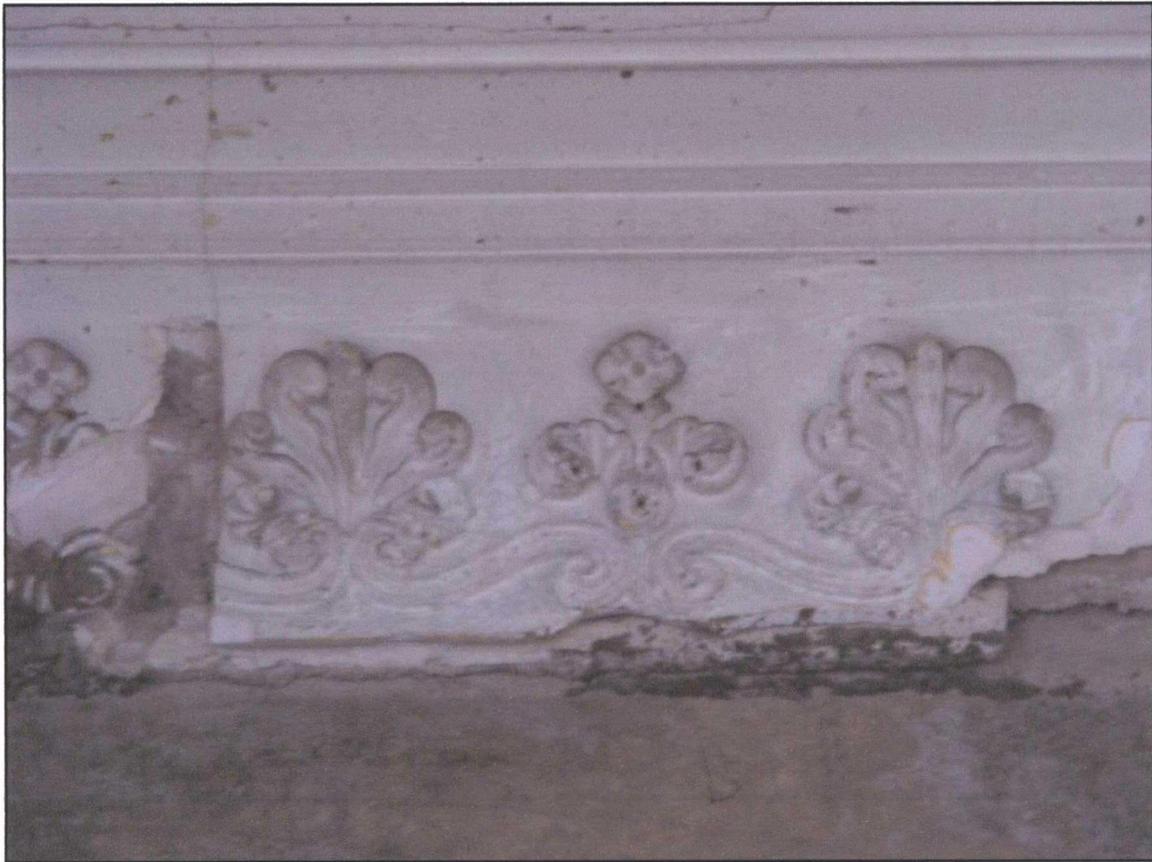
Fig. 4

The first floor of the tower is now subdivided into various bedchambers and bathrooms; it was at once evident that most of the internal divisions are of modern block work, and that the modern suspended ceilings conceal loftier ceilings of the late 18th or early 19th centuries, the stucco cornices of which survive (Fig. 4). No early wall seems to have been removed during the present works.

18th century ceiling

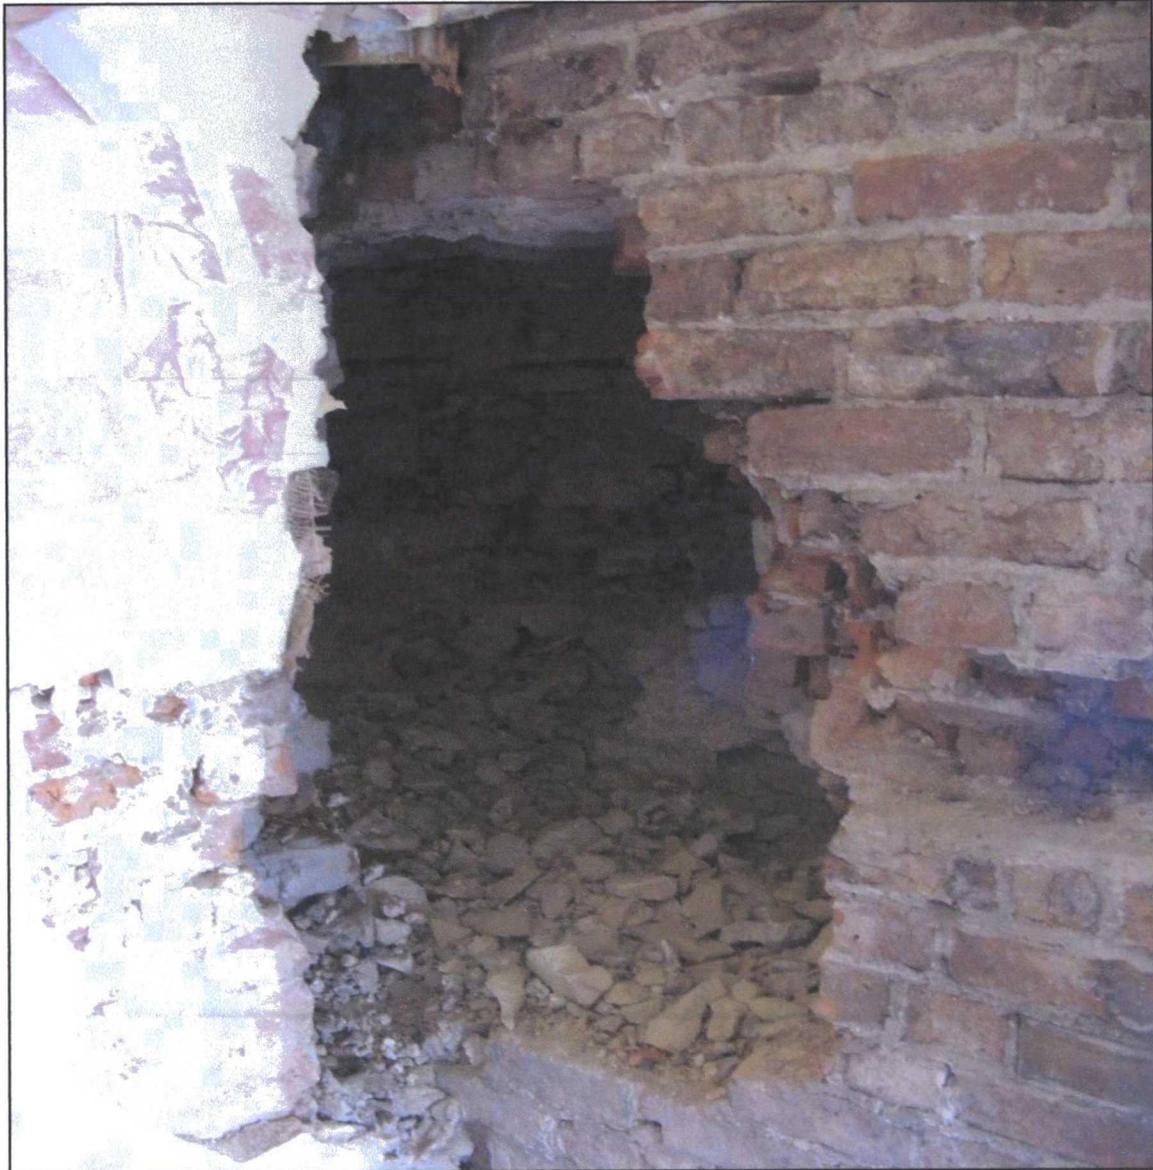
Fig. 5

The hole was broken through using only hand tools (Fig. 5). The inner face of the west front proved to be of large, hand-made bricks of late 18th/early 19th century type. Supported by this was a skin of lathe and plaster, which may well have been later. Behind the bricks, the rest of the construction consisted of mortared sandstone rubble: that is to say, the turret was not hollow, but solidly built.

Excavated hole

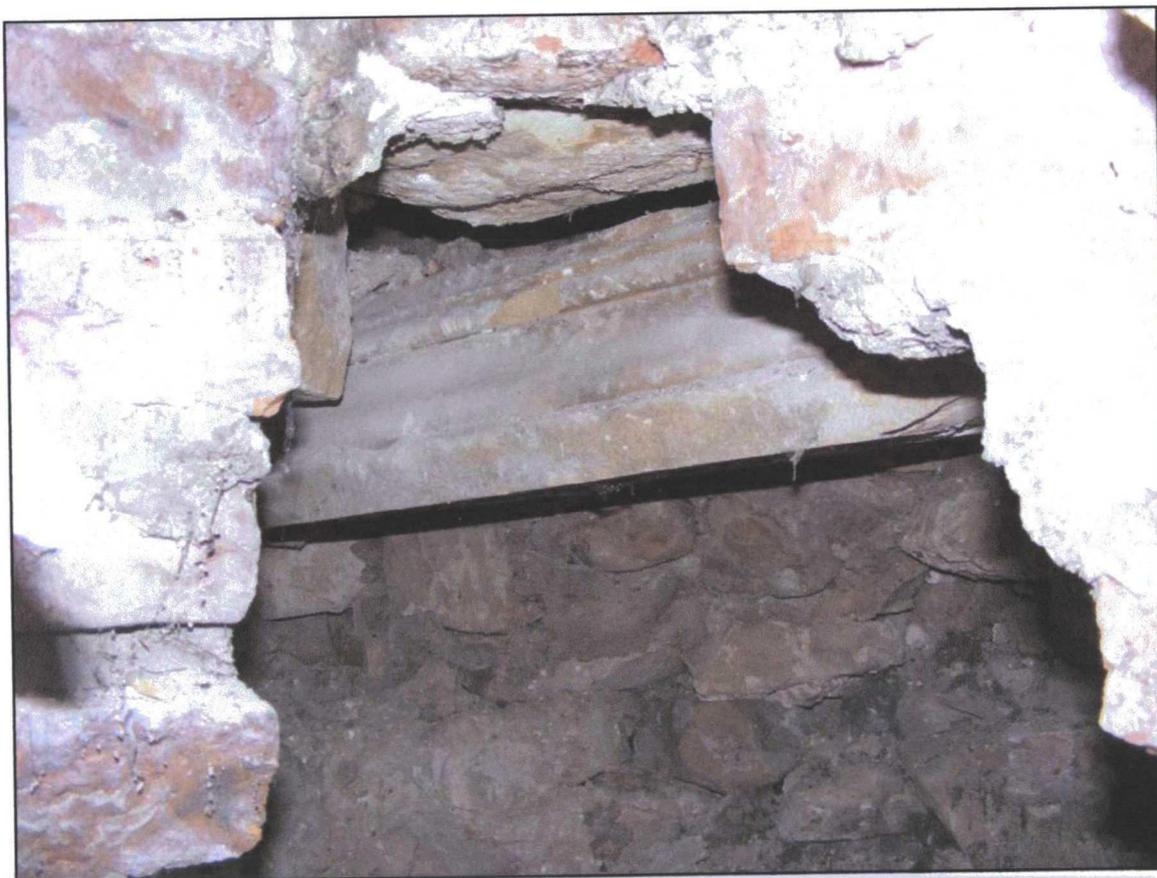
Fig. 6

Incorporated into the rubble construction of the turret was a large piece of moulded sandstone, shown in situ in Fig. 6. This proved to be a large lump of a moulded entablature, the bottom portion broken off but with a cyma and an ovolo. On the surface which would originally have been uppermost (it was upside-down when found) was a clear line dividing a clean white area from a sooty black area; this obviously represented the position of a former parapet which had stood on top of the stone.

Reused fragment of entablature *in situ*

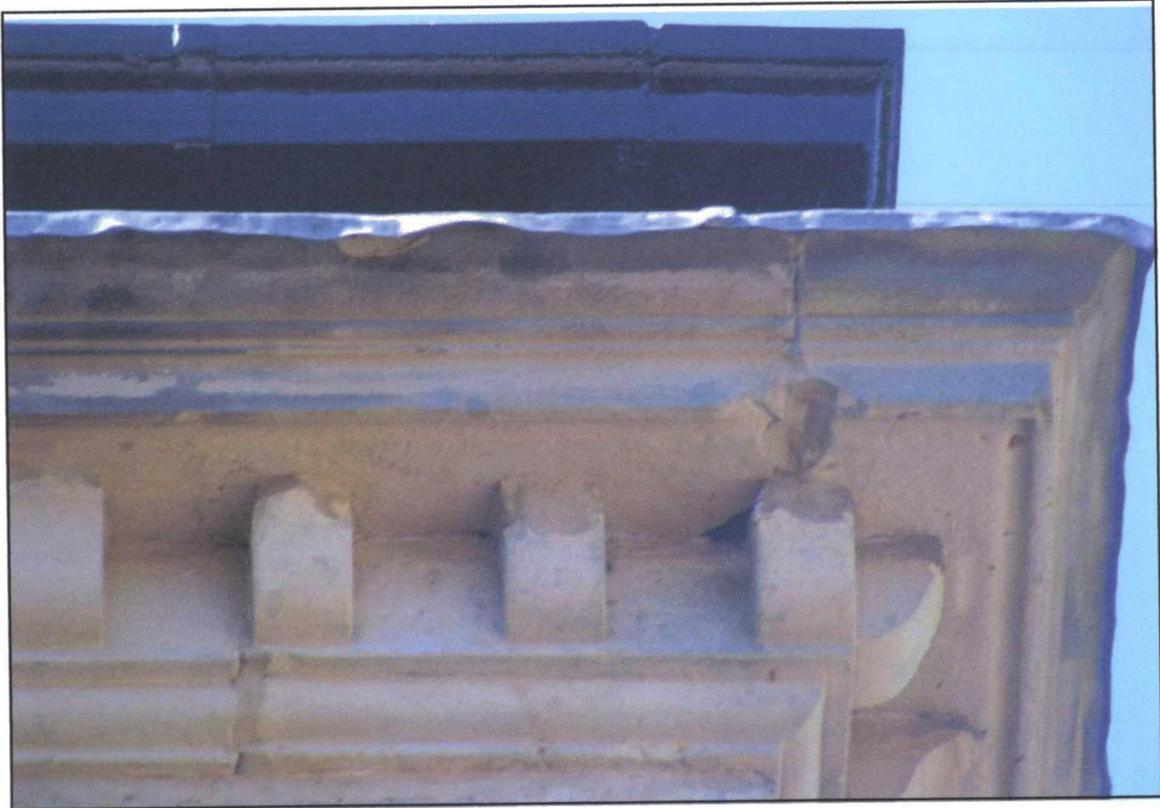
Fig. 7

A source for this fragment was not hard to find; it is a portion of the existing Ionic entablature which still runs around the building (Fig 7). The piece found in the turret has lost the dentate lower part. This is a useful piece of dating evidence; in order to build up the turret above the general height of the eaves it would have been necessary to cut out a piece of the entablature; the turret may therefore be taken as later in date than the rest of the block which is probably, in its present form, of the time of Sir Lawrence Dundas.

Entablature on SW corner of Hall
