LAND EAST OF ST WILFRID'S ROAD, RIPON.

REPORT ON AN ARCHAEOLOGICAL WATCHING BRIEF.  
OSA REPORT No: OSA09EV15.

June 2009.

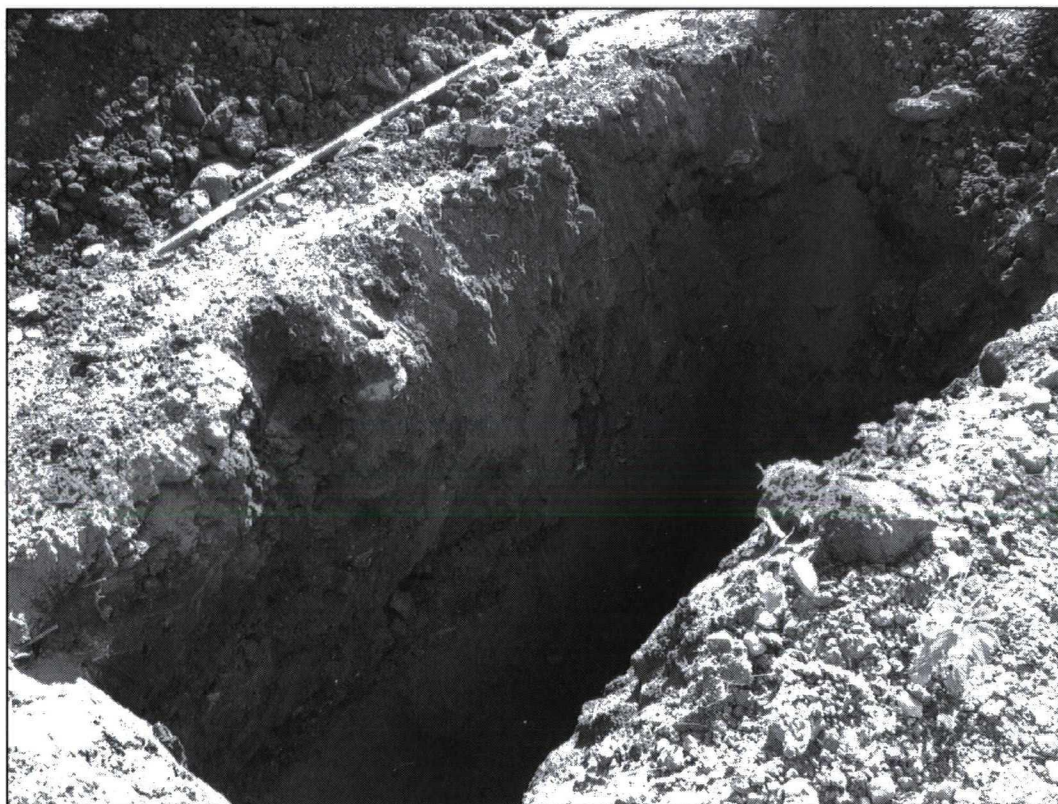
**Trench 1**, orientated northwest-southeast was located towards the northwest corner of the development site. Excavation revealed a sequence of deposits only consisting of approximately 0.8 metres of a greyish brown sandy silt deposit (100) containing frequent inclusions of small stone fragments and gravel with occasional fragments of modern brick and CBM, which sealed the brownish orange sand natural (101). No archaeological deposits were identified within the trench. (plate 2)

*Plate 2. General shot of trench 1*

Deposit (101) is possibly a recent 'made' ground deposit associated with recent demolition, sealing the truncated sand natural, probably indicating the location of a former building thought to have existed until relatively recently.
