Spital House Farm, Northallerton

Spital House Farm presents the appearance of a small Georgian farmhouse of two broad bays, with a rather lower single-bay 'cottage' added to the west end, but incorporates fabric of an earlier stone house in its end and rear elevations, which in turn re-uses medieval material from the medieval hospital which stood upon the site.

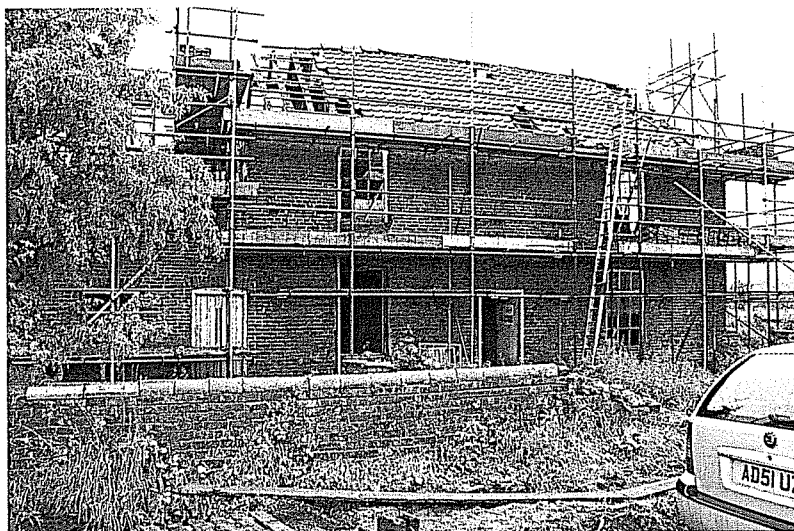
The front elevation of the main body of the house, facing south, is of old orange brick, laid in English Garden Wall Bond 1 & 5, with a pantile roof; the brick wall stands on a rough stone footing (as do all the brick internal walls). The elevation is of two storeys and two broad bays, with a boarded door under a flat-arched lintel set slightly left-of-

centre; the windows are 12-pane sashes with narrow moulded glazing bars, also under flat arches; they are now in poor condition; that on the ground floor right has been replaced by a 20th century small-paned casement. There is a stepped brick cornice at eaves level; there were end stacks, but these have fallen. To the right is the single-bay cottage, built in similar brick but in a rather less regular bond. This has a similar cornice at a lower level; the doorway, set hard up against the west end of the house, looks to be secondary, and has a slightly segmental-arched head in pink brick. The ground floor window is a 4-pane sash, with horns; the upper one, tucked directly beneath the eaves, has now lost both its carpentry and its lintel. At the west end the lower part of the south-west angle is formed by five cut sandstone blocks which oddly comprise the north jamb, chamfered to the west and rebated to the east, of a doorway, of 17th century or earlier character, that has been set north-south. This is a puzzling feature, but seems to be in situ as two pintels are still in position for the hanging of the door; nothing remains of the south jamb, and the present brick garden wall (later 19th or 20th century) is set on a line a little further to the east.

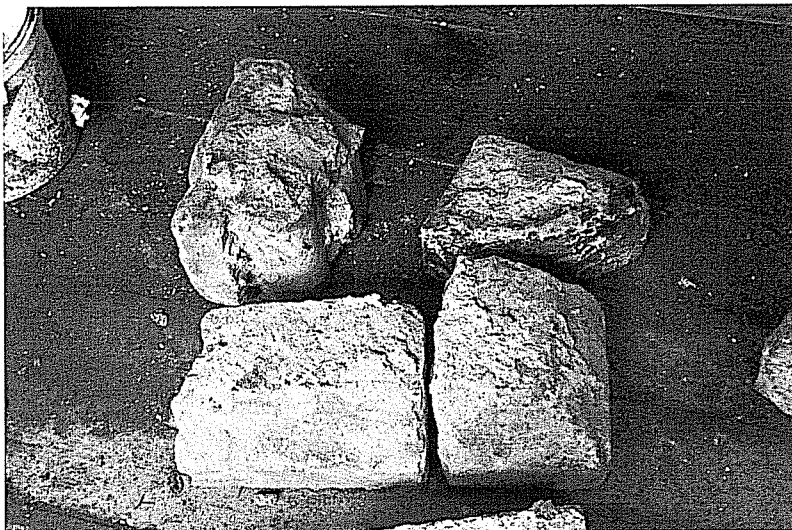
Retrieved worked stones, with roll-moulded block top left

The present orientation of the building does not align with the substantial and extensive earthworks of the hospital scattered across a series of enclosures within the precinct, suggesting that the present building owes nothing to what was on the site before the dissolution. The earthworks of a substantial hospital building lie to the east, but not in line with the standing structure. The re-used material clearly comes from the medieval hospital on the site, which documentary evidence shows had an extensive complex of buildings. The stone with the roll moulding is particularly interesting, indicating that there was a high-status Romanesque or early Gothic building with ashlar dressings erected soon after the foundation of the hospital c1200; it now seems likely that the founder was Philip de Poitou, Bishop of Durham 1197-1208, rather than his predecessor Hugh de Pudsey (1154-1194). The list of buildings given in a series of 13th century documents, and those implied by service people there such as bakers etc suggests that there was a large collection of structures akin to a small monastic establishment set within separate courts each with their own function, as implied by the earthworks on the site. Indeed when the hospital was surrendered on 19 May 1540, the warden and his confraters met in the chapter house; either this or a chapel (perhaps attached to the east end of an infirmary hall) might have provided the roll-moulded stone.
