**Staynor Hall
Selby
North Yorkshire**

**Building Survey
SE 6230 3110**

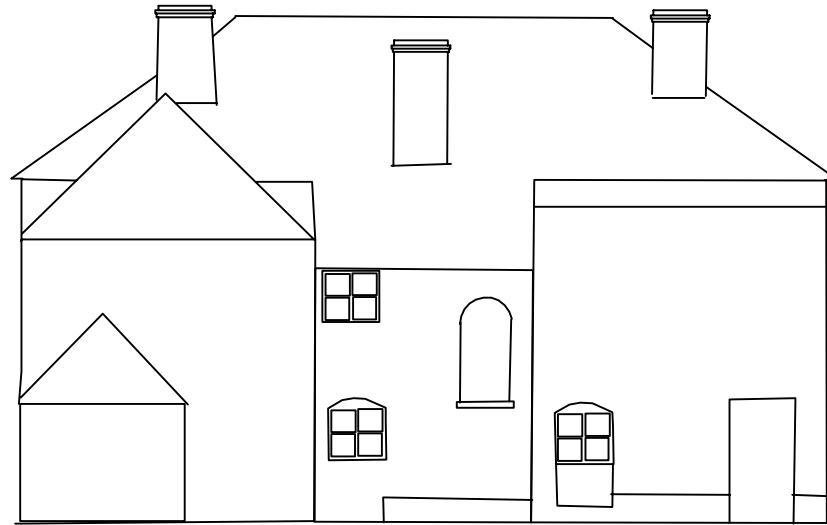
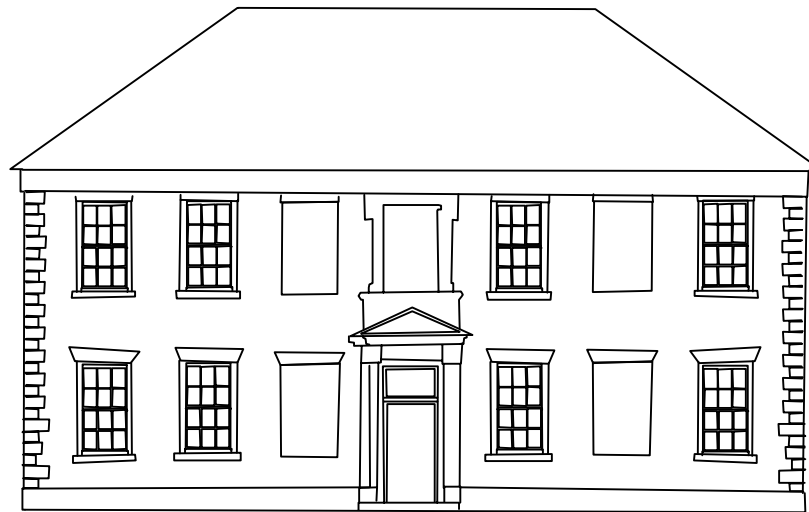
North Elevation

South Elevation

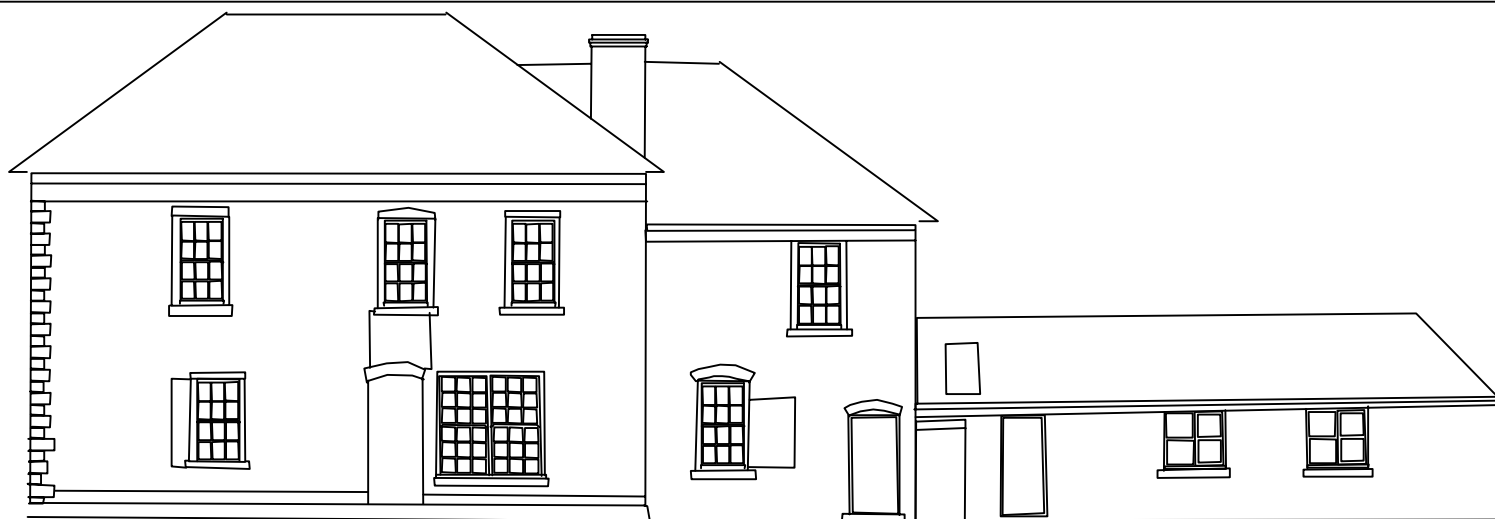
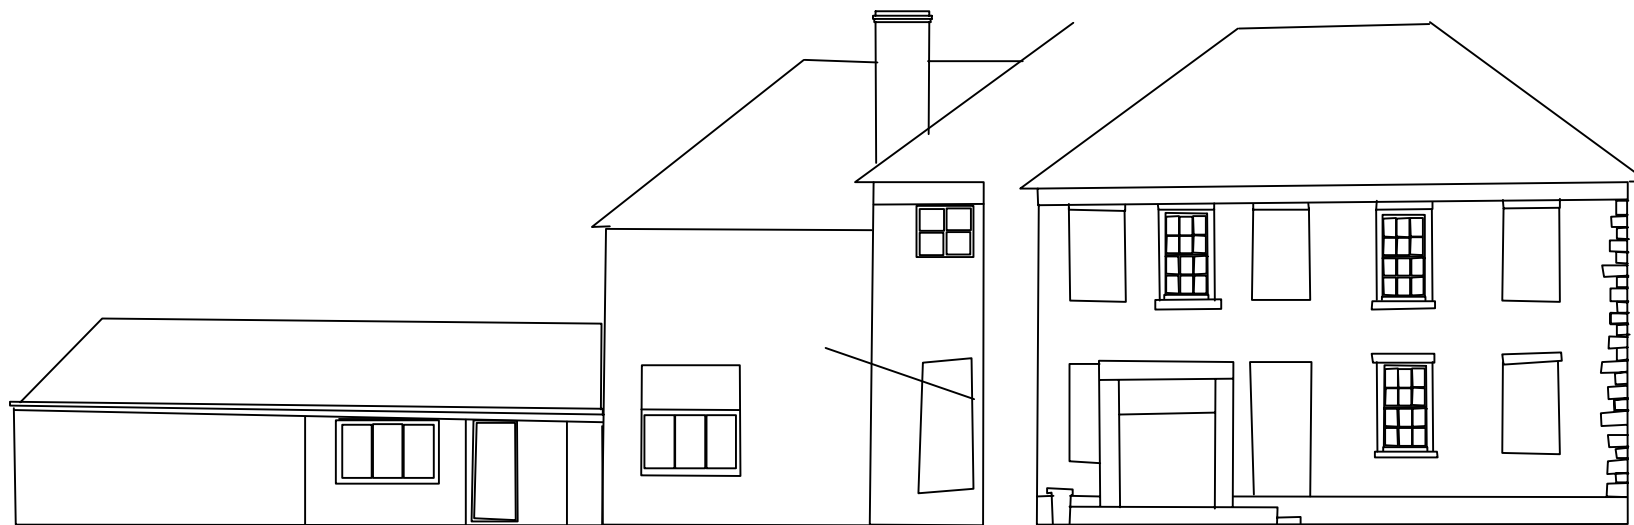
FIGURE: 9

6.2.4 The west elevation originally had five windows on the first floor, and four windows and a central door on the ground floor. The northernmost, central and southernmost windows on the first floor are blocked. The northern, two windows have been replaced by patio doors on the ground floor. The central door and southern most window on the ground floor are blocked. This regular classical façade also faced towards Bawtry Road. The windows are all tall six over six pane vertical sash windows almost flush with the exterior wall.

East Elevation

West Elevation (Rear)

West Elevation

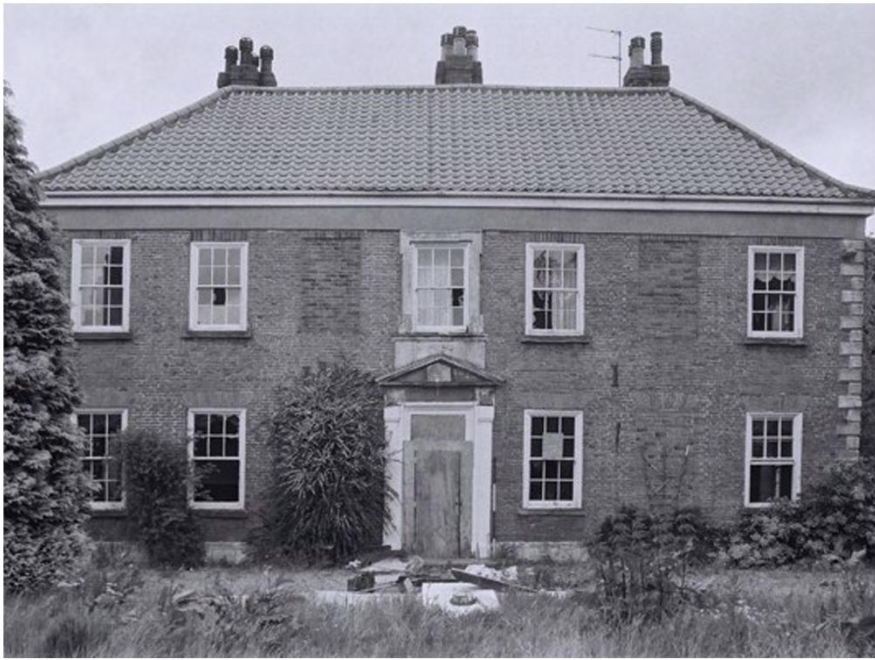
Plate 5. Staynor Hall: Exterior North Elevation. Facing South.

6.2.2 There is a two storey northern nineteenth century extension with hipped roof on the eastern wing, and a single storey nineteenth century outhouse building, which has been converted into a domestic dwelling and office.

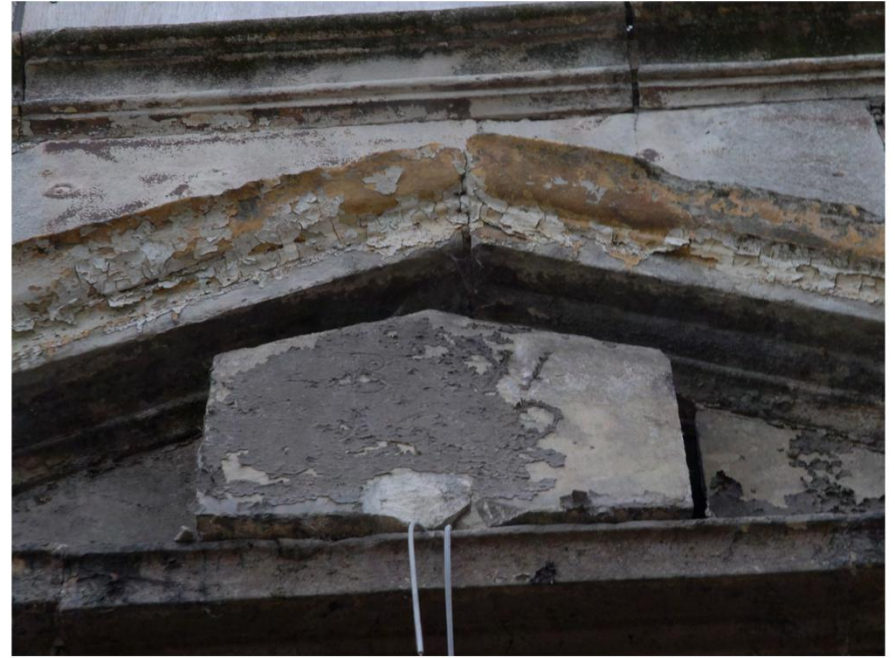
Plate 20. Staynor Hall: Exterior Datestone. Facing North.

6.2.1 Staynor Hall comprises a late seventeenth century two-storey house with later extensions. The house and extensions are built in brick with hipped pantile roofs. The house is constructed in early small flat bricks in English bond with lime mortar with flush jointing. The rear extension and outhouse are constructed in eighteenth/nineteenth century brick. The roof is a late, possibly twentieth century addition from the condition of the pantile (The use of ceramic pantile dates from the eighteenth century; there is no evidence as to what material the house was originally roofed with). There is a stone plinth on the south, east and west elevations of the house and on the northern elevation of the western wing. The guttering, flashboards and downpipes are all modern plastic replacements. A modern classical style porch had been torn down by vandals.

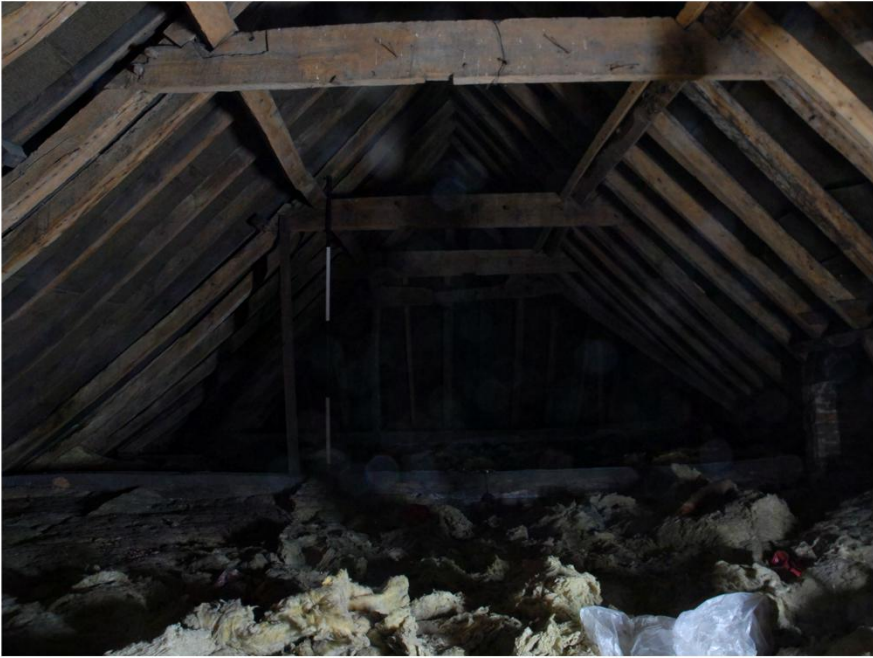
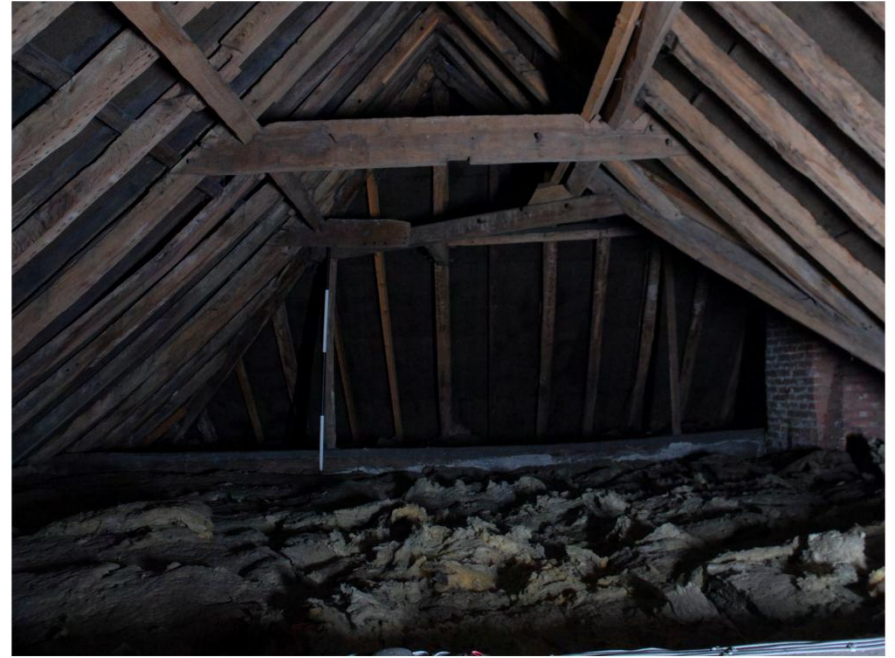
6.5.2 The structure for the hipped roof included four common rafters with collars. Several re-used timbers were noted as purlins, these included wall plates. The door between the east wing and the main attic is of plank construction with a lift latch.

Plate 53. Staynor Hall: Interior Attic. Facing West.

Plate 54. Staynor Hall: Interior Attic. Facing West.
