Denison Road, Selby, North Yorkshire

archaeological desk-based assessment

Report 2251
August 2009

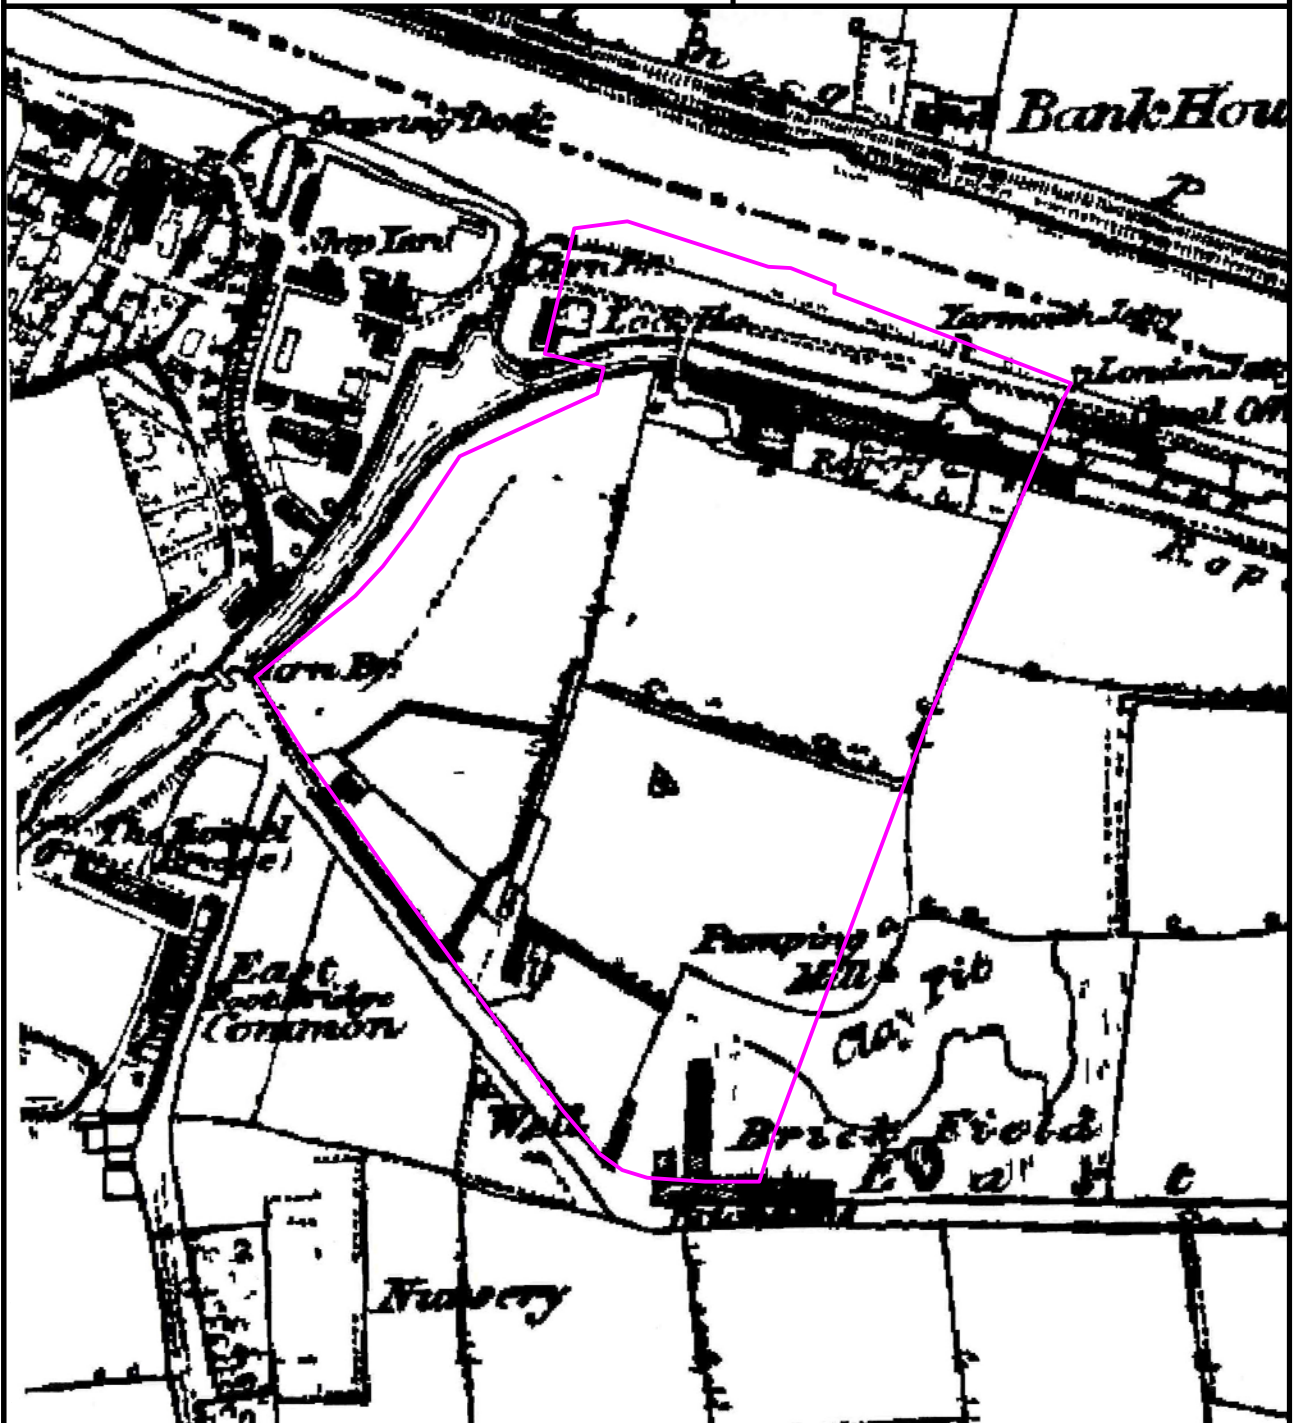
- 4.19 The 1818 map of the Manor of Selby (Figure 6) shows The Lazy Cut with the dock and buildings to the north and south but most of the site is undeveloped fields. Denison Road appears as Barlow Bridle Road on this map.

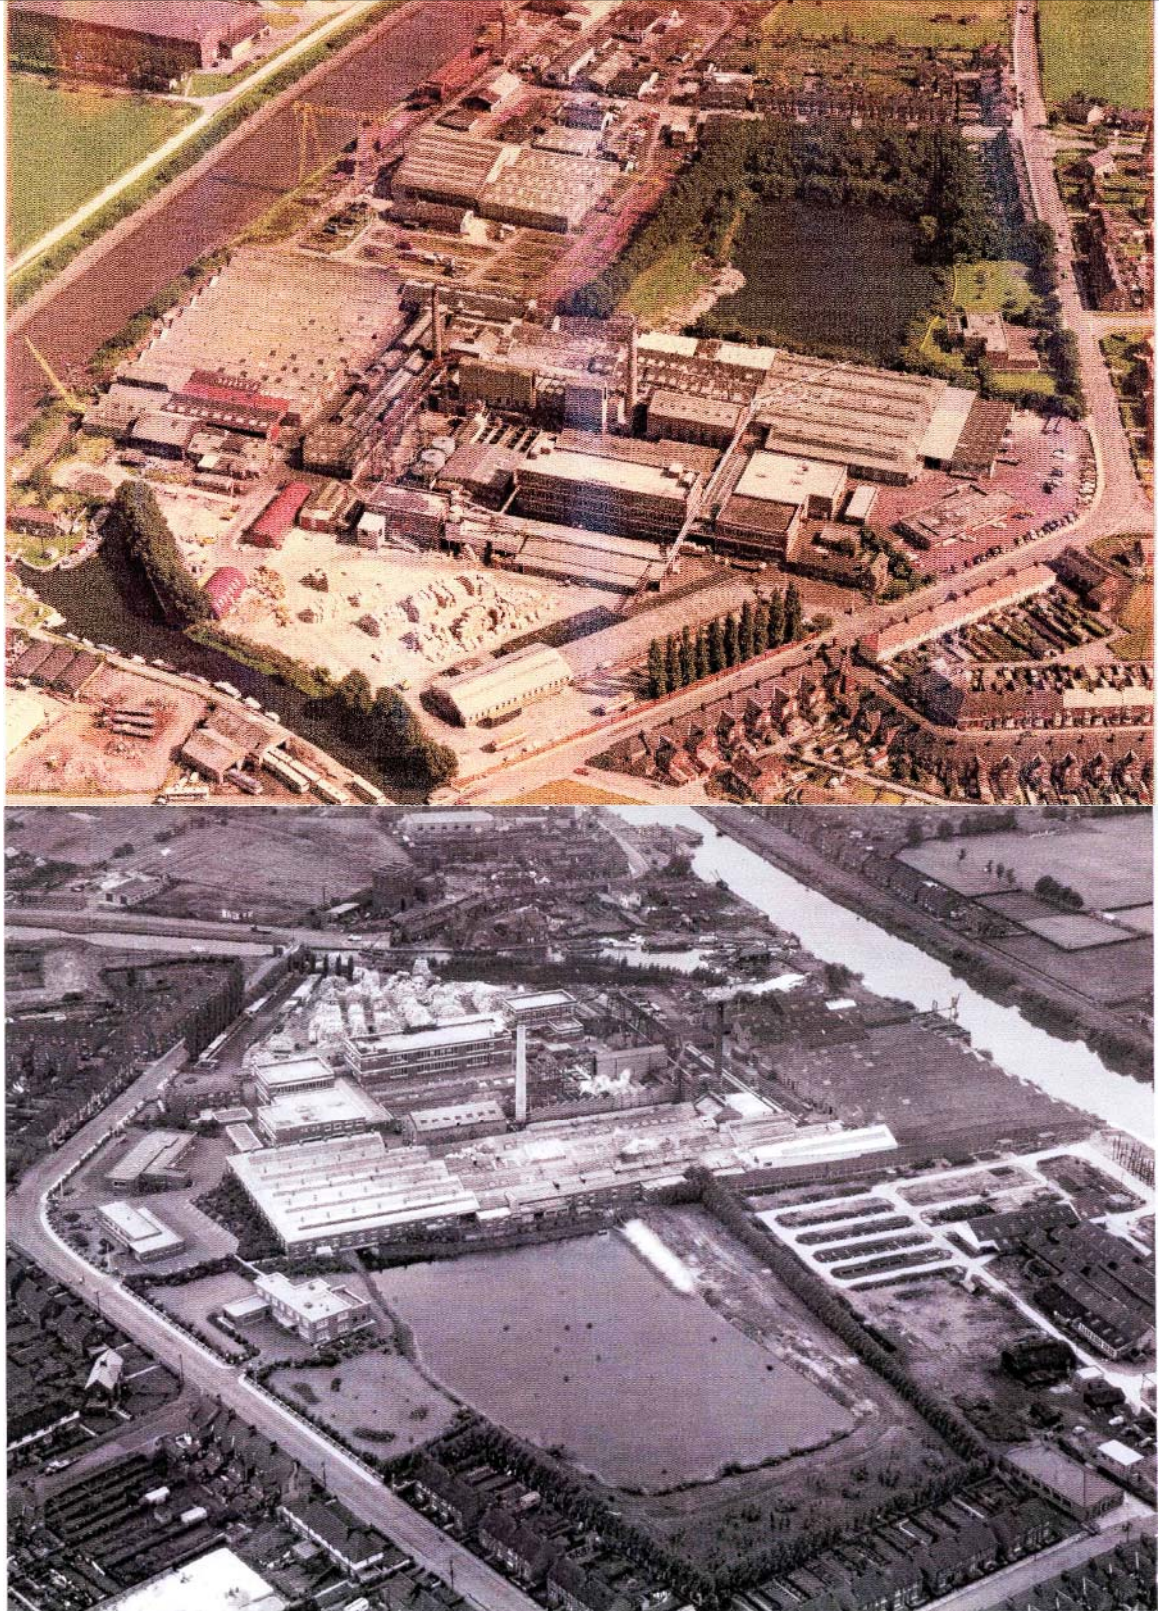
Aerial views of the site

- 4.25 The development site has undergone various changes and modifications since its origins in the early 20th century. Some of these can be seen in the aerial photographs provided by Sharon Foster (Figure 11). The site has also been subject to at least one flood, in 1947 when the River Ouse burst its banks and flooded the low-lying parts of the town (Illingworth 1947) and much of the surrounding countryside. A flood alleviation scheme has been put in place to reduce the effects of future floods (HER 2062).

- 4.28 There are no statutorily protected buildings in the vicinity of the site. Some of the buildings on the site – particularly in the northern and south-western parts are of late 20th-century date and replaced earlier structures visible in aerial photographs (Figure 11).

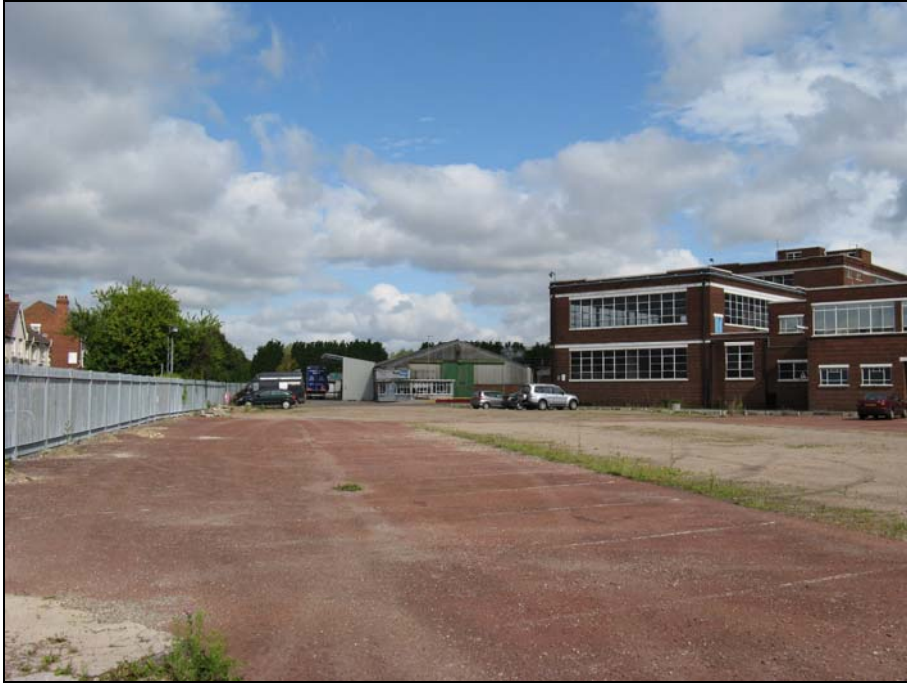
Figure 12
View westwards across the southern part of the site

western boundary along Denison Road is marked by a brick wall to the north of the entrance and a metal-post fence to the south of the entrance (Figure 12). This fence continues along the eastern boundary but was inaccessible from the site as the extant buildings are built against the boundary.

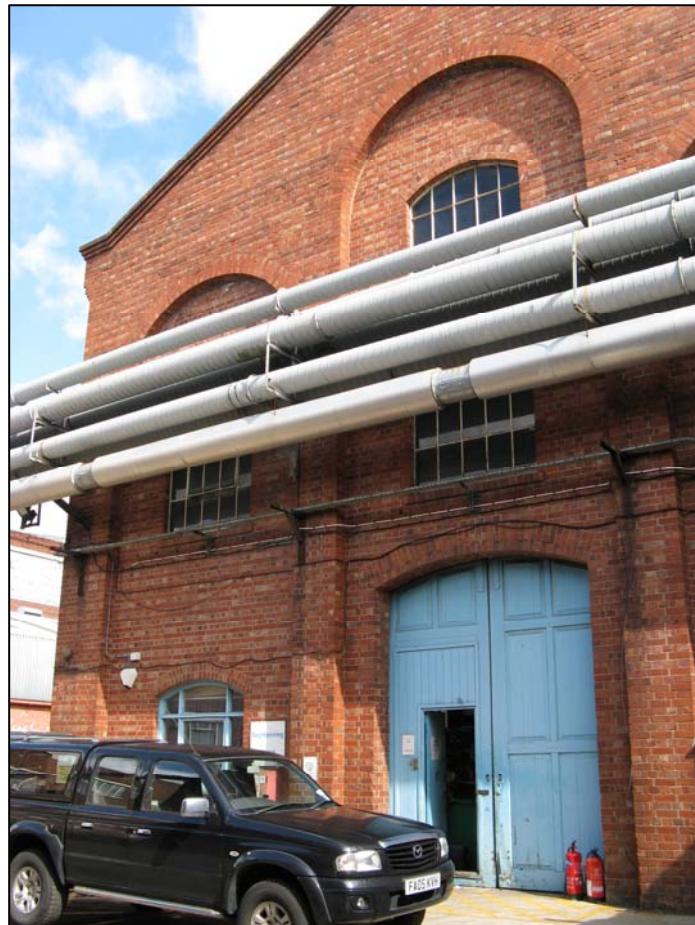
Figure 13
Brick buildings along the eastern boundary of the site

- 5.3 The structures in the eastern part of the development area are of corrugated metal with brick buildings behind (Figure 13). They have concrete floors with rails and tanks (Figure 14). The southern group of buildings has been largely cleared but there is still paper processing machinery in the northern part (Figure 15).

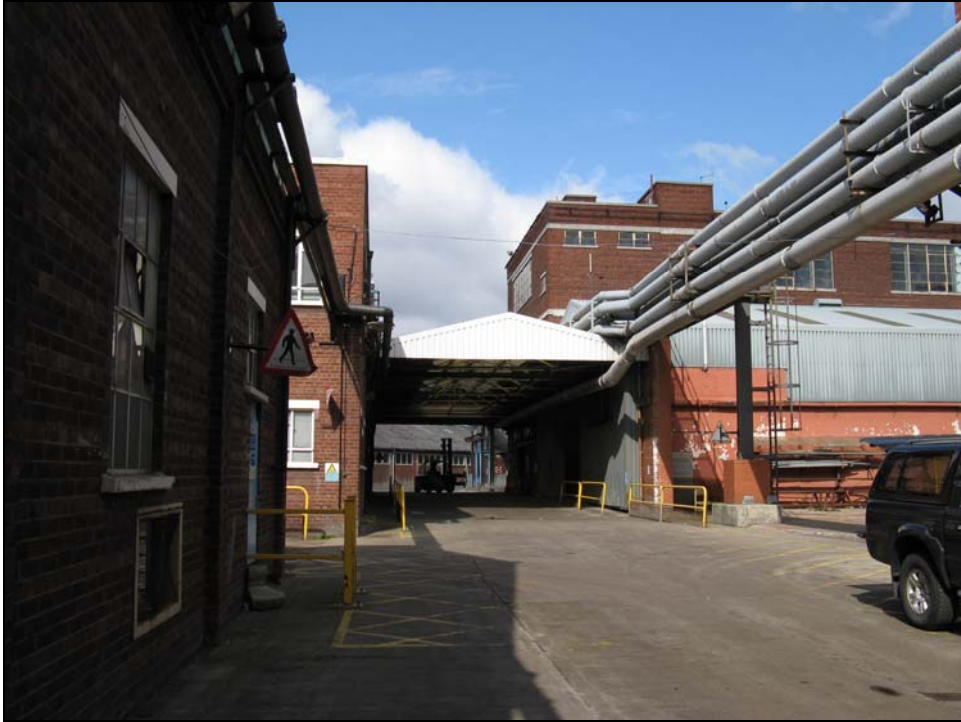
Figure 16
Central part of the development site

- 5.4 The central part of the site is occupied by substantial brick buildings and corrugated metal structures that are currently not in use (Figure 16). The tallest houses conveyor belts (Figure 17) that formerly took pulp from underground tanks. It was not possible to gauge the depth of these tanks as they were covered by iron sheets.

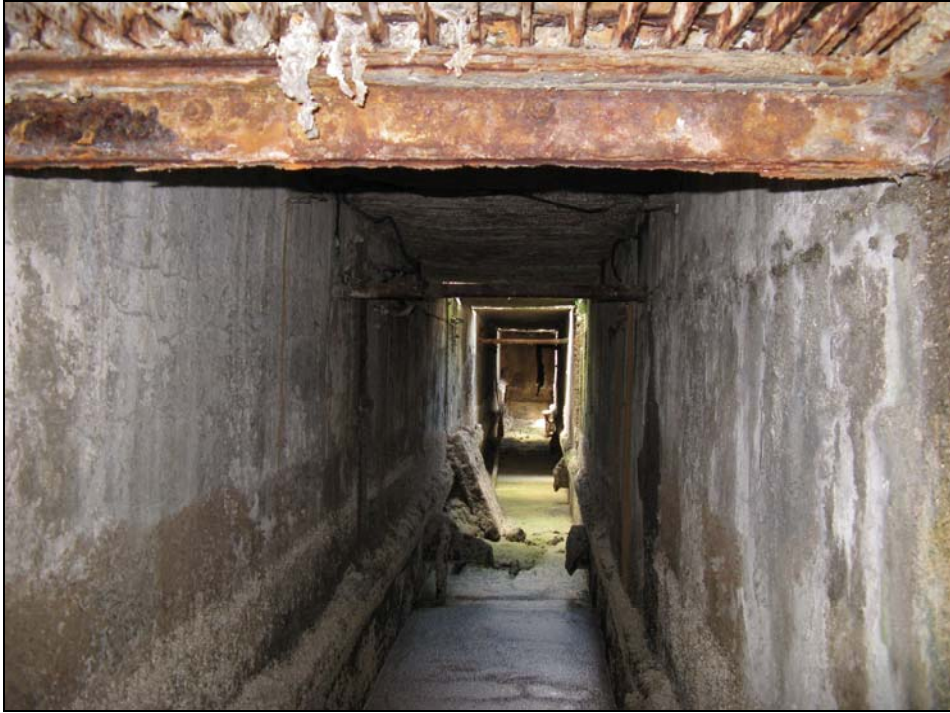
Figure 18
Narrow tank

- 5.5 A series of tanks had also been excavated in the north-central part of the site. These were part filled with water and sludge and their depth could not be ascertained (Figure 18).

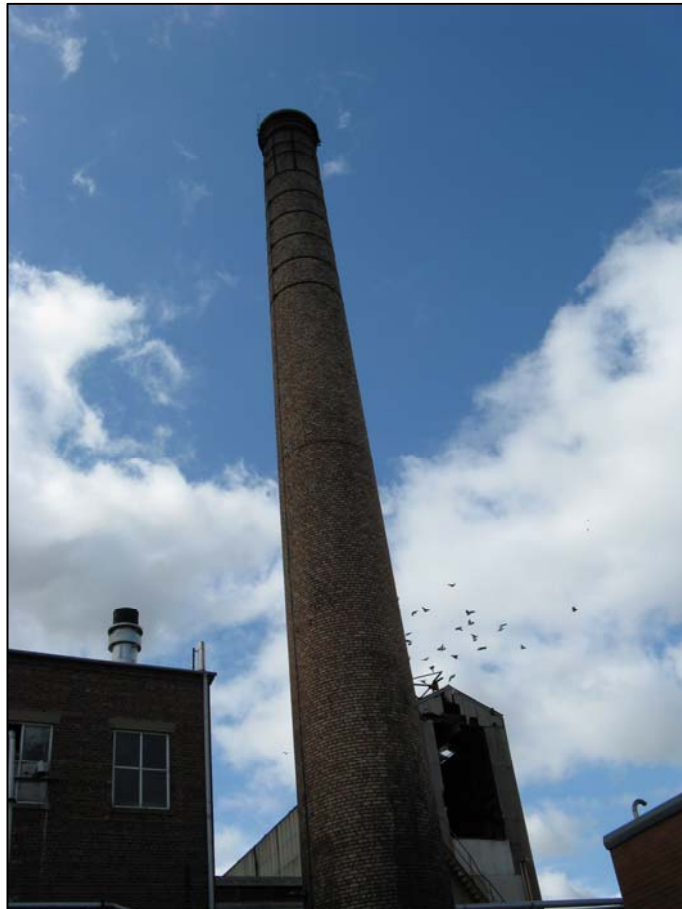
Figure 19
Brick chimney

- 5.6 The site is dominated by a brick chimney (Figure 19).
- 5.7 The northern boundary of the site (on the bank of the River Ouse) is a brick wall with open ground to its south (Figure 20). This open ground continues along the western boundary (Figure 21) although the remains of brick and concrete foundations can be seen in this area.
