**Brompton Hall
Brompton-by-Sawdon
North Yorkshire
Archaeological Watching Brief**

March 1997
MAP Archaeological Consultancy Ltd.

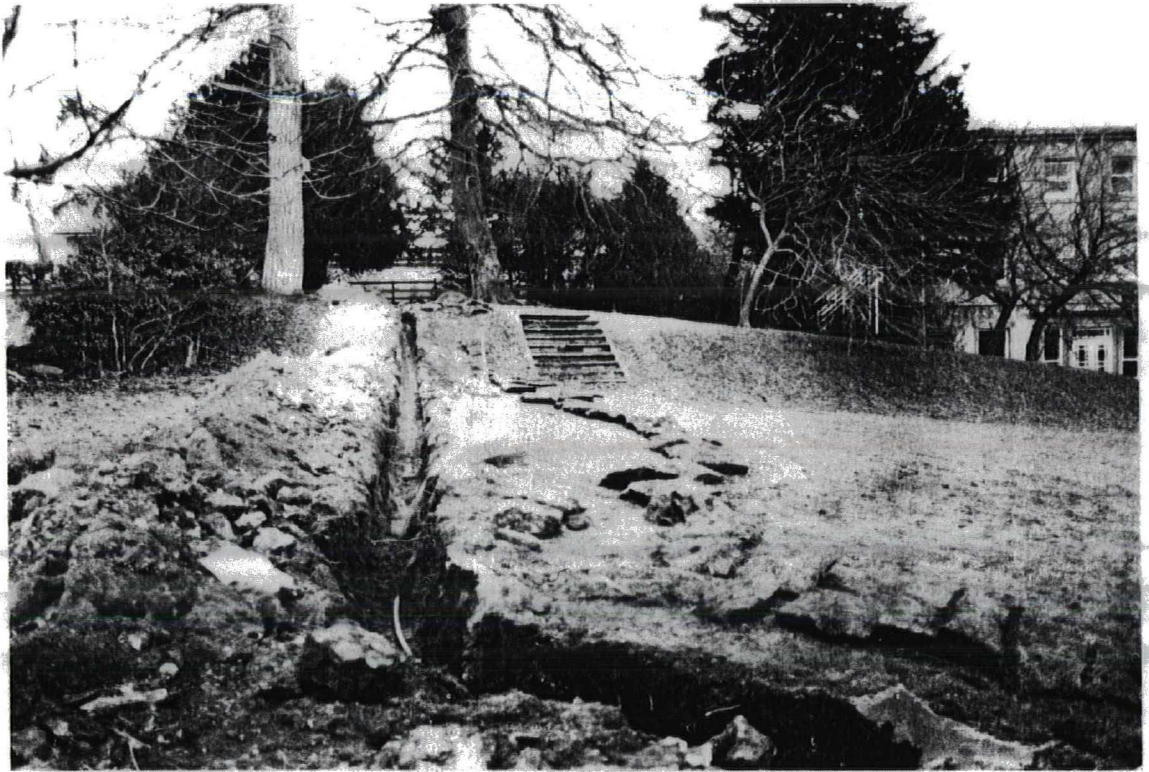
Natural bedrock (context 10000) was observed within 0.20m of the ground surface in the extreme northern portion of the pipeline (Pl. 1). Directly above the natural limestone was a friable sandy silt topsoil (context 1001). The depth of deposit was greater in the southern area of the site and natural deposits were not observed in the churchyard itself.

Plate 1. General view of pipe trench. Facing north.

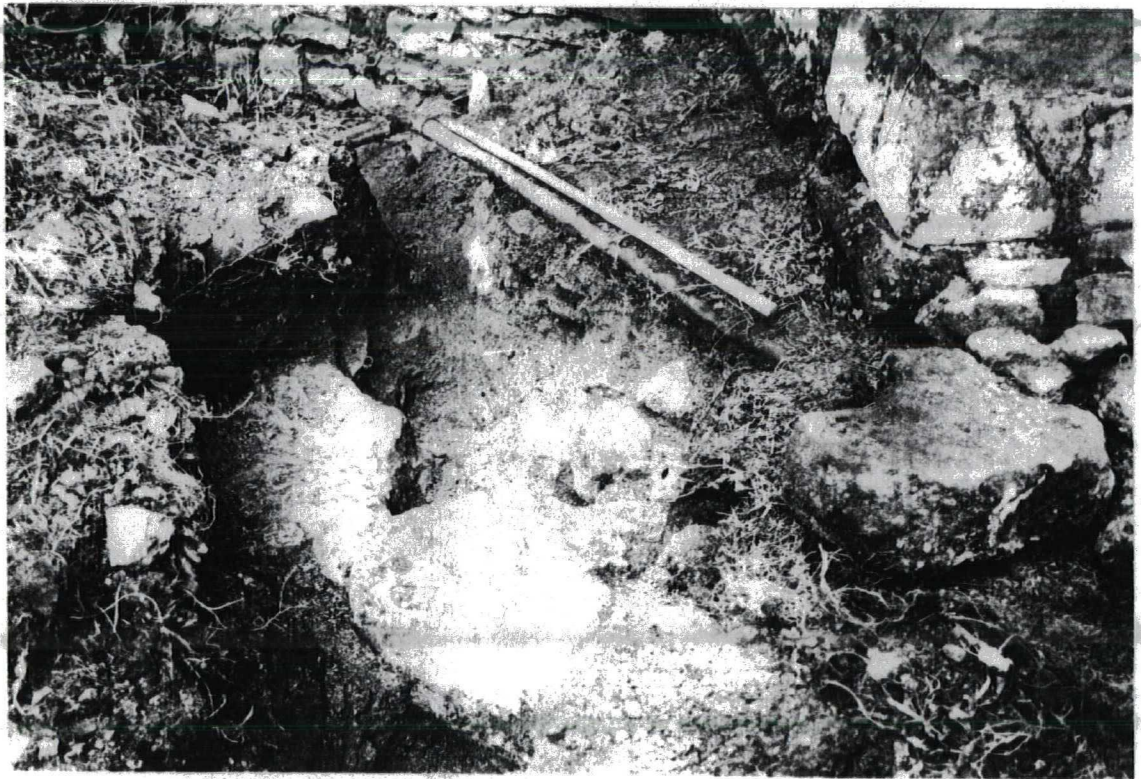
Near to the church tower (the southern most end of the pipeline : Fig. 2) within 0.31m (35.90m A.O.D) of the existing ground surface (36.21m A.O.D) two large limestone blocks were recorded in situ (context 1004 : Fig. 3 : Pl. 2). Covering the limestone blocks was a thin layer of a compacted sandy material with small white flecks and small flecks of occasional charcoal (context 1005). This may have been a bonding material which would suggest that these two limestone blocks may have been the remains of a previous wall. Two other limestone blocks were removed from this area by machine measuring c. 0.75m x 0.31m x 0.42m, they may have also originally been part of this wall.

Plate 2. View of possible wall remains. Facing south-east.

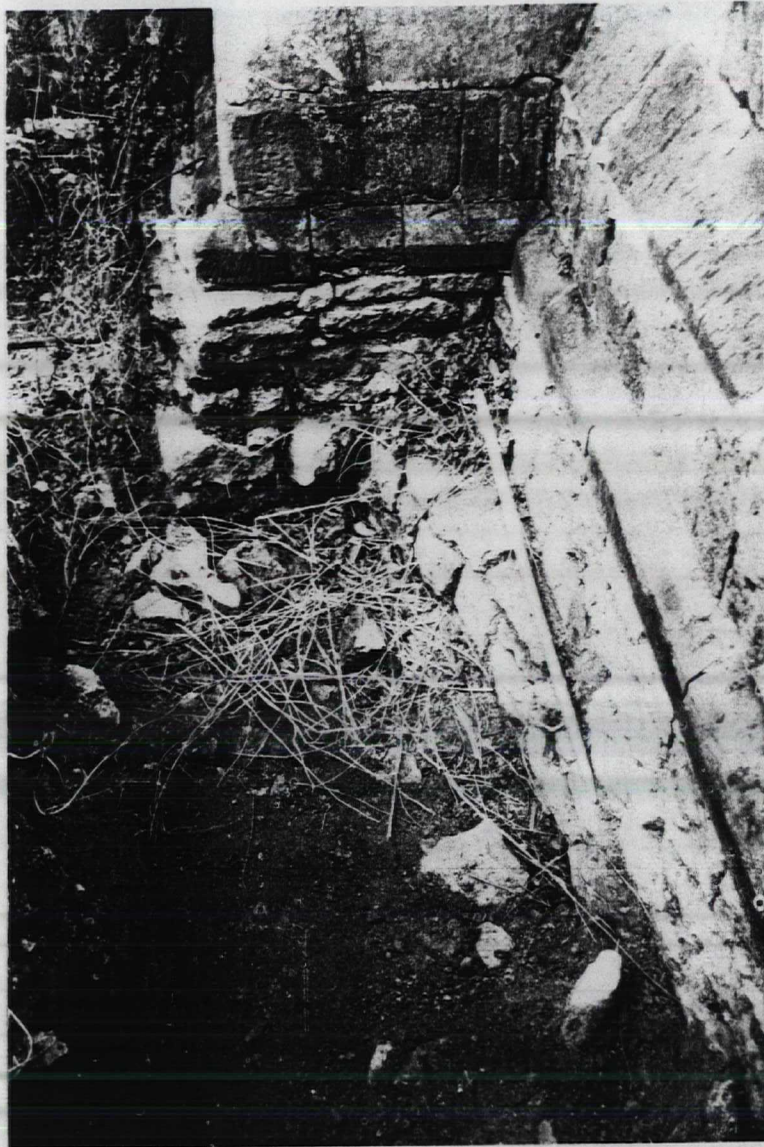
The foundation courses of the church tower (context 1007) were also observed during the excavation of the southern end of the pipe trench (context 1008 : Pl. 3).

Plate 3. View of foundation course of church tower. Facing north-east.
