MANOR FARM, LEPPINGTON.

REPORT ON AN ARCHAEOLOGICAL EVALUATION. OSA REPORT No: OSA07EV10.

MAY 2007.

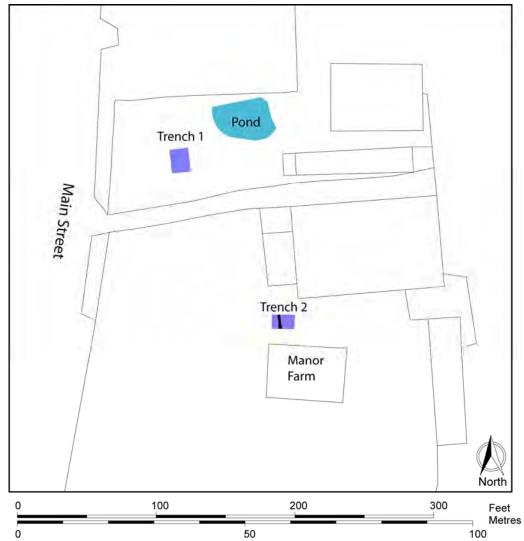
Figure 2. Trench location plan.

Two trial trenches were excavated, the locations and dimensions of which were agreed in advance in discussions between On-Site Archaeology, North Yorkshire County Council and the current Landowner.

- Trench 1: A machine-excavated trench measuring 5 metres by 3 metres located towards the northwest corner of the development site, west of the pond in an area currently under grass.
- Trench 2: A machine-excavated trench measuring 5 metres by 3 metres located immediately to the south of the larger southernmost barn and north of the current Farmhouse.

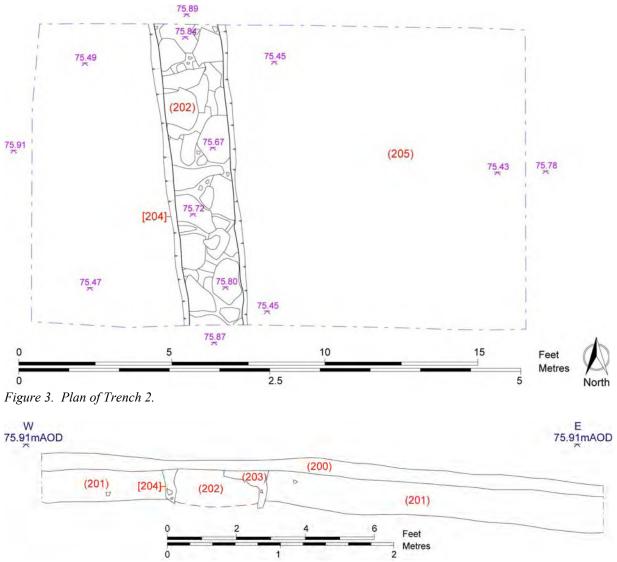
Figure 4. South facing section of Trench 2.

The earliest layer encountered was the yellowish brown clay and chalk gravel natural (205) found at a maximum height of 75.49 metres AOD, this was overlain by a yellowish brown, clay subsoil/overburden (201) measuring 0.3 metres in depth. The above deposits were cut by a single north-south orientated wall foundation [204], which continued beyond the limits of the trench excavation (see Plate 2). The foundation cut [204] measured approximately 0.9 metres in width and 0.3 metres in depth with a foundation consisting of a roughly constructed wall (202) of unbonded, large (averaging 400 mm x 300 mm x 120 mm) unworked sandstone blocks. A small assemblage of medieval and post-medieval pottery was recovered from within the wall foundation. The foundation trench was backfilled by yellowish brown, silty clay (203) containing small sandstone fragments, CBM flecks and again medieval and post-medieval pottery sherds. The trench was sealed by approximately 0.15 metres of topsoil containing small fragments of CBM and recent demolition rubble.

It is thought that the foundation wall encountered in Trench 2 relates to the previous Manor House, possibly constructed in the 18th Century, which was demolished prior to the building of the current Farmhouse in 1981. The pottery collected from within the wall foundation and from its associated construction backfill appears to confirm this dating. Parts of the previous Manor House appear to still exist, forming part of the front (west) elevation of the existing barn directly north of the foundation wall (see Plate 3).

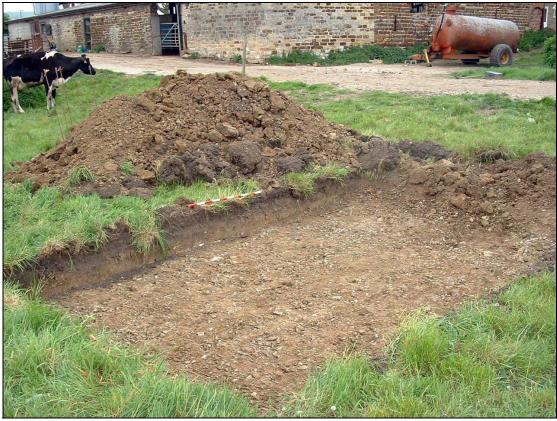
Plate 1. Trench 1 looking southeast. (Scale of 1m).

This trench was located in the northwest corner of the proposed development in an area of open garden/pasture approximately 17 metres east of the road. The trench measured 5 metres by 3 metres and was orientated north-south.

The earliest layer encountered was a grey brown silty clay and chalk gravel natural (102) found at a maximum height of 74.37 metres AOD, 0.36 metres below the ground surface. This was sealed by a yellowish brown, sandy clay subsoil (101) approximately 0.16 metres in depth and the topsoil (100) (see Plate 1).

No archaeological features, deposits or finds were revealed by excavation in this area of the development site.
