ST HELEN'S CHURCH
SKIPWITH
NORTH YORKSHIRE

Assessment Report on an
Archaeological
Investigation

Part 1: Excavation
and Building Survey

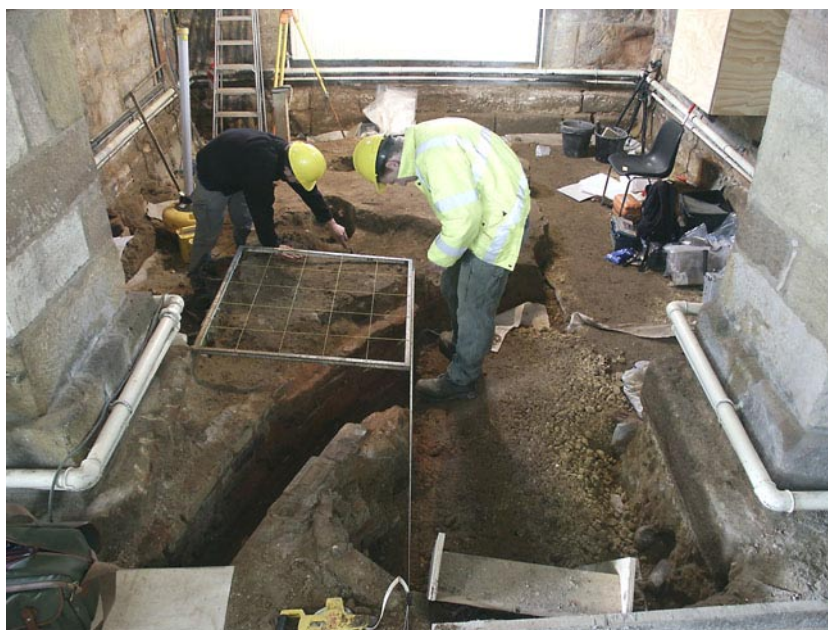
Plate 1: excavation and recording underway inside the tower

The archaeological excavations were conducted in two main phases, excavations on inside of the tower (Plate 1) were followed by excavations on the outside (Figure 2). The two areas, inside and outside, were divided into numerous small trenches so that excavations would not compromise the foundations that were being consolidated. The consolidation work was undertaken in a standard bay system, common for underpinning jobs on all types of structures, see the excavation areas (Figure 3).

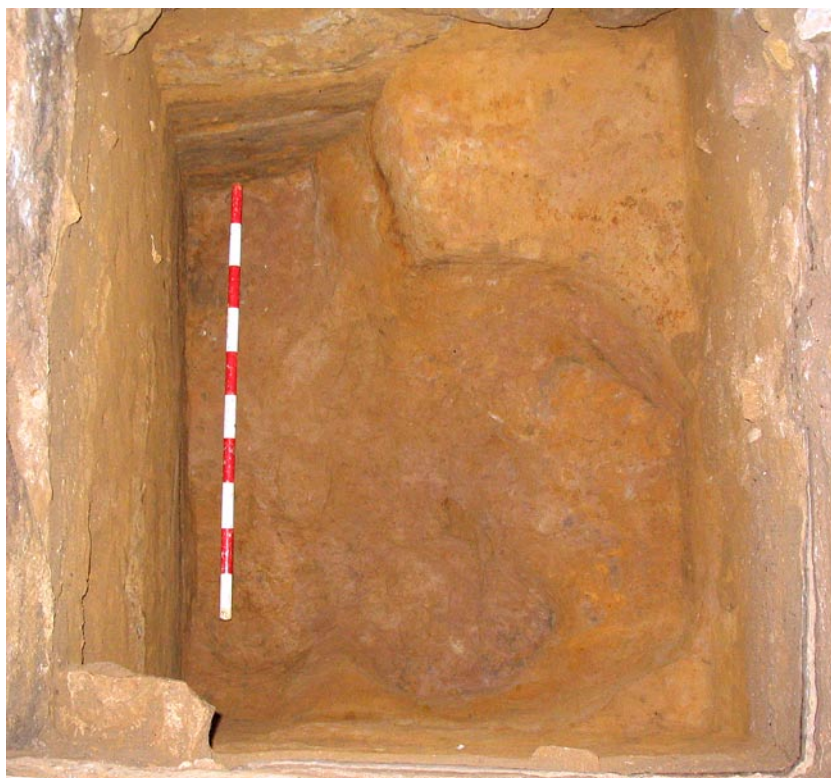
Plate 2
Early features

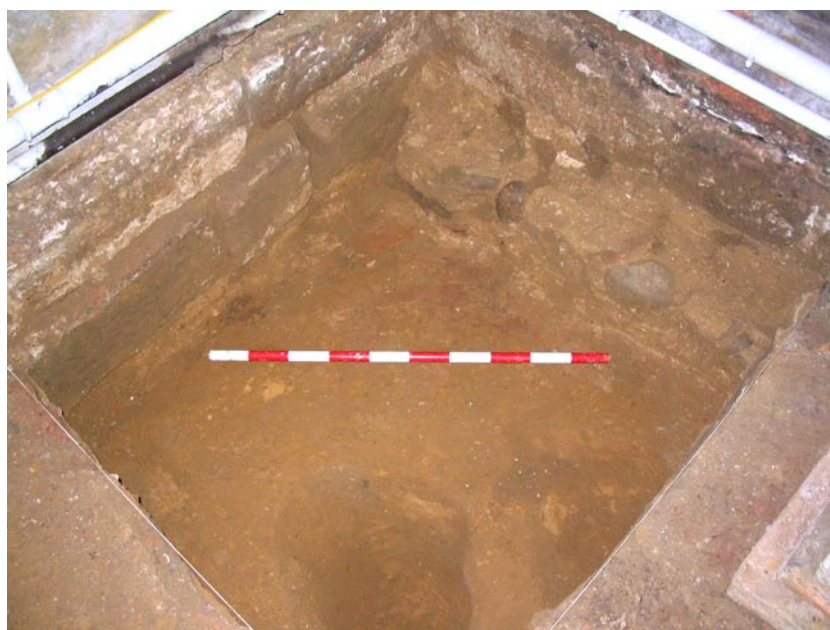
Plate 3 Construction spread for earlier building - (light red coloured) visible below elements of standing tower

cobble and occasional limestone and gritstone fragment inclusions (32065). Subsequently an additional layer of more squared in shape cobbles and gritstone fragments, up to 0.29m across, was laid down (32066). A final component of the foundation, which also spread slightly beyond the construction cut, was (32027) a layer of stiff, bluish grey, clay, which also contained patches of small gritstone fragments and sand (surface level c. 8.62m OD). 32027 also contained a fragment of Roman brick (Plate 3).

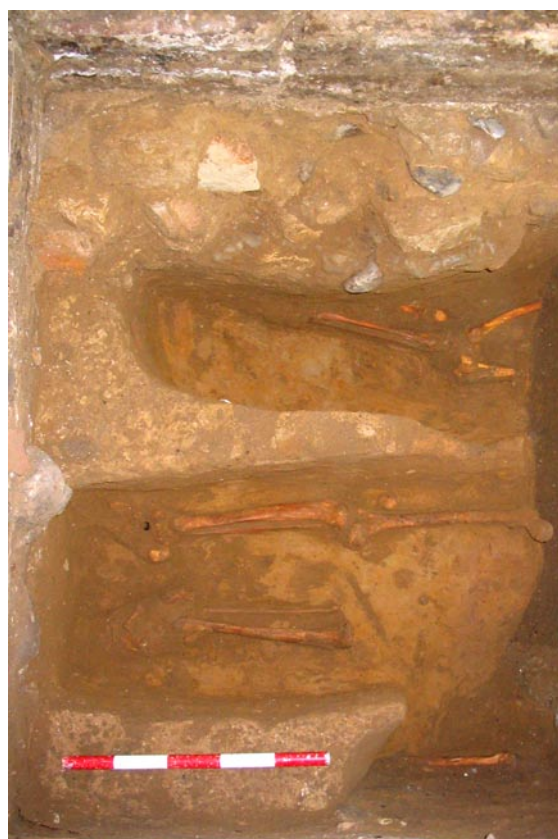
Plate 4 *Burials linked with the earlier building: legs of burials at southern side of the standing tower; note the graves cutting through the mortar floor surface.*

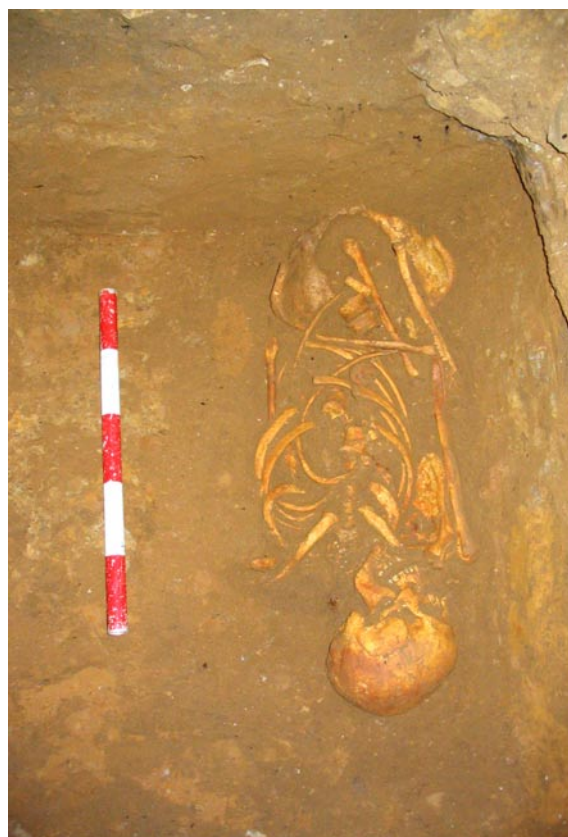
Plate 5 *Burial covered by the construction of the standing tower - burial (16029) not fully excavated as covered by east wall of standing tower*

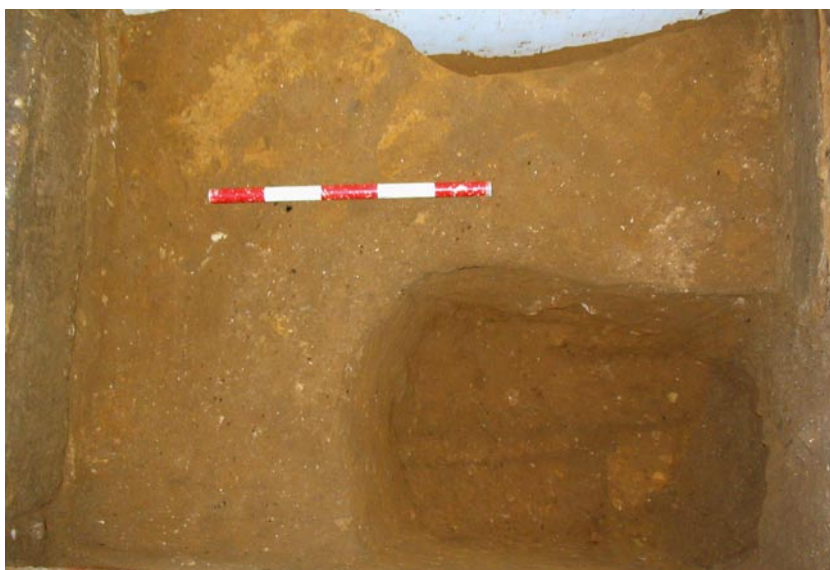
Plate 6 *Unexcavated burials from the earlier building: backfill for unexcavated graves with possible coffin stains visible.*

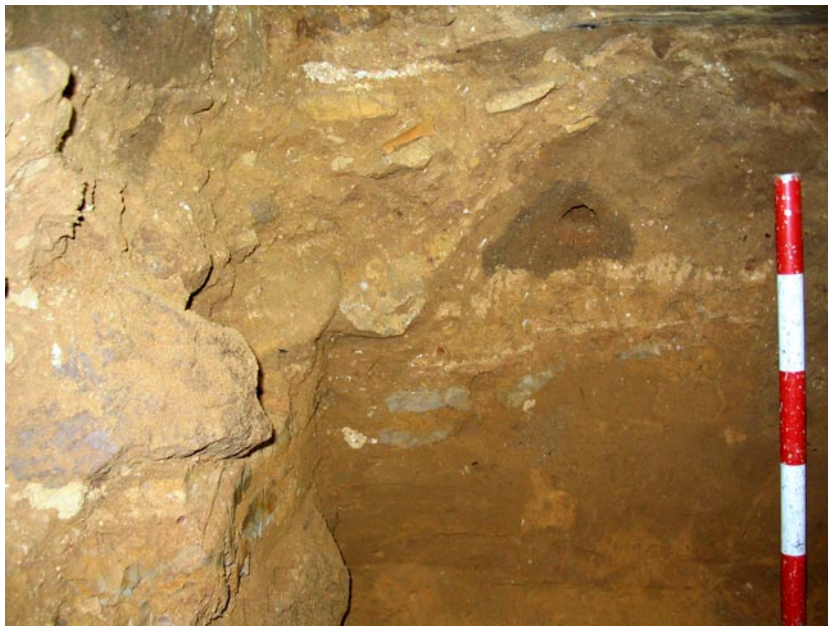
Plate 7 Section through foundations of standing building, clearly showing the construction cut for the standing tower cut through the building-up after the earlier building and mortar surface

depending on where it was and what purpose it served. The top of the construction cut for the foundations was visible at c.8.90m OD, 0.35m BGL and continued to a depth of c.8.55m OD on the northern and southern walls, its full depth was never determined on the eastern side of the tower (Plate 7).

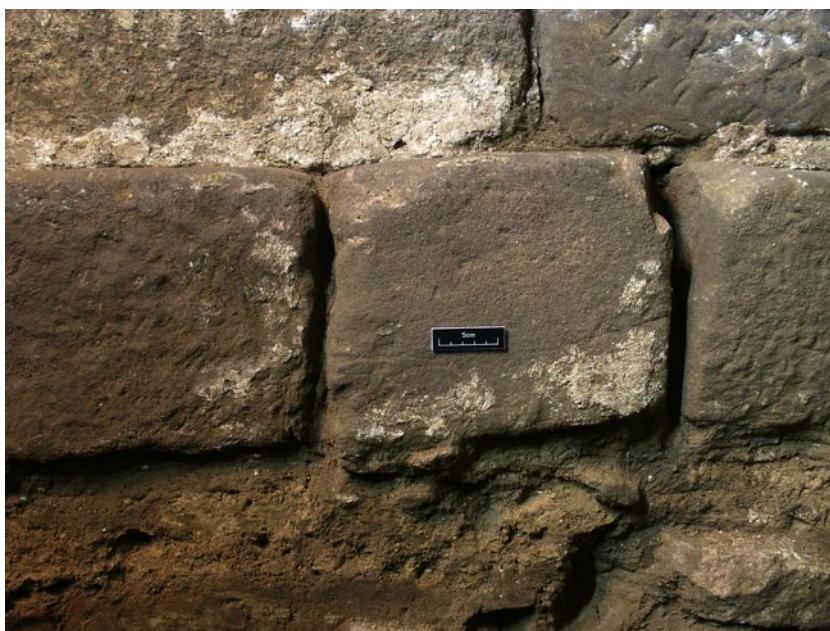
Plate 8 Plaster/ render
on side of reused
gritstone blocks

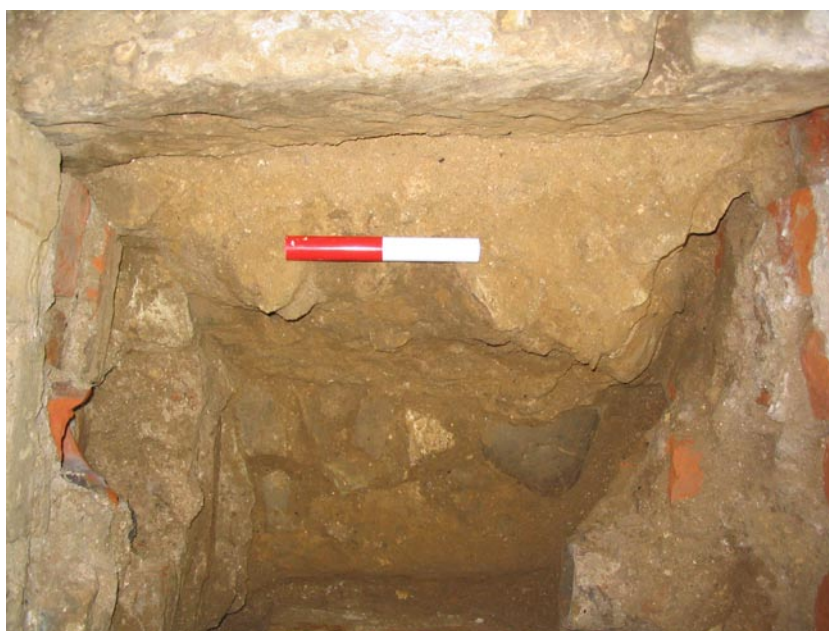
Plate 9 *Truncated standing building foundations in area t1/Q, over the top of the earlier cobble foundation.*

The small section of this foundation that was exposed to the east of the tower, in tr1/Q, mirrored what was seen internally (Plate 9). It was also possible to see similar material in t1/A which followed the line of the original nave, before the aisles were pierced through the walls at this point. However in this area excavation was limited and the deposits were massively truncated by the construction of the coal bunker.

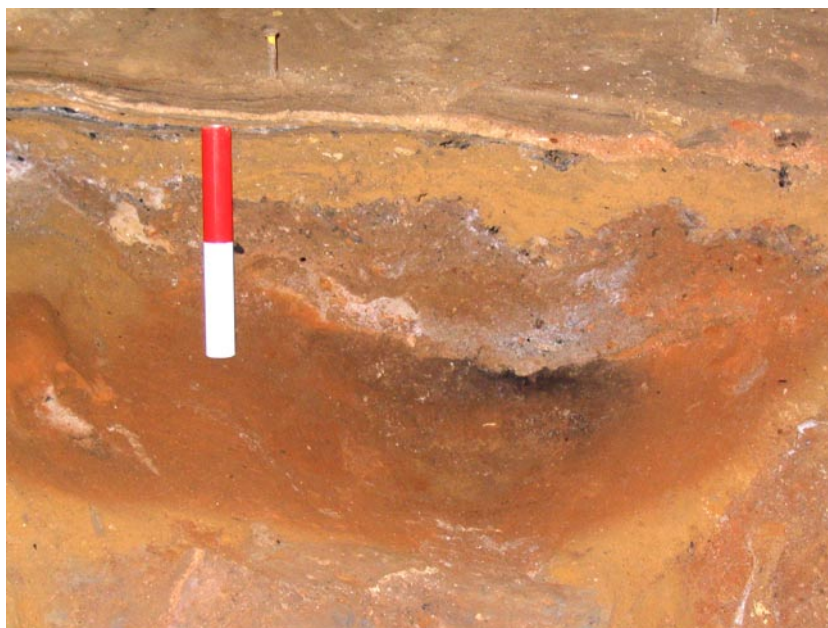
Plate 11 Section through early lead working feature

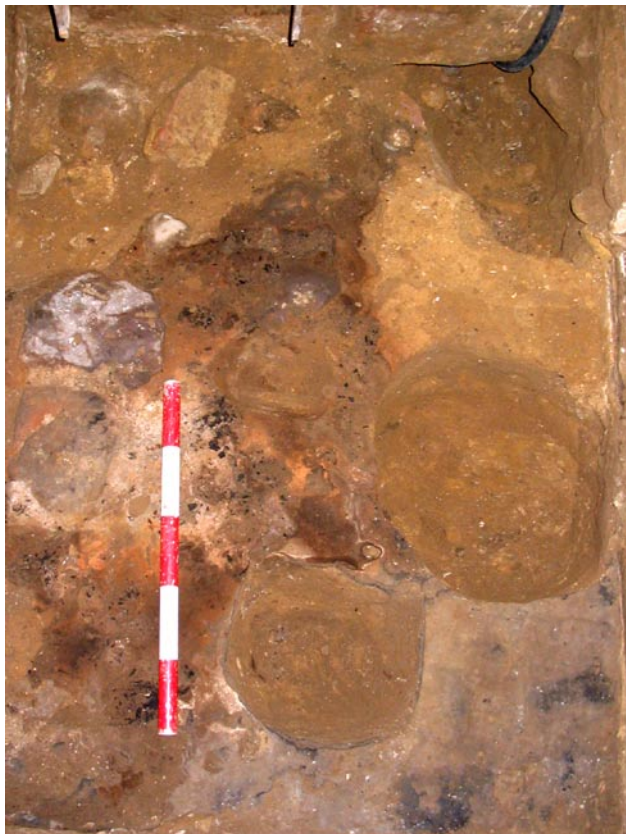
Plate 12 Floors and trample deposits in the south-east corner of the tower

mortar floor surfaces (32056). They appeared to extend over the area of the south – east of the tower, where they had not been truncated by later features (Plate 12). Environmental sampling of these deposits proved this material contained little in the way of charcoal, and thus little which could be used to date the floor surfaces.

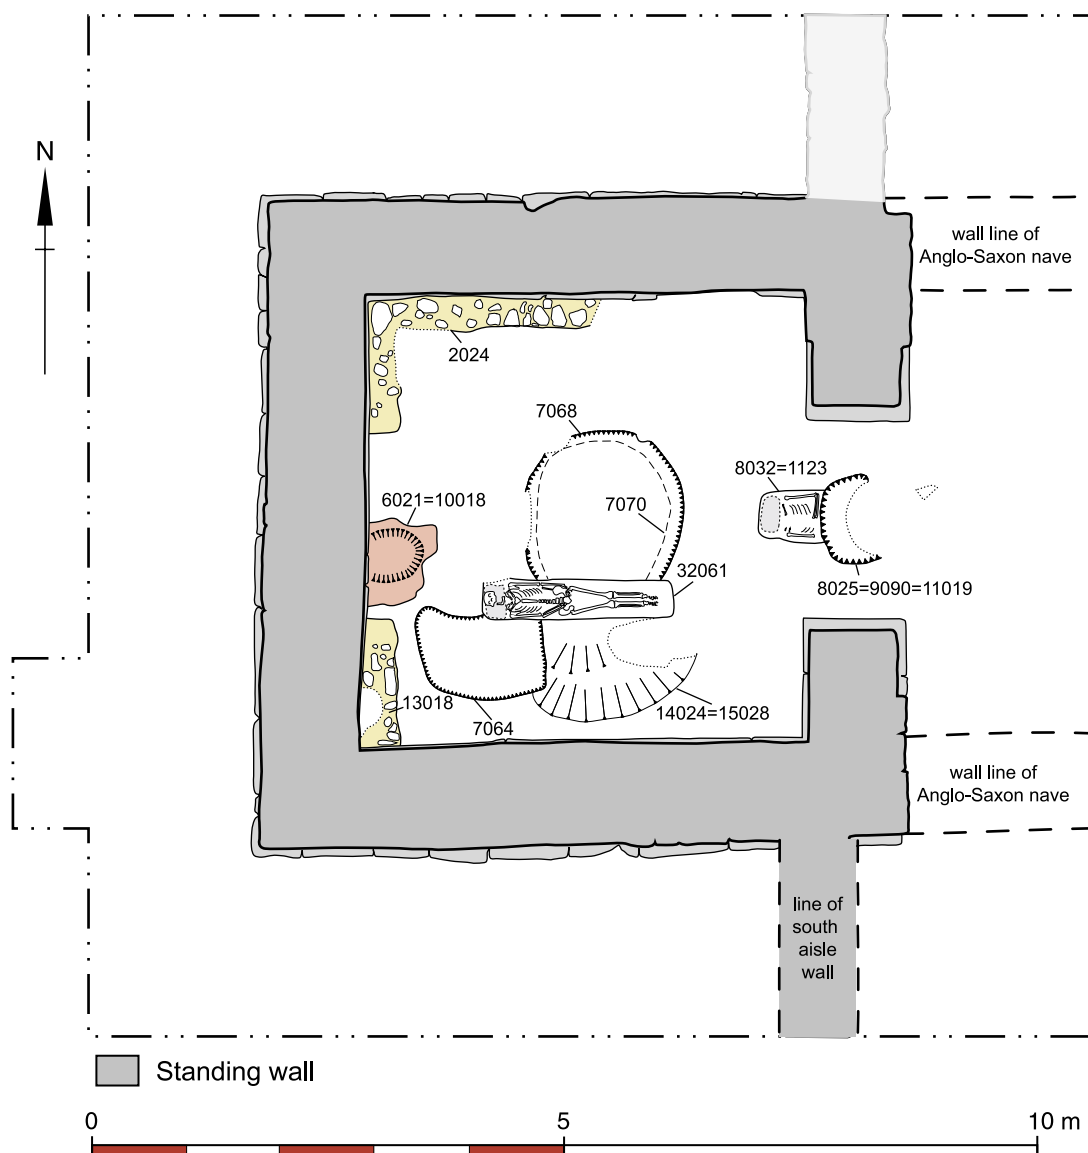
Fig.10 Late medieval and early post-medieval activity (Trench 1). Scale 1:80

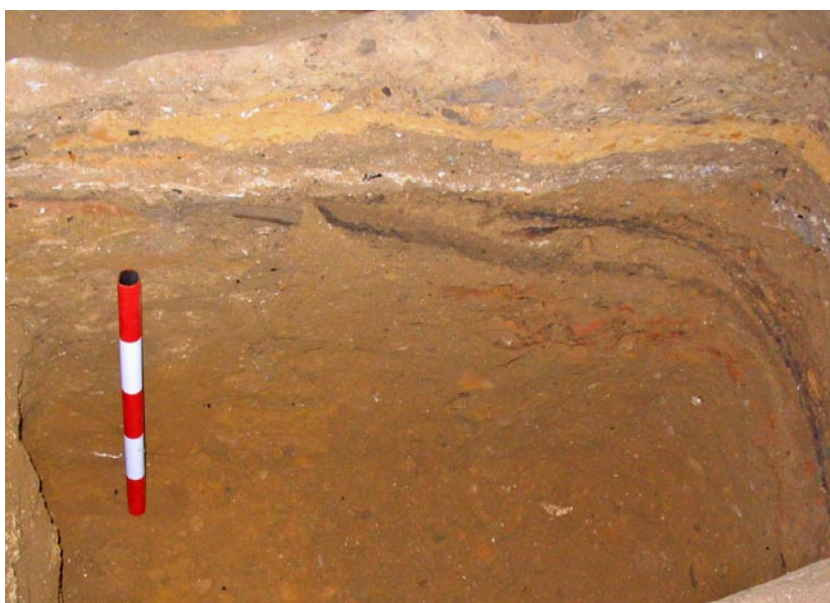
Plate 14 Cut for the possible bell casting pit visible in section of a later grave cut

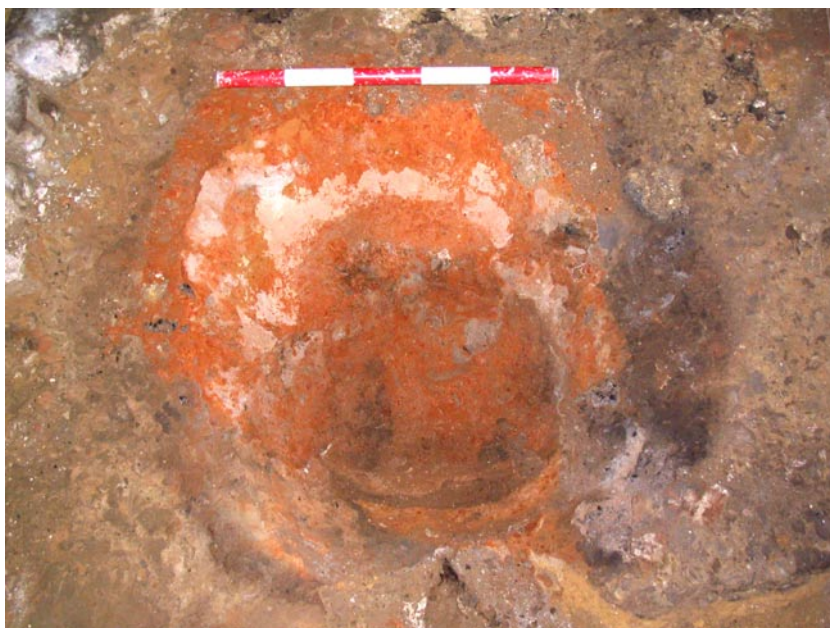
Plate 16 Post-medieval lead working hearth and lining

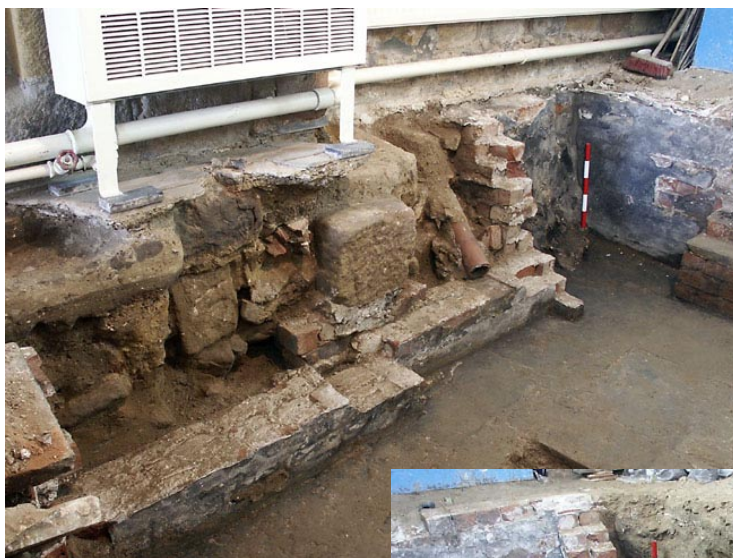
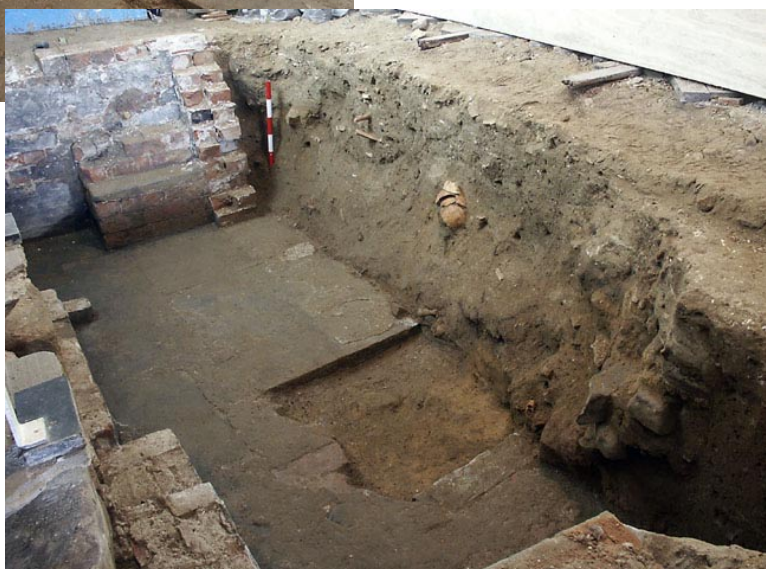
Plates 19 and 20 Earlier features and graves disturbed during the construction of the coal bunker - revealed once the walls were stripped

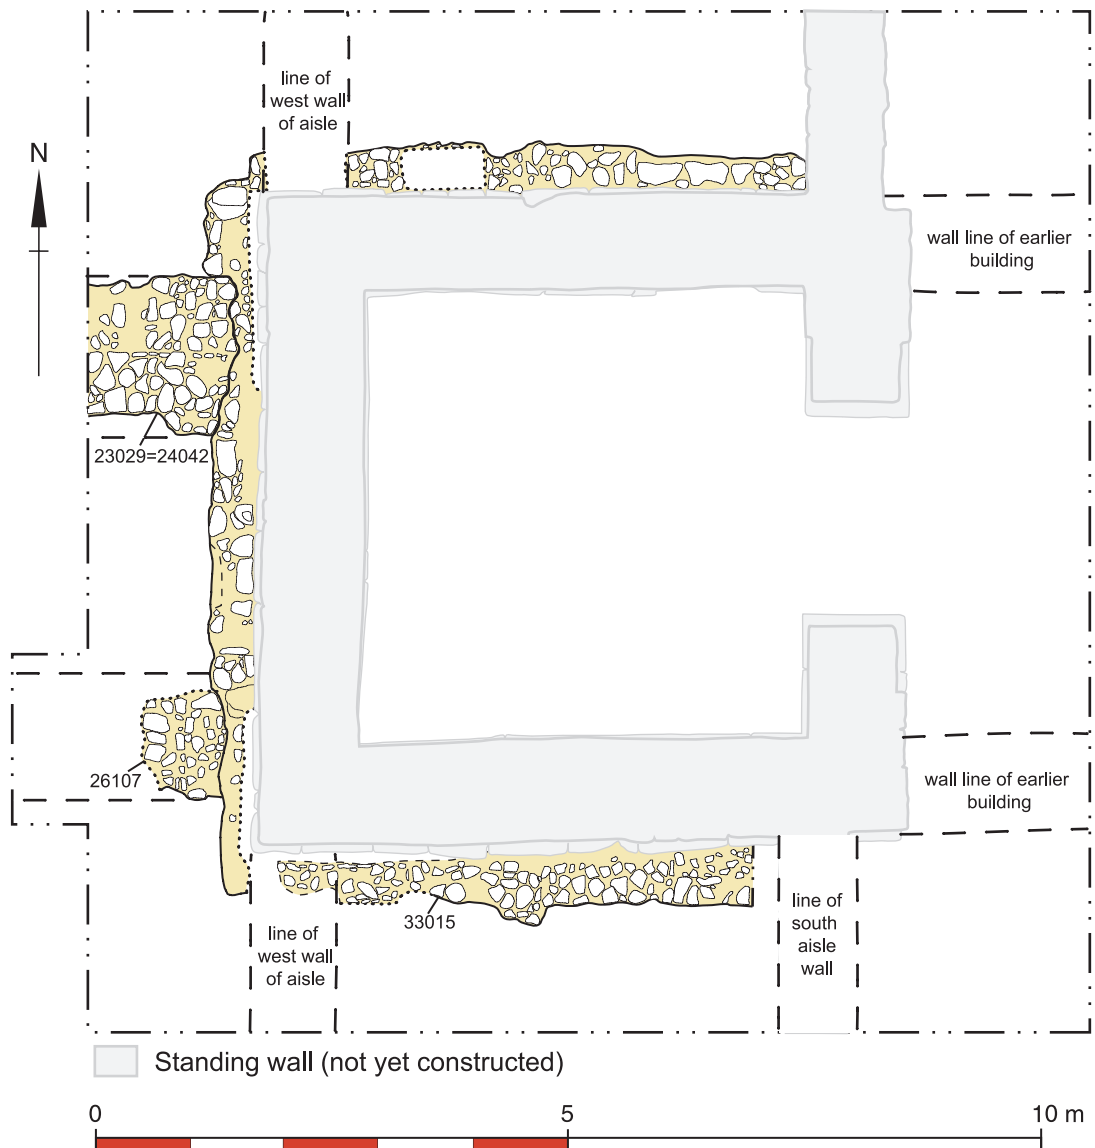
Fig.14 Construction of earlier building (Trench 2). Scale 1:80

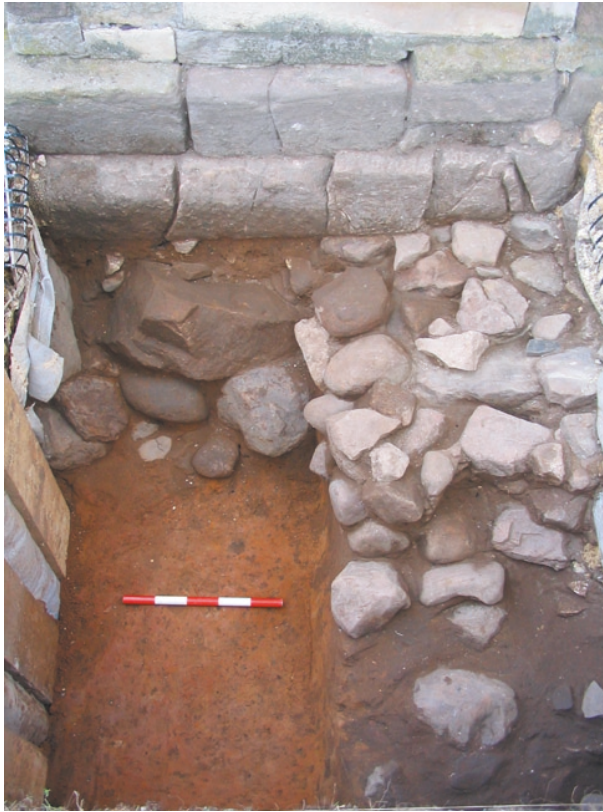
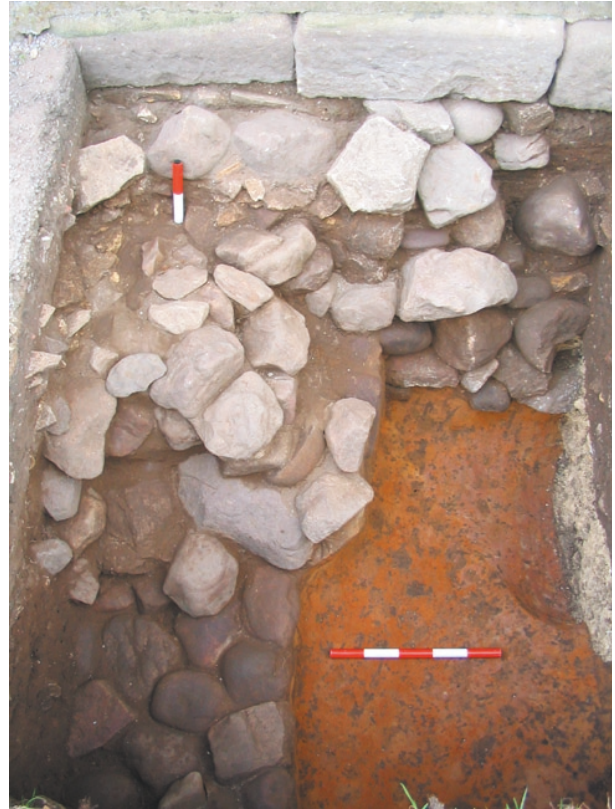
Plates 21 and 22 Northern foundation of possible apse/porticus

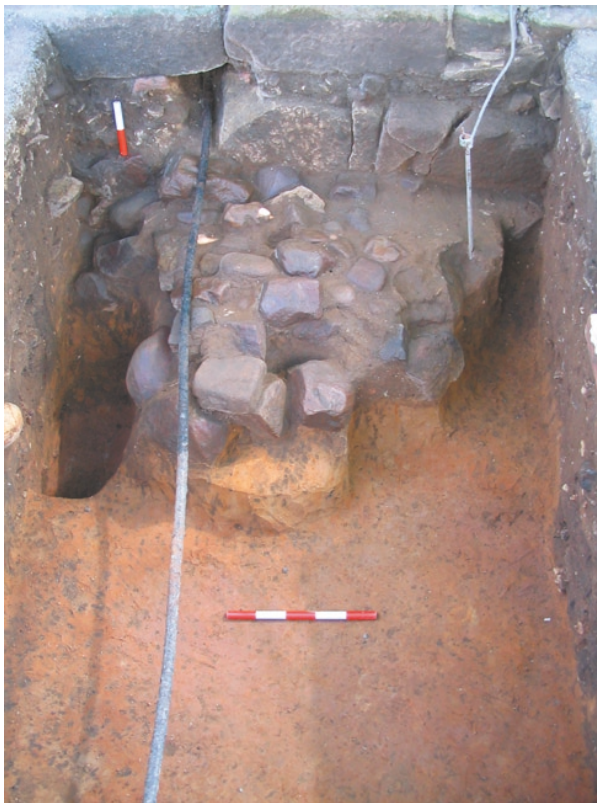
Plate 23 Southern foundation for possible apse/porticus

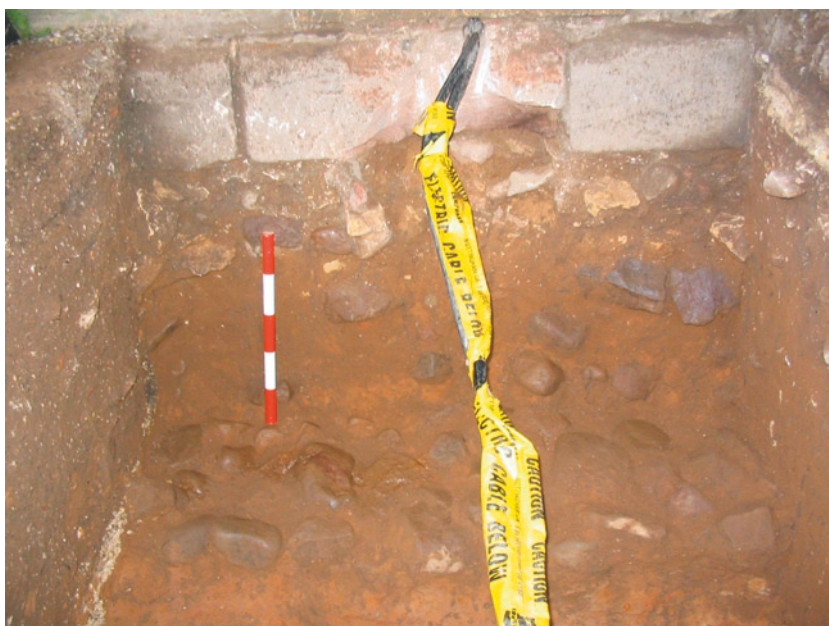
Plate 24 Rubble foundations for standing building overlying cobble foundations for earlier structure

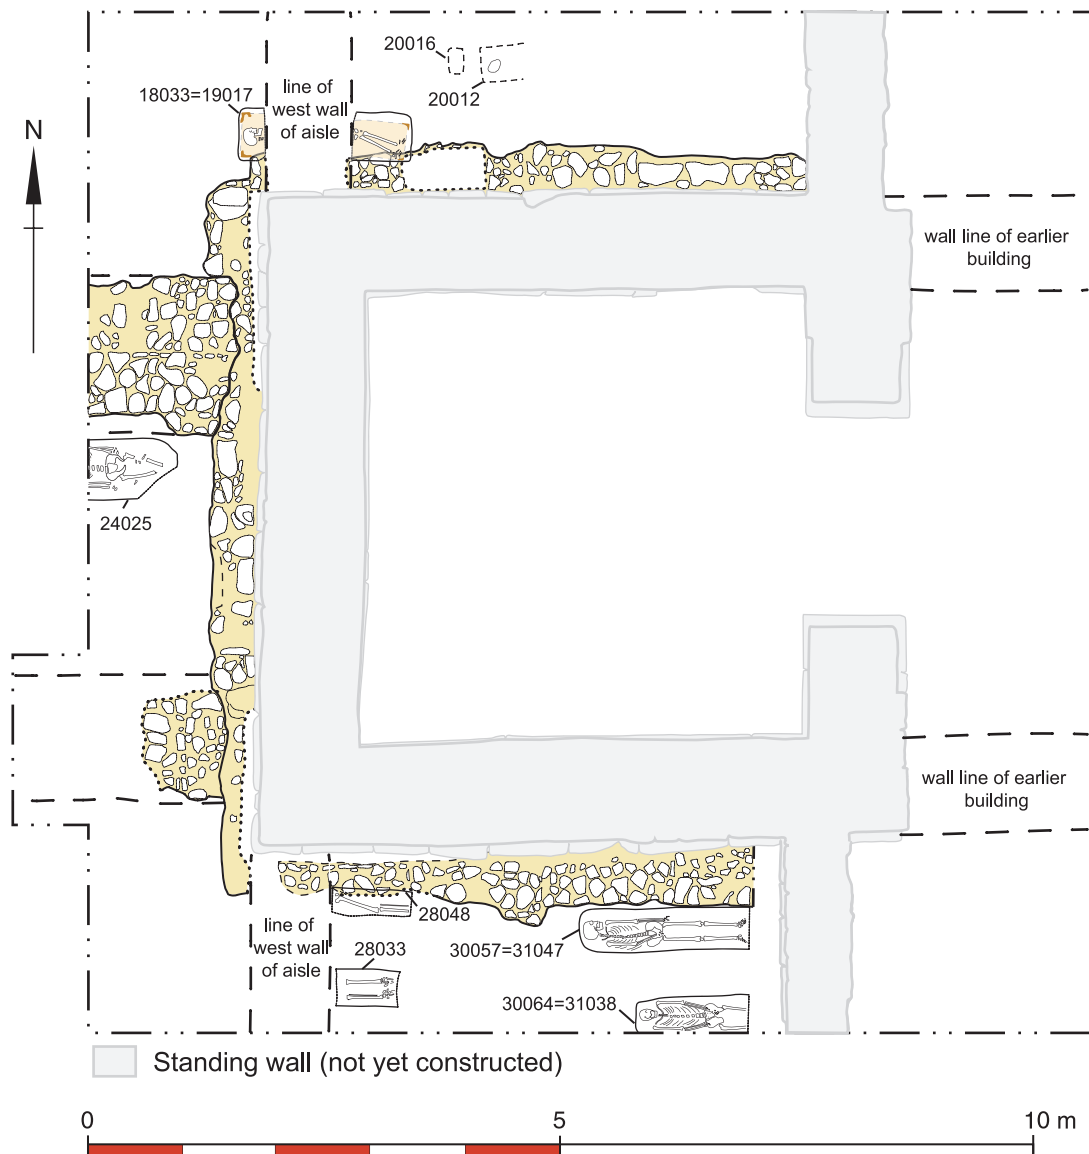
Fig.15 Burials linked with the earlier building (Trench 2). Scale 1:80

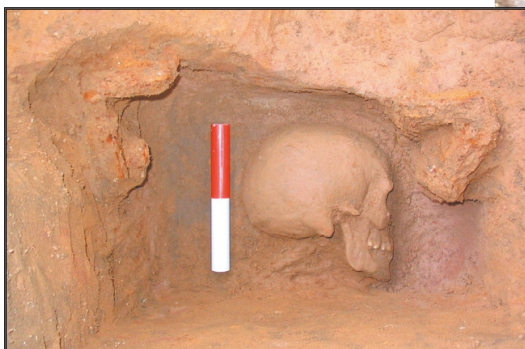
Plate 25 (and inset) Earlier burial to the north of the tower, with metal coffin fittings of a Saxon date

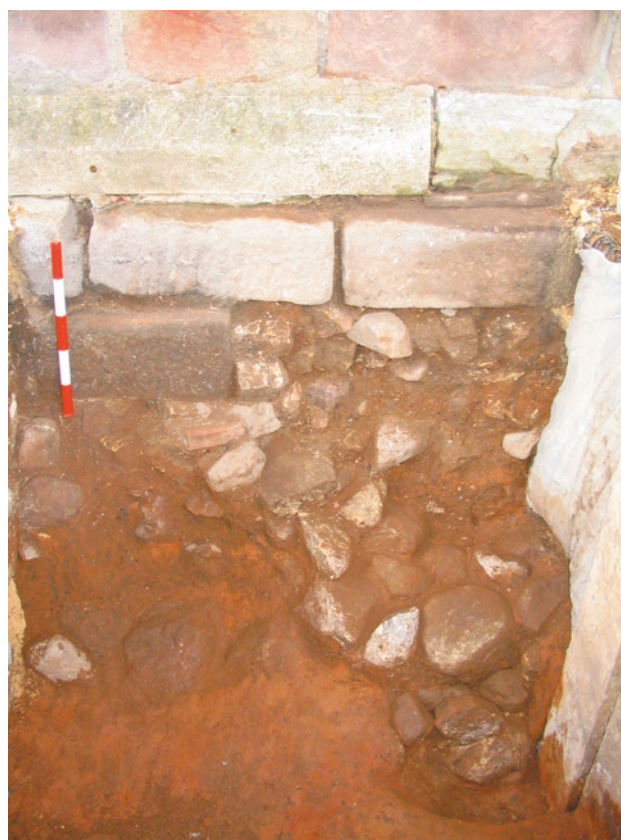
Plate 28 *The gritstone block and rubble foundations for standing tower, over the earlier cobble foundations at the south of the tower*

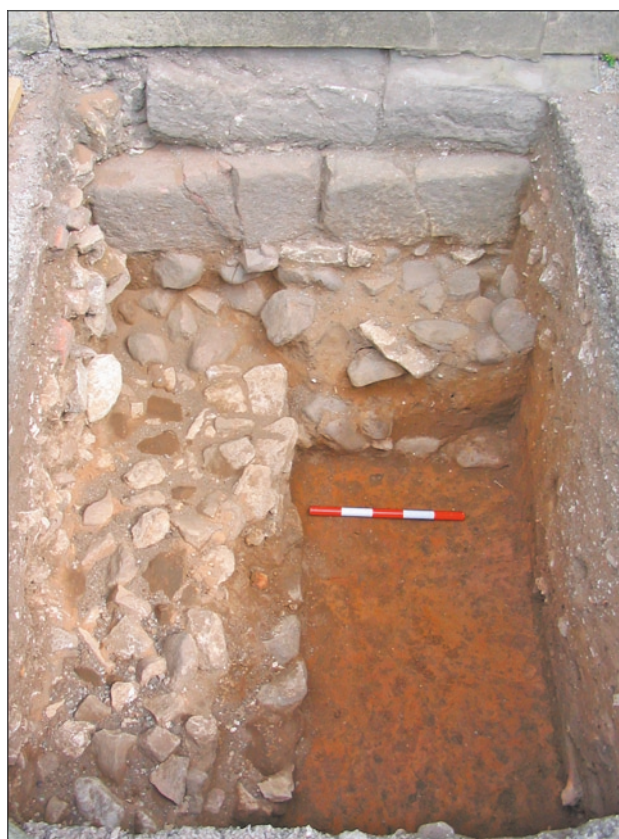
Plate 32 Southern aisle foundation

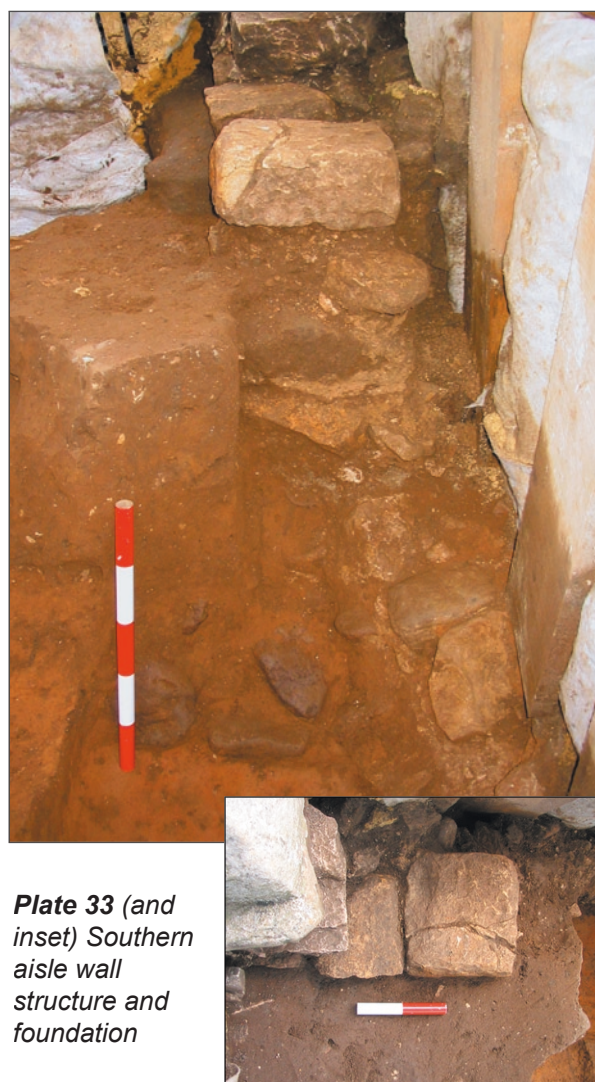
Plate 33 (and inset) Southern aisle wall structure and foundation

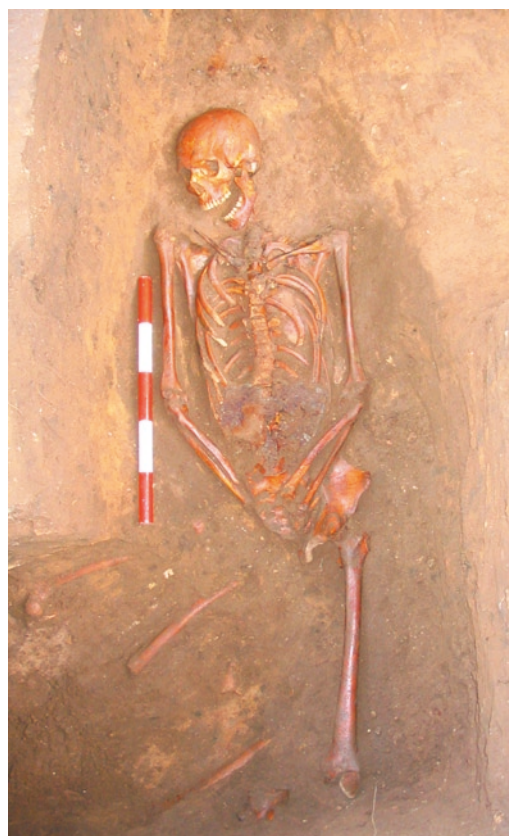
Plate 36 North – south burial truncated by later east – west burial

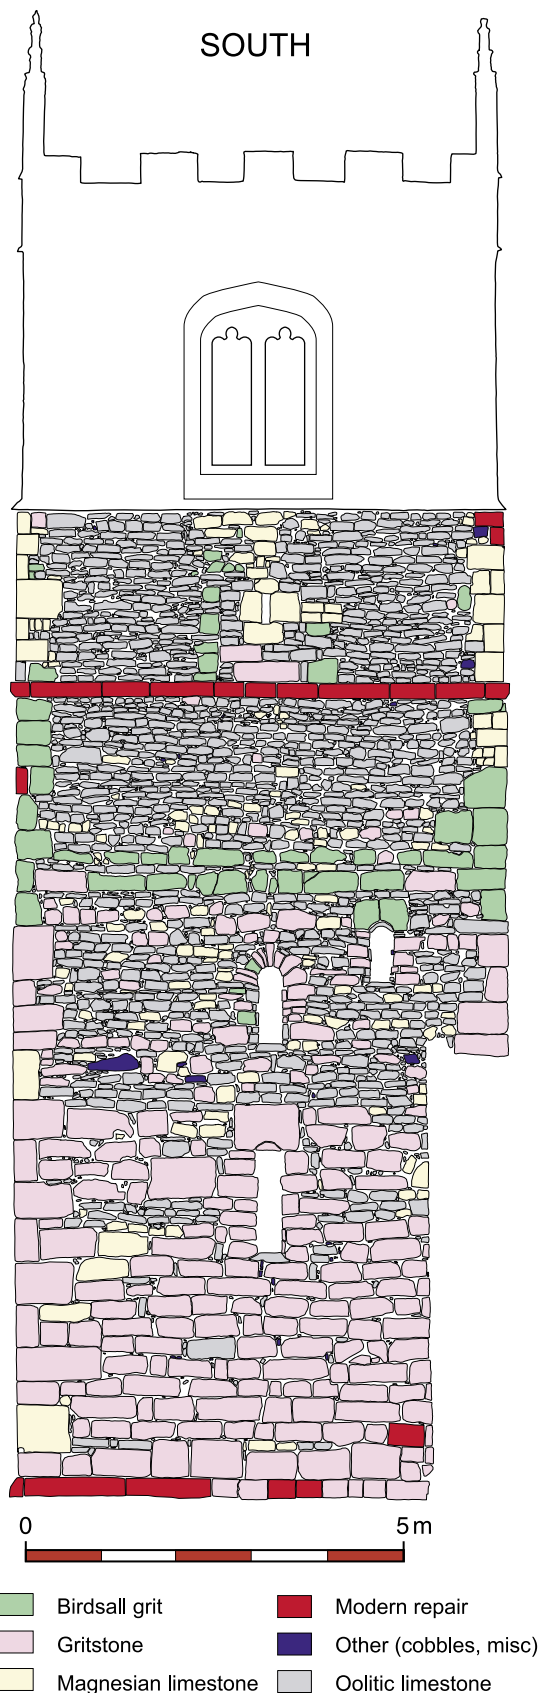
Fig.22 Tower (south elevation) stone types. Scale 1:100

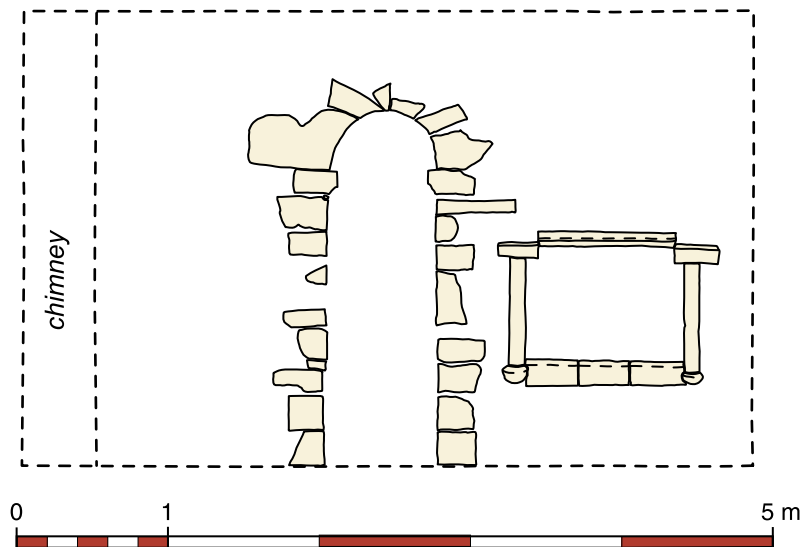
Fig.24 Blocked doorway and altar recess. Scale 1:50

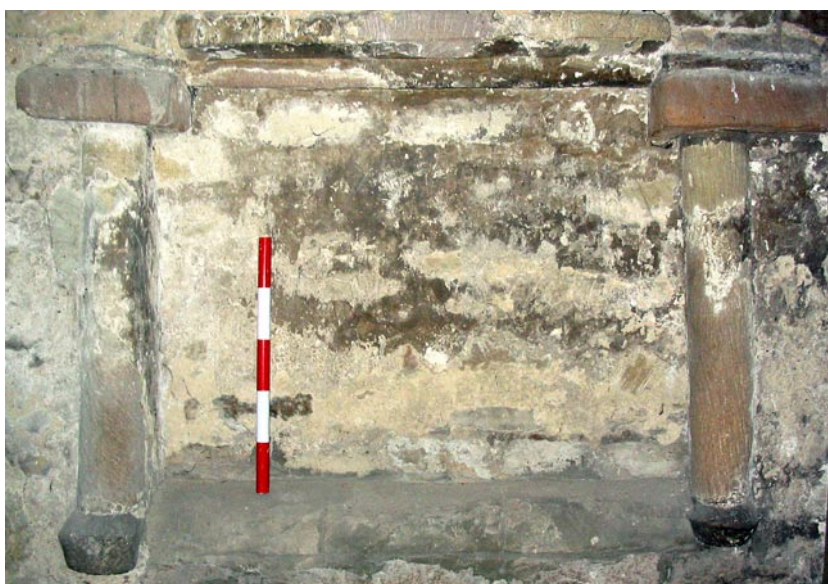
Plate 41
Altar recess

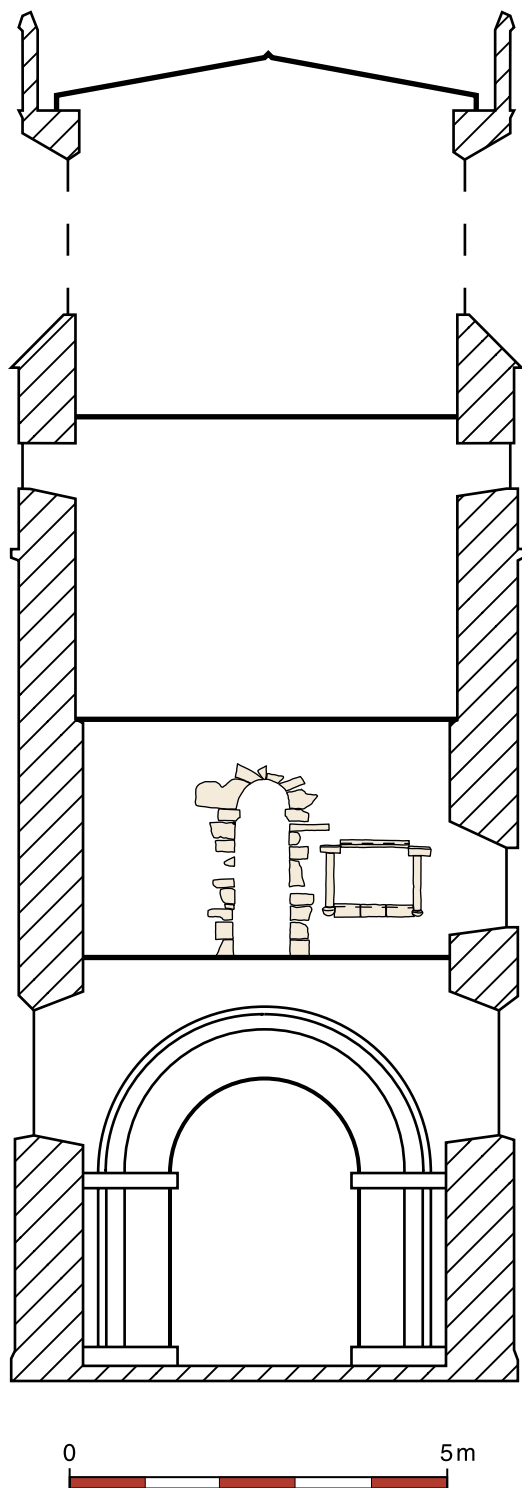
Fig.25 East elevation (internal). Scale 1:100

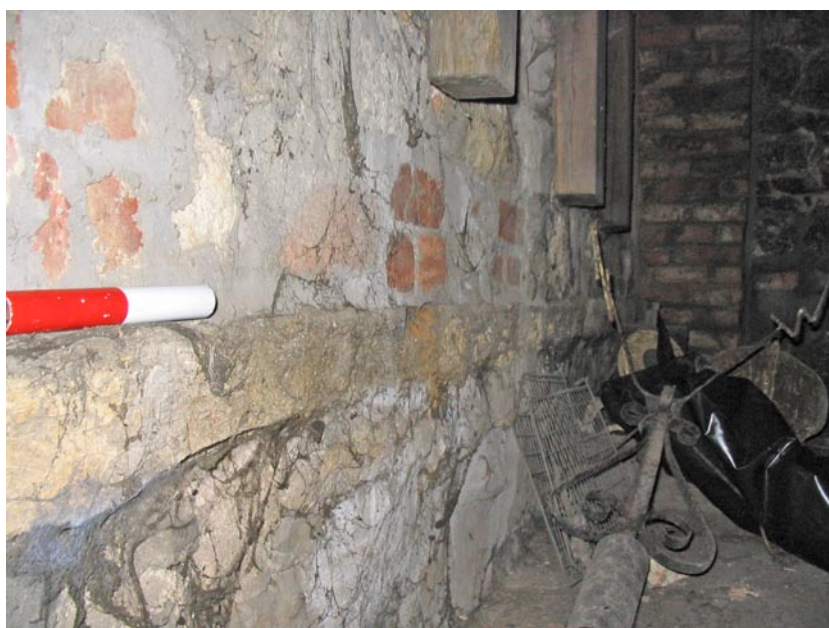
Plate 42 Possible wall plate

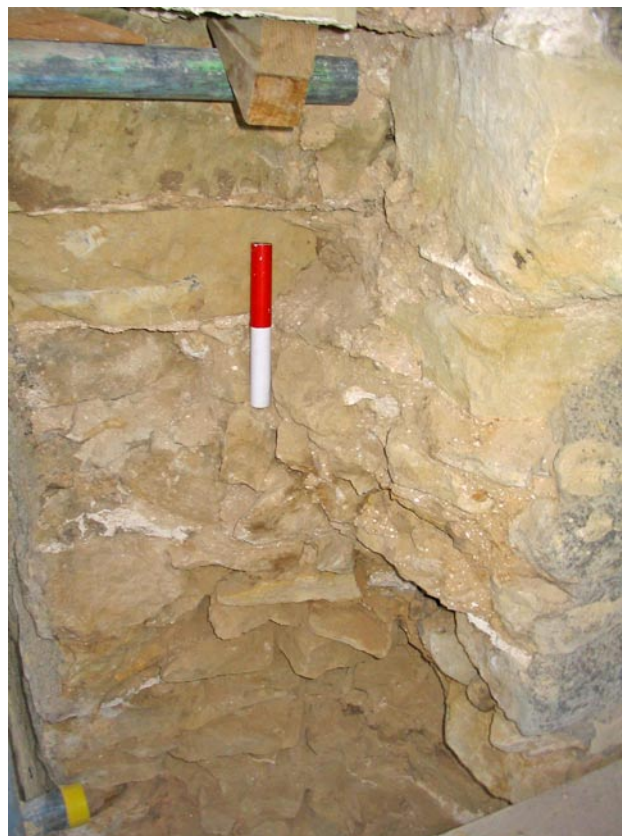
Plate 44 *Mortar working phases in tower core*
