**STUDFORTH FARM, ALDBOROUGH
BOROUGHBRIDGE, NORTH YORKSHIRE**

ARCHAEOLOGICAL WATCHING BRIEF

January 2010

**STUDFORTH FARM, BACK LANE, ALDBOROUGH
BOROUGHBRIDGE, NORTH YORKSHIRE**

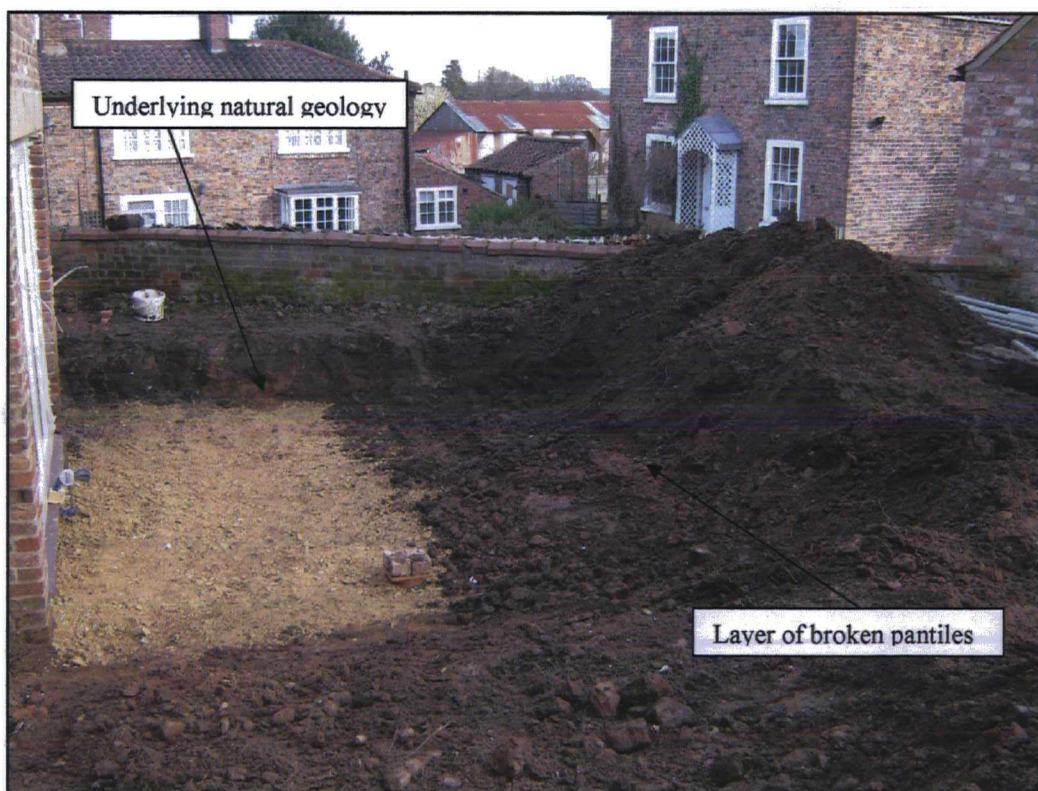
- 5.2 The made ground across most of the site was of a loamy/humic soil probably derived from earlier agricultural use and material generated from the adjacent barns with numerous fragments of ceramic building material along with occasional sherds of mainly 19th and early 20th century ceramics. The area immediately to the east of the barn contained a much higher proportion of ceramic building material, particularly pantiles, and would appear to represent the remains of waste material associated with the re-roofing of the threshing barn.

- 5.3 Also to the east of the main barn and towards the northern end of the site there was a significant concentration of ceramic building material, ceramics and animal bone fragments which had formed a midden. The vast majority of the material was of 19th and early 20th century date but there were a number of fragments of late 18th century pottery mixed in with it.

Plate 2. Looking north-east showing ground reduction to east of barn.

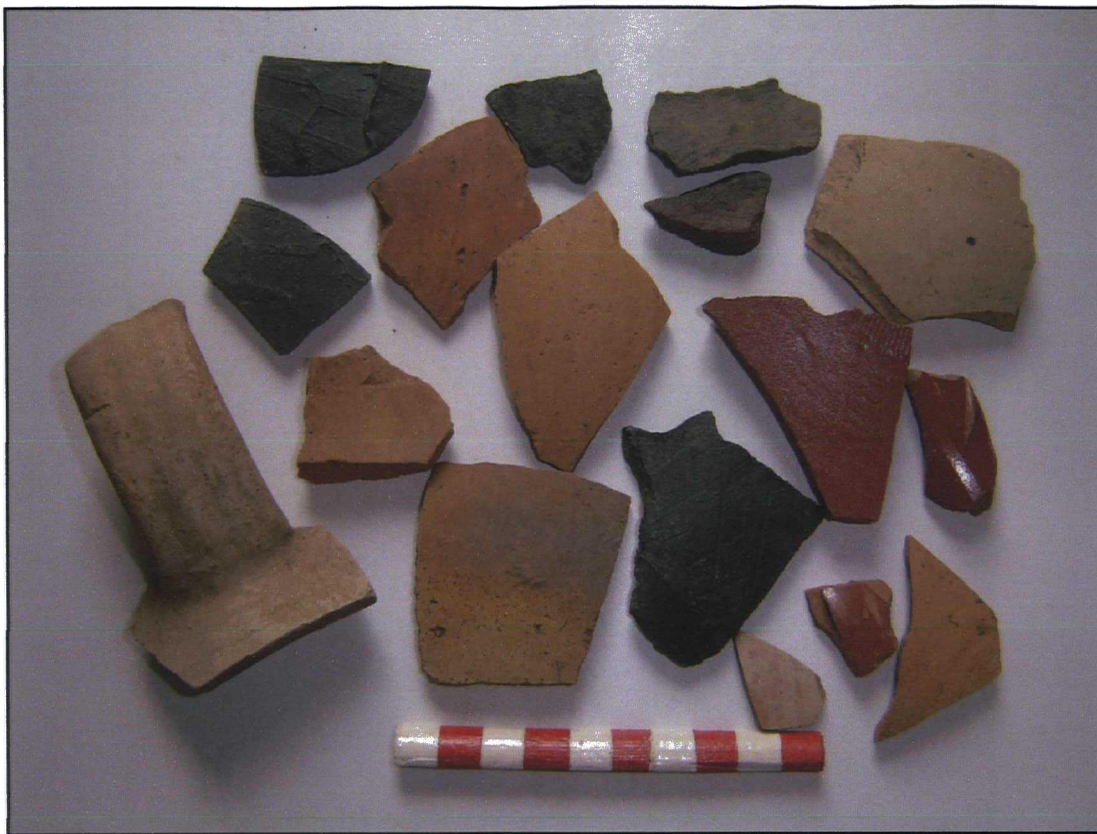
- 5.4 During the ground reduction within the barn it was thought that a circular feature of probably Roman date had been uncovered. However, further investigation revealed that the feature was of modern origin as it contained large lumps of broken up modern concrete at its base. The Roman pottery initially thought to have been associated with it proved to have been re-deposited in the doorway of a former opening in the eastern side of the building. A large amount of soil and refuse material had been dumped in the hollow caused by farm traffic through the former entrance. The Roman pottery was within this dumped material which had been collected from elsewhere.

Not all the components in this small unstratified assemblage are closely datable. Having said this, the most diagnostic components have a decidedly 'early' emphasis. Two sherds of Rusticated Ware, from the same vessel, fall within the period *c.*AD 70-130/50. The Black-Burnished Ware sherd is from a jar with acute-angled lattice, of probable second-century date. The samian, which is crisp and unworn, like much of this assemblage, includes a rim sherd with decoration *en barbotine*, of form 36, 42 or Curle 11. A Flavian or later date is indicated. The whiteware and redware flagons are not datable without further work. In summary, this is a good quality assemblage, nothing in which need post-date the second century AD.

Plate 3. Roman Pottery from Within Barn Doorway. Scale 0.1m.
