METHODOLOGY

The recent archaeological investigation conducted by Mr.K.J.Cale on behalf of North Yorkshire Consultancy on Kilgram Bridge, East Witton Out Parish has provided a useful picture of the fabric and stratigraphy across this monument.

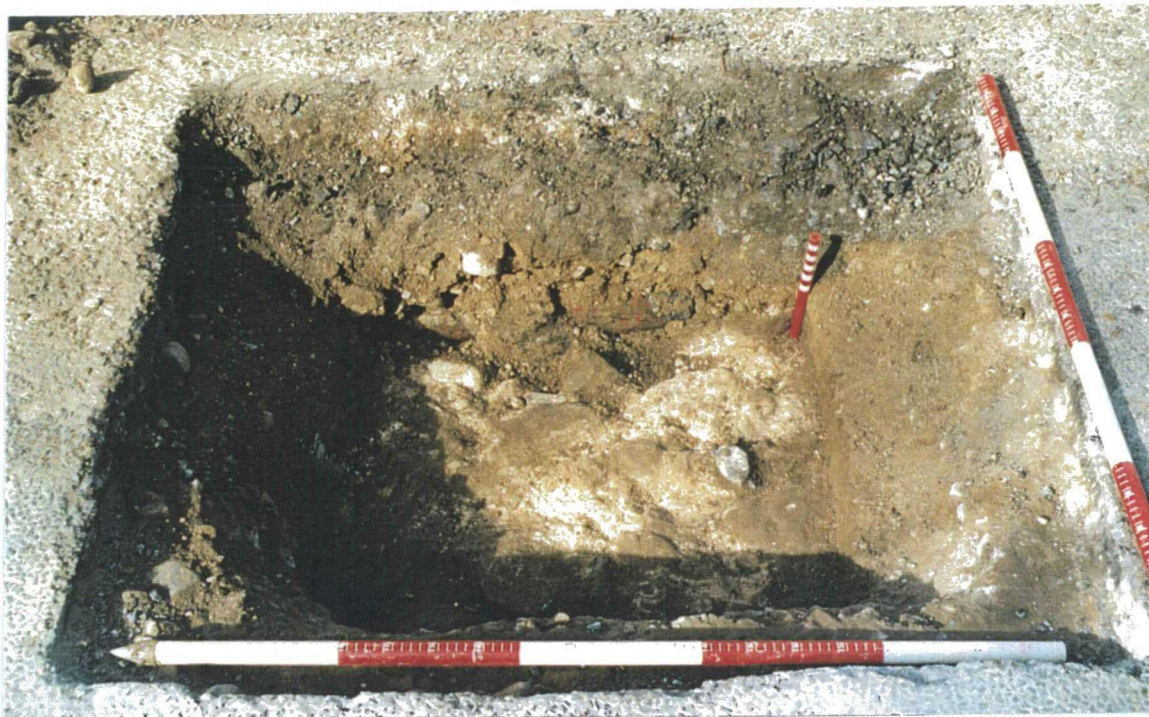
PLATE 2

Trial Hole No.3, detailing fill of pier.

The rubble and mortar fill (context 3006) of the southernmost pier was identified at 0.32m below the existing carriageway. The yellow white (10YR6/6) sandy lime based mortar. The matrix was well compacted with a high quantity of inclusions, these were dominated by water worn cobbles, limestone and sandstone fragments, these measured less than 0.30m in size. The stone content of the fill was deeply bedded. No voids were noted within this context.

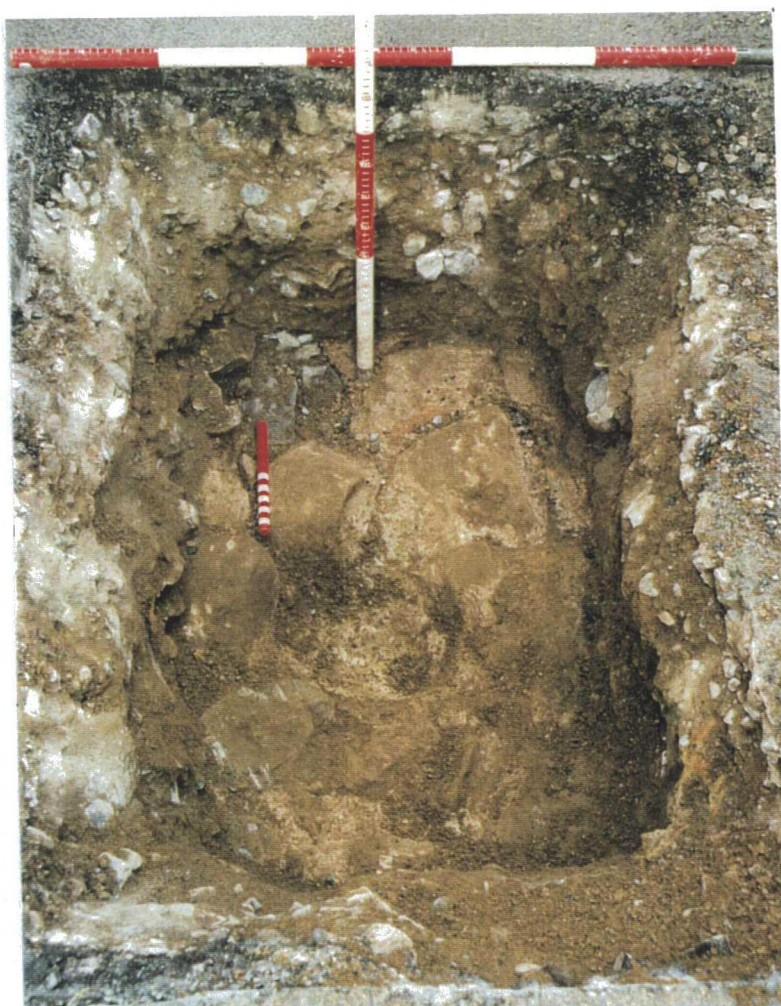
Trial Hole No.2, detailing fill of pier.

The rubble and motar fill (context 2004) of the northernmost pier was identified at 0.47m below the existing carriageway. The yellow white (10YR6/6) sandy lime based mortar. The matrix was well compacted with a high quantity of inclusions, these were dominated by water worn cobbles, limestone and sandstone fragments, these measured less than 0.30m in size. The stone content of the fill was deeply bedded. No voids were noted within this context.

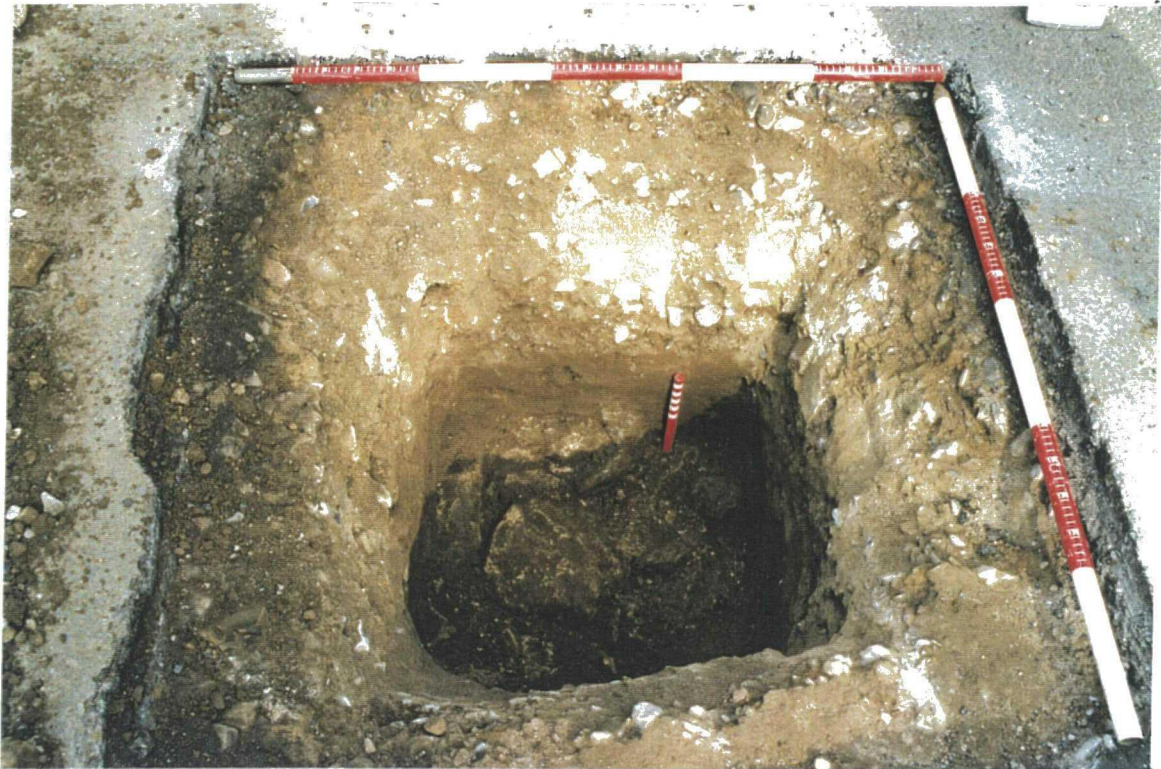
PLATE 3

Trial Hole No.3, detailing alluvial deposit and rubble fill.

A deposit of clayey silt (3005) was found to be sealing the rubble and mortar fill, this medium brown (10YR3/3) layer was very well compacted and moist and contained a low quantity of inclusions, namely the occasional water worn pebble. The matrix of the layer comparable with context 1003 identified within trial hole no.1 with the exception that this deposit only measured 0.08m deep. The provenance of this context is unsure, it is possible that it has anthropogenic origins i.e it has been suggested by Mr.W.Smollett, North Yorkshire Consultancy that the layer may have been deposited as a waterproofing membrane over the fill of the bridge, however, the layer was not identified on the northern side of the bridge. Natural accumulation as a result of flooding and trample can not be discounted. It is suspected that the matrix originated locally, it having the characteristics of an alluvial sediment.

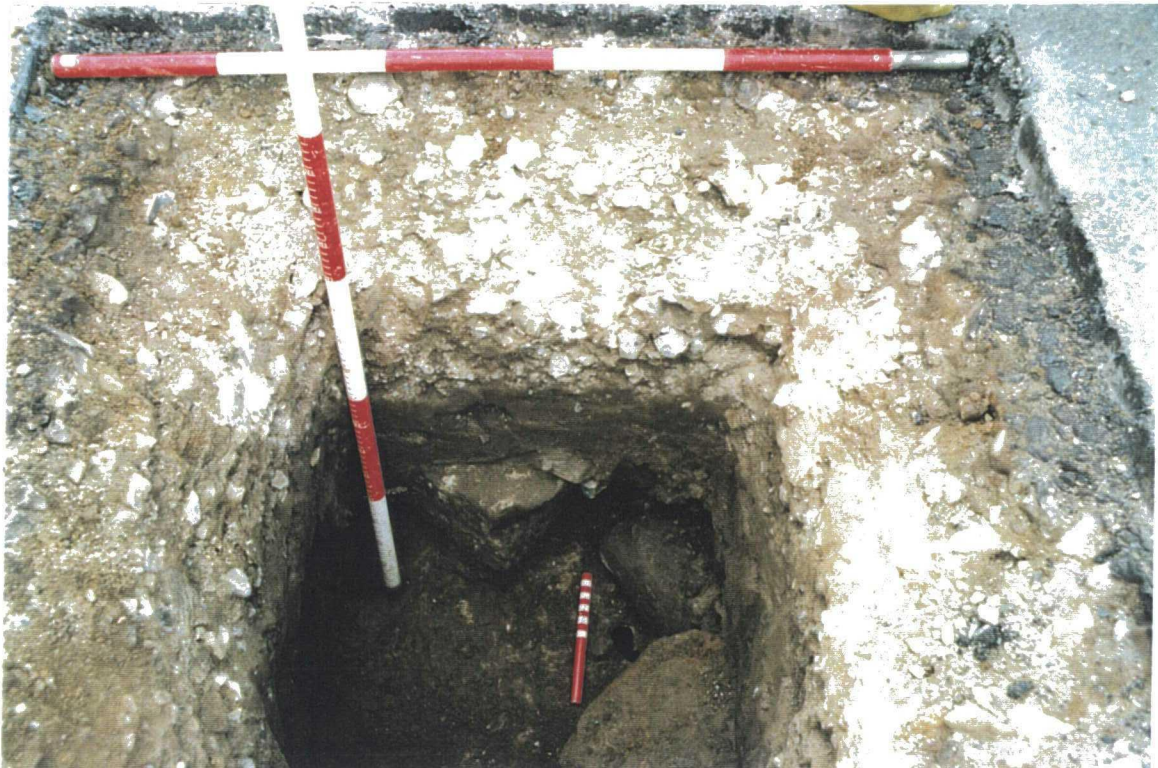
Trial Hole No.3, detailing rubble fill and mortar crust.

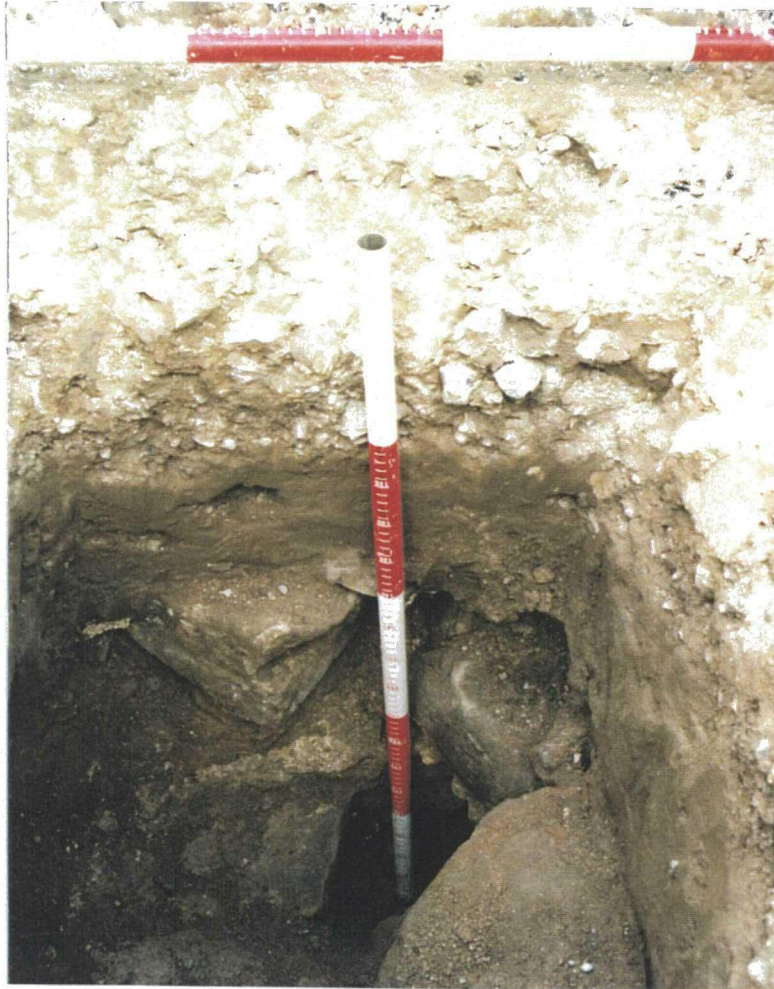
PLATE 4

Trial Hole No.3, detailing mortar crust and void onto arch ring.

As regards the impact of the proposed consolidation works on the monument, the trial holes revealed that the rubble layer (Level D) had voids between the sandstone fragments and the mortar matrix. The voids varied in form and size up to that which could accommodate a 150 mm diameter sphere. It is felt that these may threaten the stability and strength of the structure and would benefit from liquid grouting, however, this should be calculated and assessed by a Civil Engineer. The fill of the piers (Level E) appeared to be extremely well compacted, however, it is understood from Mr.Smollett that a recent structural evaluation on the elevations of the bridge revealed voids within their fill and again may benefit from grouting.
