**ALDWARK MANOR GOLF CLUB,
ALDWARK,
NORTH YORKSHIRE**

**REPORT ON AN
ARCHAEOLOGICAL
EVALUATION**

**1998 FIELD REPORT
NUMBER 55**

IMPLICATIONS ON THE CONSTRUCTION
OF AN AGRICULTURAL BUILDING AT HOME FARM,
ALDWARK, NORTH YORKSHIRE SE 469 630

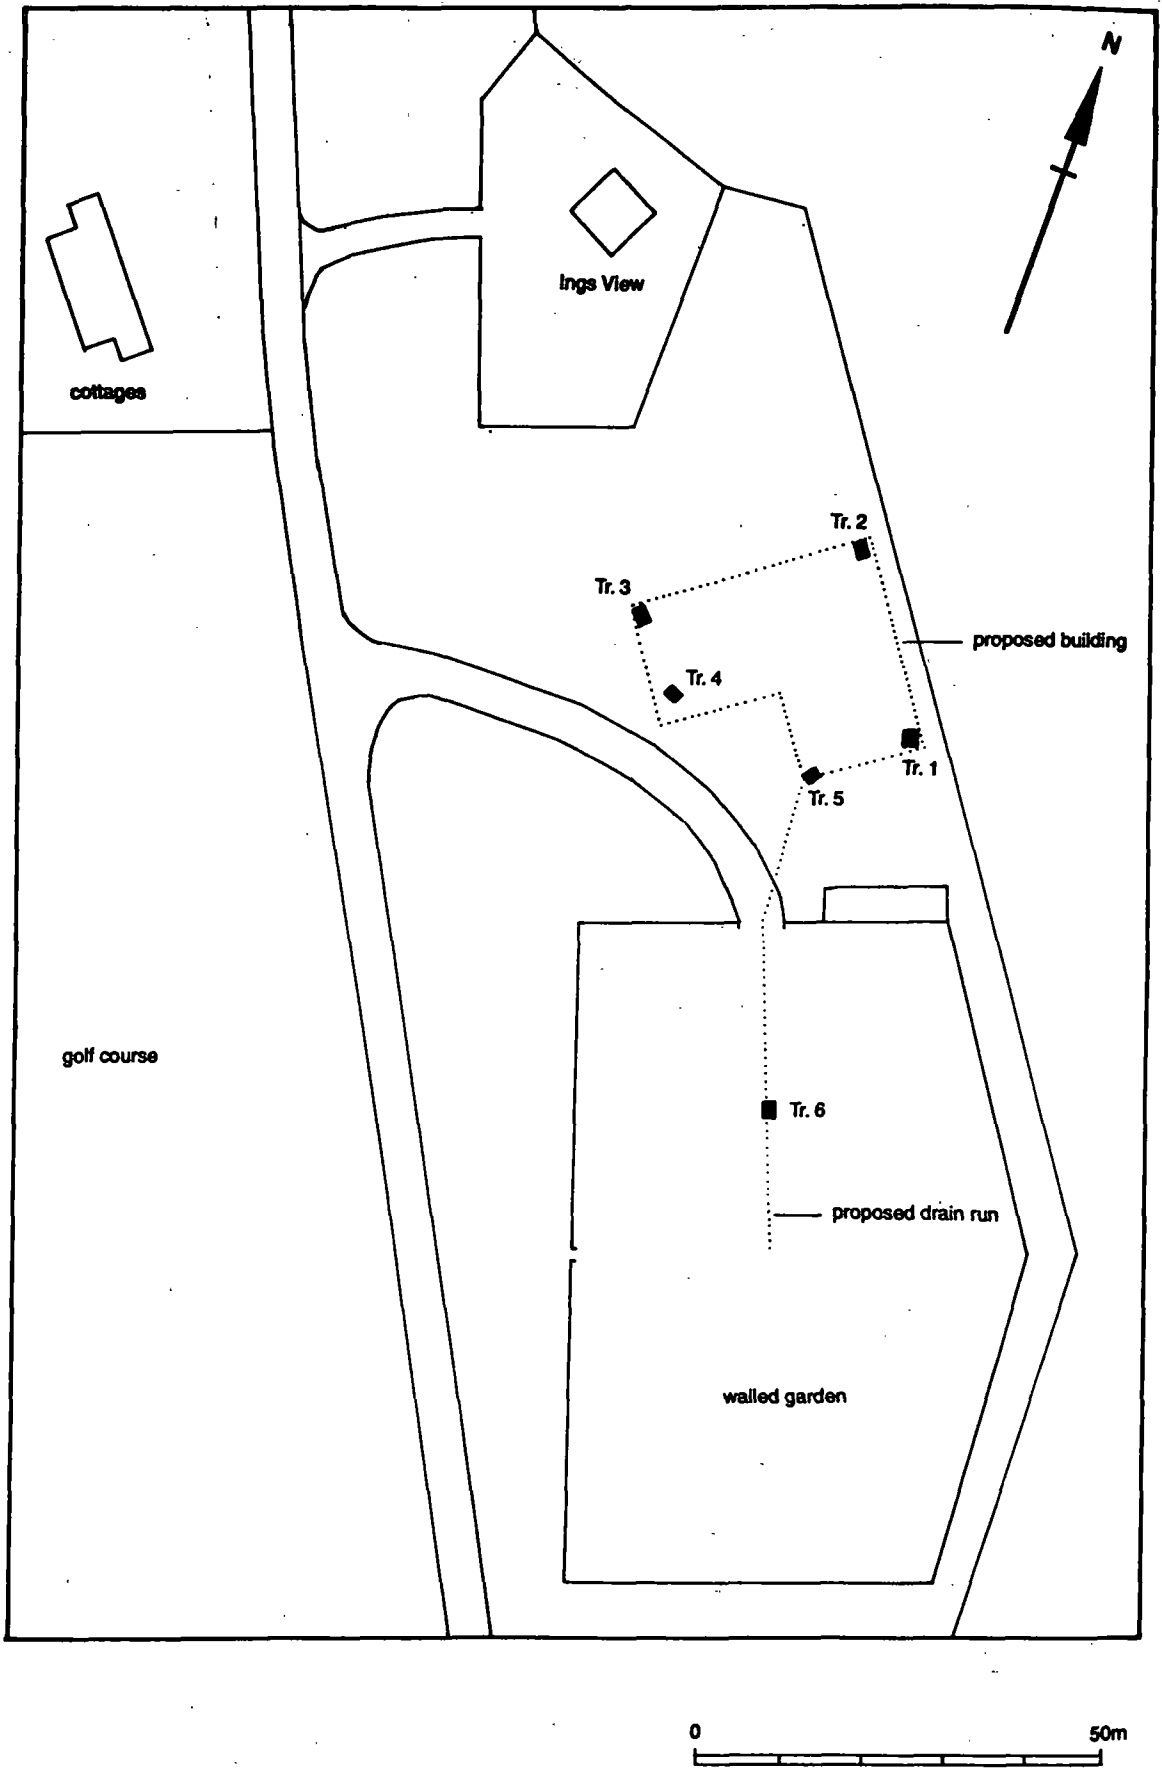
Figure 2 Trench Location Plan

The evaluation consisted of the excavation of six trenches each measuring approximately 1.70m x 1.50m in surface area, (Figure 2, Trench Location Plan). The position of the trenches was determined by the plan of the proposed building, five of the trenches being located close to corners of this. The sixth trench was located in a walled garden some 35m to the south of the proposed building on the proposed drain run for the development.

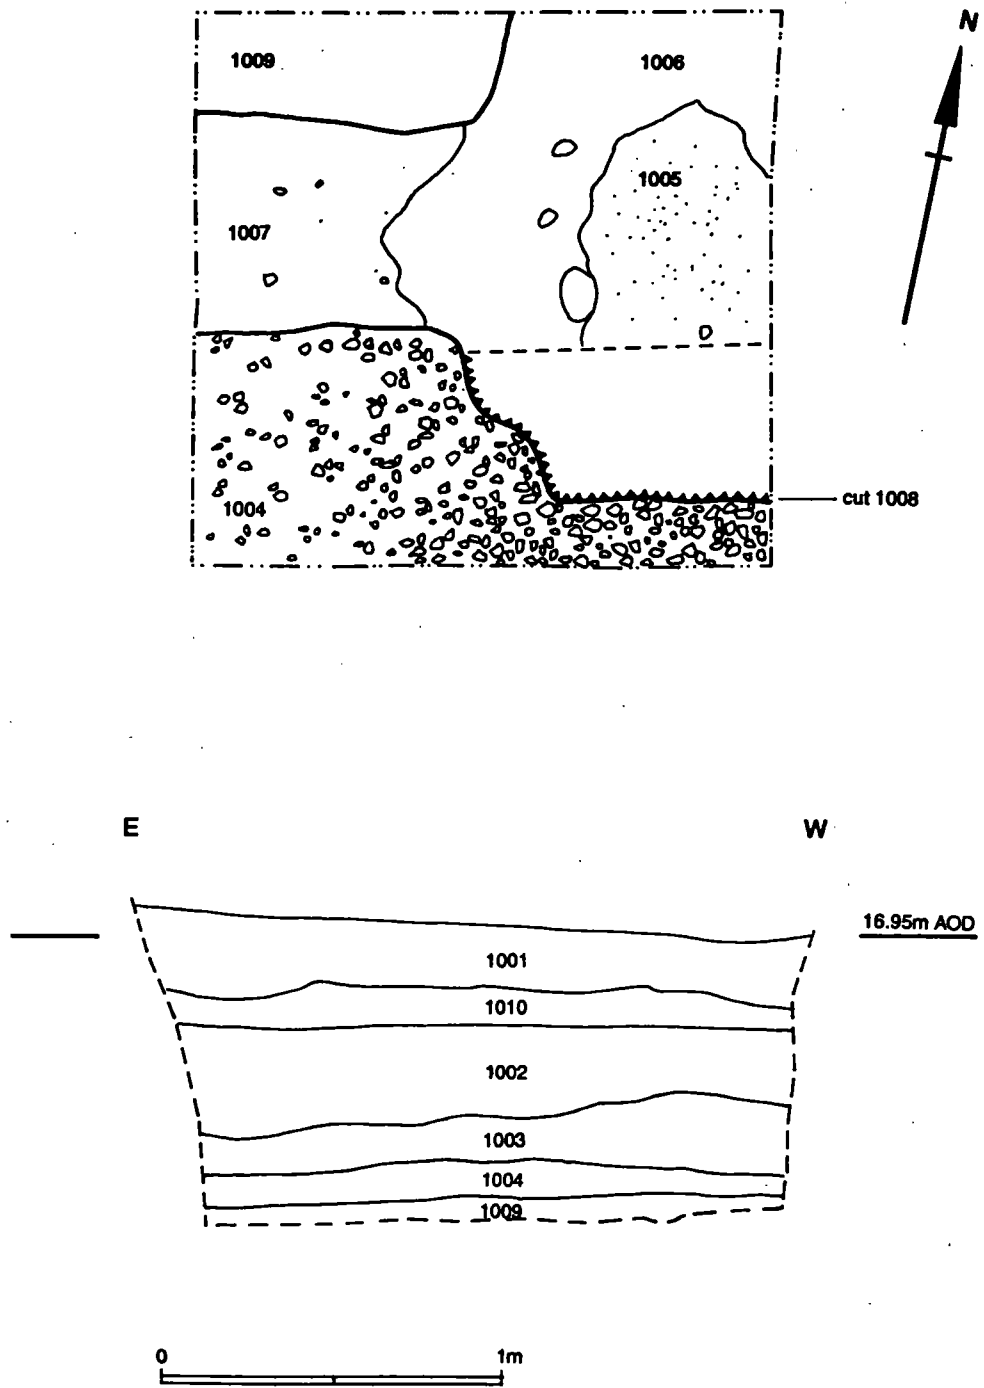
Figure 3 Trench 1, Plan and North facing section

Natural drift deposits in the form of orangish and orangish yellow sandy clay, context 1009, were located at a depth of some 0.77m BGL (Below Ground Level)(16.20m AOD(Above Ordnance Datum)). Sealing this material, in the southern part of the trench, was a spread of stones of a size 0.01m – 0.06m and up to 0.10m thick. This deposit was interpreted as a metalled surface.

Immediately north of this surface was part of a large cut feature, context 1008. The full shape of cut 1008 is not known but what may be a channel or gully (rather than an integral part of 1008) some 0.60m wide and aligned approximately east – west was seen to lead to or from this feature. A segment was cut across 1008 and this showed the feature to display sheer vertical sides. The base of the feature was not reached despite excavation to a depth of 0.30m (1.10m BGL). The lowest excavated fill in cut 1008 was context 1006, an orange brown, stiff, silty clay with some reddish brown mottling, that contained pockets of clayey silt and occasional flecks of charcoal. A single sherd of 11th century gritty ware was recovered from this fill. It was noted that 1006 lay stratigraphically above context 1007, a brownish orange clayey silt that occupied the east-west aligned channel and was not excavated. Sealing 1006 was context 1005, a charcoal rich, brown clayey silt containing occasional cobbles. The function of cut 1008 is not known. The perfectly vertical sides of the feature may suggest that it was once lined, perhaps with wood that has since decayed. The presence of the related channel make it likely that something was either fed to or from the large cut. An industrial use, or perhaps the control of water are possible interpretations. It is not known if 1008 cut through the adjacent metalled surface 1004 or if both features are associated and contemporary.

Sealing 1008 and the remnants of the metalled surface 1004, was context 1003, a layer of pale grey, slightly sandy silt containing the occasional small stone and fleck of charcoal and whose upper profile rose up to the west. It is possible that 1003 developed as a soil above the redundant features below. Quite why 1003 should rise up to the west is uncertain though it could conceivably relate to subsequent incorporation into a ridge and furrow field system.

Directly over 1003 lay context 1002 a light brownish yellow silty sand. Although no finds were recovered from this material it clearly represents human deposition. Above 1002 lay context 1010, a pale greyish brown sandy silt that forms the present topsoil and was in turn sealed by context 1001 an accumulation of leaf mould and compost.

Archaeological features were located in two of the excavated trenches, Trenches 1 and 2. The large cut feature with an associated channel in Trench 1 that had cut through an earlier metalled surface was almost certainly of medieval date and may have been related to the control of water. The metalled surface in Trench 2 also appears to be of medieval date. All of these features are likely to relate to activity associated with the probable manorial complex that research suggests lay immediately to the north. All of the trenches demonstrated a build-up of deposits above the level of the drift geology to that of the present ground surface and this was seldom of a depth of less than 0.60m. Certain of these deposits display considerable similarity from trench to trench, in particular contexts 1003, 4005 and 5004 which appear to represent relict topsoils of some antiquity. In Trenches 4 and 5 these lay directly over the drift whereas in Trench 1 this had formed over features of medieval date. The only other relict topsoil was 6003 in Trench 6 which was not sealed until the later 19th century. Other contexts for which correlation (again on the grounds of similarities in texture, consistency, finds and stratigraphic positions) can reasonably be made are 1002, 2005, possibly 3002, 4003 and 5003. All of these contexts were pale silty sands that contained occasional charcoal flecks and small fragments of what is probably 13th + century tile and collectively extend over a substantial part of the site. The origin of these contexts is probably through later medieval or post medieval deposition and they appear to effectively seal, in places at least, underlying medieval features.

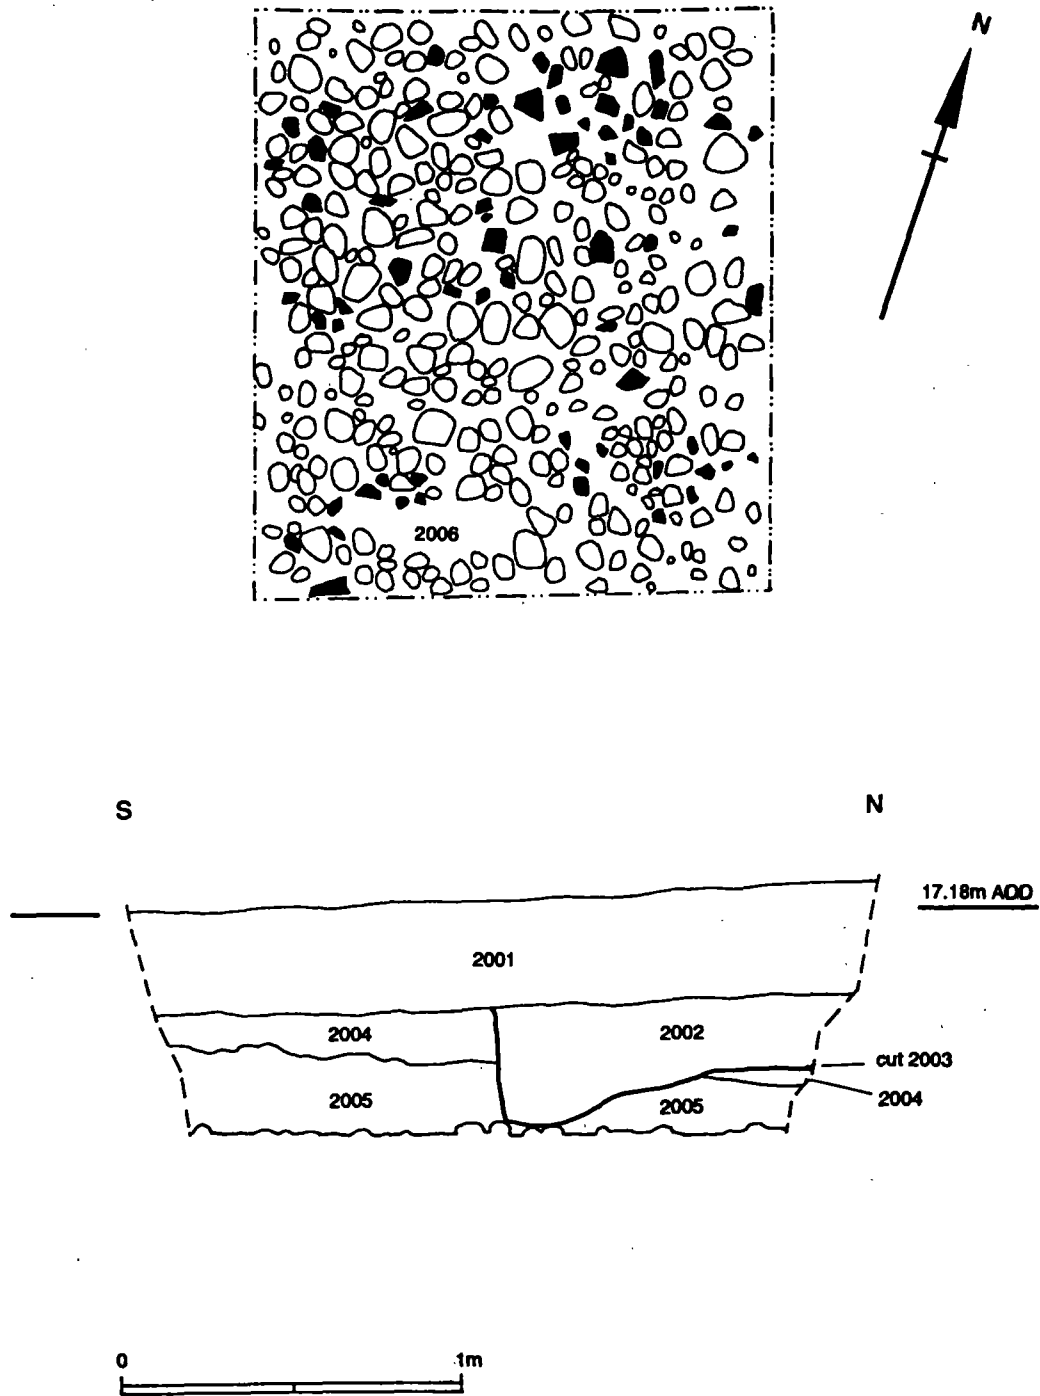
Figure 4 Trench 2, Plan and East facing section

The earliest deposit encountered in Trench 2 was a dense spread of cobbles of a size 0.06m – 0.14m that contained tile fragments throughout its matrix, context 2006, and occurred at a depth of 0.70m BGL (16.48m AOD). This spread was seen in places to be up to three stones deep and clearly represents a metalled surface, perhaps of a track or yard. Tile from this surface appears to be of a 13th + century date. Lying directly over this surface was a deposit of light yellowish brown silty sand, context 2005. This material contained a few fragments of brick and tile of a 14th + century date. Context 2005 bore similarities in terms of texture to context 1002 in Trench 1, although by what process this material was deposited is uncertain. A layer of pale, brownish grey sandy silt, context 2004, overlay 2005. No finds were recovered from this material and although its origin is not certain it may be that it represents a zone of mixing between the present topsoil and context 2005, it being noted that the interface with both the topsoil and 2005 was very blurred and indistinct. Parts of a pit were seen to cut through 2004 in the north-west part of the trench, context 2003. This pit displayed steep sides and a base that rose slightly to the north. The single fill of the pit, context 2002, was a mid greyish brown sandy silt that contained cockle shells, fragments of possible medieval tile, some decayed bone and part of a plant pot. It is clear that this pit is of 19th or 20th century origin and was probably cut for the disposal of domestic refuse. The pit was not seen to (though may well have) cut through the extant topsoil, context 2001, a greyish brown sandy silt.

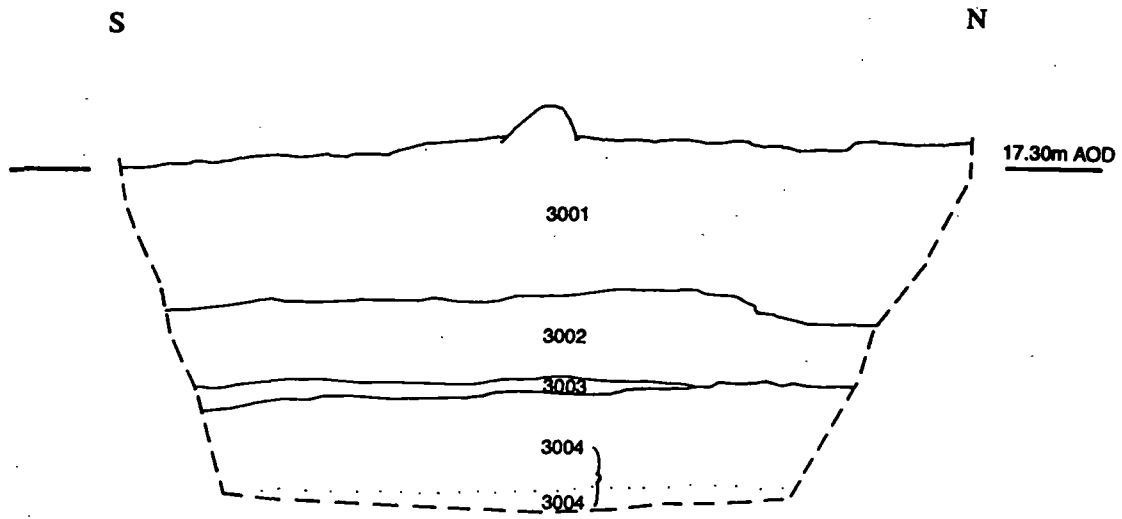
Figure 5 Trench 3, East facing section

Brown, slightly sandy clay overlain by pinkish brown sandy clay formed the banded natural drift deposit in Trench 3, context 3004, and was located at a depth of 0.70m BGL (16.59m AOD). This was overlain by context 3003 a thin deposit of yellowish brown, slightly clayey silty sand that contained 13th + century tile fragments and occasional charcoal flecks. The density of tile within this context suggests that it was formed by a spread of demolition type debris, though whether as merely a dump or as a cmde surfacing is not known. Overlying 3002 was context 3002 a compact, yellowish brown silty sand that contained charcoal flecks and fragments of 13th + century tile. The origin of this material is uncertain. A thick deposit of mixed material, context 3001, that included modern building rubble, wood, a refrigerator and concrete formed the uppermost deposit in Trench 3. This context clearly derived from dumping in recent years.

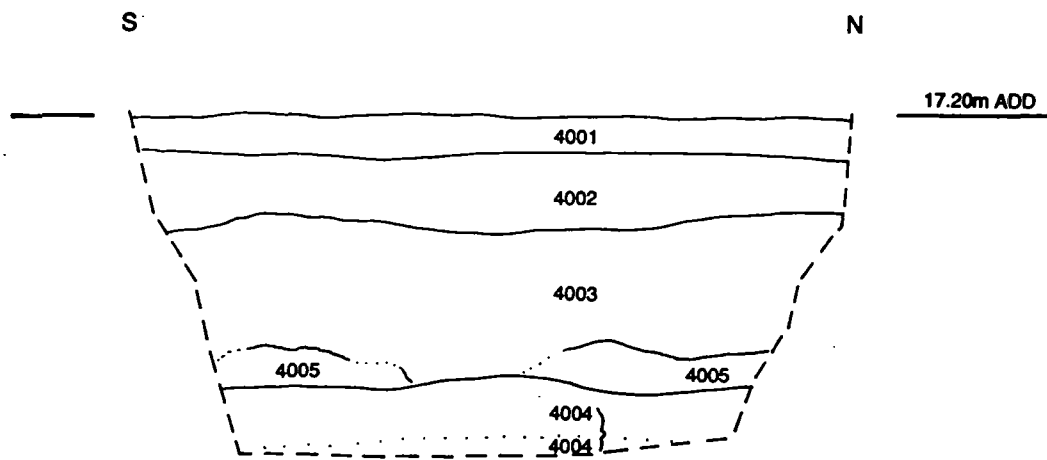
Figure 6 Trench 4, East facing section

Natural drift deposits occurred at 0.77m BGL (16.43m AOD), context 4004 in Trench 4. This material proved to be banded. The lower part was composed of palish brown, slightly sandy clay. The upper part was a yellowish orange, compact, pure sand. It was initially thought that the upper sand element may have been of human deposition, but the absence of finds and the clean, pure nature of the material lends weight to the notion that it is likely to form a part of the drift. Context 4003, a deposit of light yellowish brown, fairly compact, slightly silty sand, sealed the drift deposits. It was noted that parts of the lower zone of 4003 were slightly darker and siltier than the upper. Although these darker components were in no way continuous they were allocated a separate context number, context 4005. The only finds apparent in contexts 4005 and 4003 were very small flecks of brick or tile that proved to be too small to be of any diagnostic value in terms of dating. It is considered that context 4005 may once have formed part of a

disturbed relict topsoil whilst context 4003 represents human deposition, of an unknown purpose, above this. The existing topsoil in Trench 4 was of two parts. The lower of these was a dry, compact, mid greyish brown sandy silt, context 4002, the upper, later part, was a soft damp dark greyish brown silt, context 4001, largely derived from compost and leaf mould.

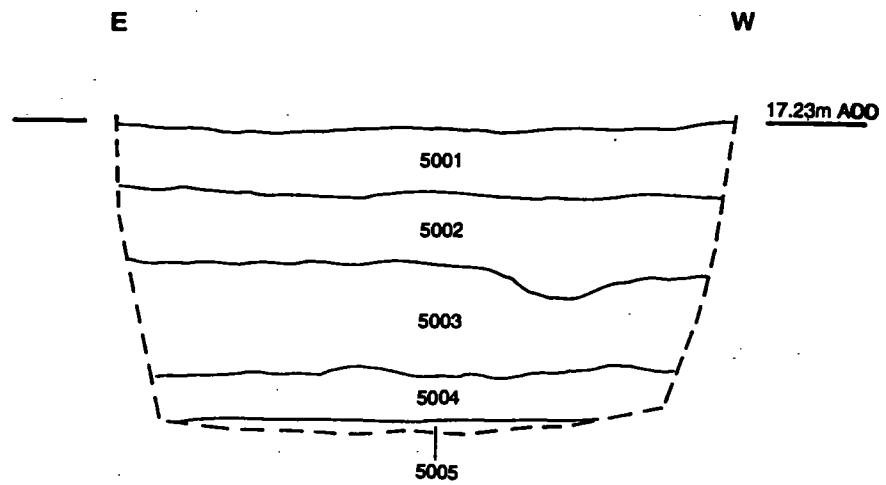
Figure 7 Trench 5, North facing section

At a depth of 0.85m BGL (16.41m AOD) a stiff, brownish yellow clay forming the upper part of the drift was located, context 5005. This material was sealed by context 5004, a layer of slightly clayey mid yellowish brown silty sand, possibly an old topsoil horizon. Context 5003, a light brownish yellow, slightly silty sand that contained the occasional charcoal fleck and small fragments of 13th + century tile together with a small quantity of flecks of burnt clay, sealed context 5004. Whilst probably of human origin the function of deposit 5003 is uncertain. A layer of light greyish brown sandy silt, context 5002 lay over 5003 and represents a topsoil. This material was in turn overlain by context 5001, a recent deposit of compost.

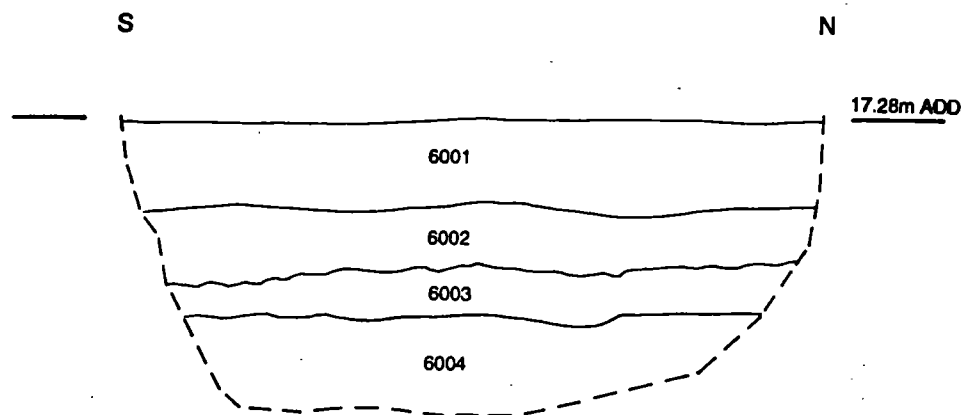
Figure 8 Trench 6, East facing section

Trench 6 was excavated along the projected course of a proposed surface water drain and was located within a walled garden some distance to the south of the other trenches. A yellow, stiff clay, of the drift, context 6004, occurred at a depth of 0.54m BGL (16.72m AOD). This material was overlain by context 6003, a mid brown sandy silt. Context 6003 is likely to have formed a topsoil prior to the construction of the walled garden and the raising of ground levels therein. That 6003 was darker and softer than other relict topsoils in Trenches 1, 4 and 5 is likely to be due to its having been an active topsoil/horticultural soil until the later 19th century when the walled garden was built. A very mixed deposit, context 6002, overlay 6003. This was composed of two principal elements that both occurred at the same horizon. One of these was a buff coloured clay, the other a dark brown sandy silt. This material is interpreted as deposition to raise the ground level, in which the clay element may be derived from redeposited "natural" of the drift. Sealing context 6002 was the deep, well dug over topsoil, context 6001, that until recent years was used for horticultural purposes.

The surface water drain (to run from the south of the building to a well in the centre of the walled garden) is due to cut more deeply into the ground than other proposed works associated with this development. It is thus suggested that the excavation of this be archaeologically observed in the stretch from the new building to the edge of the walled garden.

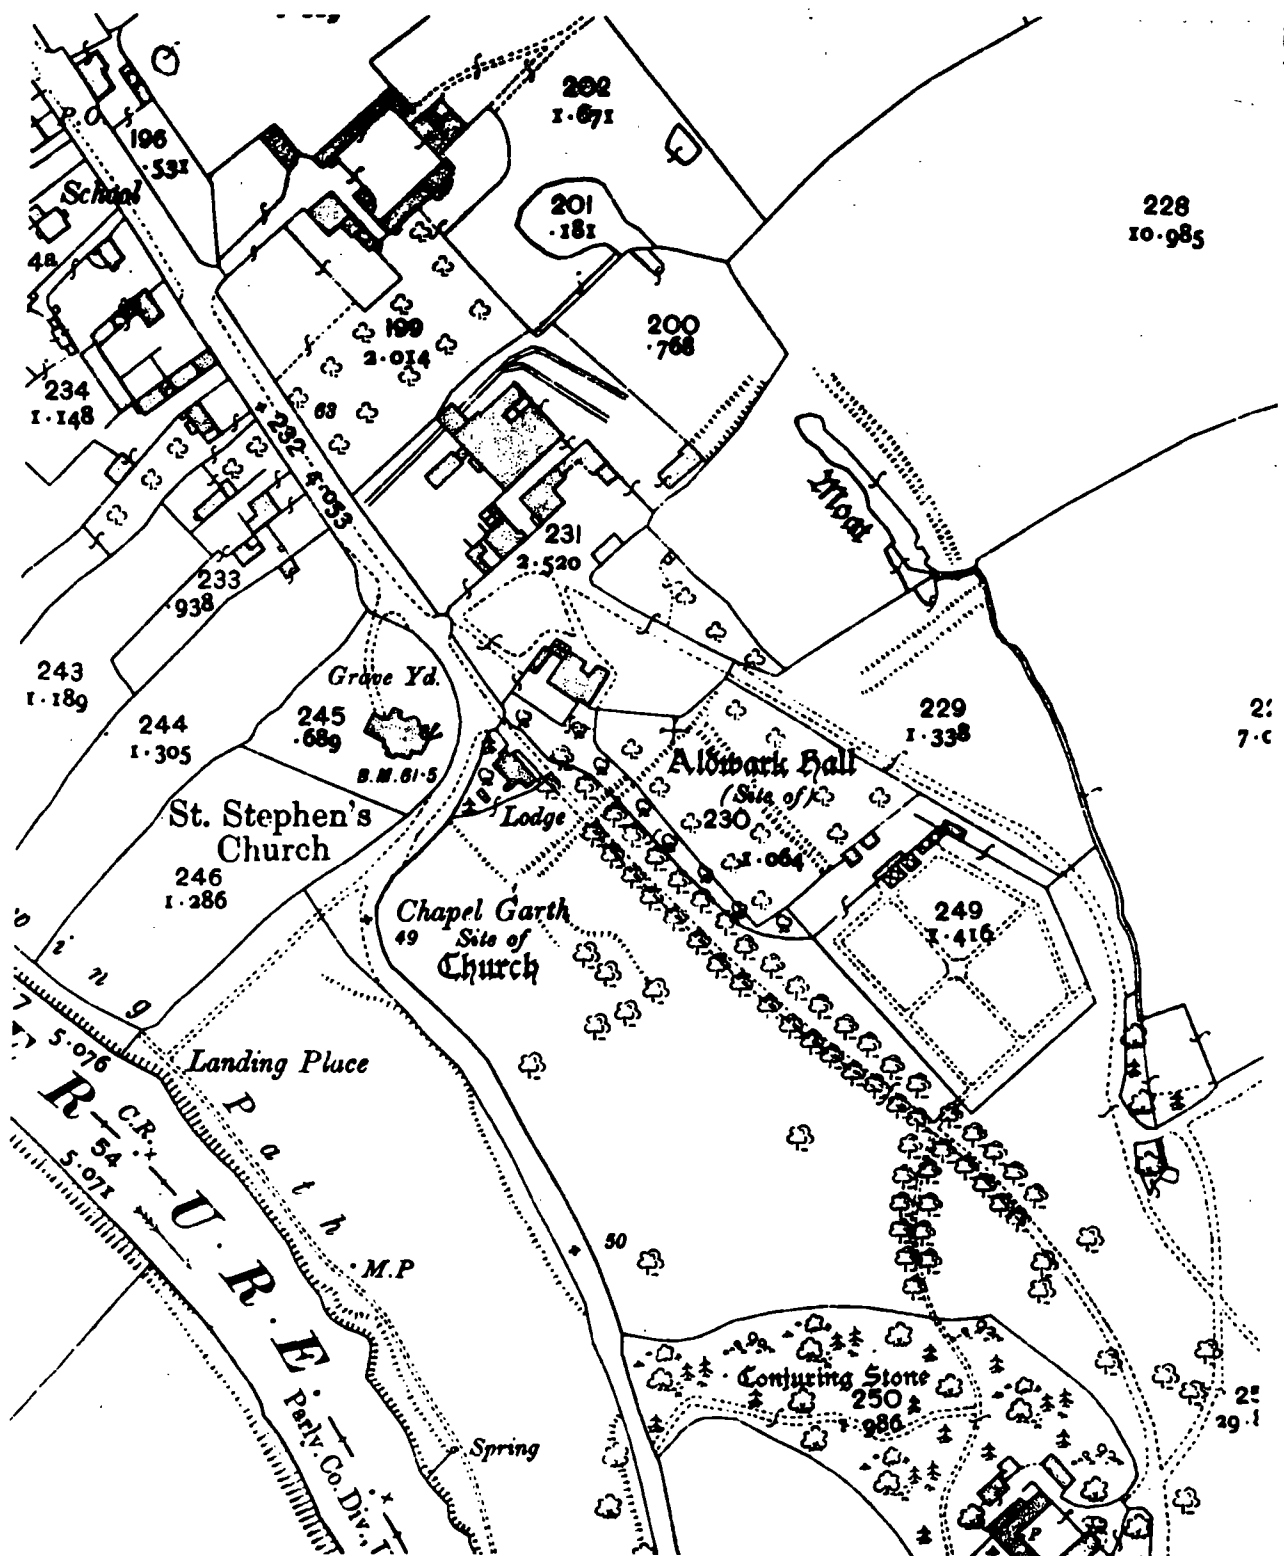
Figure 10 Extract from 1909 Ordnance Survey map

A manor is recorded in Domesday as belonging to Ligulf and was subsequently owned by the Count of Mortain, (VCH, 1928). It is not certainly known where the earliest manor house in the village was located. The last vestiges of a moated site lie some 40m to the north of the development site. Maps of 1856 and 1909 (Figure 9 and 10) show that until comparatively recent times large parts of the moat survived as an upstanding site. Although Le Patourel states that a house stood on the island (possibly the medieval manor house) it is not certain what the source of this information is, or indeed if the house was the manor house, (Le Patourel, 1973). A possible alternative site for the manor house is a location under the modern house named Ings View just south-west of the moat. The grounds for this argument are that the 1856 map shows a small area of raised ground with text beside it stating "site of Aldwark Hall". The 1909 map also shows the site of "Aldwark Hall" in this same position. It is possible that during the medieval period the location of the manor house could have changed. South-east of the possible manor site a bowling green is recorded on the 1856 map and south of this a field known as chapel garth that is reputed to have been the site of a domestic chapel, (O.S. card NYCC SMR). Also shown on the 1909 map is a north-west to south-east aligned ditch that runs across the area of the development site.

Note was made in section 2 of traces still apparent of the north-west to south-east aligned ditch that was recorded on the 1909 O.S. map. Whilst the date of this ditch is not known for certain it may be of some antiquity. It is recommended that if construction works are to impinge on this feature below the level of the topsoil then attempts be made to raise ground level rather than reduce it.

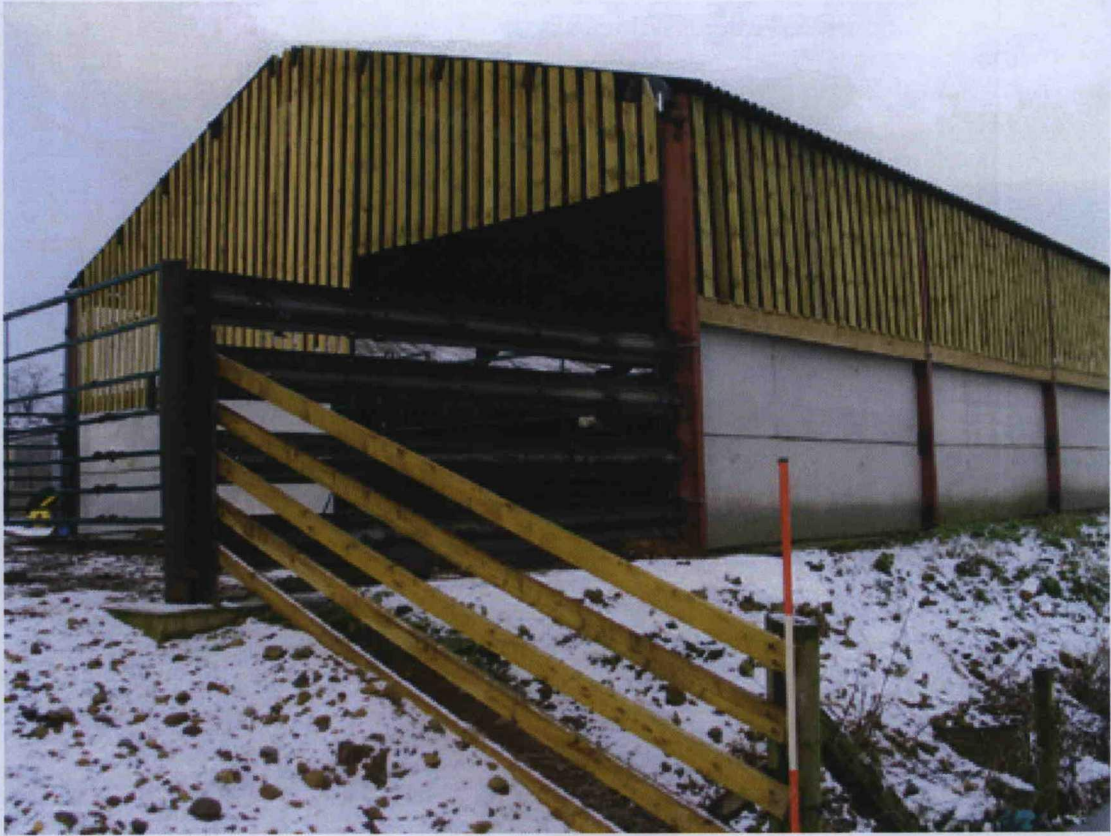
- 3.1 The development took place in the Summer of 2006 with the barn being constructed upon the site of an existing building (Brian Proudley pers. comm.).
- 3.2 The ground surface was raised and the barn built upon a platform of aggregate, and therefore the floor surface of the building is 0.80m above the level of the field. (pl. 1, 2 and 3).
- 3.3 The development has not occurred within the area of the earthworks of the moat, but was in the farmyard. In this respect the site has not been disturbed.
- 3.4 There are no further works or services proposed for this development.

Pl. 2 To show the stone foundation upon which the barn was built, looking NW

- 4.1 The barn at Home Farm is now completed and in use. There will be no disturbance of the ground for services or drains relating to the building and therefore no opportunity to examine beneath the ground at this site.
- 4.2 The construction method of building the barn on a raft or platform is the course of action that would minimise damage to archaeological sites and so this building would have a minimum impact upon any below ground archaeological features.
- 4.3 In considering that the work on site is now complete and following a site visit by the author to record the development, it is recommended that no further archaeological work could be undertaken.

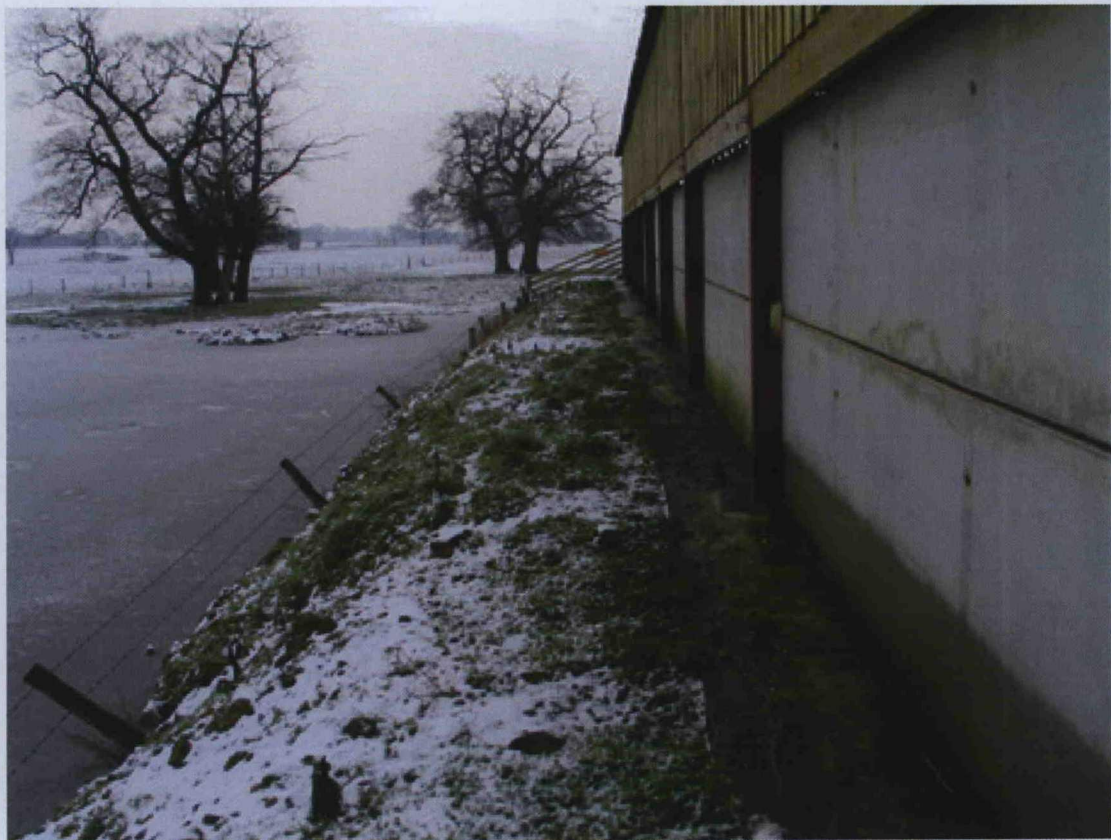
Pl.3 To show the barn upon a stone foundation, looking SE towards the moat
