**Morrison's Supermarket
Castlegate
Malton
North Yorkshire**

**Archaeological Evaluation by Trial Trenching
SE 7882 7151**

Contents	Page
Figure List	2
Plate List	2
Non Technical Summary	3
1. Introduction	4
2. Site Description	4
3. Archaeological and Historical Background	5
4. Aims and Objectives	7
5. Methodology	8
6. Results	9
7. Conclusions	13
8. References and Bibliography	14
9. List of Contributors	15
Appendices	
1. Context Listing	29
2. Finds Catalogue and Assessment	31
3. Archive Listing	33
4. Photographic Listing	34
5. Written Scheme of Investigation	37

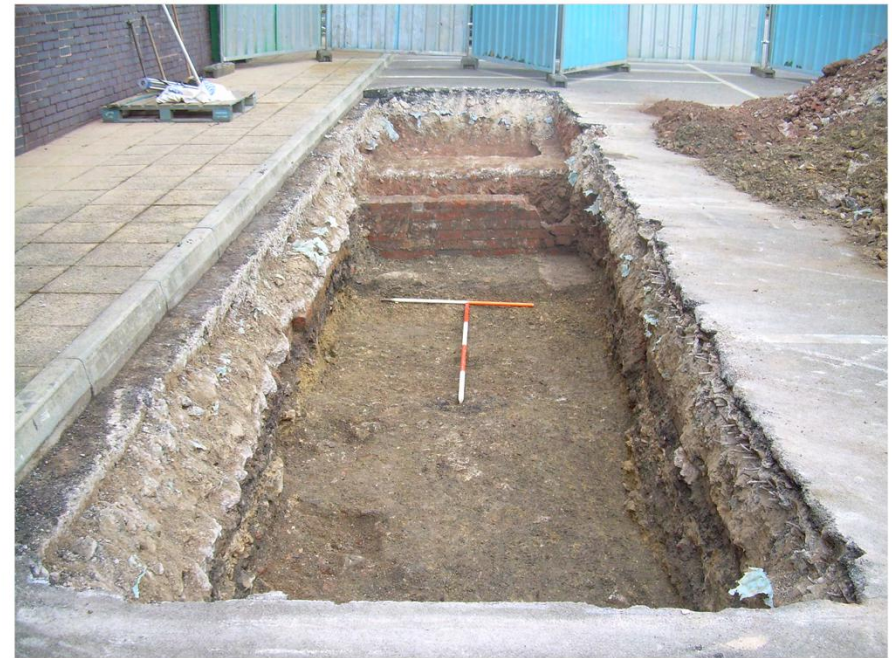
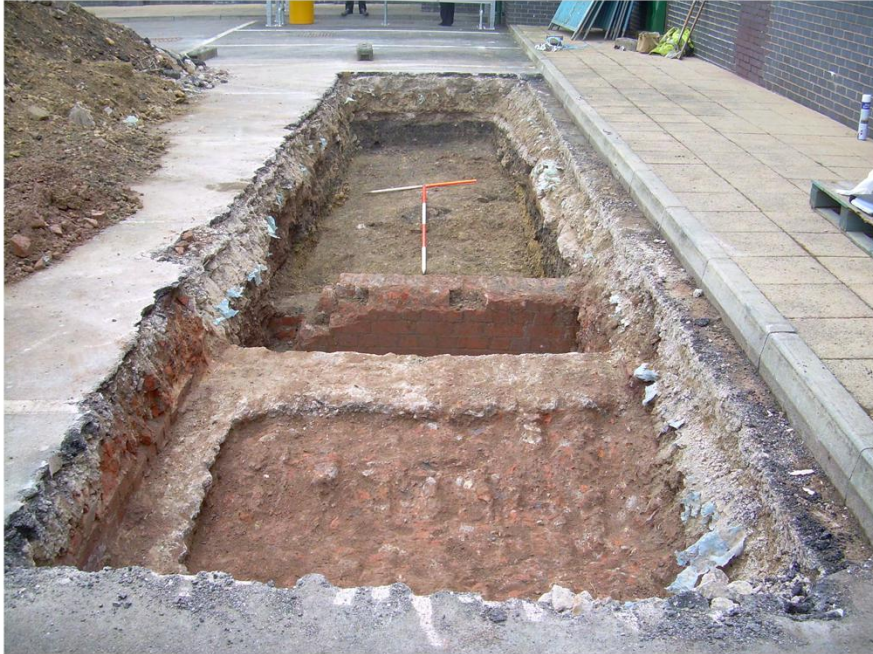
6.1.1 Evaluation Trench 1 was located in the 1.5m south of the south wall of the supermarket building. There was 0.50m of overburden at the eastern end of the Trench, excavation ceased at a concrete foundation of a late 1980's substation removed by the expansion of the supermarket in 1999. There was approximately 0.90m of overburden at the western end of the trench, was removed by machine to reveal three archaeological features. Existing ground level lay between 19.32m and 19.23m AOD. The initial excavated level in the trench was at between 18.74m AOD and 18.23m AOD (Pls 2-3).

Plate 2. View of Trench 1 after cleaning. Facing East.

Plate 3. View of Trench 1 after cleaning. Facing West.

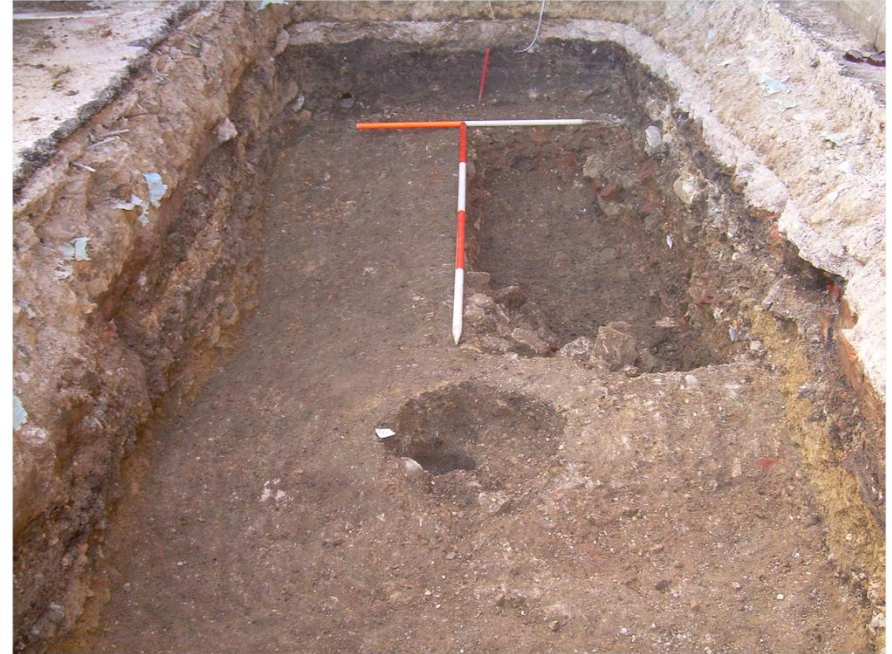
Pit 1019 (Pl. 4) was located in the north-west corner of Trench 1 and a 1m wide segment was excavated through this pit. The pit measured 2.63m by 1.40m and was 0.50m deep with a flat base at 18.09m AOD. This pit fill

(context 1018) contained sherds of seventeenth and eighteenth century pottery.

Posthole 1023 (Pl. 4) was sub-rectangular in plan with a diameter of 0.32m and a depth of 0.23m (base at 18.17m AOD). There was a distinct post-hole impression in the cut with a diameter of c. 0.15m. Posthole 1023 was filled by deposit 1020, which contained a sherd of late medieval pottery.

Plate 4. Trench 1: Posthole 1023 and Pit 1019. Facing West.

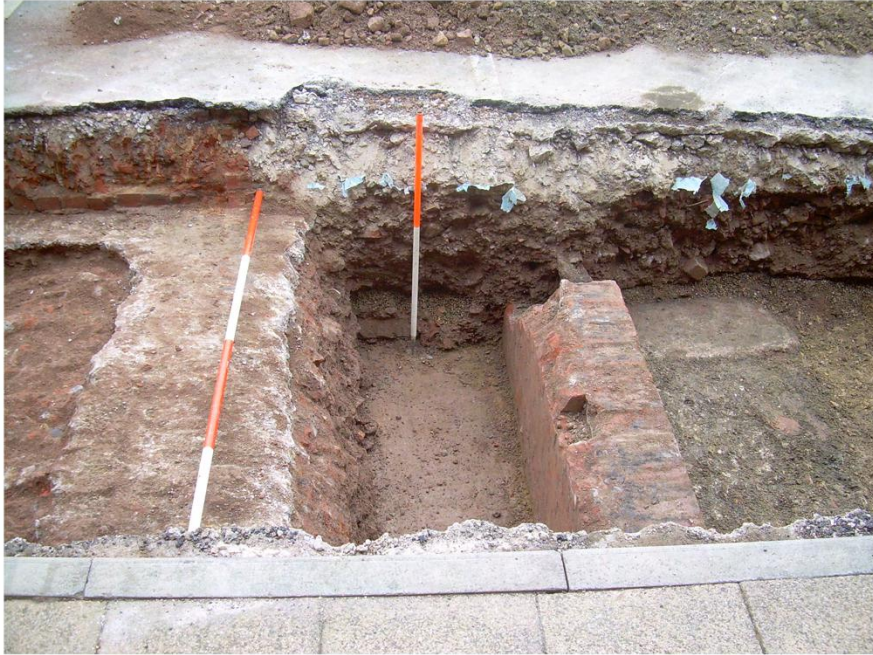
After removal of the tarmac (context 1001) and reinforced concrete (context 1002), which was c. 0.5m deep, revealed modern foundations from a Substation demolished in 1999/2000 (wall 1003 and concrete foundations 1004). Beneath this former substation was a brick rubble deposit (context 1005), which overlies and butted the former brewery building (concrete floor 1007 and brick wall 1006; Pl. 5). The cellar floor was at 18.14m AOD, and the top of the wall was at 18.83m AOD.

Plate 5. Trench 1: Concrete Floor 1007 and Brick Wall 1006. Facing South.

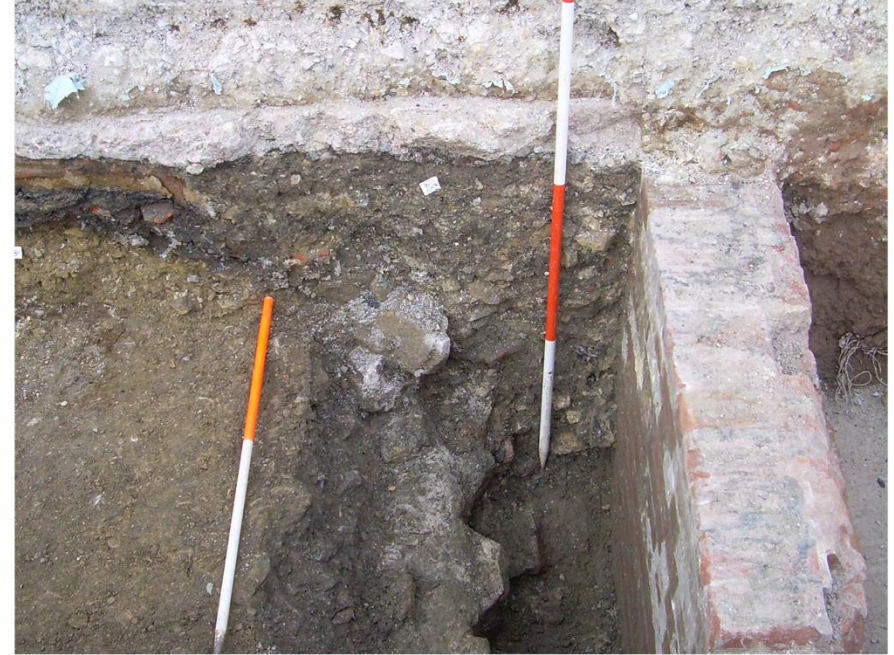
To the west of wall 1006 was a linear feature (fill 1011 and cut 1012), which was fairly modern in date, cutting through brick surface 1013 and sealed below concrete floor 1010. Cut 1012 (Pl. 6) measured 1.43m by 1.10m and was 1.30m deep. Deposit 1011 contained mid-late nineteenth century pottery.

Plate 6. Trench 1: Linear Cut 1012. Facing North.

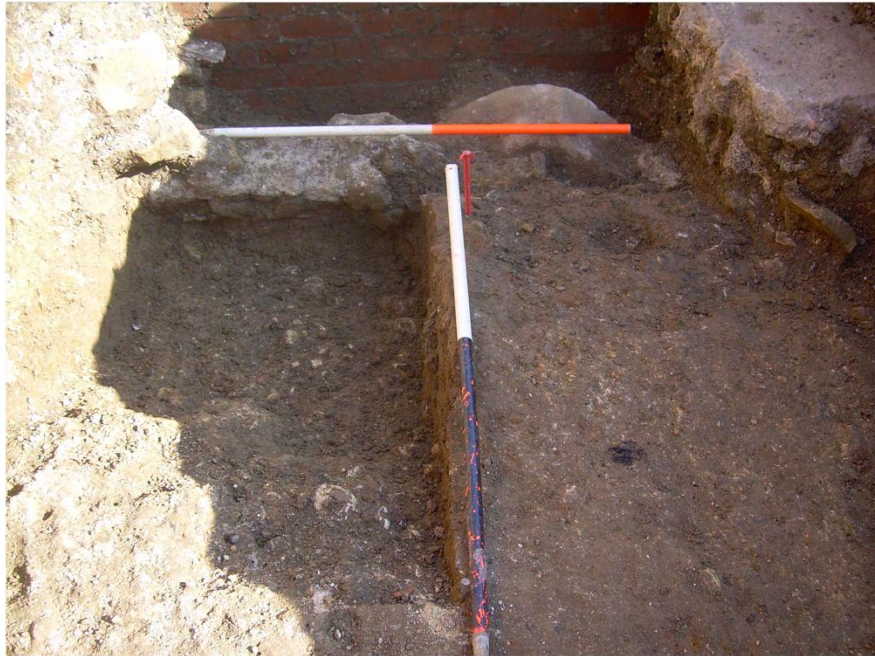
There was an earlier linear feature west of wall 1006. Linear feature 1027 (Pl. 7) contained wall 1025, and was filled by deposits 1024 and 1027. Wall 1025 (Pl. 8) was a possible property boundary wall, with only the core remaining, all facing stones had been robbed. Wall 1025 was aligned north south, west of the later brewery wall 1006. Deposit 1024 contained tile fragments, and Deposit 1027 contained nineteenth century pottery, a residual sherd of Humber ware and ceramic building material.

Plate 7. Trench 1: Cut 1028. Facing East.

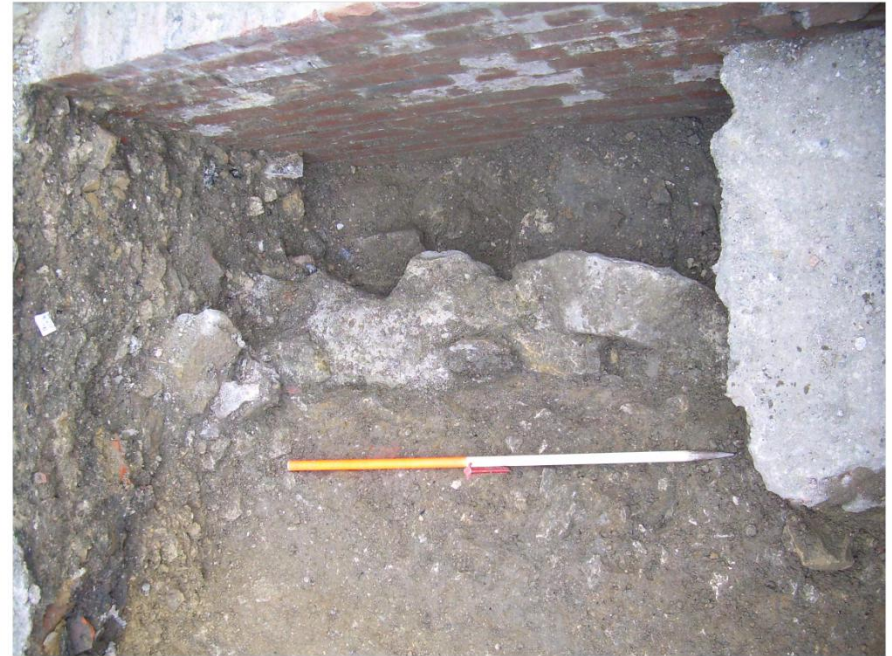
Plate 8. Trench 1: Wall 1025. Facing North-east.

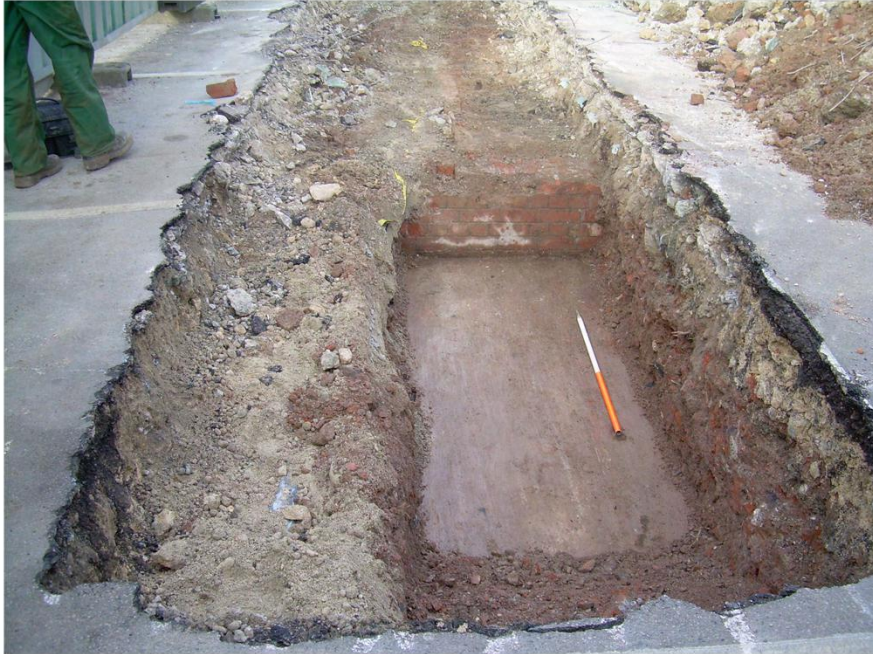
The concrete floor 2019 (Pl. 8) was at 18.15m AOD and was removed to reveal a twentieth century concrete pipe (Pl. 13) in a construction trench at a depth of 17.94m AOD (fill 2022 and cut 2023).

Plate 9. Trench 2: Concrete Floor 2019. Facing West.

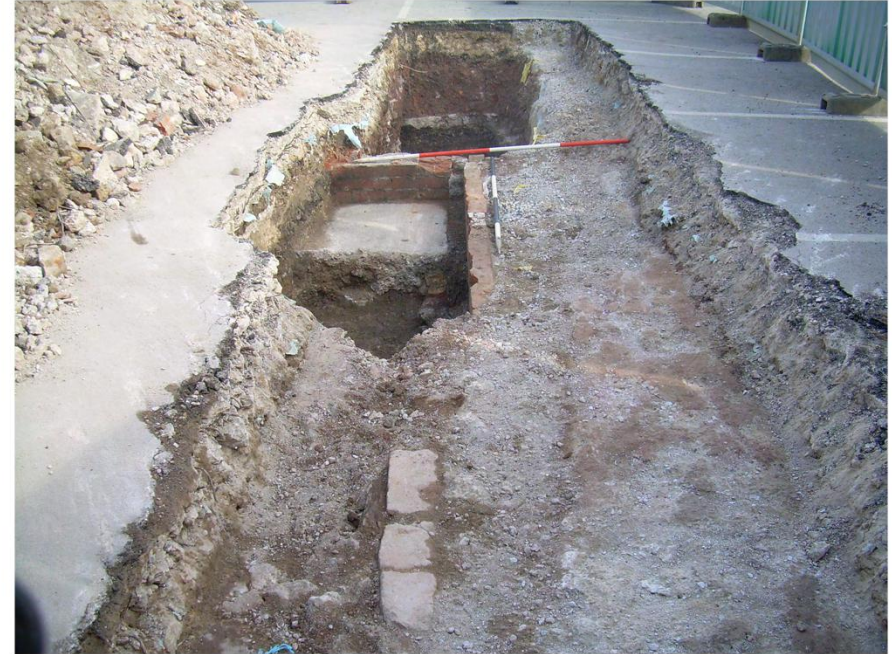
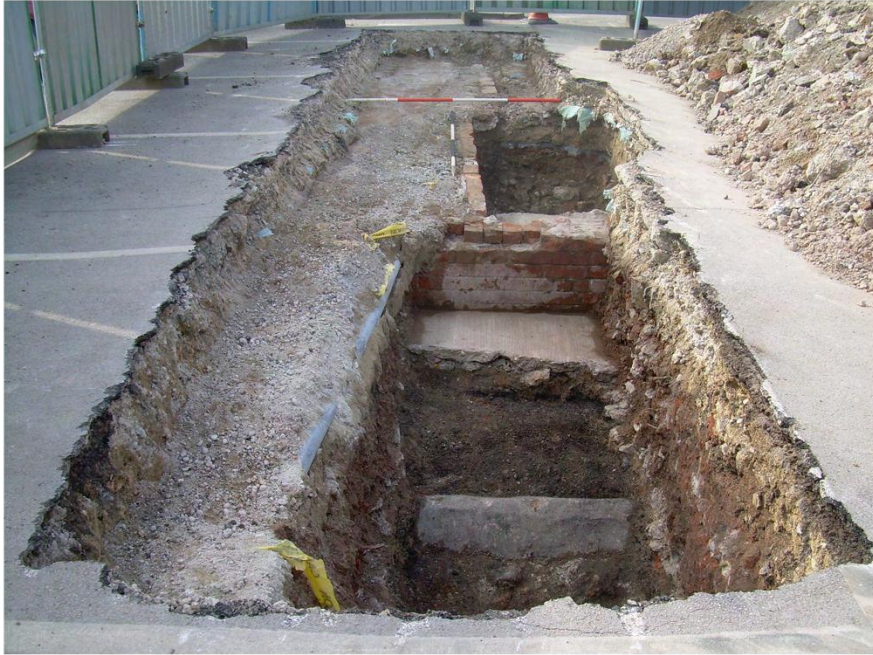
6.2.1 Evaluation Trench 2 was located approximately 10m south-east of Trench 1. Between 0.34 and 1.20m of overburden was removed (Pls. 9-11). During Machining a concrete floor was removed (Pl. 9). A modern electricity duct prevented further excavation over the majority of this trench, two sondages to the north of the electricity duct were excavated. Archaeological deposits were revealed at 0.70m and 1.15m below the car park surface, at 18.54m AOD and 17.85m AOD respectively. Existing ground level lay at 19.14m AOD.

Plate 10. View of Trench 2 after cleaning. Facing East.

Plate 11. View of Trench 2 after cleaning. Facing West.

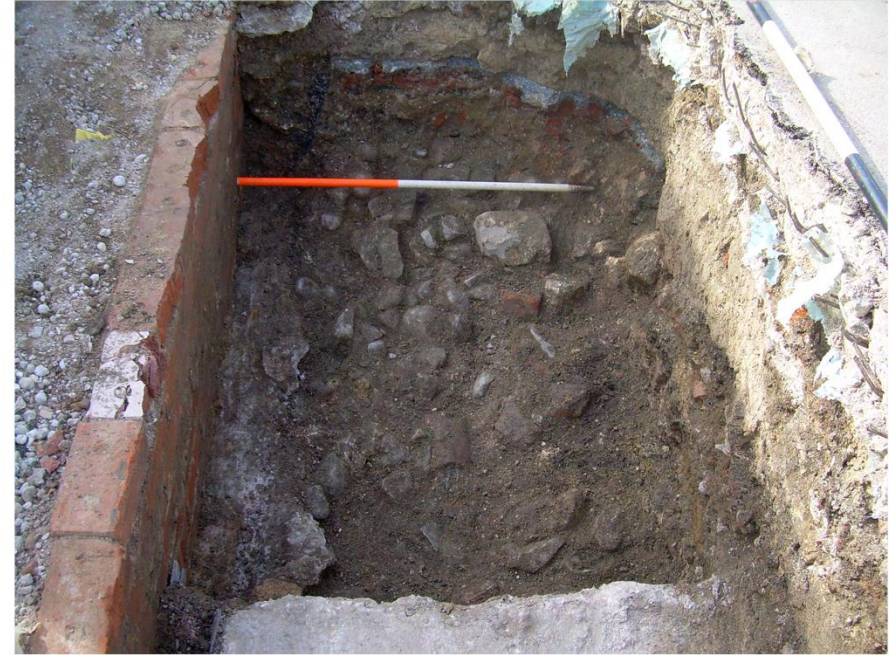
Beneath Phase 2 concrete surface 2015 was a deposit of silt (context 2016), which overlay a cobble surface (structure 2017). This cobble surface (context 2017; Pl. 12) possibly predates the nineteenth century brewery. In the base of the Phase 2 pit 2014, at c. 17.96m AOD, a deposit of silty clay was observed (context 2029).

Plate 12. Trench 2: Cobble Surface 2017. Facing West.

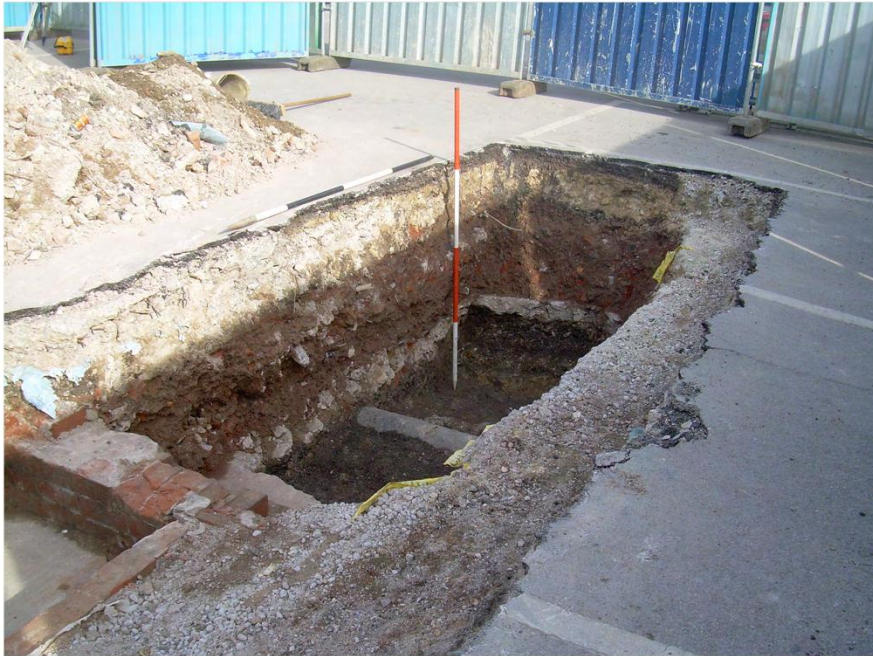
A north-south aligned brick wall (structure 2024), which had been left in situ, further machine excavation was undertaken (Pl. 13). A Modern construction cut (2011) for a concrete base 2010 and its backfill (context 2009) and Deposit 2012, a sandy mortar deposit, was removed to the west of Wall 2024. A deposit of Brick rubble (context 2018) was removed east of Wall 2024. Another concrete floor (structure 2019), was revealed after the removal of brick rubble 2019, this floor butted and was contemporary with Wall 2024.

Plate 13. Deposits and Modern Pipe at Eastern end of Trench 2. Facing North-east.

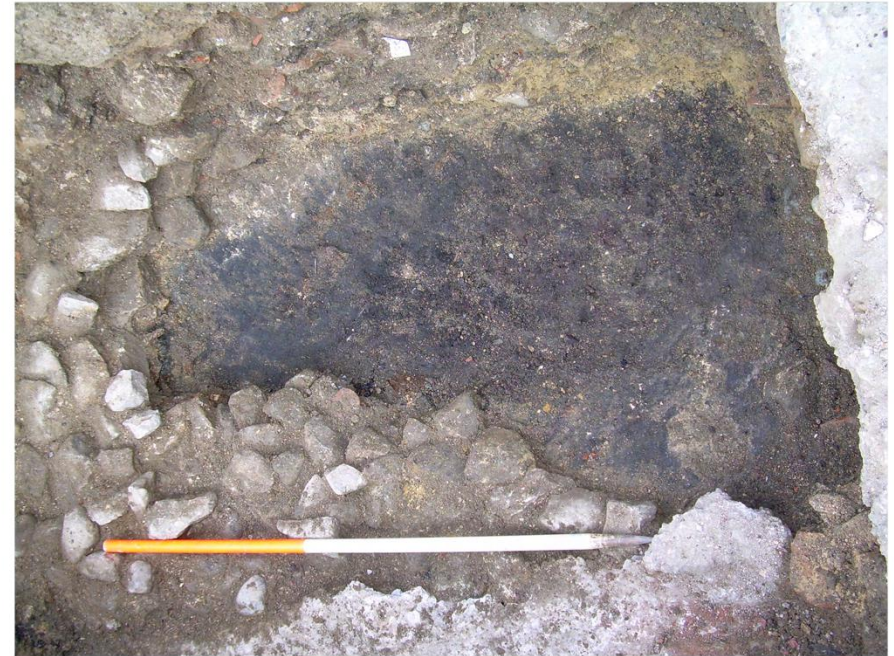
Beneath deposit 2012 was a relatively recent pit (fill 2013; cut 2014). Pit 2014 (Pl. 14) measured 1.30m by 0.84m and was 0.50m deep. Deposit 2013 contained mid-late nineteenth century pottery. Pit 2013 cut through a concrete surface 2015.

Plate 14. Trench 2: Pit 2014. Facing North.
