**Kingsley House**

**Middleham**

**Archaeological Watching Brief  
Phase 2 – the garages**

**Archaeological watching brief at Kingsley House, Middleham  
Phase 2 – the garages.**

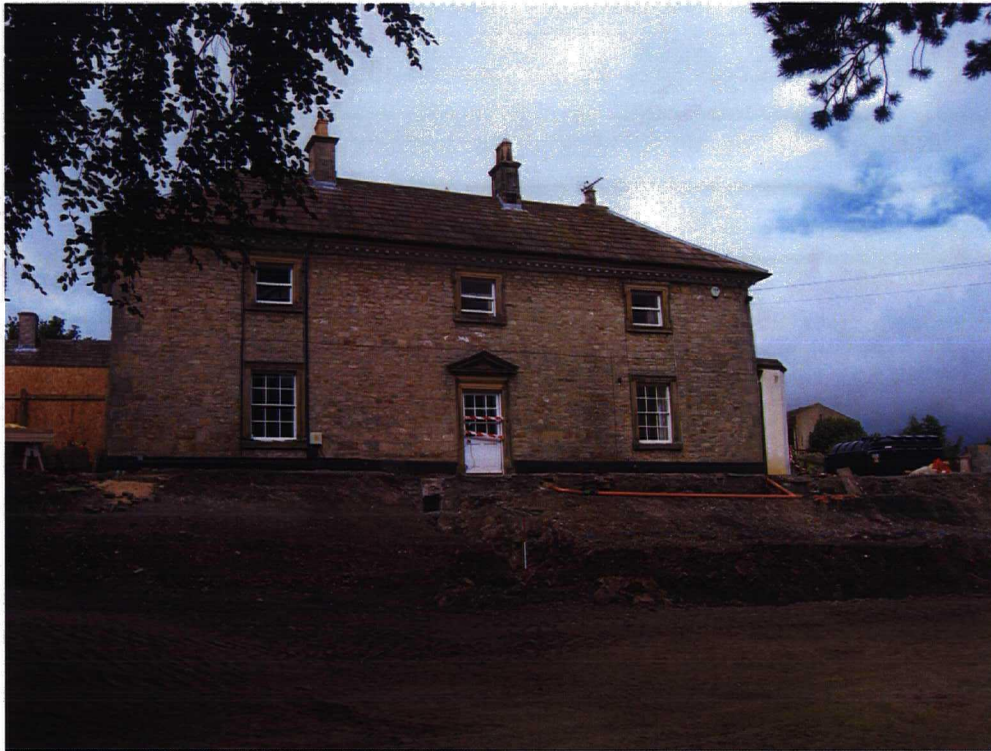
Fig 3. Kingsley House from the east.

The east front of Kingsley House is impressive, with a central door flanked by two 16-pane sash windows at ground level and 3 smaller windows at the first floor. The door- and window-dressings are of finely worked sandstone, and there are some well-worked quoins, but otherwise the stonework is of well-constructed but randomly-coursed rubble blocks. This side was intended to be rendered, as the north side still is.

Below the ground floor, at cellar or basement level, the stonework appears to be even more random. This impression may be genuine, or may be suggested by the fact that the wall below ground level has not been re-pointed and is in a worse state of repair than the wall above it.

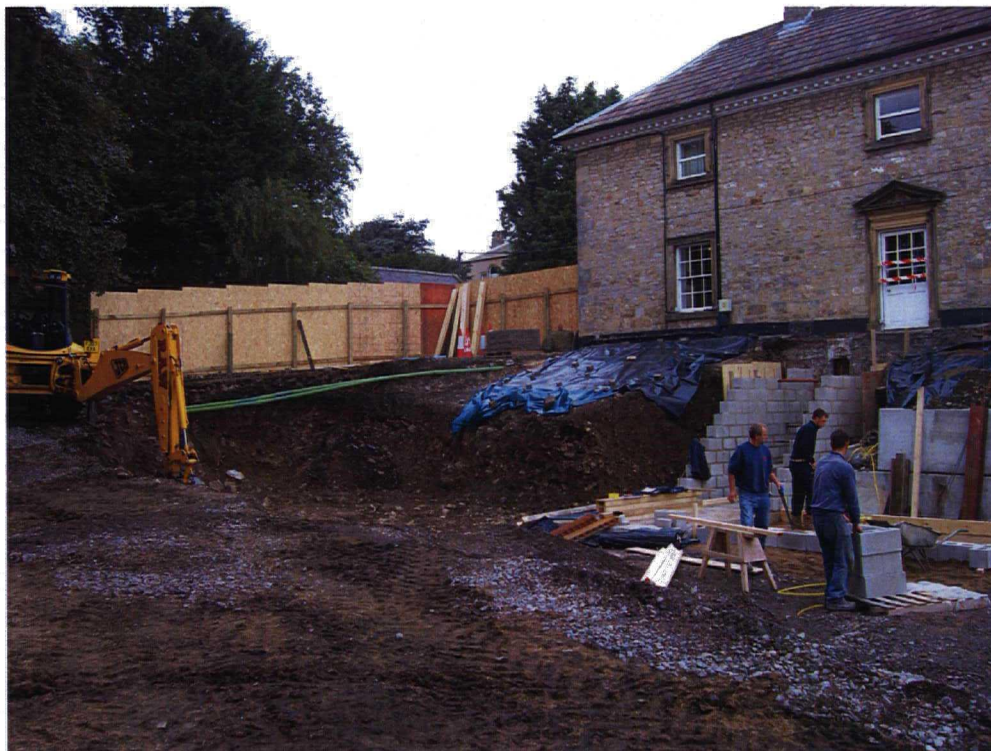
Fig 4. Kingsley House – the development area.

During the latter part of the 20<sup>th</sup> century the central doorway opened on to a terrace on the east side of the house, which was flanked by a shrub garden which sloped away to a cleared level approximately 2.5m below the threshold of the door. The shrub garden was planted into imported dark topsoil (001) approximately 0.5 to 1.5m in depth.

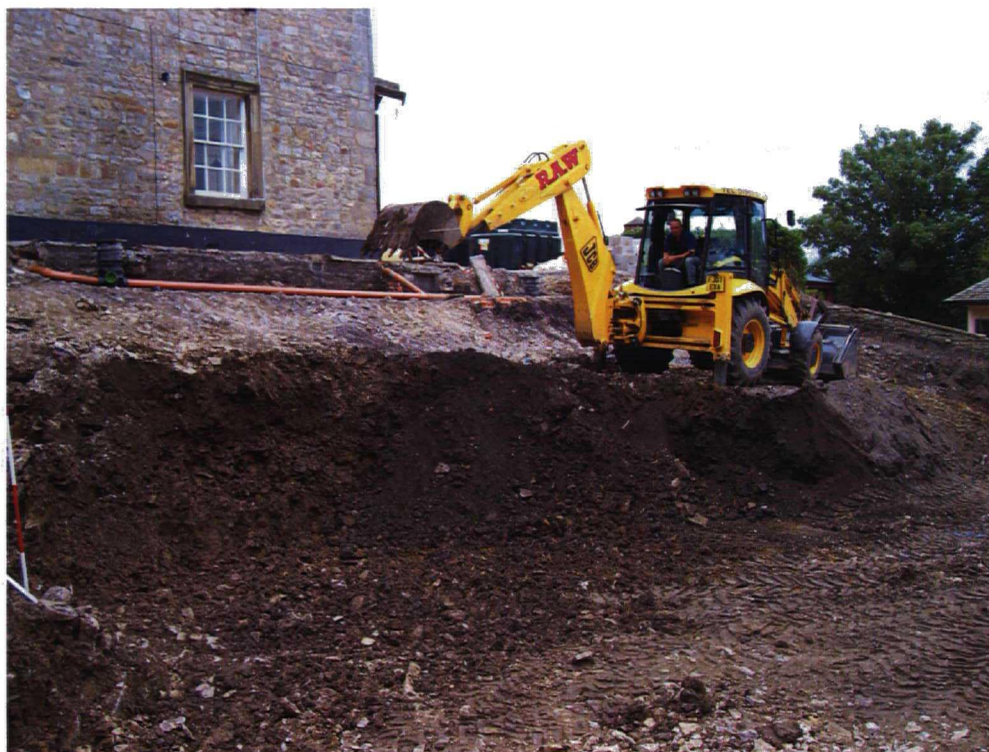
Fig 5 Removal of the shrub garden soil and early stony soil 002.

The shrub garden soil was removed to reveal a lighter, more sandy-coloured soil matrix (002), probably derived from the soils natural to this area, which contained quantities of gravel, angular cobbles and larger stone blocks. A width of approximately 2 to 3m was left in place against the house; beyond this the area was cleared to bedrock (fig 5). Small quantities of brick and some animal bone were present in this material. Three sherds of medieval pottery were recovered; one unglazed cooking pot or cistern sherd in a pale oxidised fabric; one lower neck sherd of a green-glazed jug in an oxidised fabric; and one brown-glazed

Material 002 did not appear to have any stratification, and was certainly not *in situ*. Approximately 1m of the material situated against the house was wetter and therefore darker than the material further out, but there did not appear to be any differentiation in the composition of the material and it has been considered as one context. The simplest explanation for its origin is that it was scraped up from the immediate area and piled against the house for stability and to support a terrace, probably immediately after Kingsley House was built. However, there is no proof of its origin and date of deposition; it could have come from anywhere in the vicinity and been deposited at any time before, say, 1950.

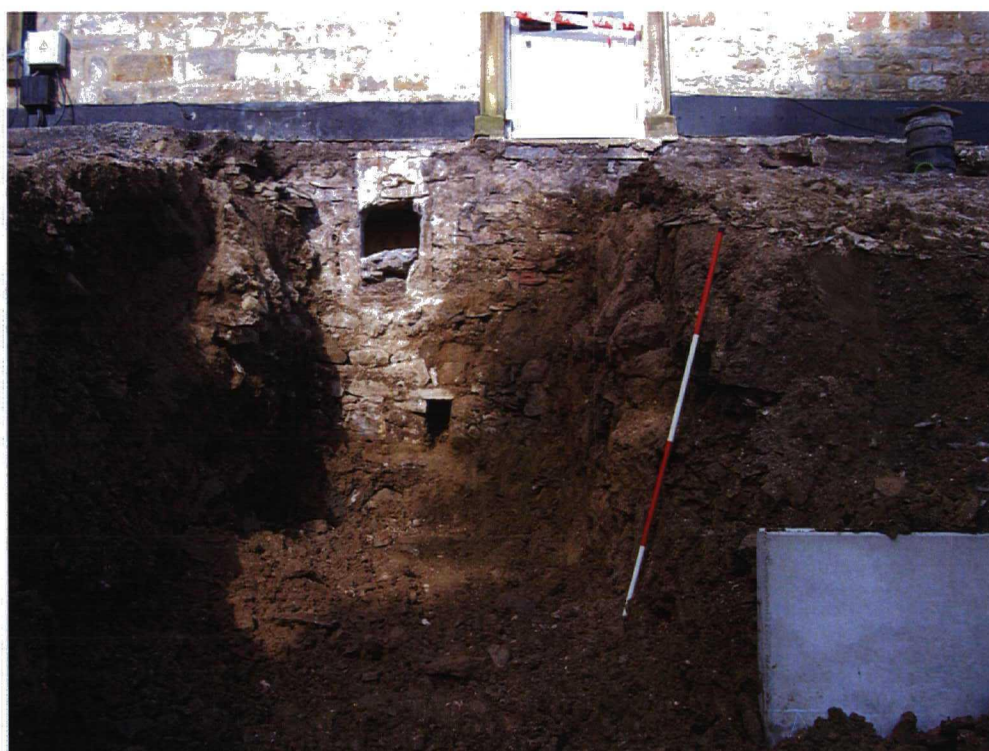
Fig 6. The wine cellar window and drain opening.

A trench between 1.50m and 2m wide was excavated through this material up to the house wall (fig 6), as space for a passageway from the garages and new steps to the terrace once the construction was complete. This met the house wall at a point against the wine cellar, which was to have a doorway inserted to give access to the garages from inside the house. At a point approximately 550mm below the level of the late 20<sup>th</sup> century terrace, a window 650mm high and 500mm wide was located. It had a slab sill and re-used medieval jambs and lintel. In its final use this was below ground level, and had been converted into a coal chute with a hatch in the surface of the terrace above it. The wine cellar had been used for storing coal.

Approximately 800mm below this window, slightly off-set to the north, was a slab-lined drain 250mm high by 150mm wide. This ran through the wall from the cellar, but there was no trace of it continuing outside the building; presumably it ran into the accumulated soil and rubble, which acted as a soak-away. Fragments of a number of glass beer and wine bottles were recovered from it, including a full profile of a dimple-based bottle of early to mid-nineteenth century date.
