**OSGODBY GRANGE FARM, OSGODBY,  
SELBY, NORTH YORKSHIRE**

**SURVEY AND RECORDING REPORT**

**REPORT NUMBER 2010/53**

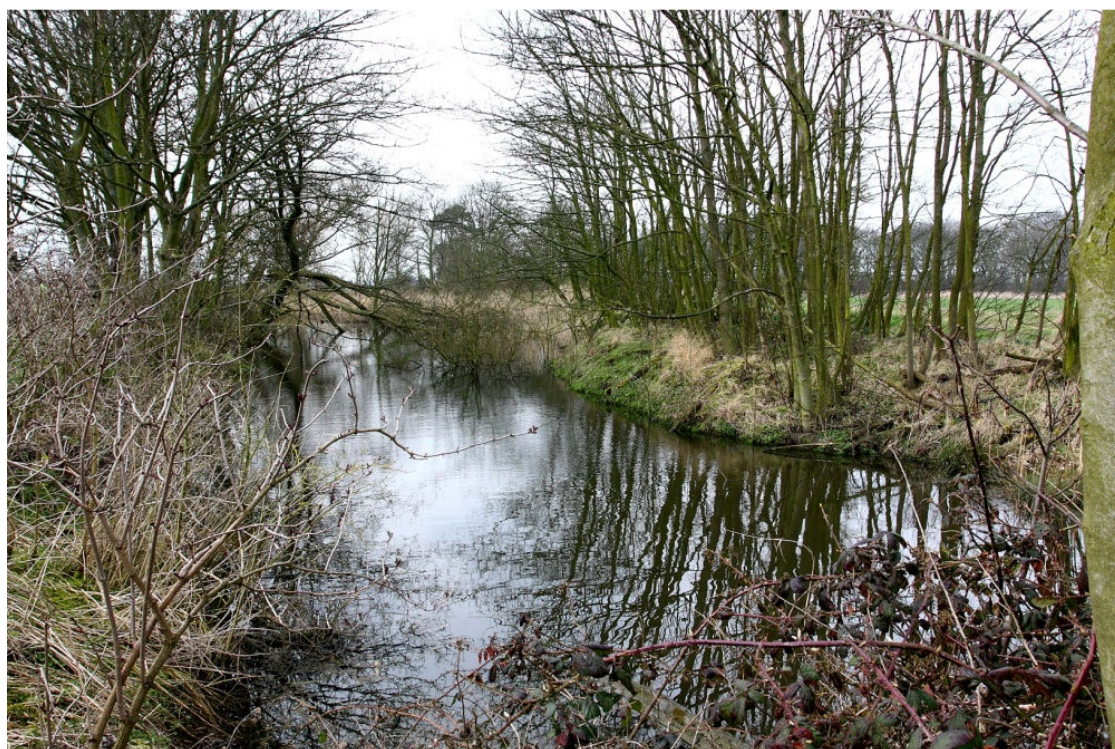
**Plate 1** *Pond 1 from E end, looking WNW*

Pond 1 (NGR: SE 64987 34254) is surrounded by a margin of rough grass and scrub, lies at the northern edge of a large arable field and is aligned approximately east – west. It is located approximately 110m from the north-east corner of this field and is bounded on its northern side by a drainage dyke. Access to the pond is via a north – south running track that leads to the South Duffield Road. Pond 1 presently measures some 120m long and has a width ranging from 13m – 28m. Its basic plan-form can be described as linear with a wide central bulge that tapers to the W and tapers even more sharply to the E. Two small, low, islands are located in the wider central part of the pond the largest of which measures

around 3.5m across, the other somewhat smaller. It was not possible to ascertain the depth of the pond much beyond its sides though the presence of fallen branches protruding above the surface of the water suggests that this is presently likely to be in the region of 1m.

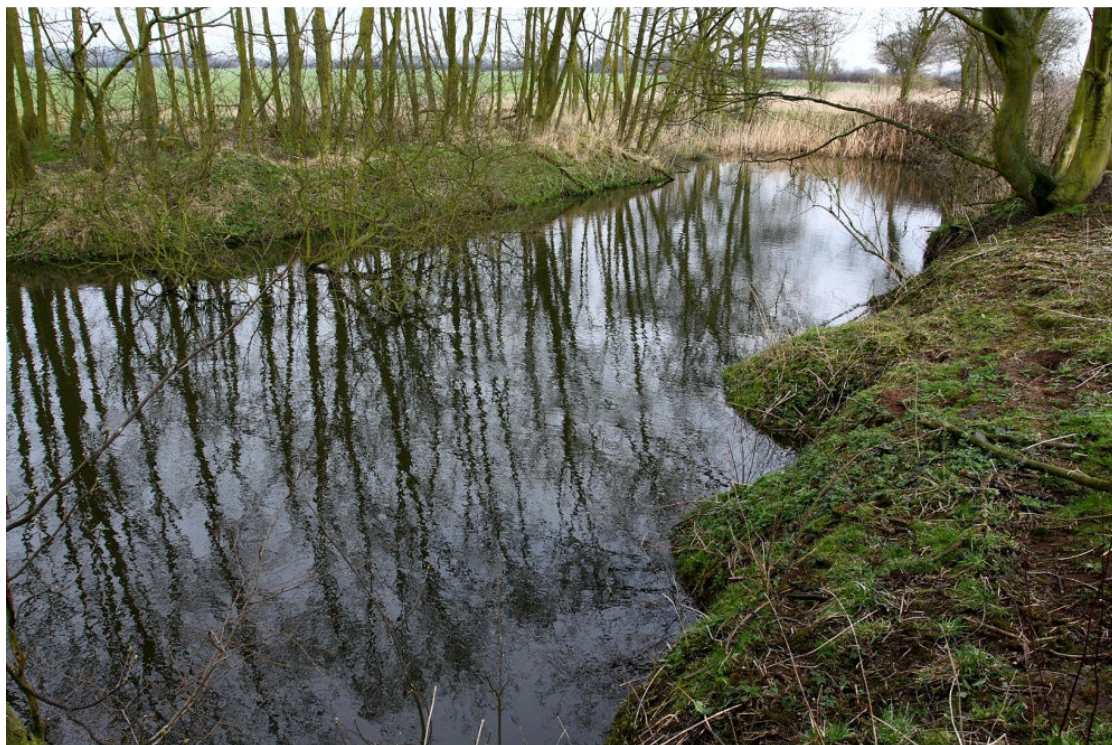
**Plate 2** Pond 1 from S side of central part, looking ENE

There is no evidence for a lining of stone, nor of any metalled surface providing access to the pond from the track. The earthen sides of the pond are in some places quite steep, in others very gentle whilst their height, above water level ranges from just a few centimetres to in excess of 1m. There are no indications of a stone lining or timber revetment. Although the land around the pond is generally fairly flat and level there is a hollow bulge immediately south of the central parts that measures around 23m (east - west) by 11m (north – south). A mound of earth measuring approximately 24m (east – west) by 9m (north – south) is located at the extreme NW side of the pond. Having sides that are generally steep and standing nearly 2m tall the origin of this feature is not certain though its incongruous relationship to the pond may suggest it to be relatively modern. The volume of material in this mound is such that it could only represent a small fraction of the total up-cast from construction of the pond itself though it is possible that it could relate to the deposition of sediment from occasional cleanings out of the pond.

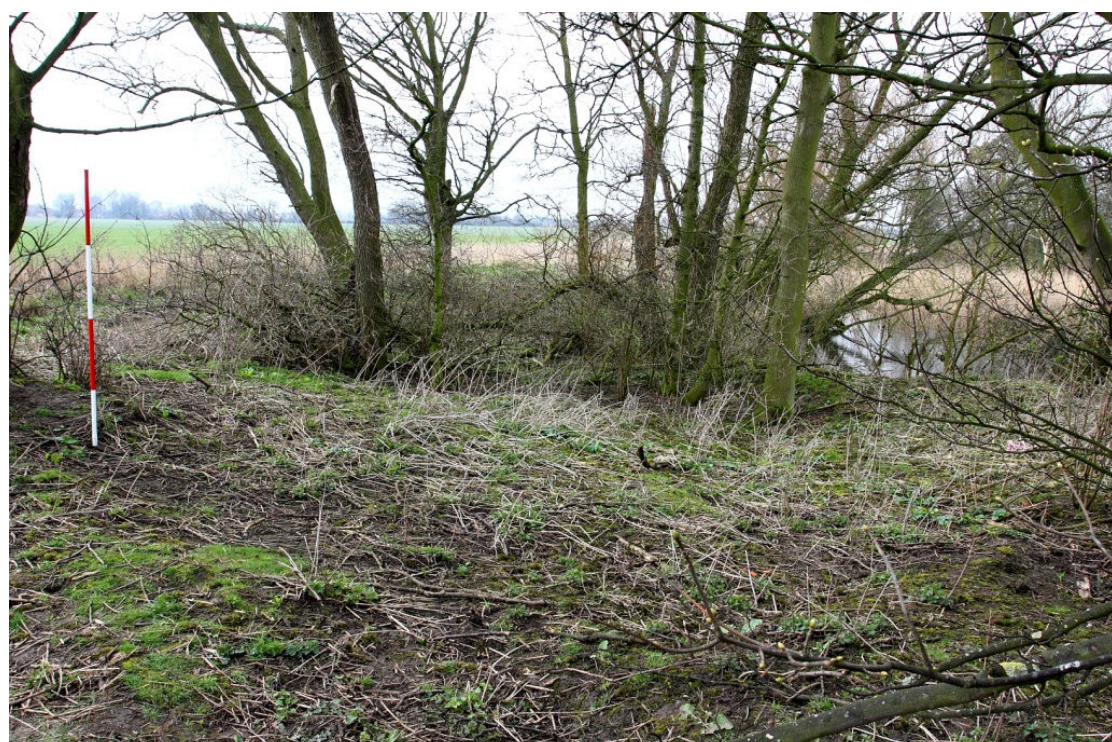
**Plate 3** Pond 1, central part of S side showing wooded hollow marking position of former S pipe, looking W

It is clear that the results of the present survey represent the main east – west aligned body of the 19<sup>th</sup> century decoy pond. The slight bulge on the north side of the surveyed pond relate to the position of the former northern pipe whilst the bulge and hollow on the south side likewise relate to the former pipe on this side.

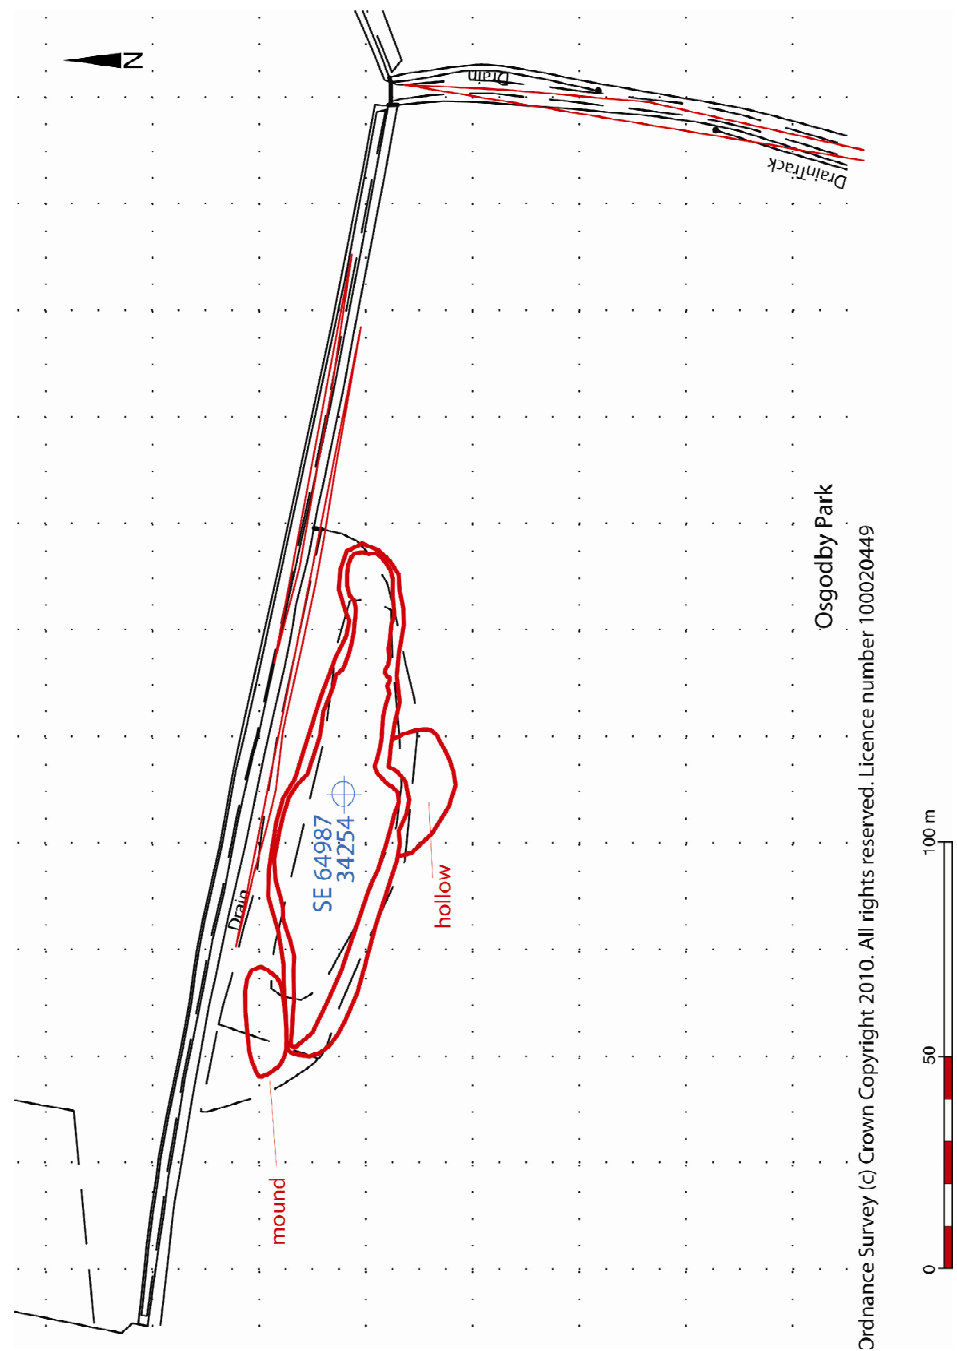
**Figure 3** Pond 1, YAT survey data in red (double red lines = top and bottom of pond sides), O.S. digital mapping in black.

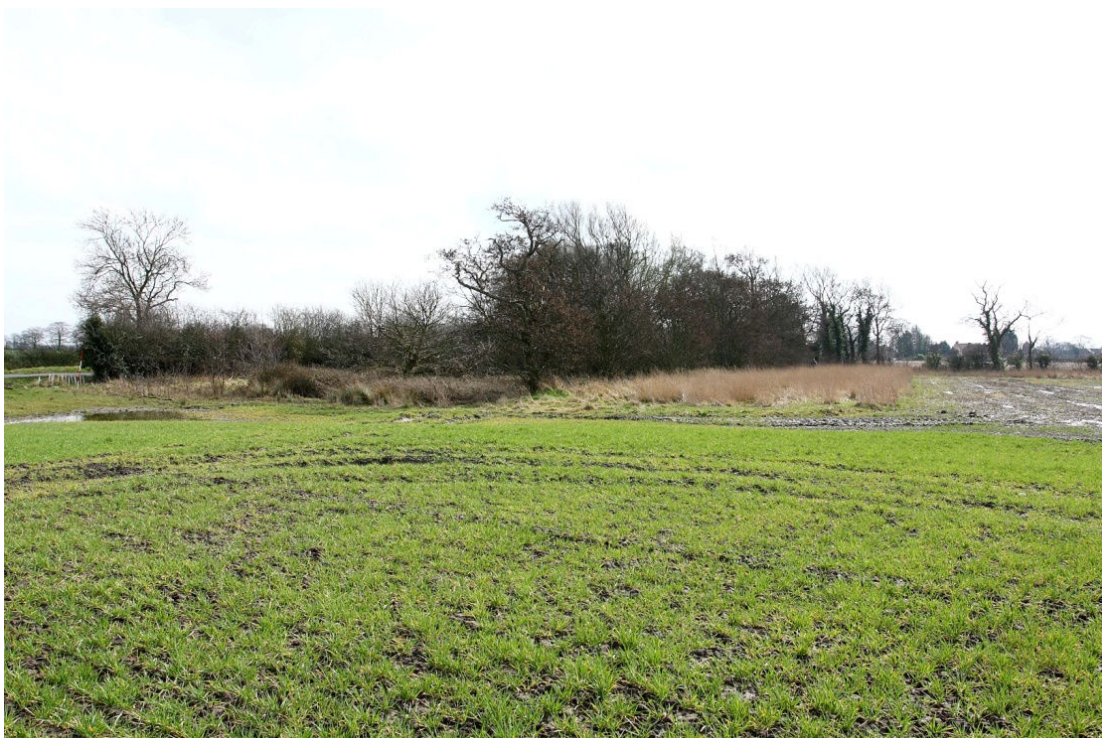
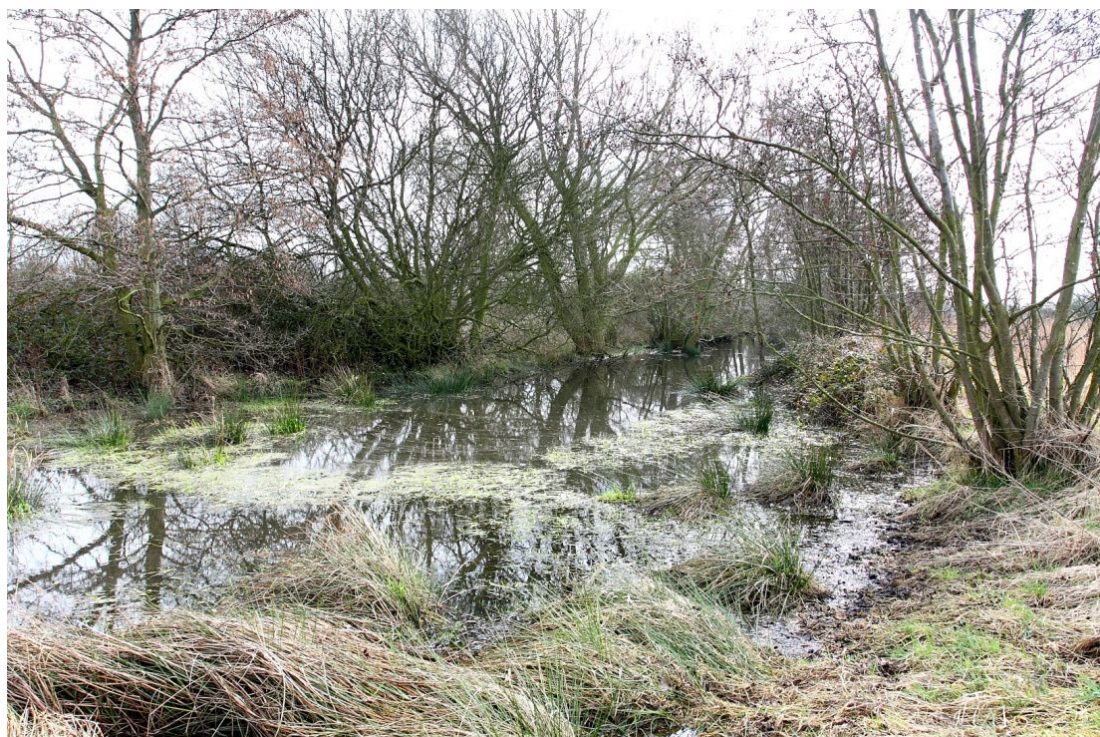
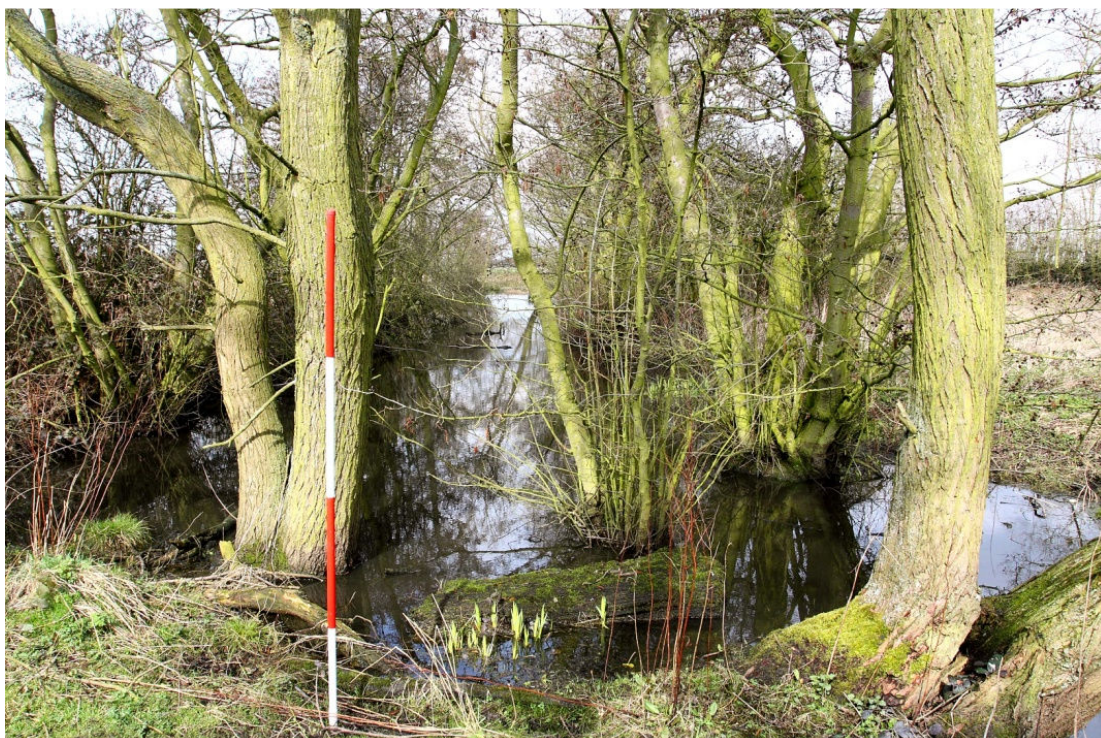
The pond is linear in plan-form, orientated almost exactly north – south and has a length of 80m and a width of up to 12m; the pond being marginally wider at the north end than the south. No islands are present within the pond. There is a dense surrounding of trees and scrub whilst the interior of the pond is partially overgrown with reeds and contains quite a number of fallen branches. The present depth of the pond could not be ascertained though probing around the edges suggested variations of depth in these areas of between 200mm – 400mm. The few irregularities to the pond's generally straight sides appear likely to relate to tree growth and intrusive vegetation. The low edging to the pond is entirely earthen, there being no indications of a stone lining, stone base or timber revetment. In most places the pond edging is very gently sloping, only in a few restricted areas, mostly the western side, are these steeper.

**Plate 5** Pond 2, looking SE

**Plate 6** Pond 2, from near SE end, looking NNW

**Plate 7** Pond 2, from SW end, looking N

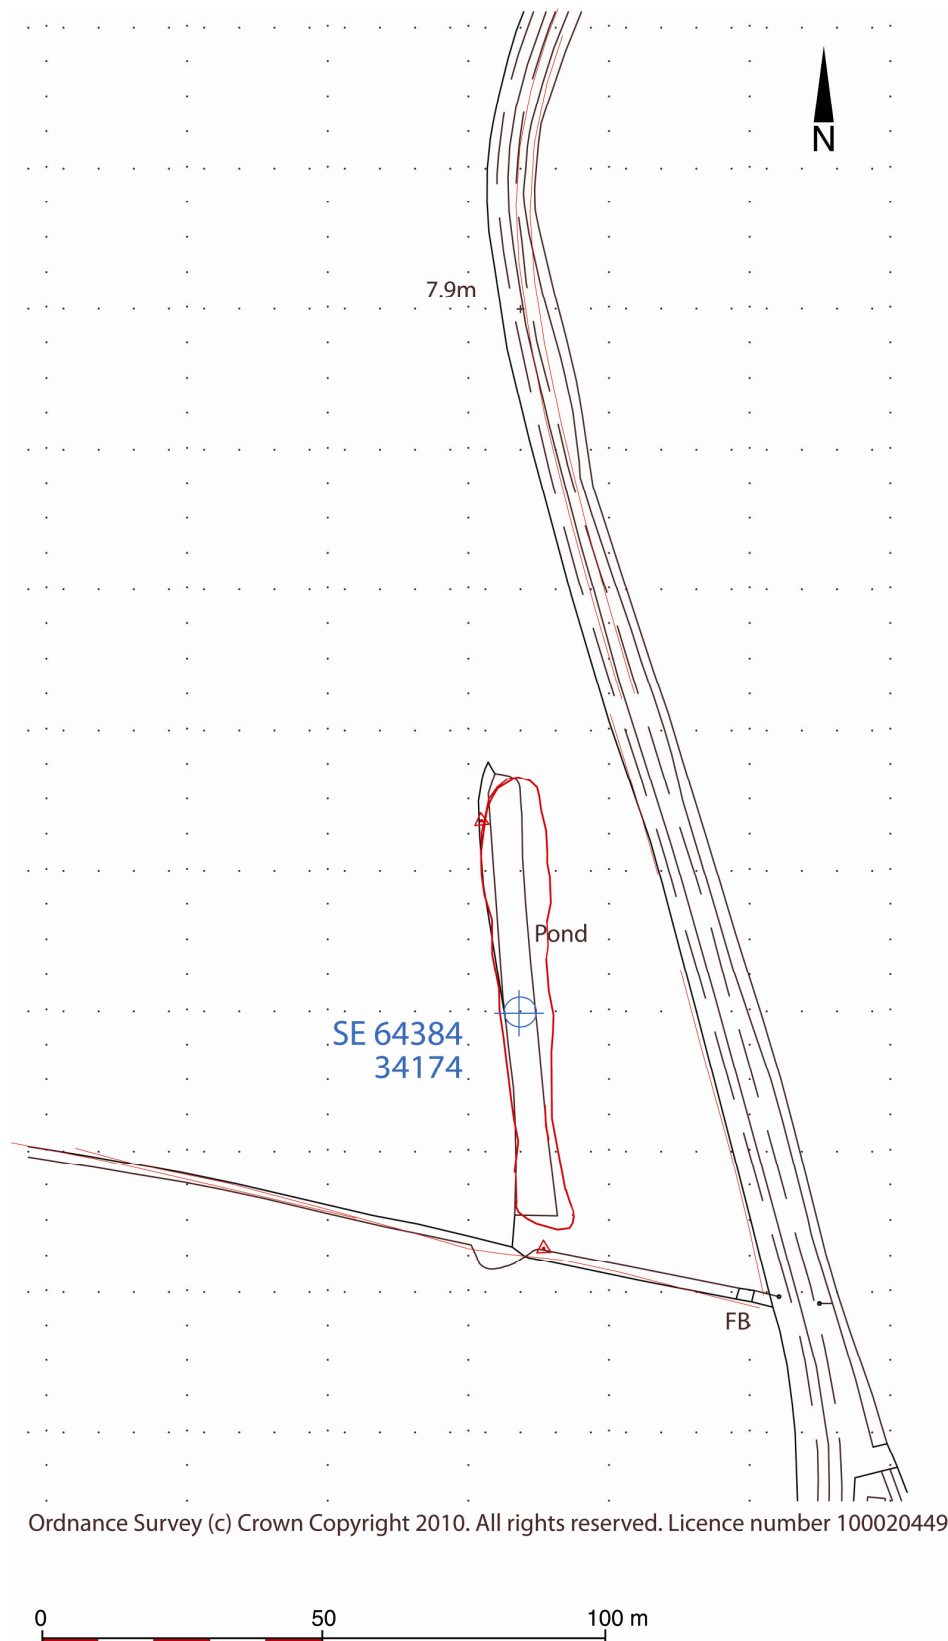
**Figure 4** Pond 2, YAT survey data in red, O.S. digital mapping in black.

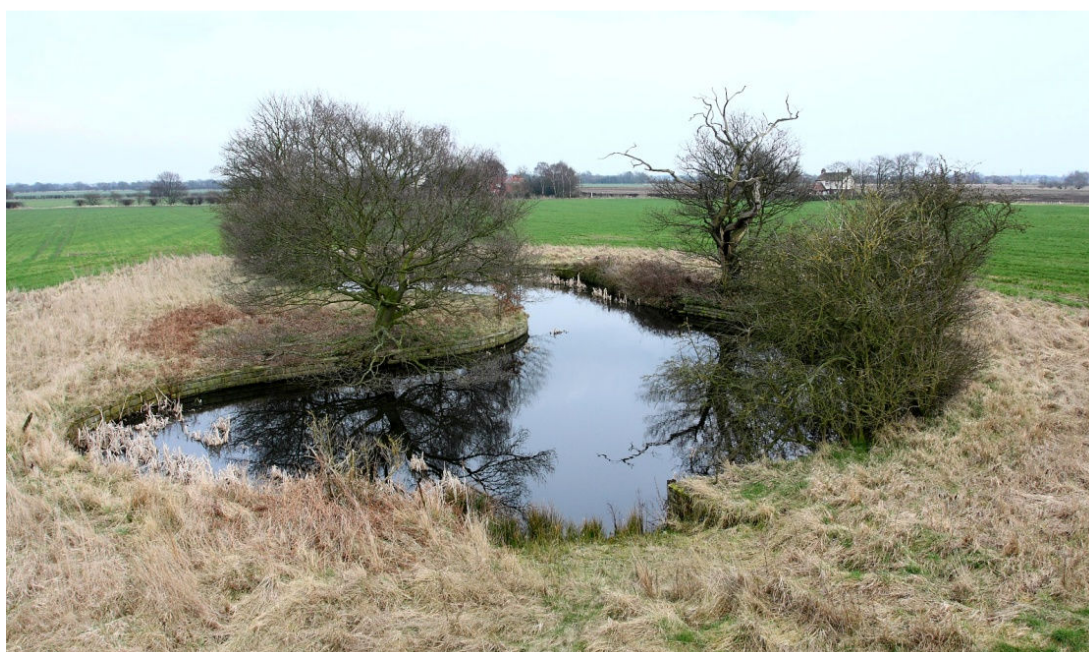
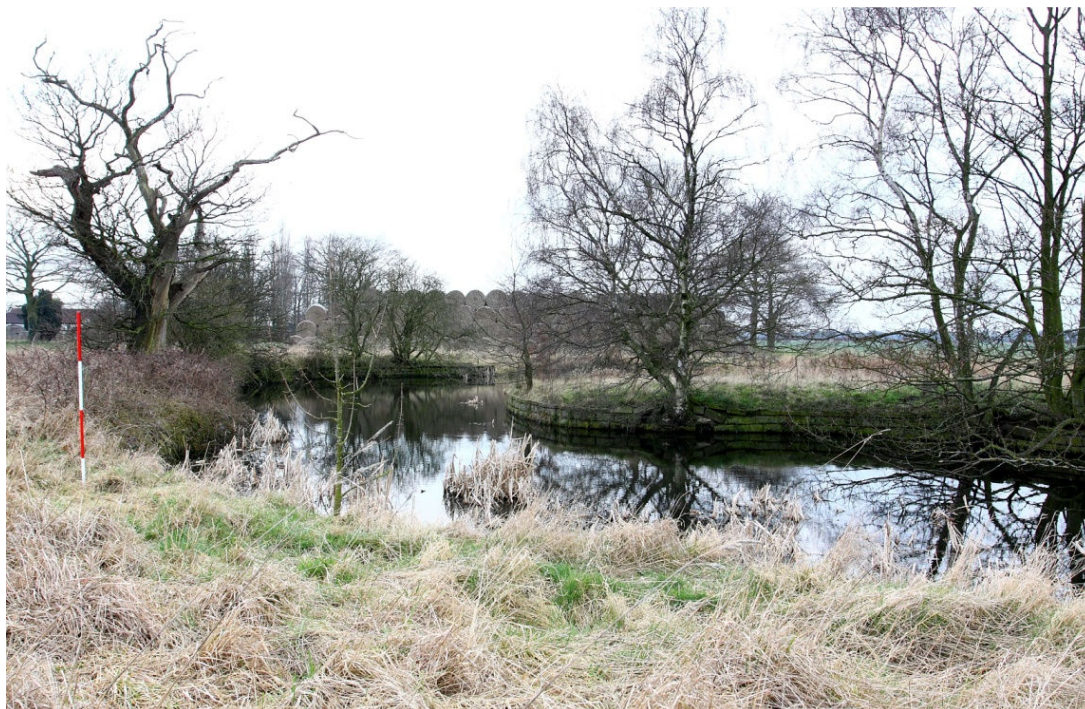
Pond 3 (NGR: SE 6484 34008) is located around 250m south-south-west of Pond 1 within the same arable field, and about 150m to the north-east of Osgodby Hall. Although a border of rough grass surrounds the pond this is completely surrounded by flat arable land and cannot be directly accessed via a track or path. The pond is of a kidney shaped plan-form which measures around 52m in its longest axis (east – west), between 19 – 28m wide in its north–south axis with a width at its central neck of only around 9m. The pond does not support any islands. The sides of the pond are formed of vertical walling of stone. The stone is of rusticated blocks and is regularly laid in courses some 0.18m deep surmounted by a capping of thinner blocks. In a few places small areas, restricted to the southern side, some collapse of the walling is evident. In several areas trees are growing through the stone walling and this seems certain, if un-checked, to cause further collapse. Shallow probing towards the edges of the pond could not confirm the presence of a metalled base, though it is possible that such may lie concealed beneath accumulated sediments. The surface of the water lies around 0.5m below the top of the side walls. Close to the edge of the walls the pond has a water depth of around 0.65m; the depth interior to this was not ascertained.

**Plate 8** *Pond 3 and its wider setting, looking E*

**Plate 9** Pond 3 overall shot, looking W

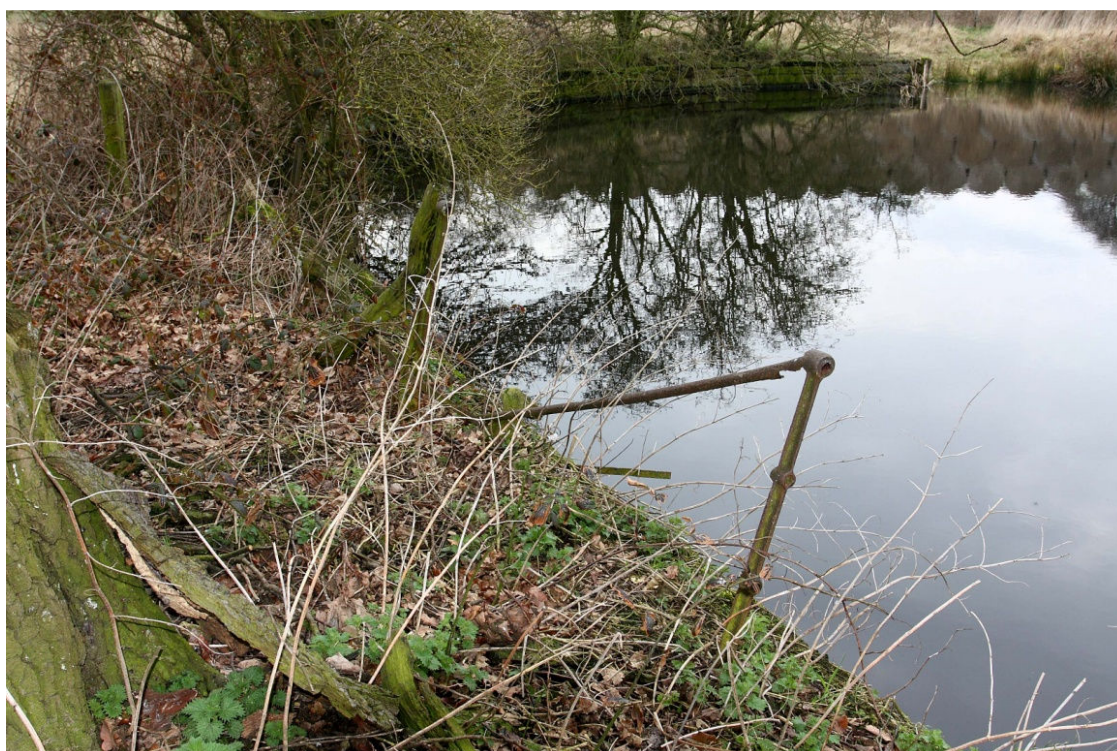
A few small broken fragments of wrought iron posts, together with a few pieces of rectangular section iron railing survive around the pond and clearly originally formed a barrier around the feature. Subsequently, a series of cruder wooden posts supporting barbed wire were erected around the pond though again, little of this now survives. The pond does not appear on the first edition O.S. map of 1851 though it does appear in editions of the next series of the 1890's. The pond is clearly of later 19<sup>th</sup> century origin.

**Plate 10** Pond 3 detail of iron railing with later wooden post to top left, looking E

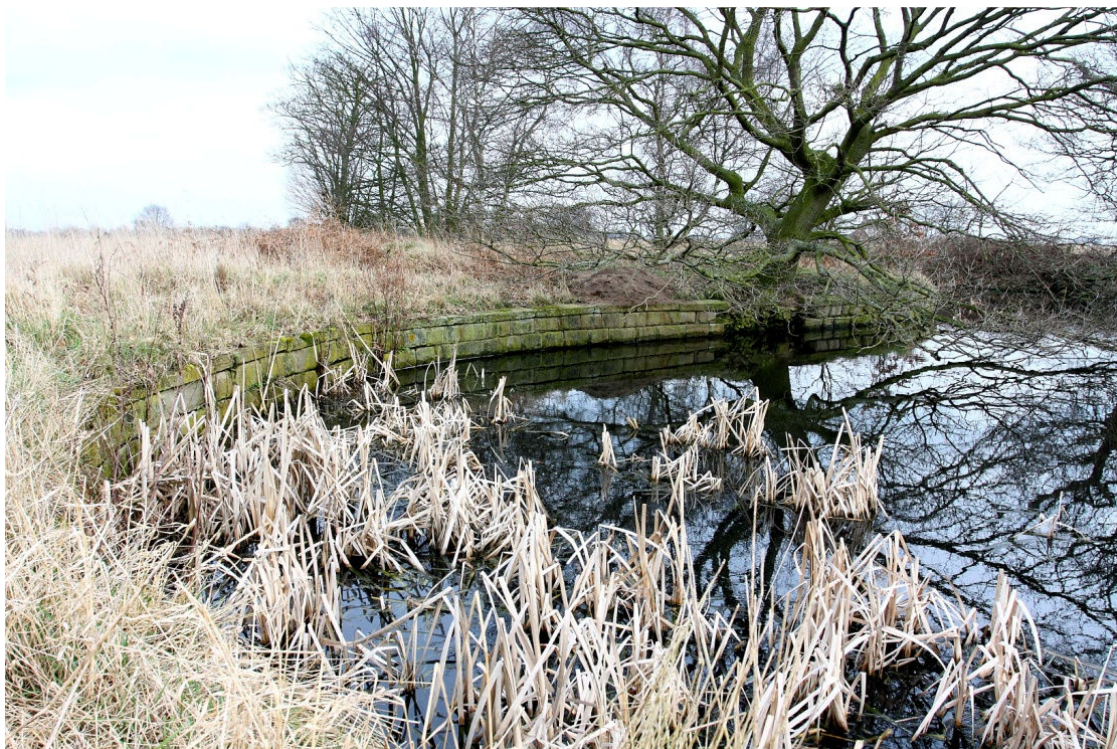
**Plate 11** Pond 3 tree damage to S side, looking E

Threats to the features at the present time appear to be restricted almost solely to neglect. Ponds 1 and 2 in particular contain numerous tree branches and their borders have been colonised by various flora whilst trees growing against and within the stone walls of Pond 3 have led to small localised areas of collapse. In their present condition none of the four surveyed features can be described, in archaeological terms at least, as of national or regional significance and careful programmes of repair and maintenance are likely to be of limited archaeological impact. However, any such likely impacts can only be assessed once a firm programme of proposals has been formulated. Had the park and Pond 1 not undergone the transformations involved in its whole-scale conversion to arable then the entire park landscape could have been considered as of greater importance. In the purely local context the recorded features are of some interest.

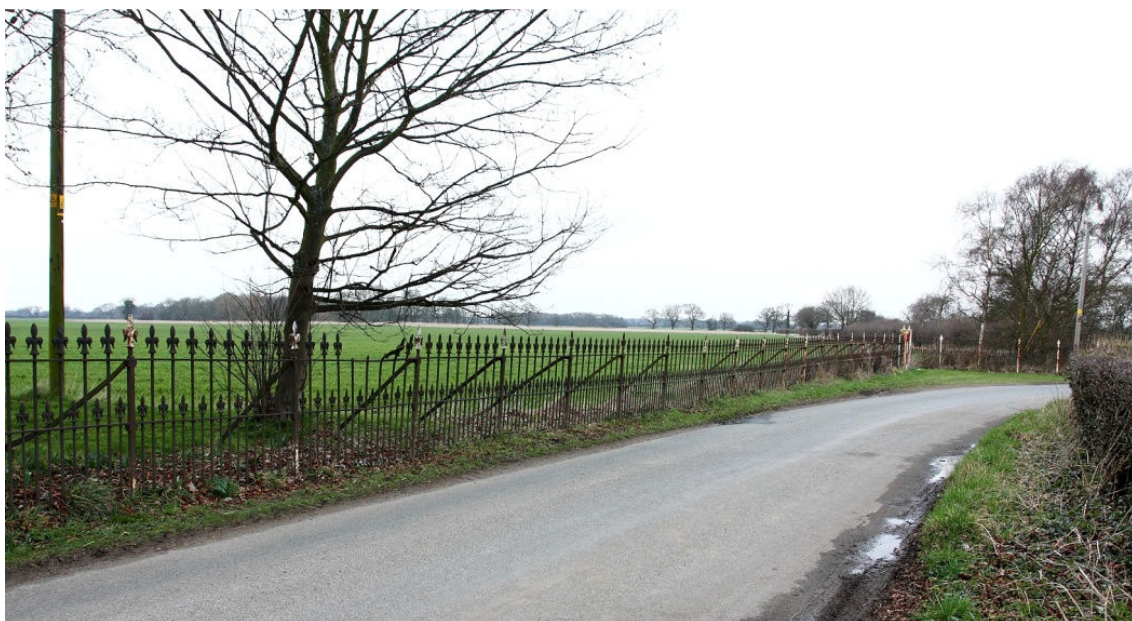
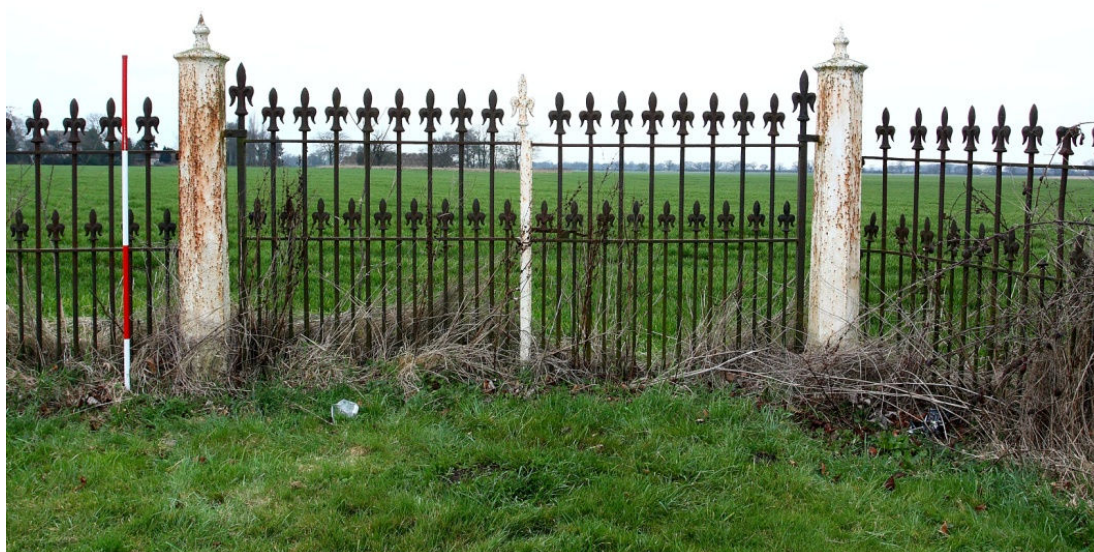
A section of 19<sup>th</sup> century iron railings forming part of the park boundary survive at its south-east corner and follows, to the north and west sides, the course of a bend in the South Duffield road (NGR: SE 65074 33914). This is comprised of a 44m long stretch aligned south-west – north-east and a further east – west aligned stretch some 33m in length. The railings are constructed of mass produced sections each some 1.8m in length and bolted at either side to square section posts in excess of 35mm across. Two rectangular section horizontal rails extend across each section, the lower at a height of 1.07m BGL, the upper at 1.67m BGL. Eight equally spaced vertical rails of 25mm diameter extend to a point just above the upper rail whilst nine vertical rails of around 20mm diameter are positioned between each of the larger verticals though these extend to a height just above that of the lower rail. Bracing, internal to the railings, is provided by rectangular section bars that extend from the upper part of each post and into the ground at an angle of around 45 degrees. The precise method by which the brace is secured to the post is simple, yet elegant. The upper end of the brace angles through a socket in the post whilst the retaining bolt, which secures the sections of rails to either side, passes through the brace and holds it fast. Each post and each vertical rail is decorated with a fleur-de-lis head. Although this device is often used decoratively in what appears to be an almost indiscriminate manner it is also a symbol often linked to royalty and the nobility in their coats of arms. Whilst not pushing the point too far, there may be allusions to status and grandeur in the use of this device, that exceeded that of the park and its owners. The railings are of wrought iron and the fleur-de-lis heads of cast iron. A pair of gates are present in the angle of the railings. The gates posts are of octagonal section cast iron and taper slightly to the tops which are surmounted by ornate points. The gates themselves are of the same design as the railings.

*Plate 12 Park railings, looking NNE*

*Plate 13 Park gates, looking W*

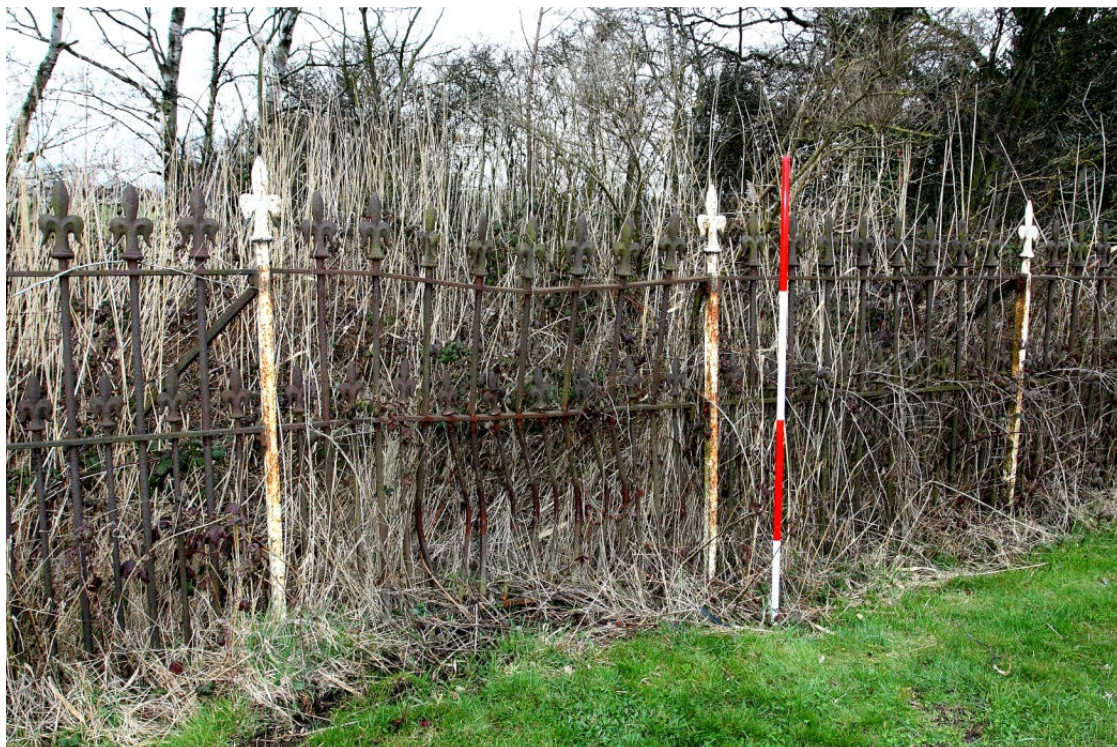
The railings are generally in a reasonable state of preservation and there are no gaps, or missing sections, within the extant two stretches. A very few of the fleur-de-lis heads are missing and there are small areas where the railings are buckled, mostly towards the E part of the E – W stretch, presumably as a result of collision by motor vehicles. There seems little doubt that what damage does exist could be repaired. Although the railings are not marked on any of the O.S. maps consulted, maps of the 1890s show that a driveway extended from the area of the gates on South Duffield Road, eastwards to the Hall. This driveway, which no longer exists, is not indicated on the 1851 map and would appear therefore to be a later 19<sup>th</sup> century development. It is not known if the surviving railings represent surviving parts of a once more extensive barrier of rails.

**Plate 14** Damage to E – W stretch of park railings, looking NNE
