ARCHAEOLOGICAL  
SERVICES  
DURHAM UNIVERSITY

Green Walk  
Temple Grounds  
Richmond  
North Yorkshire

archaeological monitoring

report 2452  
July 2010

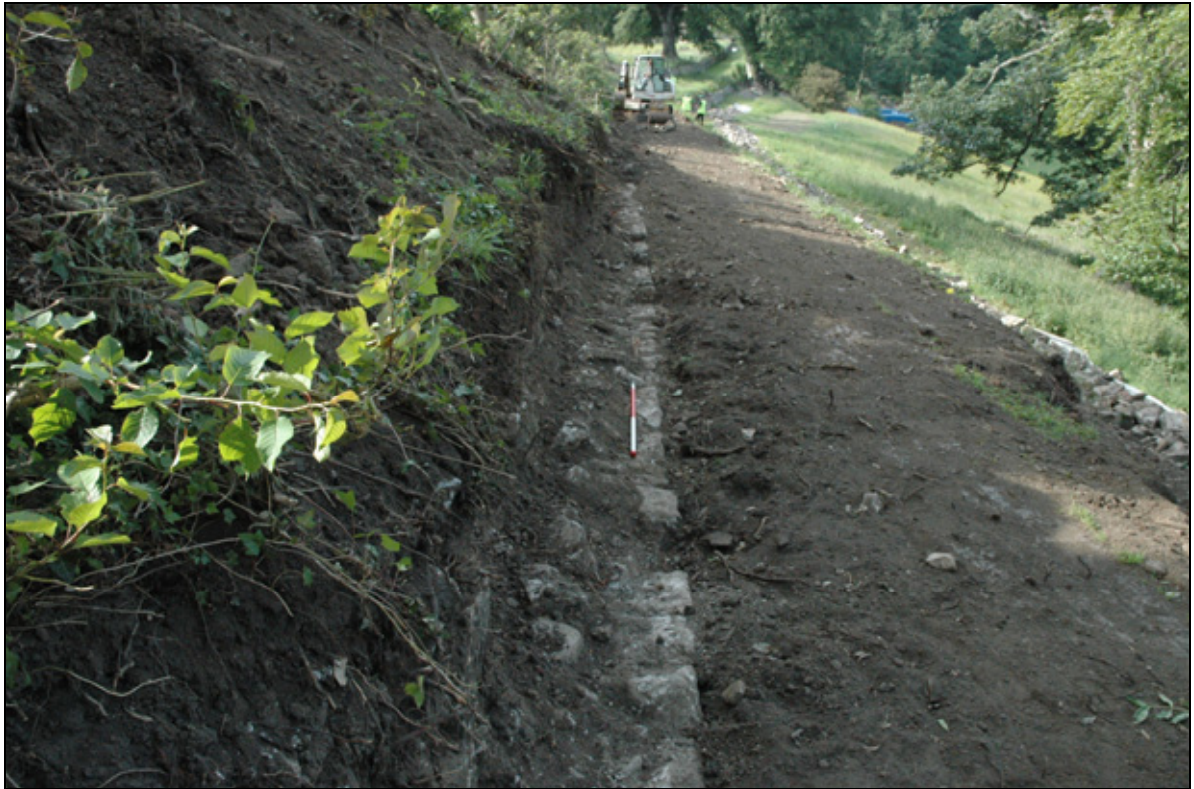
- 5.2 The footings for the upper wall (Figure 3) measured 20m+long x 0.36m wide x 0.24m in height were encountered at a depth of 0.25m below ground level (bgl). Immediately above the footings was topsoil. The footings for the lower wall measured 20m+long x 0.42m wide x 0.22m in height, and were encountered at a depth of between 0.35m and 0.65 bgl (Figure 4). The footings were covered in wall collapse and topsoil. Natural subsoil was not encountered during the excavations.

Figure 3: footings for upper retaining wall, looking south

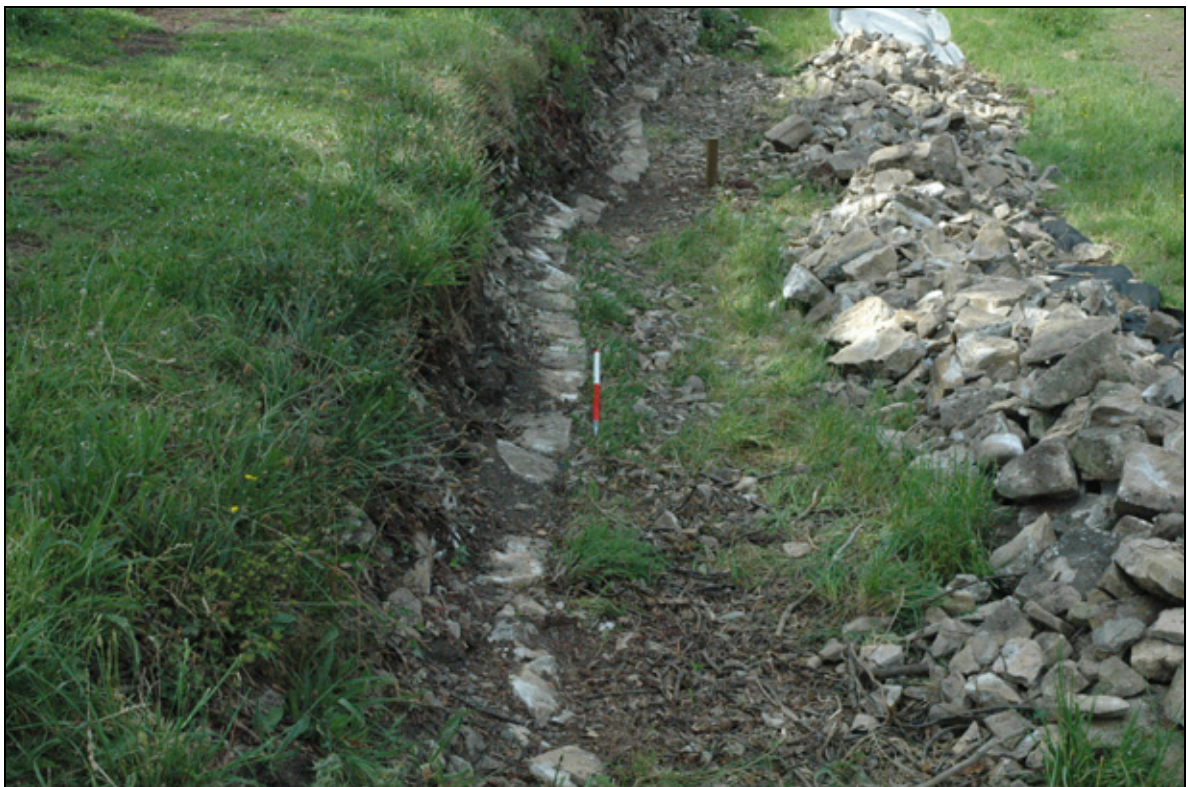
Figure 4: footings for lower retaining wall, looking south
