**10 Plum Street
Norton
Malton
East Yorkshire**

**ARCHAEOLOGICAL EVALUATION
BY TRIAL TRENCHING**

September 2010

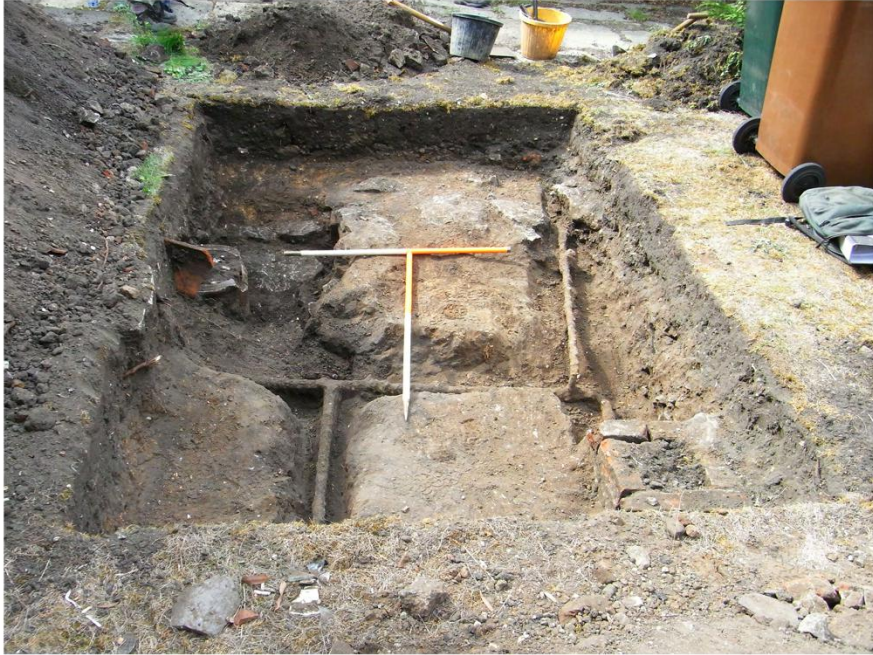
Plate 3. Trench 1: Modern Features. Facing East.

All features sealed by the modern garden soil were dated to the early-mid nineteenth century. These features included a stone feature, possibly a French drain (contexts 1012, 1013 and 1014), a brick lined culvert containing a salt-glazed drain (contexts 1005-1010) and a water pipe trench and a brick stop tap (contexts 1002-1004). These features relate to the buildings erected in the nineteenth century and visible on the First Edition Ordnance Survey Map (Fig. 4).

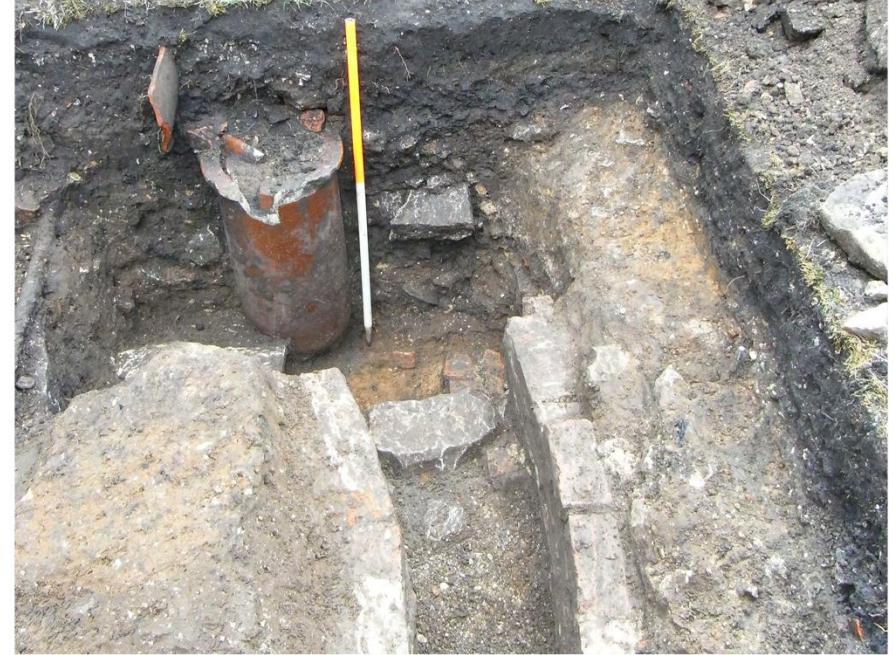
Plate 4. Trench 1: Drain Culvert 1007 and Soakaway Pit 1010. Facing South.

The drain/soakway fills (contexts 1006 and 1008) contained early to late nineteenth century pottery, residual sherds of Medieval and Roman pottery, Clay tobacco pipe fragments, animal bone and modern glass. The subsoil deposit (context 1011) contained pottery sherds dating from the Roman to Modern periods, and included sherds of a Staxton ware cooking pot, ceramic building material and animal bone.

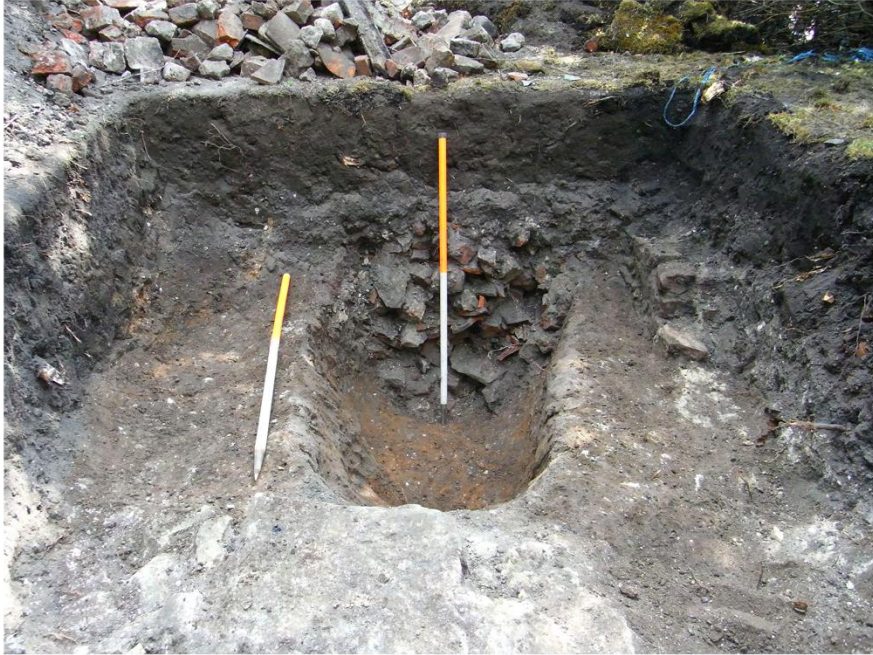
Plate 7. Trench 2: Pit Cut 2003. Facing South.

Pit 2003 cut through subsoil deposit 2004, and was filled by Deposit 2002, which consisted of stone, brick, pantile and mortar rubble. Pit 2003 was sub-rectangular in plan with steeply sloping sides and a flat base. Pit 2003 was located in the centre of the southern half of Evaluation Trench 2 and continued beyond the southern baulk of Evaluation Trench 2. The base was at 22.55m AOD.

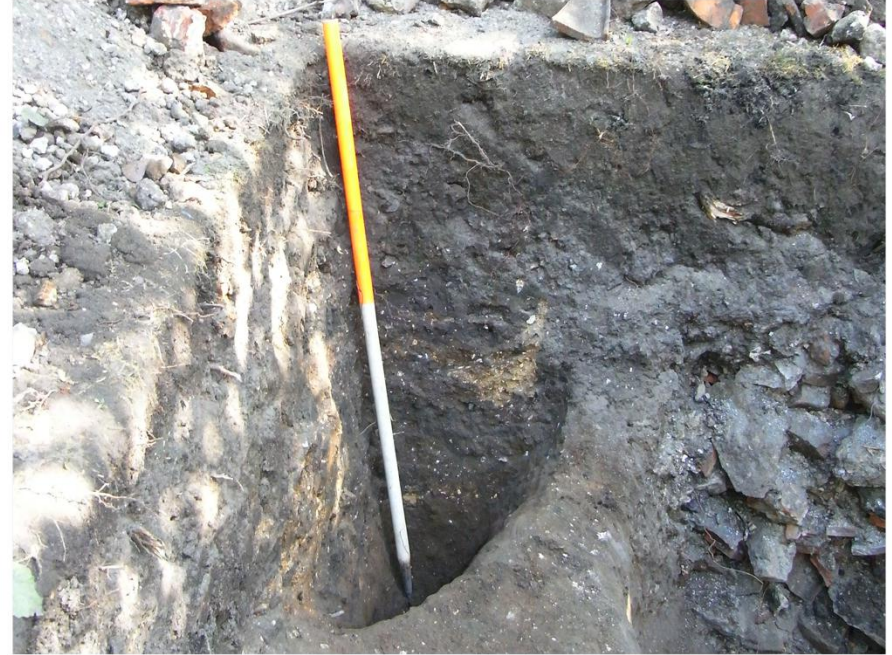
Plate 8. Trench 2: Pit Cut 2008. Facing South.

To the east of Pit 2003, in the south-eastern corner of Evaluation Trench 2, was another pit (cut 2008). Pit 2008 continued to the east and south. Pit 2008 was filled by a mixed deposit of backfilled topsoil, subsoil and natural sands and gravels.

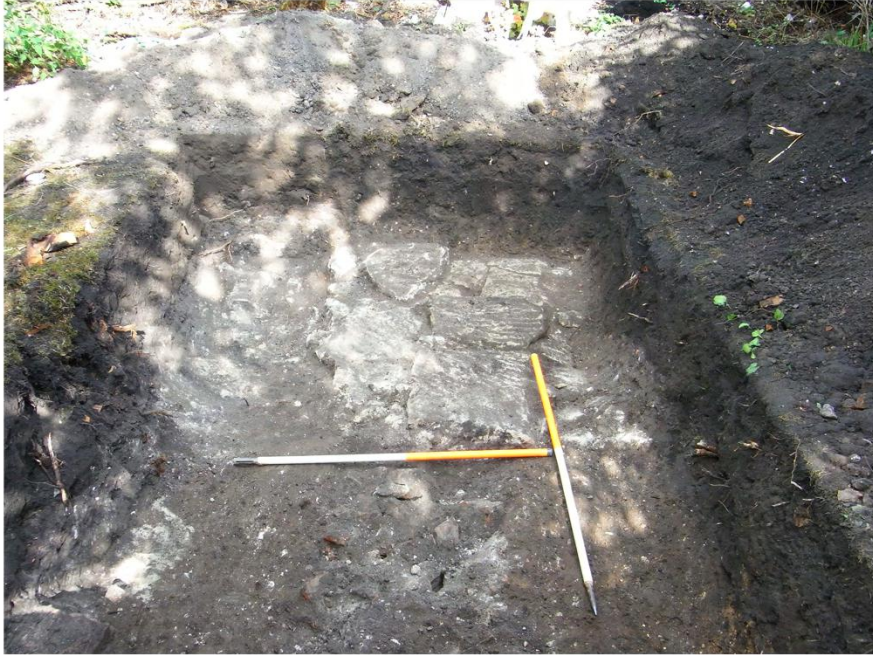
Plate 9. Trench 2: Limestone Floor 2005. Facing North.

In the south-western corner of Evaluation Trench 2, was a brick wall (structure 2005), which comprised three courses of plain brick bonded with mortar. Across the northern half of Evaluation Trench 1 was a rough limestone floor (structure 2006). Both wall 2005 and floor 2006 were constructed above subsoil (context 2004).

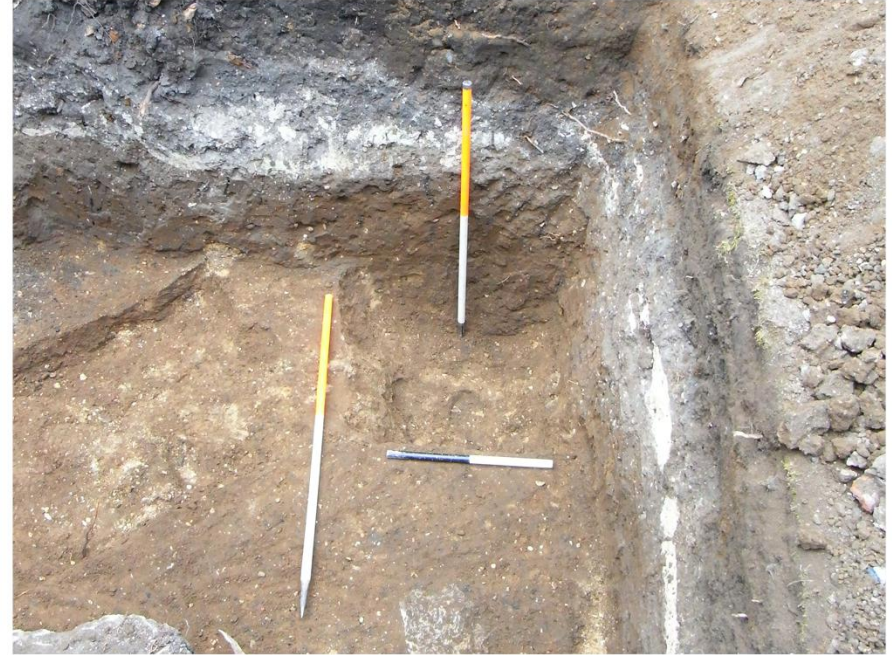
Plate 10. Trench 2: Gully 2010. Facing West.

A single linear feature, aligned east-west was visible cutting through natural sands and gravels at the northern end of Evaluation Trench 2. A 0.90m wide segment was excavated through the western side gully cut 2010. Gully cut 2010 had steep sides with a slightly rounded flat base (flat based U-shaped profile). This feature was filled by deposit 2009, a brown silty sand and a sherd of Roman Greyware was recovered. A soil sample was taken, and the flotation produced fragments of charcoal. Deposit 2009 was sealed by subsoil 2004.
